Bridge Inspection Report

02841
SH 1-01 LM 18.41
over
Drainage Ditch

Structure Number: 02841

Facility Carried: SH 1-01 LM 18.41

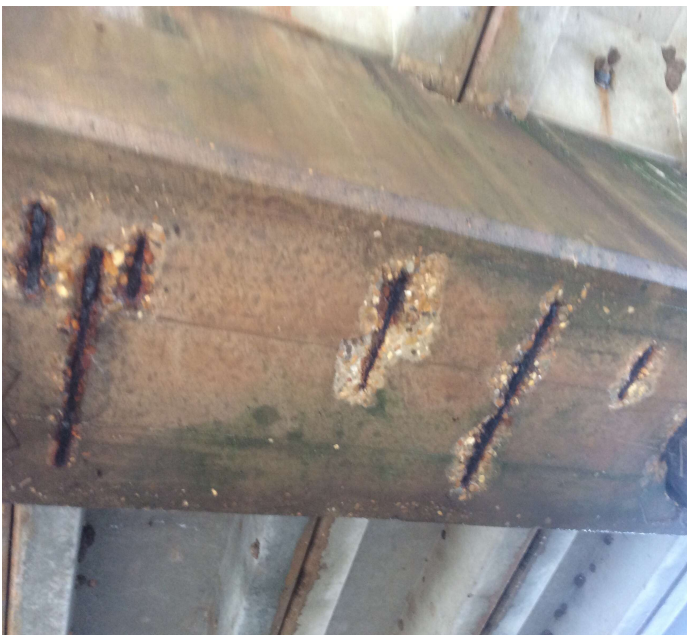
1150 - Check/Shake		2		0	0	2	0
234 - Reinforced Concrete Pier Cap	1- Ben.	75	ft.	58	9	8	0
<p>Caps: 25' each / Bents 2-4. Bent 2: Small areas of delaminations and spalling on bottom face of cap - reinforcing steel exposed with some rust and section loss (exposed rebar - CS3 8'). Bent 2 & 4: Small contact spalls under channel legs (spall - CS2 9')</p> <p>Old Notes. Repaired by State Forces. Bent 3: Apparent lateral and longitudinal movement of piling and cap - leaning to the right and back. Cap appears to have moved approximately 6" to the right and 6" back from original position. Movement has resulted in the reduction of bearing area for precast channel beam units of Span 3 at Bent 3 - only 4-5" of legs remaining on cap on right side (Units 5-7) and half-width of outer leg of Unit 1 remaining on cap (left end of cap).</p>							
1080 - Delamination/Spall/Patched Area		9		0	9	0	0
1090 - Exposed Rebar		8		0	0	8	0

Cap - Bent 2: Small areas of delaminations and spalling on bottom face of cap - reinforcing steel exposed with some rust and section loss.

PHOTO 1 Description Cap - Bent 2 bottom face (corrosion)

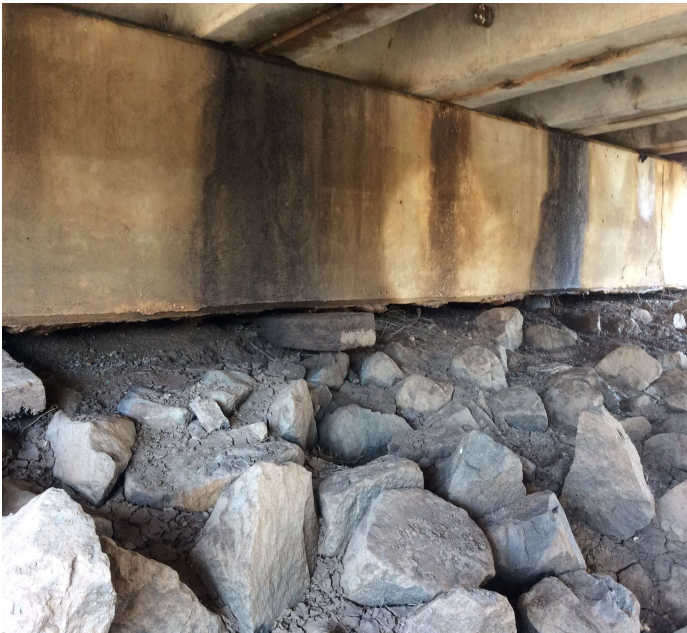
Endslope - Bent 5: - Minor settlement (4-5") of fill material under bottom face of cap - full length of abutment.

PHOTO 1 Description Endslope - Bent 5 (settlement)

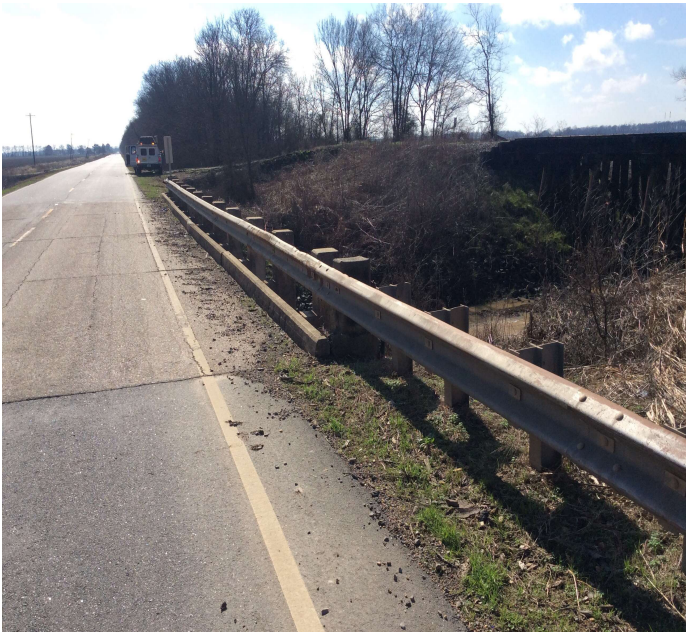
Signs - Bent 5: Object markers, posts, and log mile signs are missing (have been knocked down) on both side - object marker and broken post currently lying down behind railing on right side.

PHOTO 1 Description Sign - Bent 5 left (missing)

Repaired by state forces.

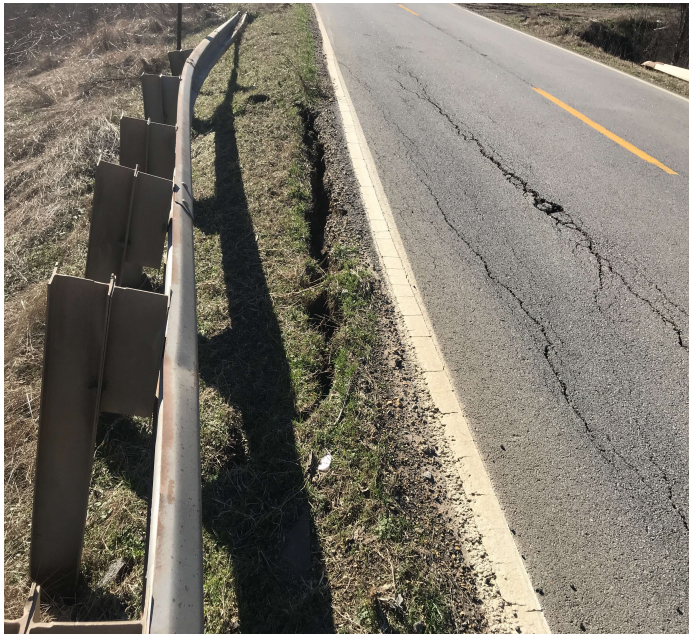
South end of bridge, right side slope embankment and roadway have slipped causing settlement to roadway and drop off at edge of pavement.

PHOTO 1 Description Approach edge of roadway has erosion up to edge of asphalt and base failure and possible erosion under roadway.

County crew have sealed the top off, not allowing water infiltration. Additional work will be done as time and weather permits.

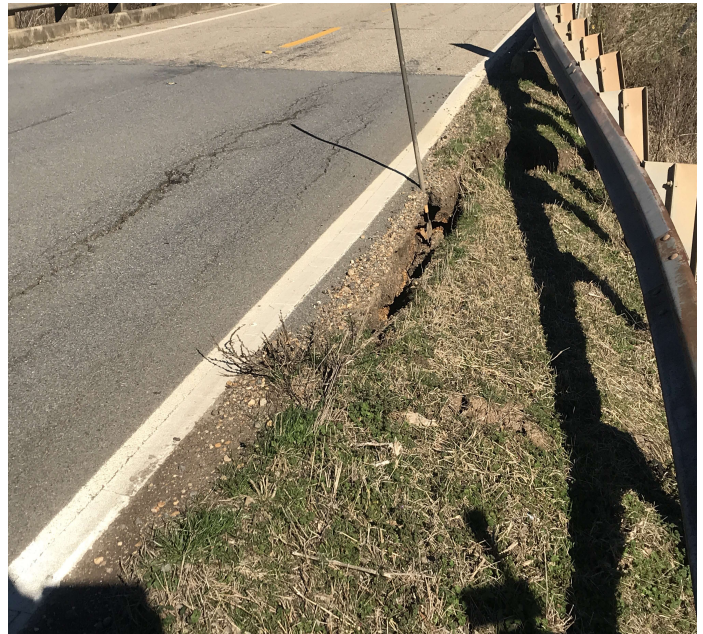
PHOTO 2 Description Approach bent 1 right side slope erosion.

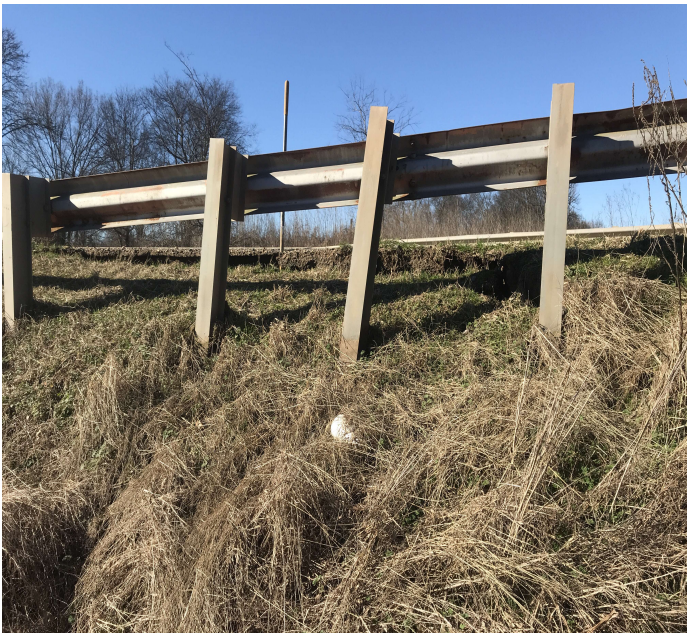
PHOTO 3 Description Approach right side of roadway has material sliding off of shoulder up to roadway.

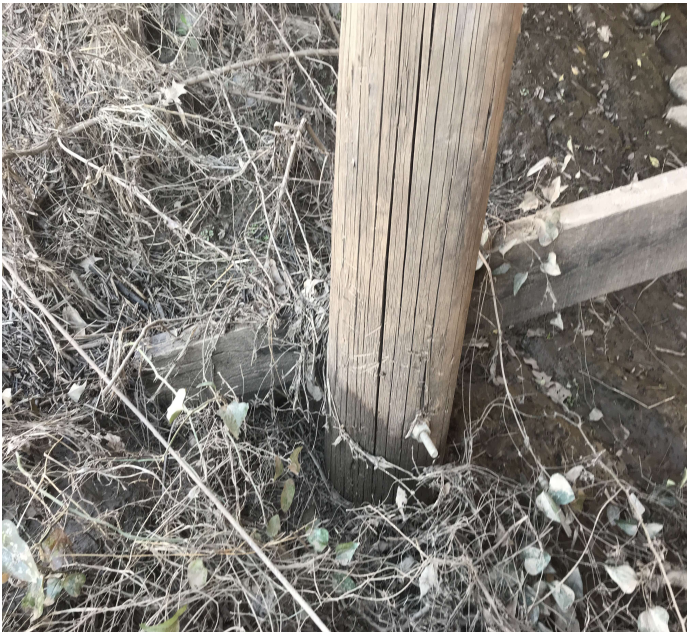
Bent 4 pile 1 has decay with large checks and hollow area near ground line.

PHOTO 1 Description Bent 4 pile 1 has heavy checking and decay with hollow area near ground line.

Charlie: lets place a splice around bent 2 pile 1 - cut out the bad section and replace the pile for bent 4 pile 1

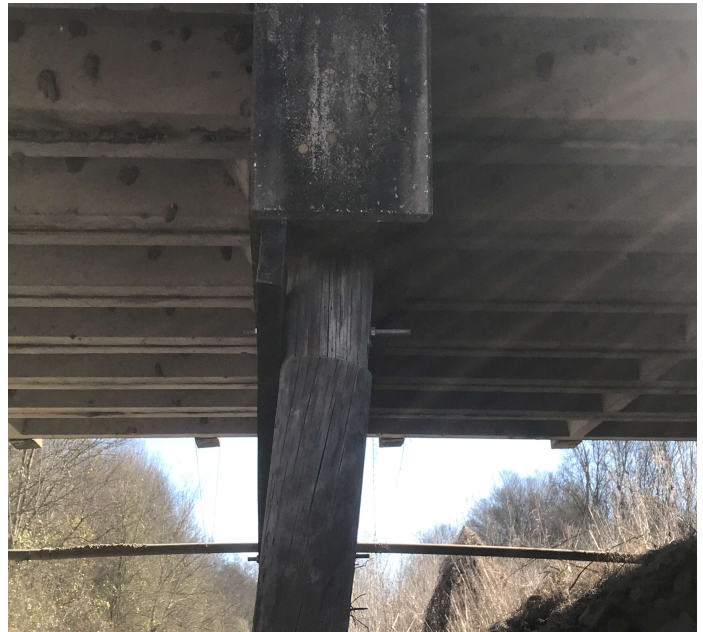
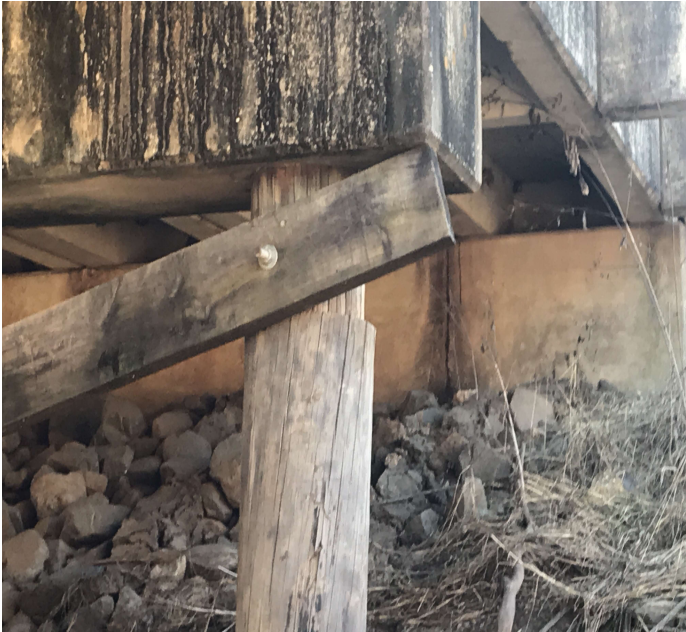
Bent 2 pile 1 has been spliced near cap with no concrete collar.

PHOTO 2 Description Bent 2 pile 1 has spliced piece of piling with no collar.

PHOTO 3 Description Bent 2 pile 1 has spliced piece of piling with no collar.
