Bridge Inspection Report

02842
SH 1-01 LM 18.45
over
Cyress Creek

Structure Number: 02842

Facility Carried: SH 1-01 LM 18.45

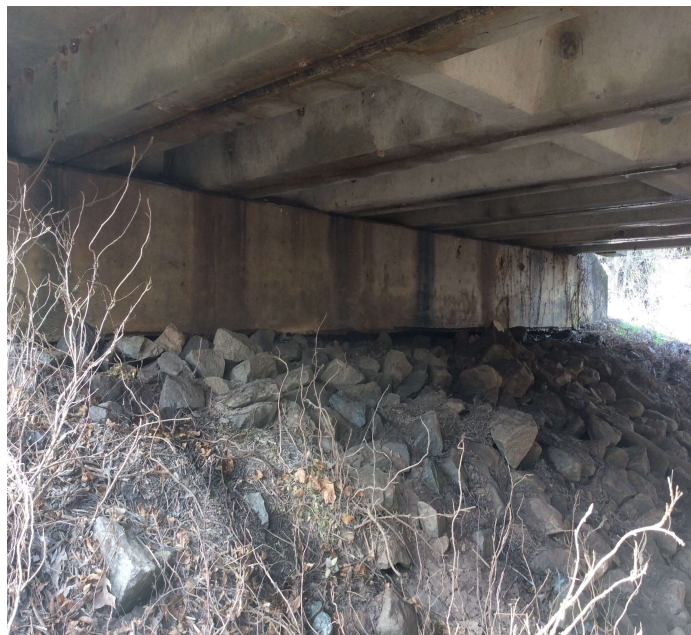
PHOTO 1 Description Endslope - Bent 1 (minor settlement)

Endslope - Bents 1-5: - Minor settlement (4-5" @ Bent 1, 10-12" @ Bent 5) of fill material under bottom face of cap - full length of abutment.

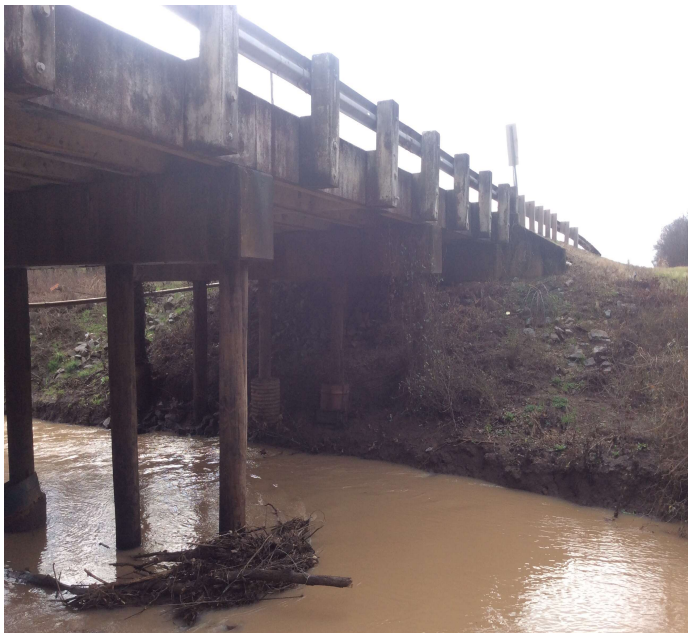
PHOTO 1 Description Endslope - Span 1 left (vegetation)

Endslopes - Span 1 & 4: Vines and other vegetation growing on slopes and up piling at Bents 2 & 4.

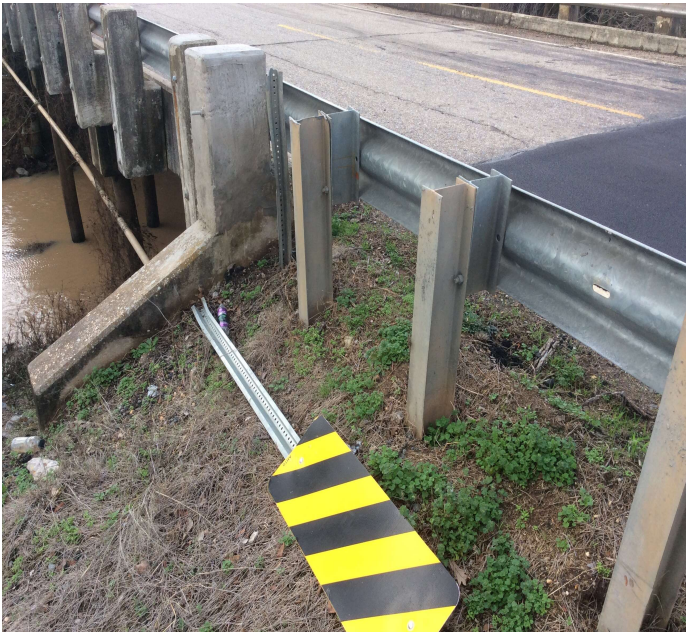
PHOTO 1 Description Sign - Bent 5 right (knocked down)

Signs - Bent 5: Object markers, posts, and log mile signs are missing (have been knocked down) on both side - Object marker and broken post currently lying down behind railing on right side.

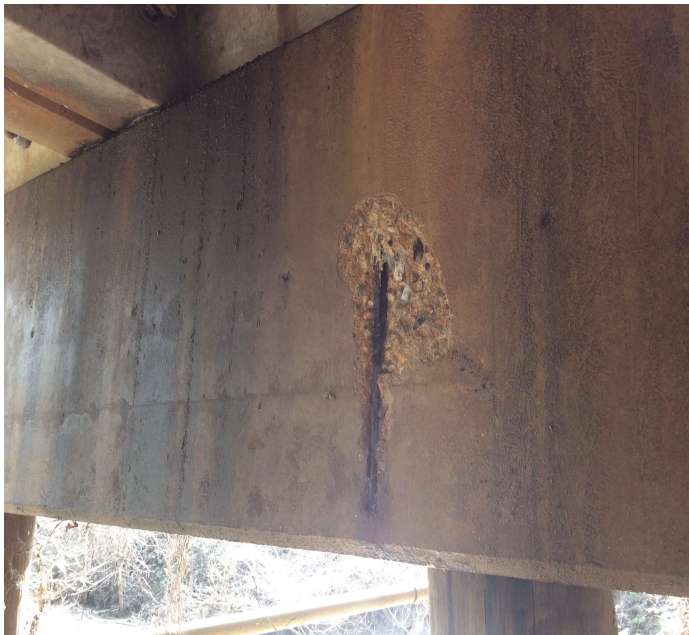
PHOTO 1 Description

Bent 2: Small areas of delaminations and spalling on bottom face of cap - reinforcing steel exposed with some rust and section loss.

Review and repair as necessary.

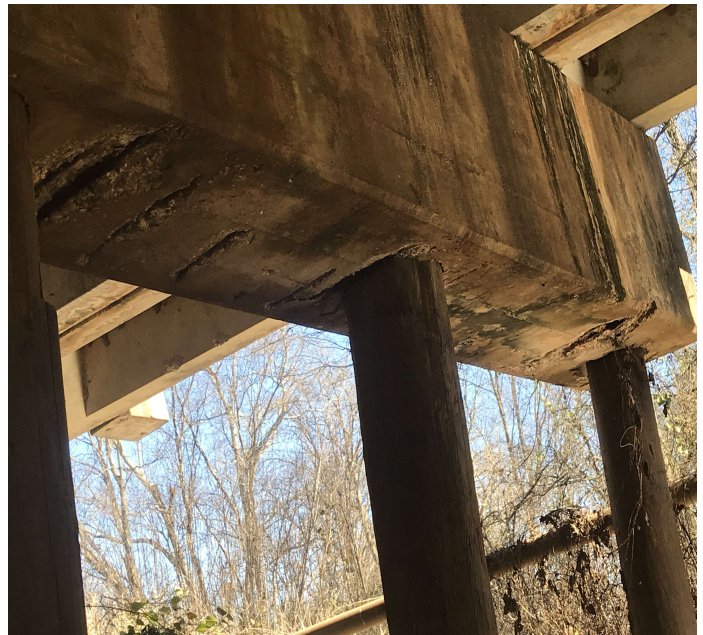
Bent 4: Small areas of delaminations and spalling on right ahead and bottom face of cap - reinforcing steel exposed with some rust and section loss

PHOTO 2 Description Bent 4 cap has spall with exposed rebar under and on edges of cap.

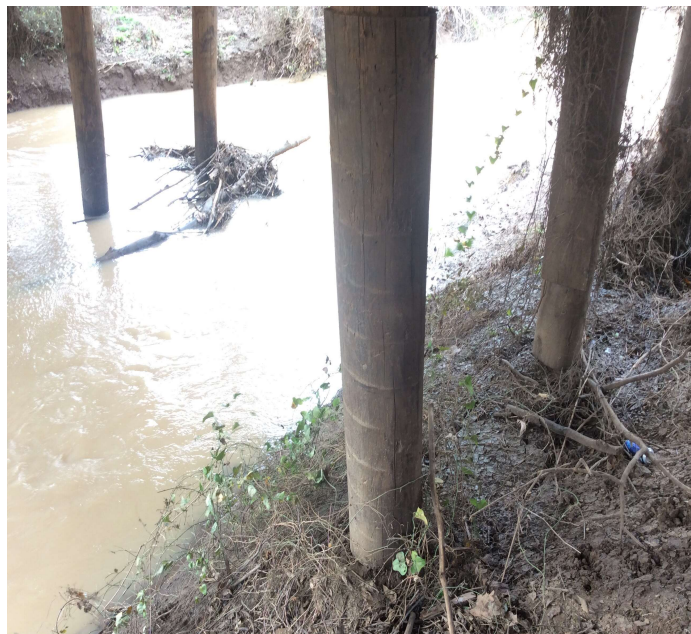
PHOTO 1 Description

Bent 2 Piles 4: Moderate checking.

Bent 3 Pile 1: Hollow-sounding 4' down from top.

Bent 3 Pile 5: Moderate checking.

Bent 4 Pile 1: Hollow-sounding.

Bent 4 Pile 3: Top 1' is hollow.

Bent 4 Pile 4 hollow from ground up 3'.
