Bridge Inspection Report

06931
SH 1-01 LM 7.01
over
Canal # 43

Executive Summary

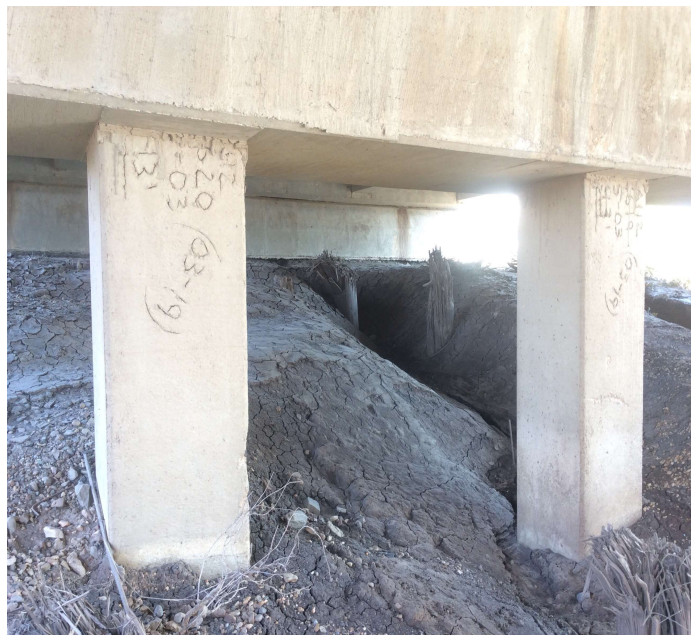
End slope - Span 5: Scattered areas of various degrees of erosion of embankment from Bent 6 abutment down to and between Bent 5 piling.

PHOTO 1 Description End slope - Span 5 (erosion)

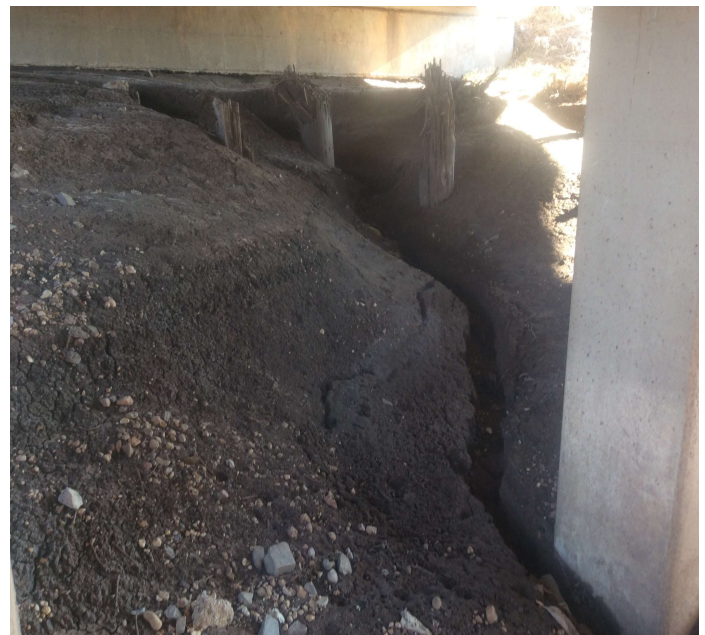
PHOTO 2 Description End slope near bent 6 abutment has erosion to channel bank.

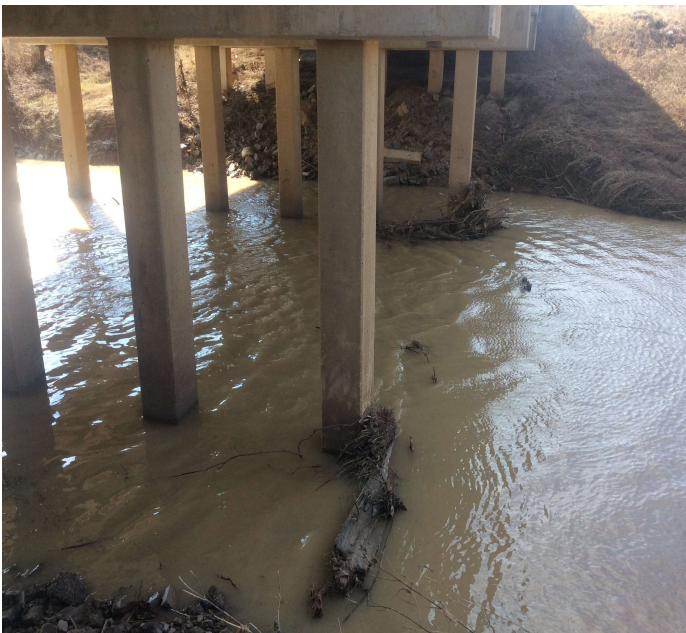
COMPLETED - Bent 4 upstream against column 1 tree and debris.

01/19/2016 GGL-KLR: Only minor amount of debris build-up in place this inspection.

PHOTO 1 Description Channel - Spans 2-4 (small amount of debris)

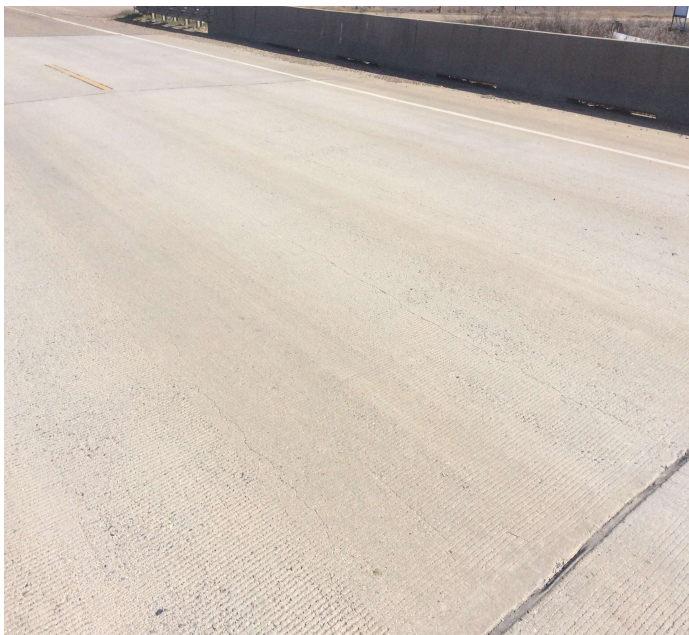
Deck - Spans 1, 4 & 5: Unsealed, minor- to moderate-sized longitudinal cracks - in right lane of Span 1 and in both lanes of Spans 4 & 5, with some reflective efflorescence on soffit of Span 1.

PHOTO 1 Description Deck - Span 4 (longitudinal cracking)

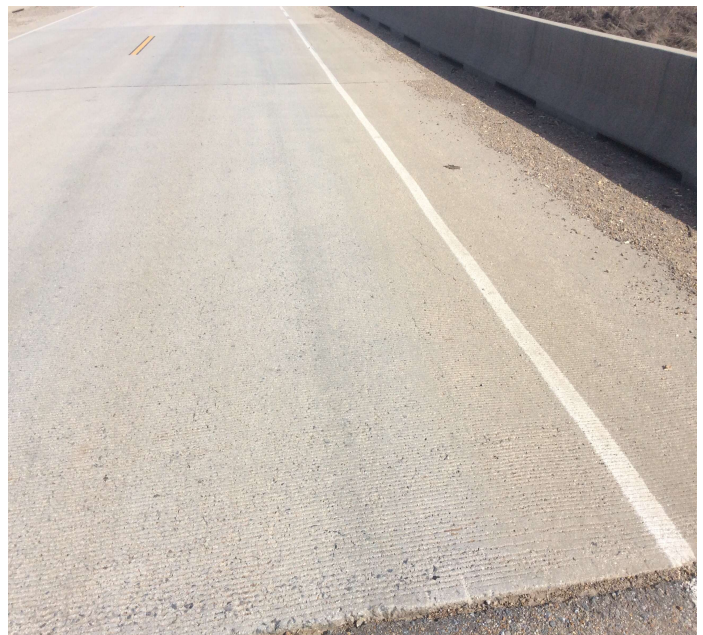
PHOTO 2 Description Deck - Span 1 right (cracking)

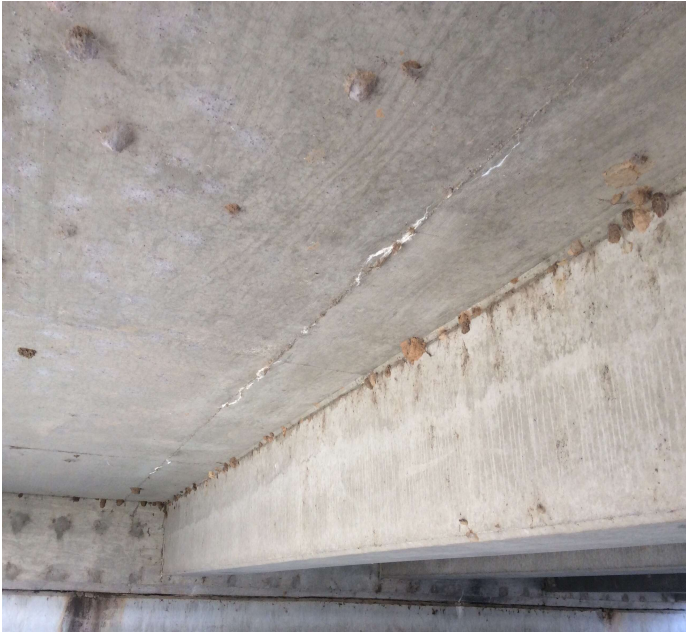
PHOTO 3 Description Soffit - Span 1 Bay 4 (efflorescence)

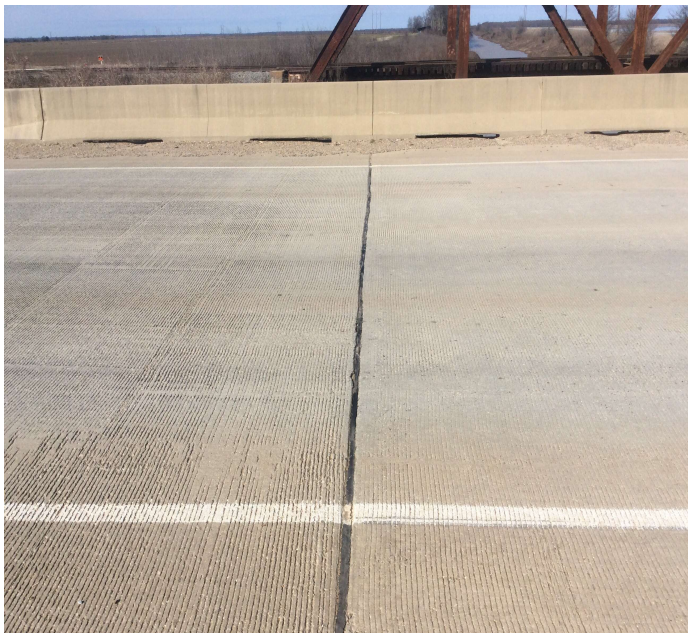
Joints - Bents 2-5: Poured joint material is intact, but is losing adhesion in many places.

PHOTO 1 Description Joint - Bent 2 (losing adhesion)

clean, repair , and re-apply adhesive to make joint material stick

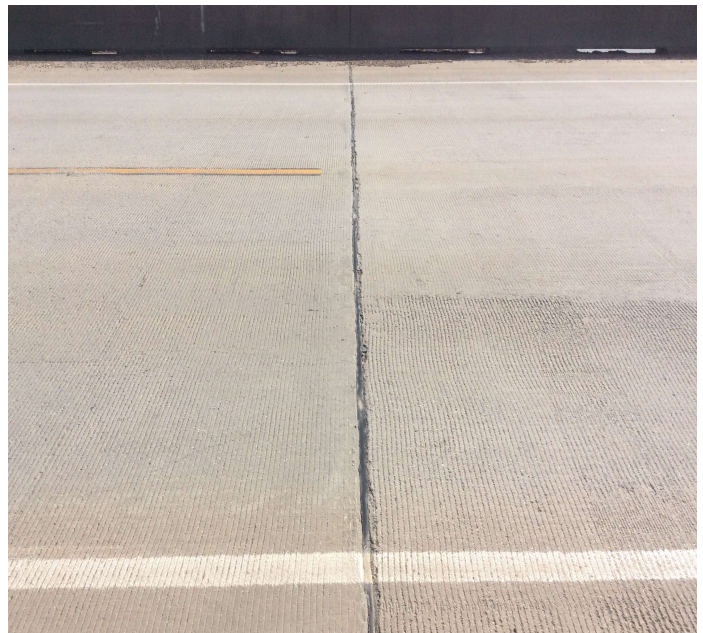
PHOTO 2 Description Joint - Bent 5 (losing adhesion)

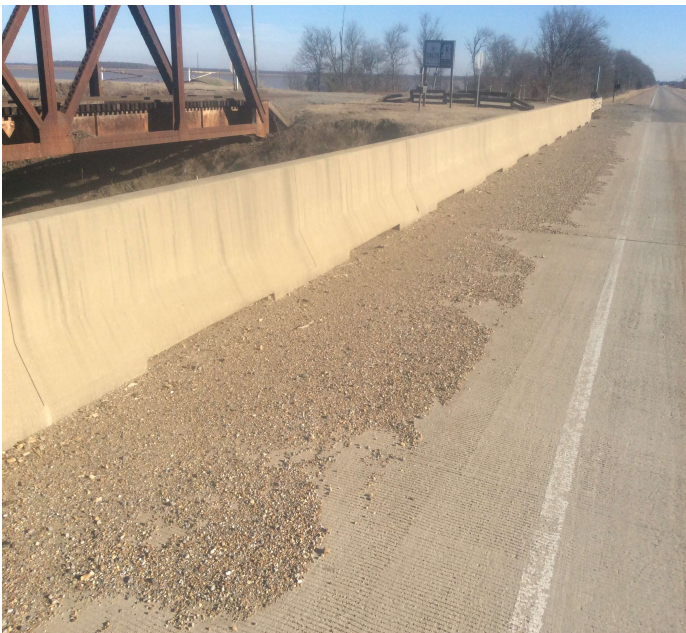
Both gutter line have gravel and debris restricting storm water run off.

PHOTO 1 Description Left gutter line has gravel and dirt restricting storm water run off.
