Bridge Inspection Report

06932
SH 1-01 LM 7.91
over
Coon Bayou

Structure Number: 06932

Facility Carried: SH 1-01 LM 7.91

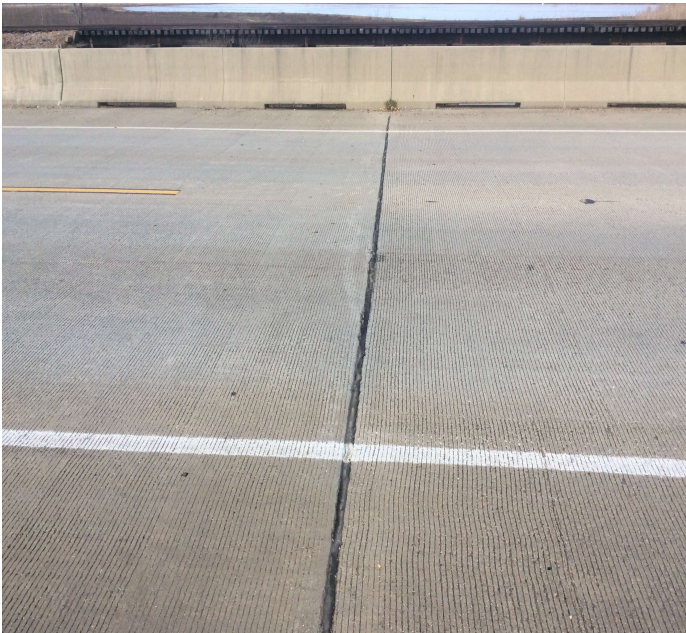
Joints - Bents 2 & 3: Poured joint material is intact, but is losing adhesion in many places.

PHOTO 1 Description Joint - Bent 2 (material losing adhesion)

clean, and re-attach joint material
