# Bridge Inspection Report

**06933**  
**SH 1-01 LM 9.70**  
**over**  
**Boggy Bayou**

Structure Number: 06933

Facility Carried: SH 1-01 LM 9.70

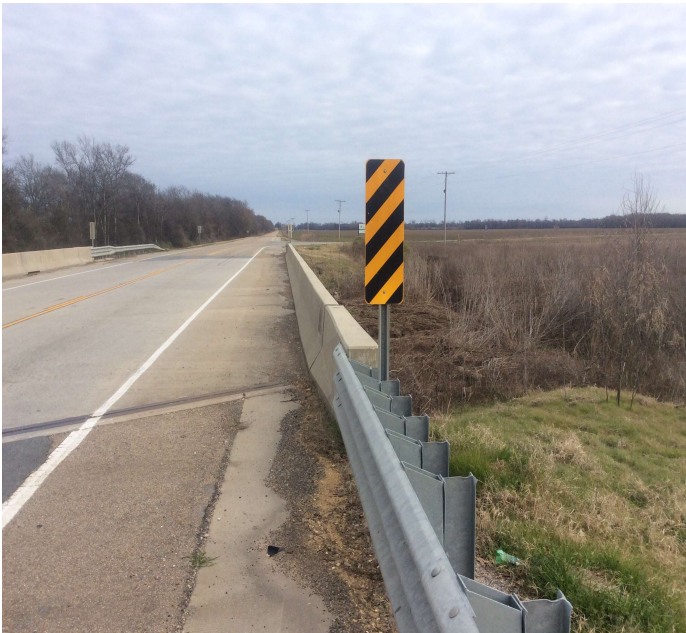
Log mile signs - both ends of bridge: No route and section signs. Object markers and posts in place.

PHOTO 1      Description      Log mile sign - Bent 1 right (sign missing)

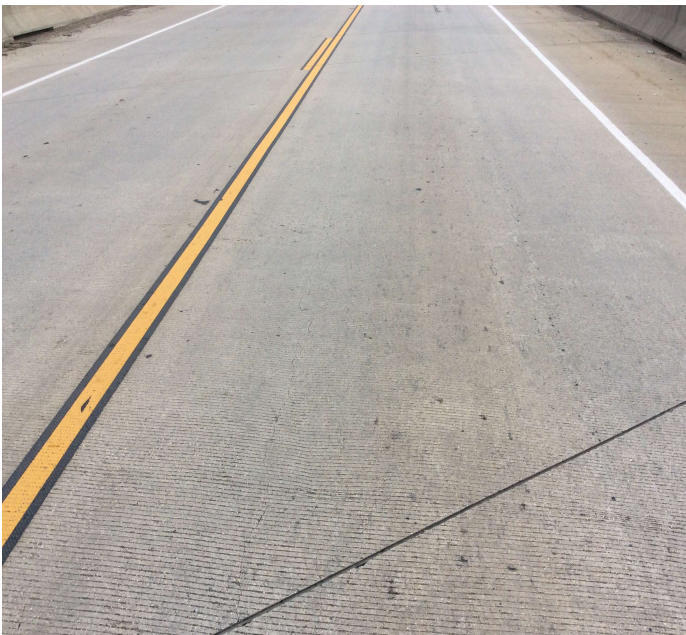
Deck - all spans: Unsealed, moderate-sized longitudinal cracks along each side of Girders 3 & 4 - full-length of bridge.

PHOTO 1      Description      Deck - Span 2 right (longitudinal cracking)
