# Bridge Inspection Report

**07031**  
**SH 1-01 LM 3.99**  
**over**  
**Canal # 19**

Structure Number: 07031

Facility Carried: SH 1-01 LM 3.99

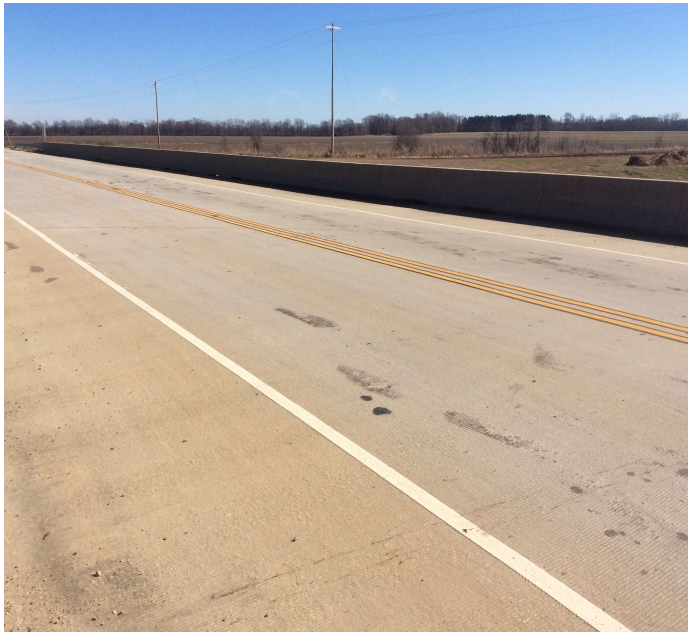
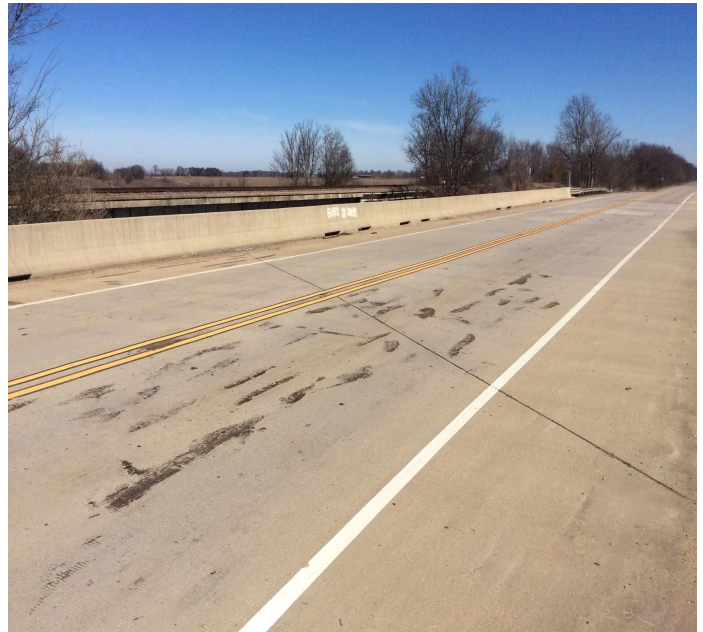
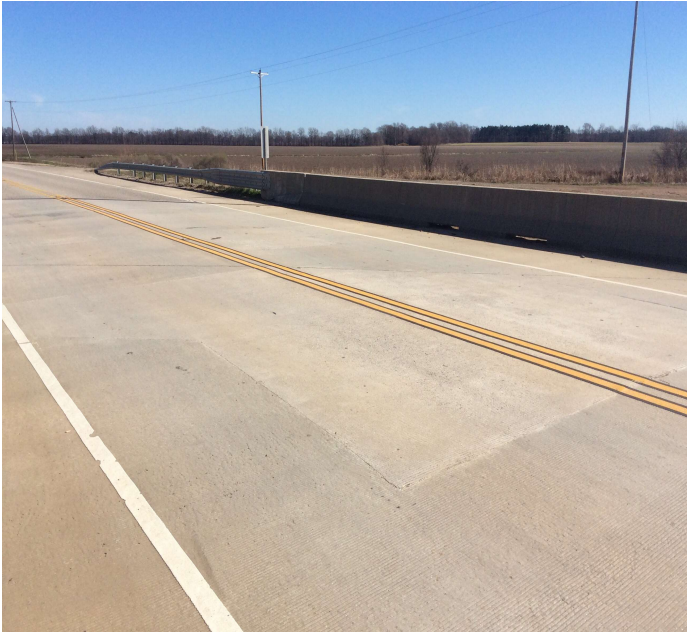
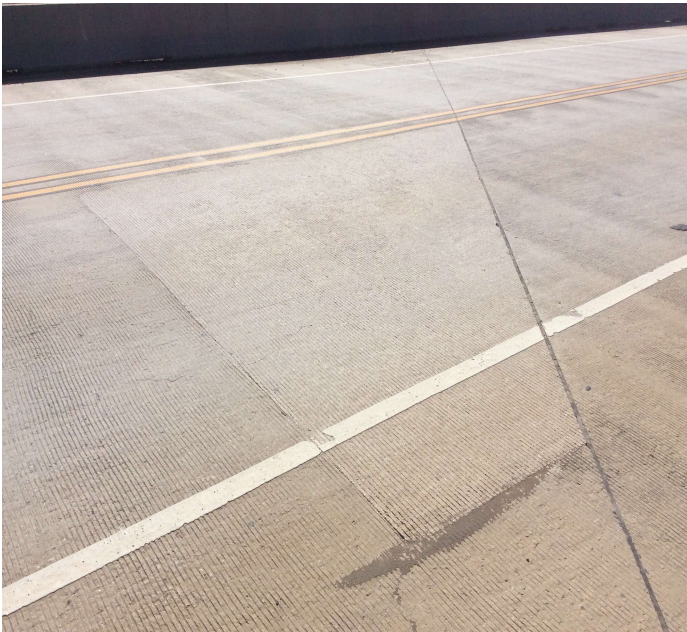
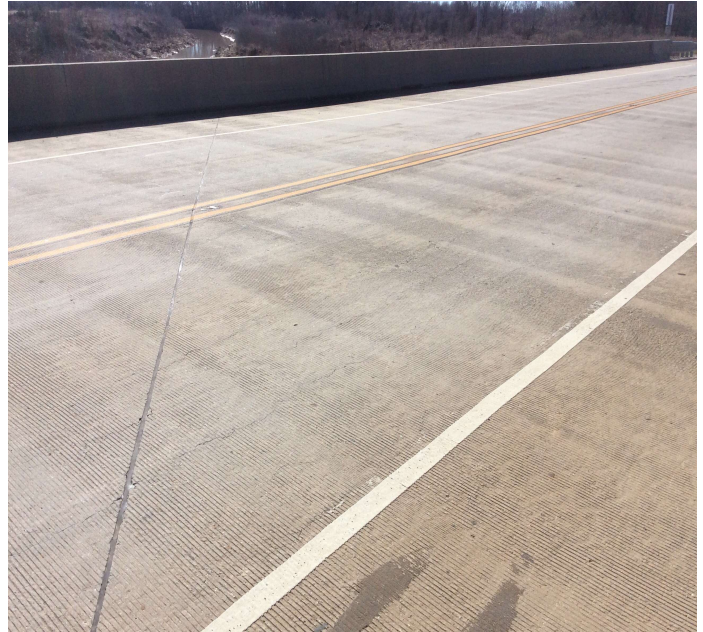
Deck - all spans: Several minor- to moderate-sized longitudinal cracks - full length of bridge. Some cracks have been sealed in the past, but seal has worn away or cracks have extended beyond seal.

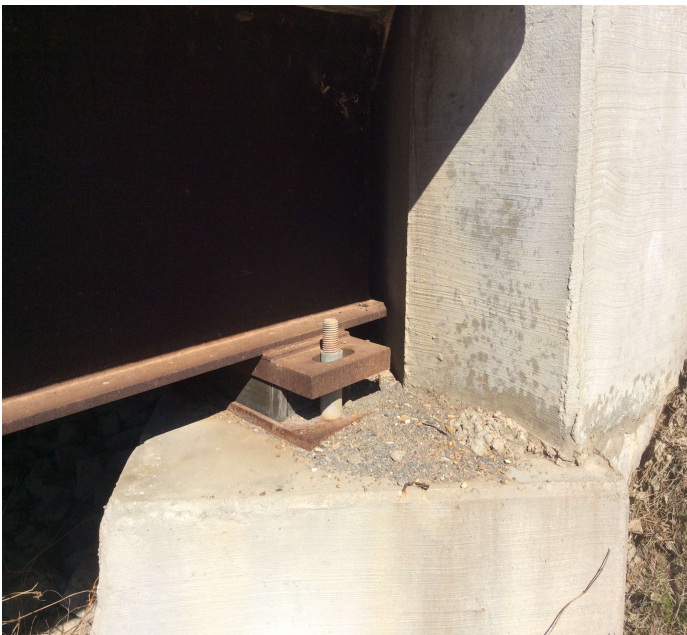
Bearings - Bent 6: Anchor nuts missing off various bearings - 5 total.

PHOTO 1      Description      Bent 6 Bearing 5 right (nut missing)

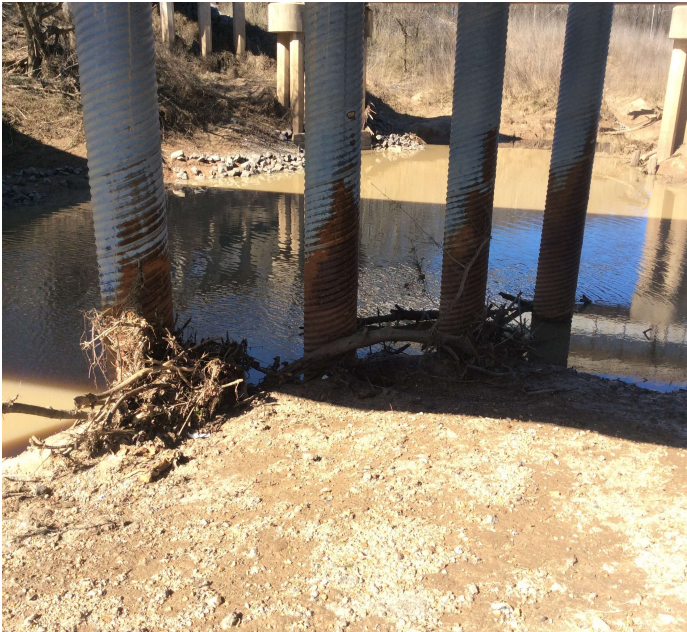
CORRECTED - Span 4 at bent 4 debris has built up around pile causing bank erosion.

PHOTO 1      Description      Bent 4 Piles 1-4 (no debris build-up)

GGL-KLR: No debris removal required this inspection.

Repaired.
