# Bridge Inspection Report

**06662**  
**US 79-10 LM 8.73**  
**over**  
**Holmes Ditch**

## Bridge Inspection Report

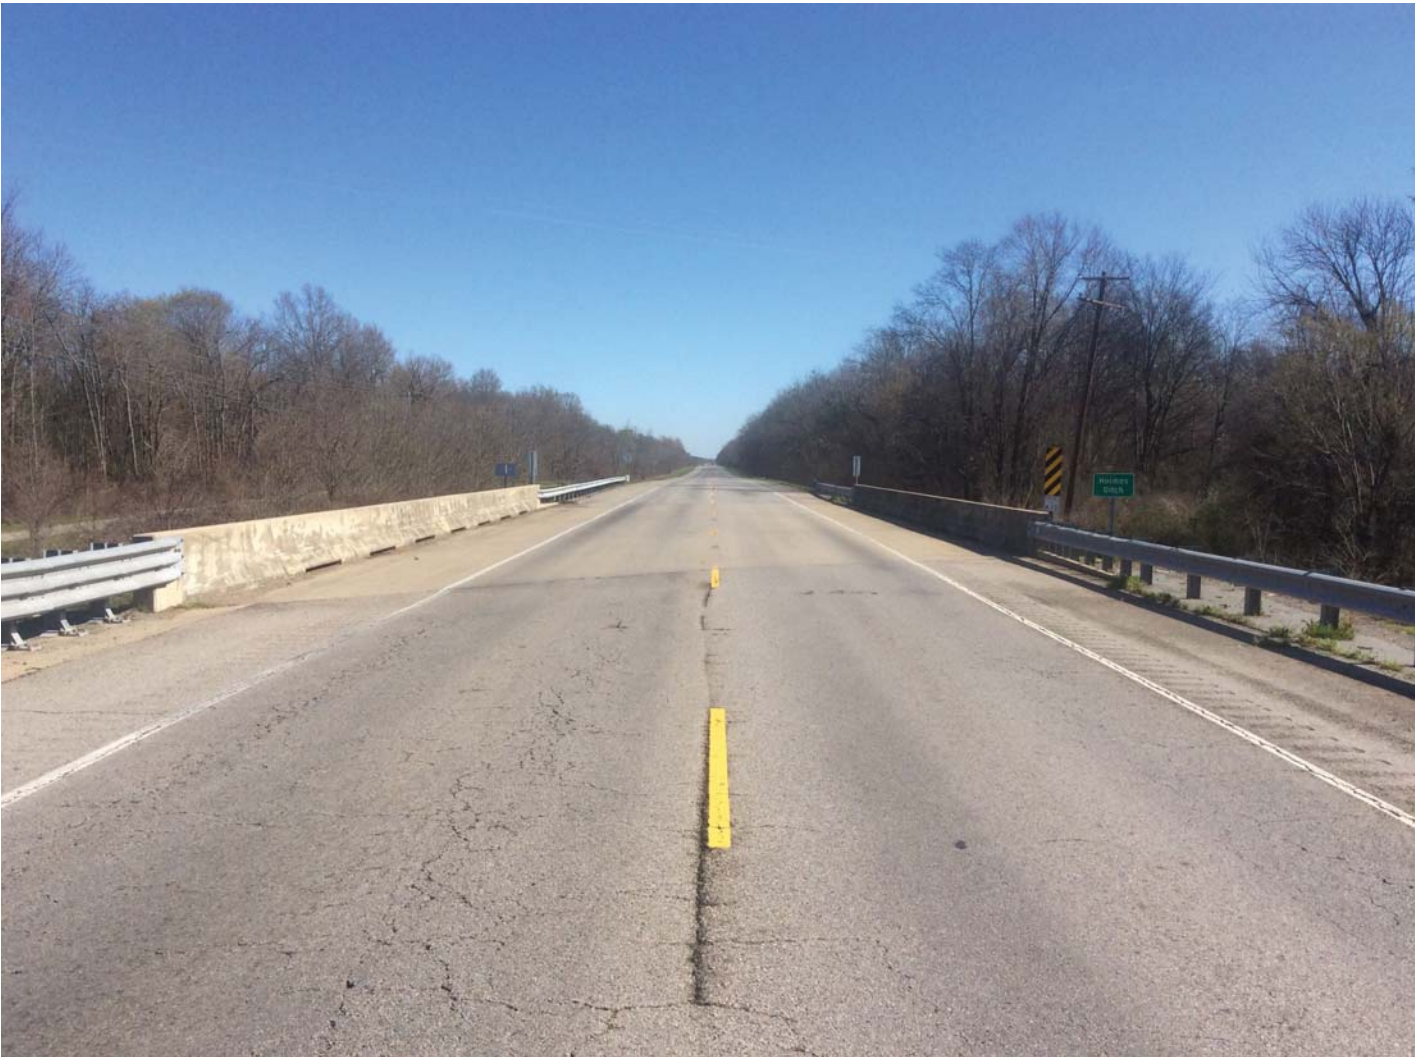
No asphalt overlay on the bridge deck

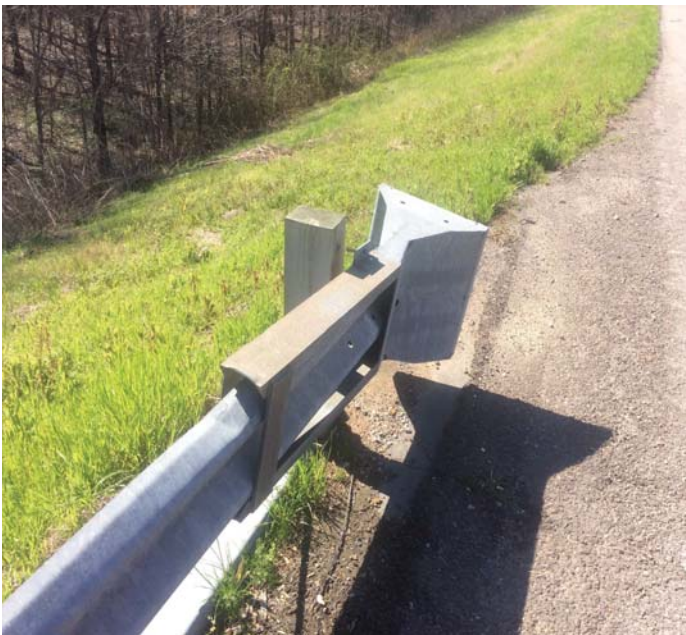
Approach railing - Bent 1 right: Screw holding terminal end has stripped out/ come loose - end is somewhat sagging.

PHOTO 1      Description      Approach railing - Bent 1 right: Screw loose in end

Felecia: need to tighten lag bolts advise when complete

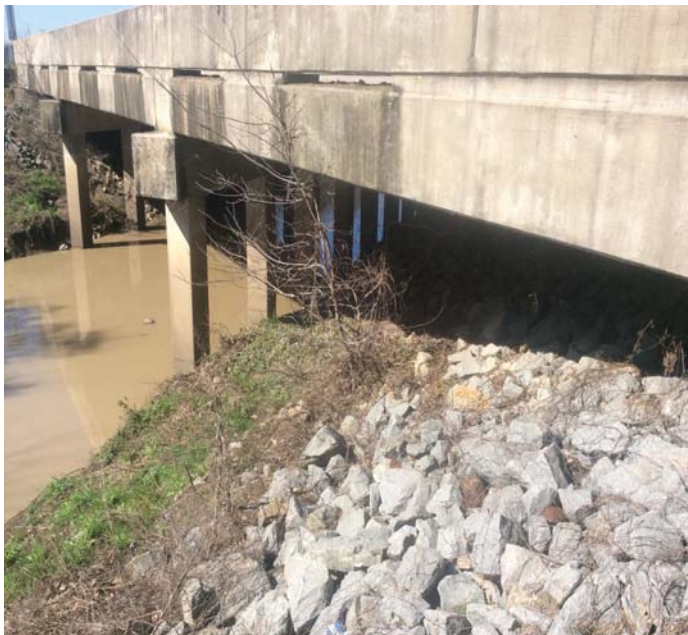
Endslopes - Spans 1 & 3: A couple small trees/bushes growing up just under left and right sides of bridge.

PHOTO 1      Description      Endslope - Span 3 right: Vegetation

Felecia: remove vegetation, advise when complete

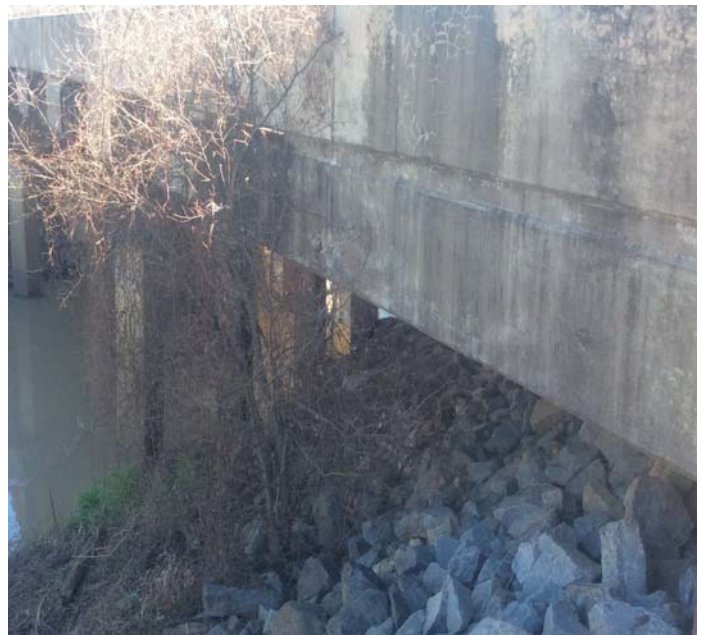
PHOTO 2      Description      Endslope - Span 1 left: Vegetation
