Bridge Inspection Report

06663

US 79-10 LM 10.53

Salt Bayou Relief Ditch

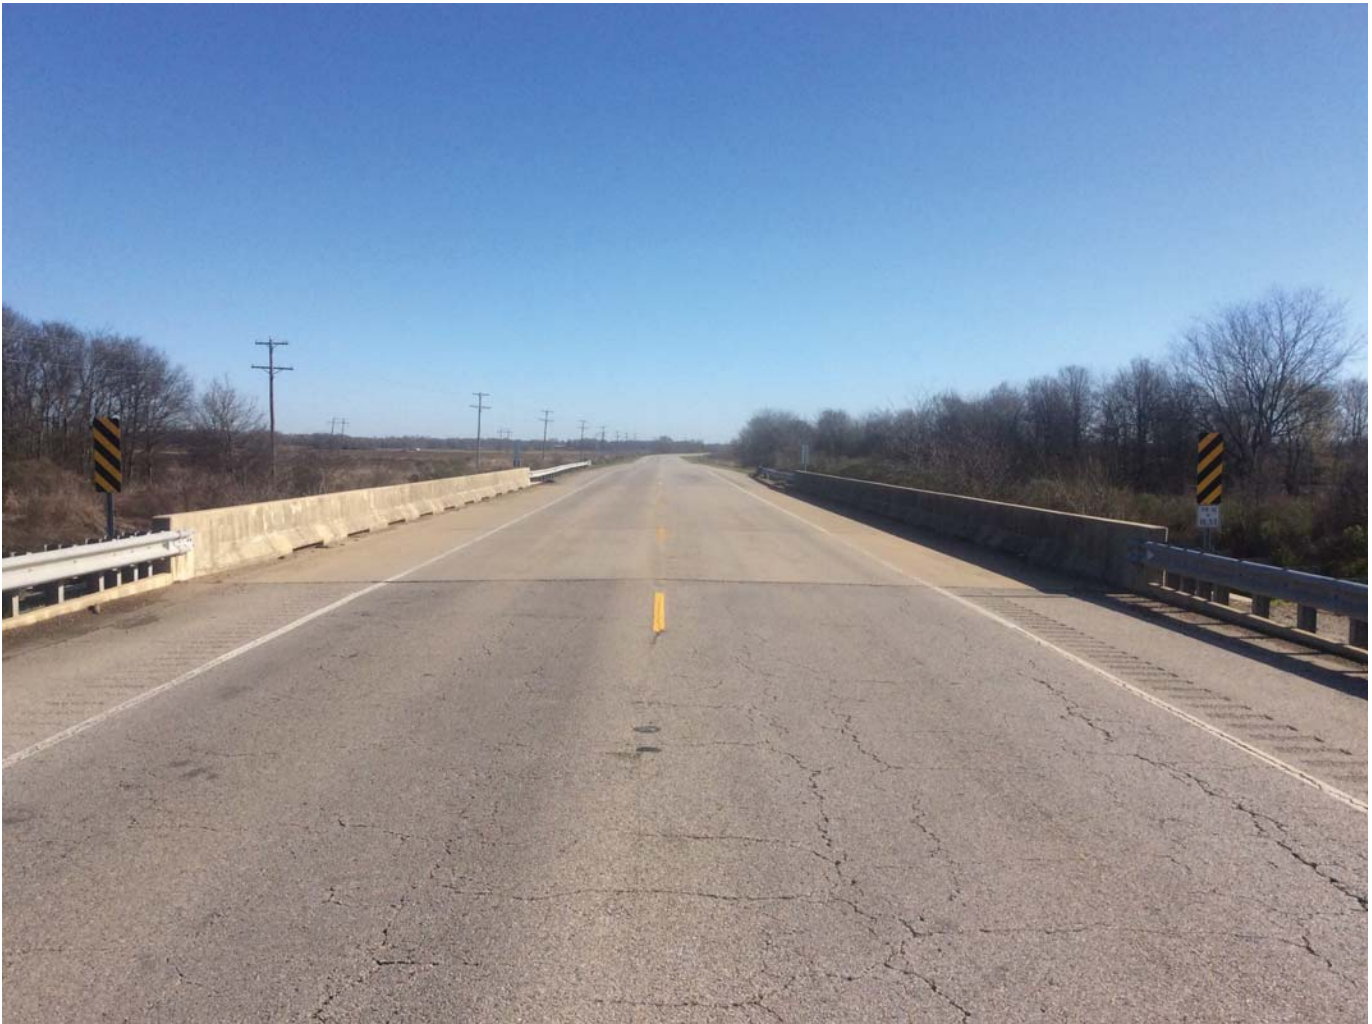
No asphalt overlay on the bridge deck

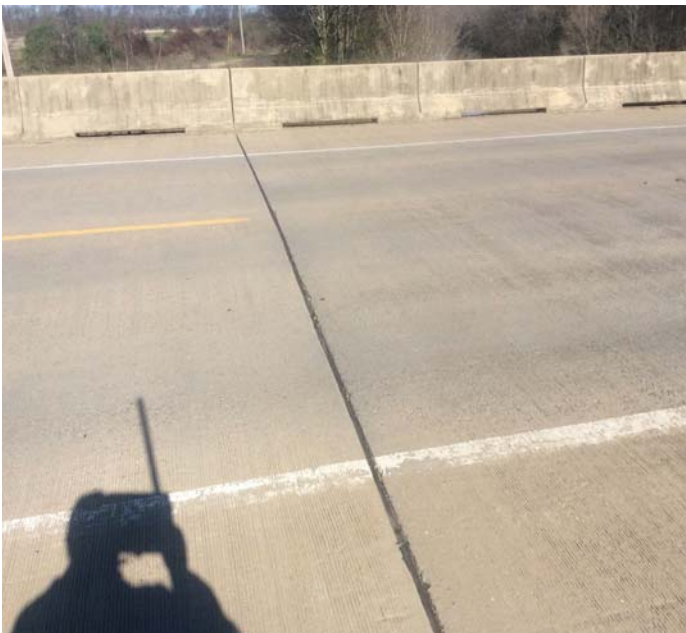
Joints - Bents 2-4: Pourable joint material is intact, but has lost adhesion in most places.

PHOTO 1 Description Joint - Bent 2: Loss of adhesion

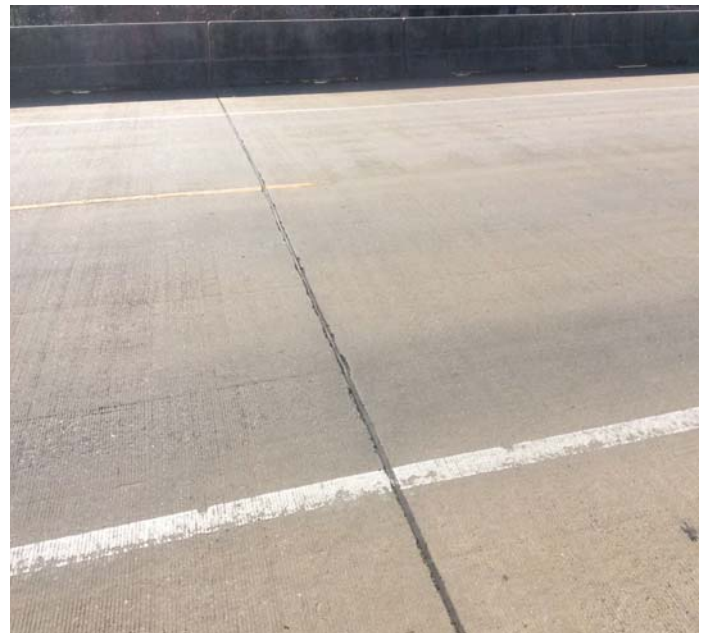
PHOTO 2 Description Joint - Bent 4: Loss of adhesion

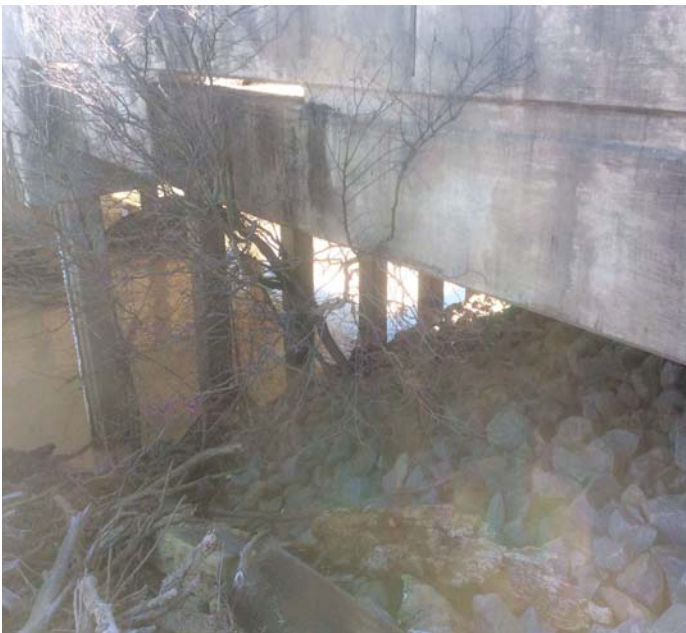
Endslopes - Spans 1 & 3: A couple small trees/bushes growing up just under left and right sides of bridge.

PHOTO 1 Description Endslope - Span 1 left: Vegetation

Remove vegetation, advise when complete

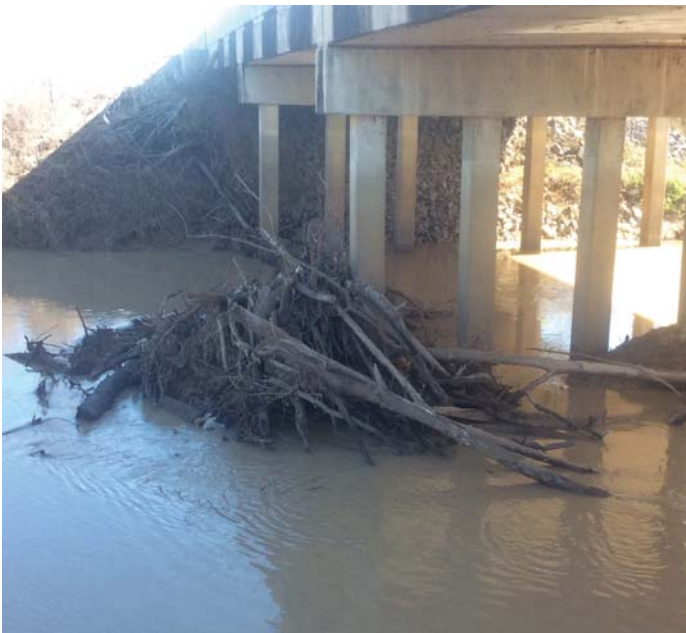
Channel - Bent 3: Significant build-up of logs, limbs, and other debris against pile on left side of bridge.

PHOTO 1 Description Channel - Bent 3 left: Debris build-up

Felecia: remove debris, contact Ronnie is his help is needed
