# Bridge Inspection Report

**06664**  
**US 79-10 LM 11.09**  
**over**  
**Bear Bayou**

Structure Number: 06664

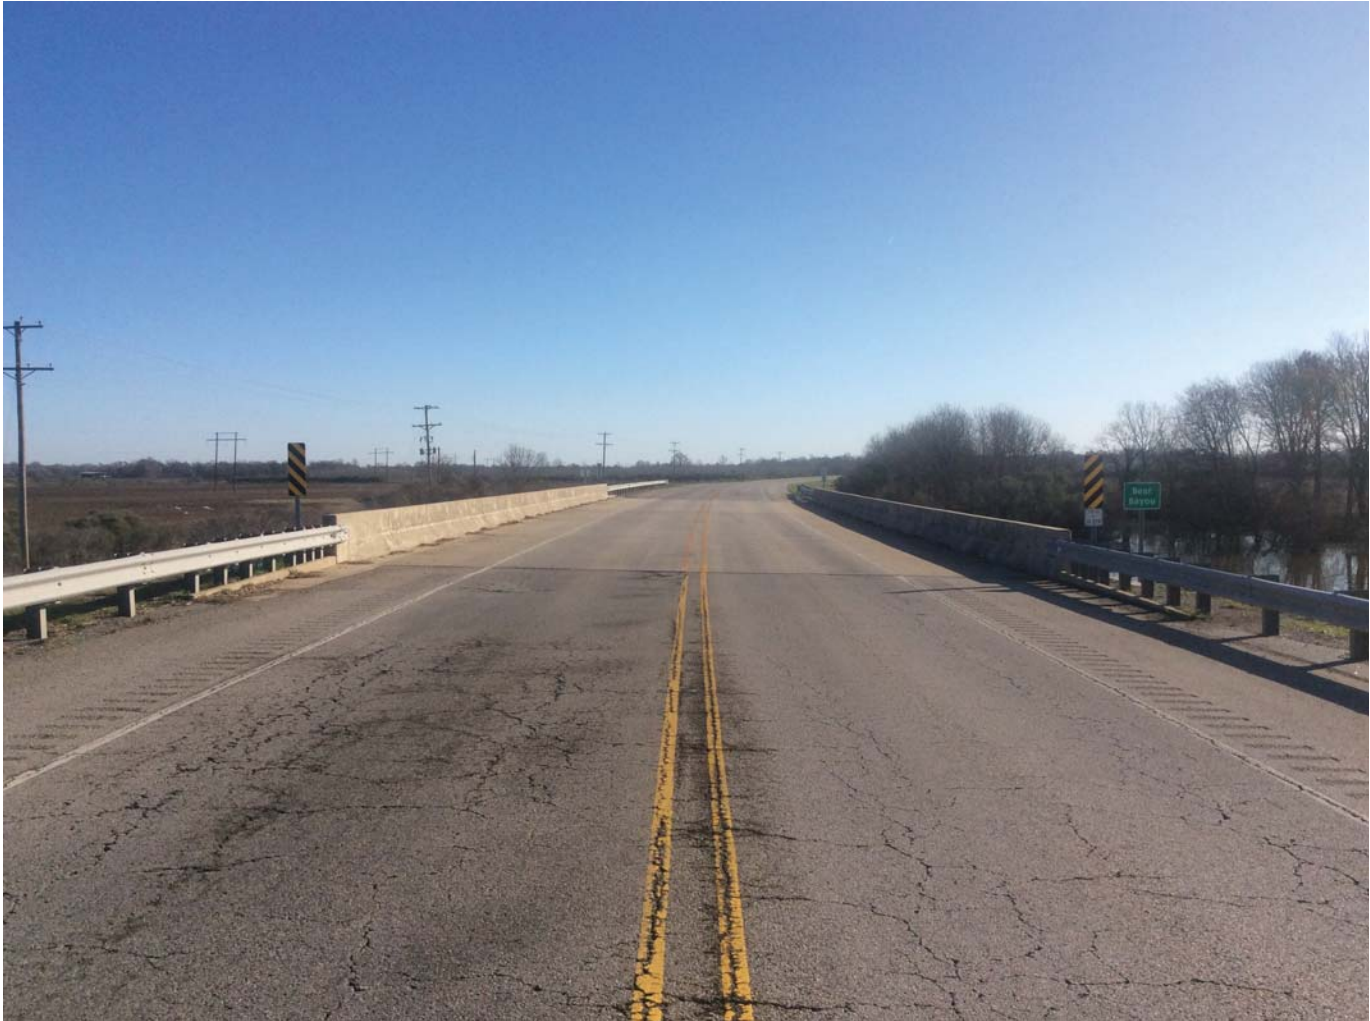
No asphalt overlay on the bridge deck.

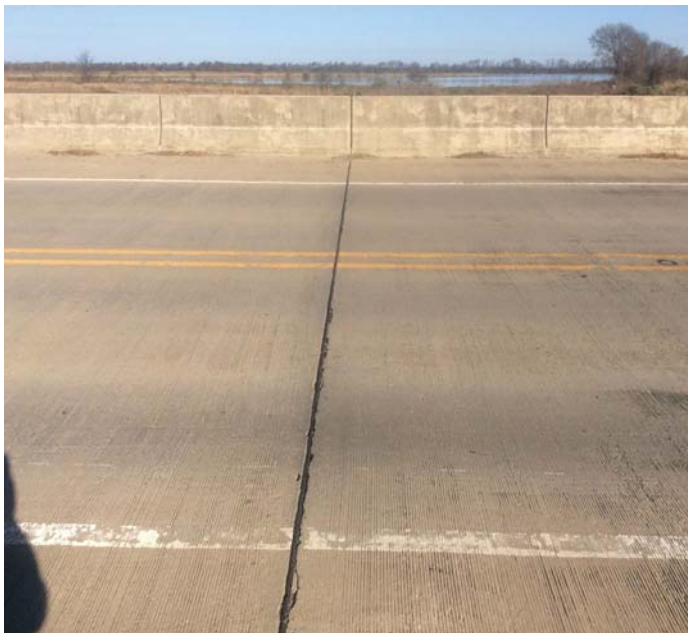
Joints - Bents 2-5: Pourable joint material is intact, but has lost adhesion in most places.

PHOTO 1      Description      Joint - Bent 2: Loss of adhesion

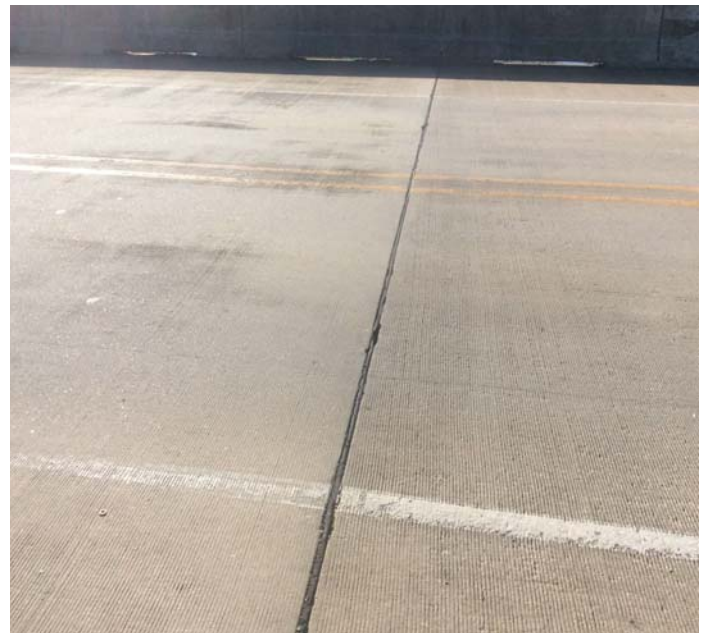
PHOTO 2      Description      Joint -Bent 4: Loss of adhesion
