# Bridge Inspection Report

**A0731**  
**US 79-10 LM 4.28**  
**over**  
**Bradley Slough**

Facility Carried: US 79-10 LM 4.28

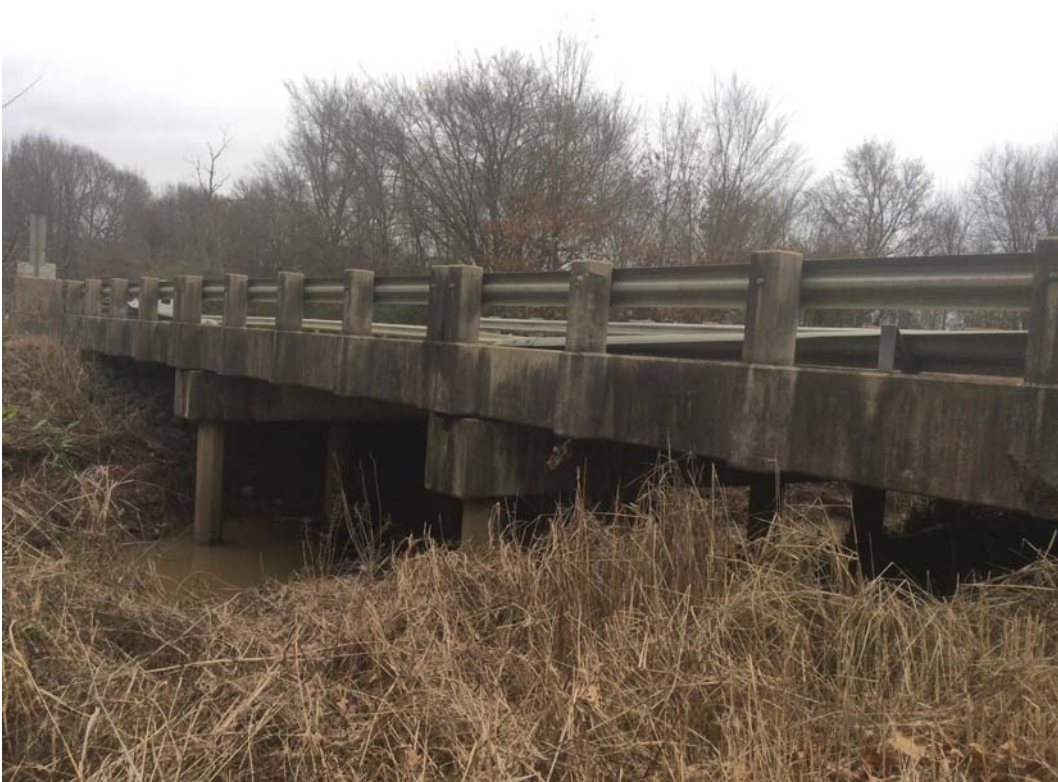
No asphalt overlay on the bridge deck

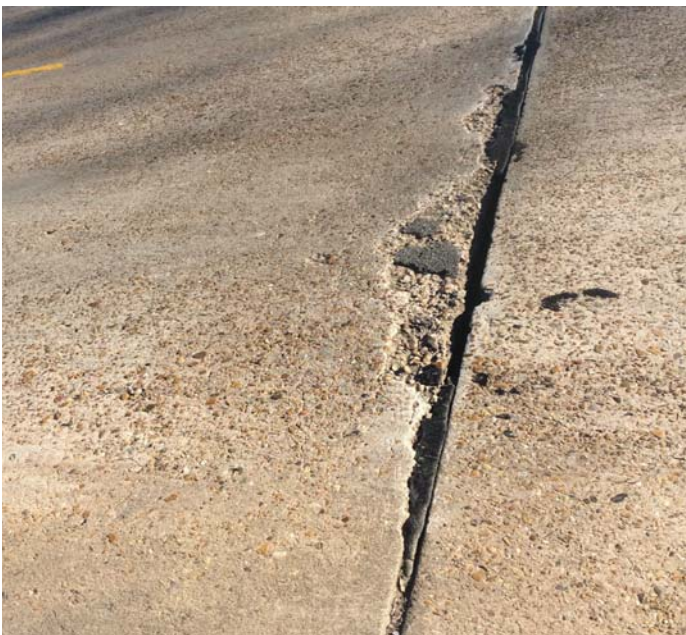
PHOTO 1 Description

Joint – Bent 3: Some spalling along left ahead side of joint (6') with some of pourable joint seal missing in same area (2'). 1-2' section of pourable joint seal missing along centerline.

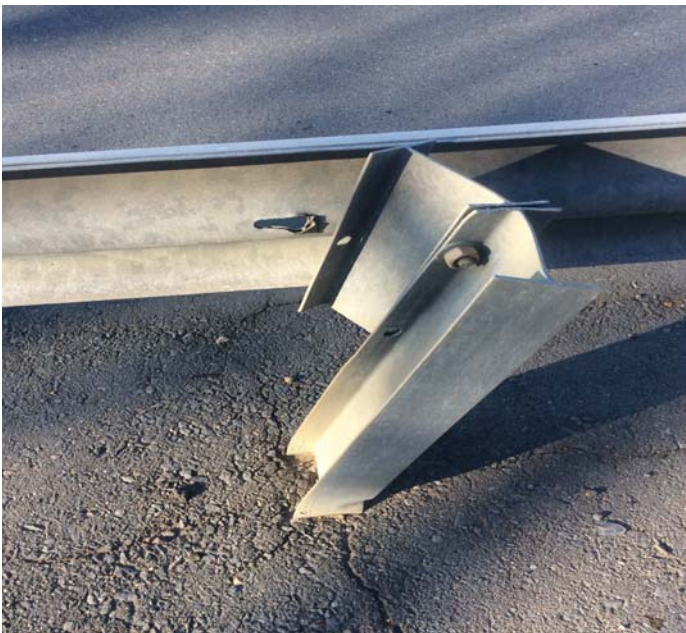
Approach railing - Bent 1 right: Impact damage to one or two posts (one post is no longer bolted to rail).

PHOTO 1      Description      Approach roadway - Bent 1 Right:  
Damage

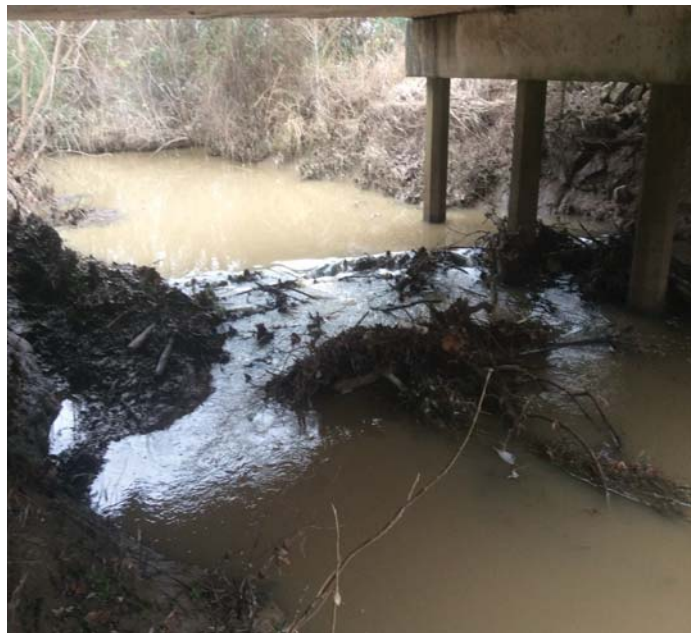
Channel – Span 2: Beaver dam across channel under bridge.

PHOTO 1      Description      Span 2 left side beaver dam

Jefferson: Remove

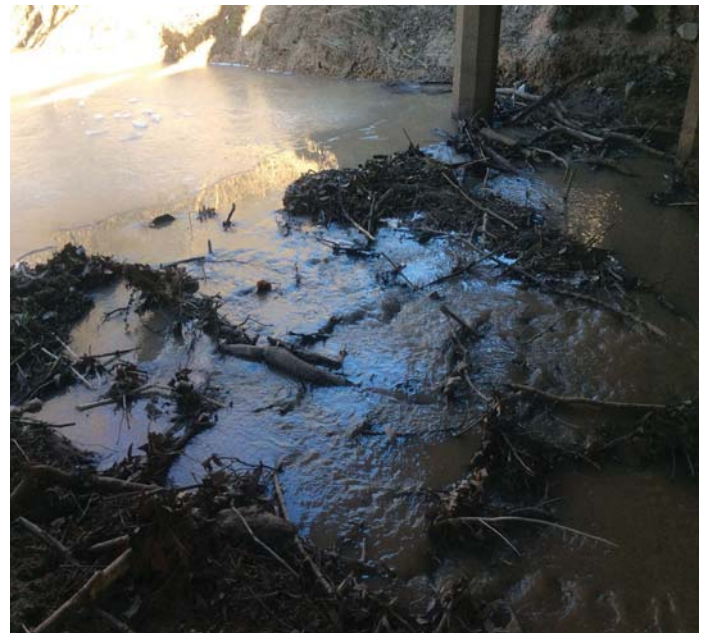
PHOTO 2      Description      Channel - Span 2: Beaver Dam
