Bridge Inspection Report

A0733
US 79-10 LM 5.20
over
Wabbaseka Bayou

Structure Number: A0733

Facility Carried: US 79-10 LM 5.20

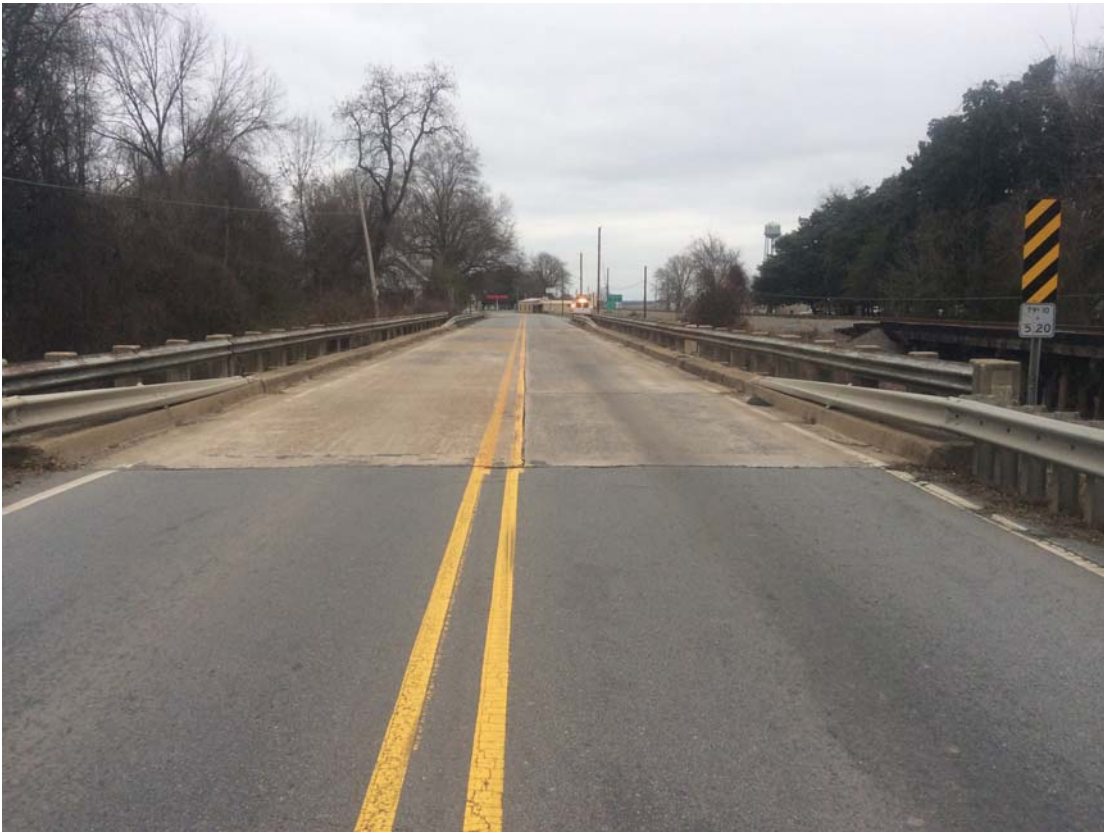
No asphalt overlay on the bridge deck

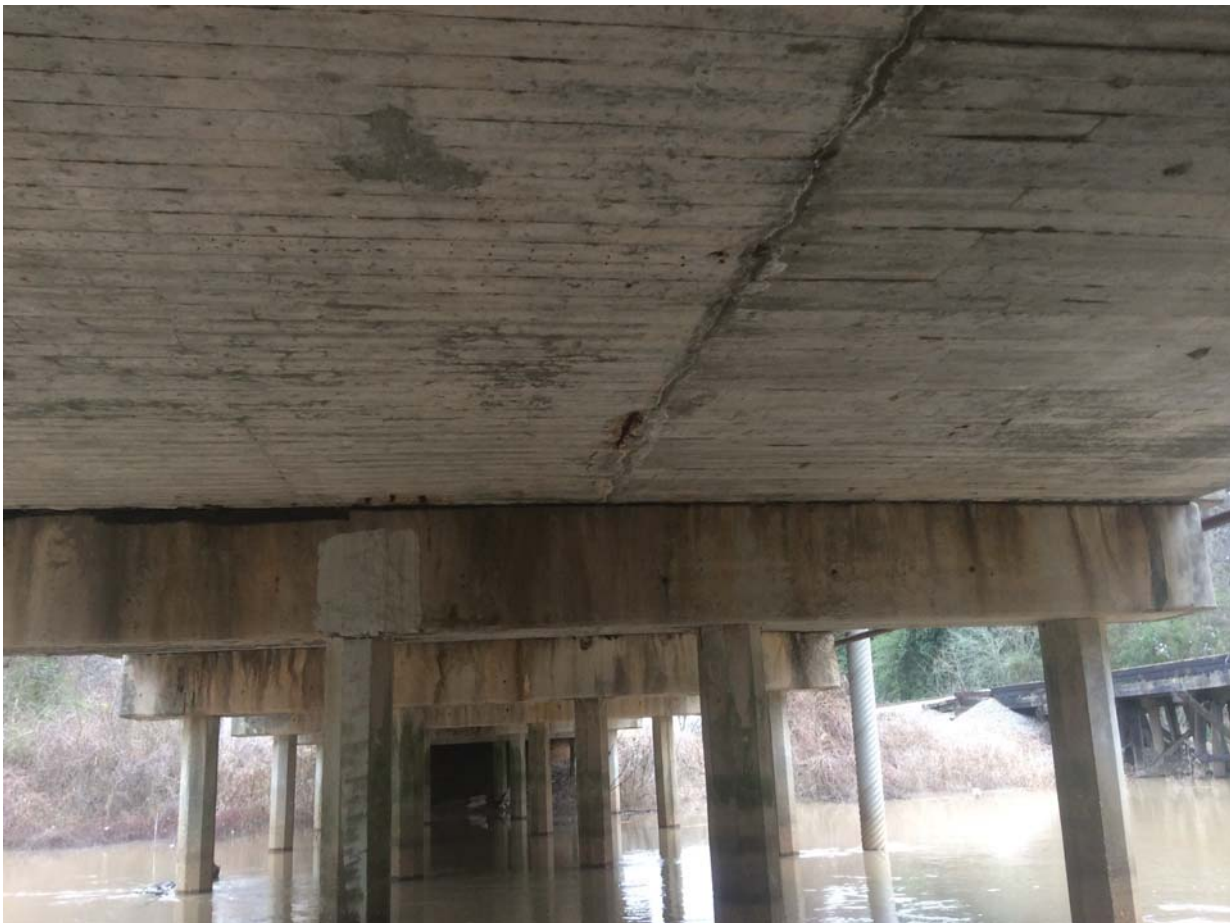
Span 2 at centerline -
spall with exposed
rebar

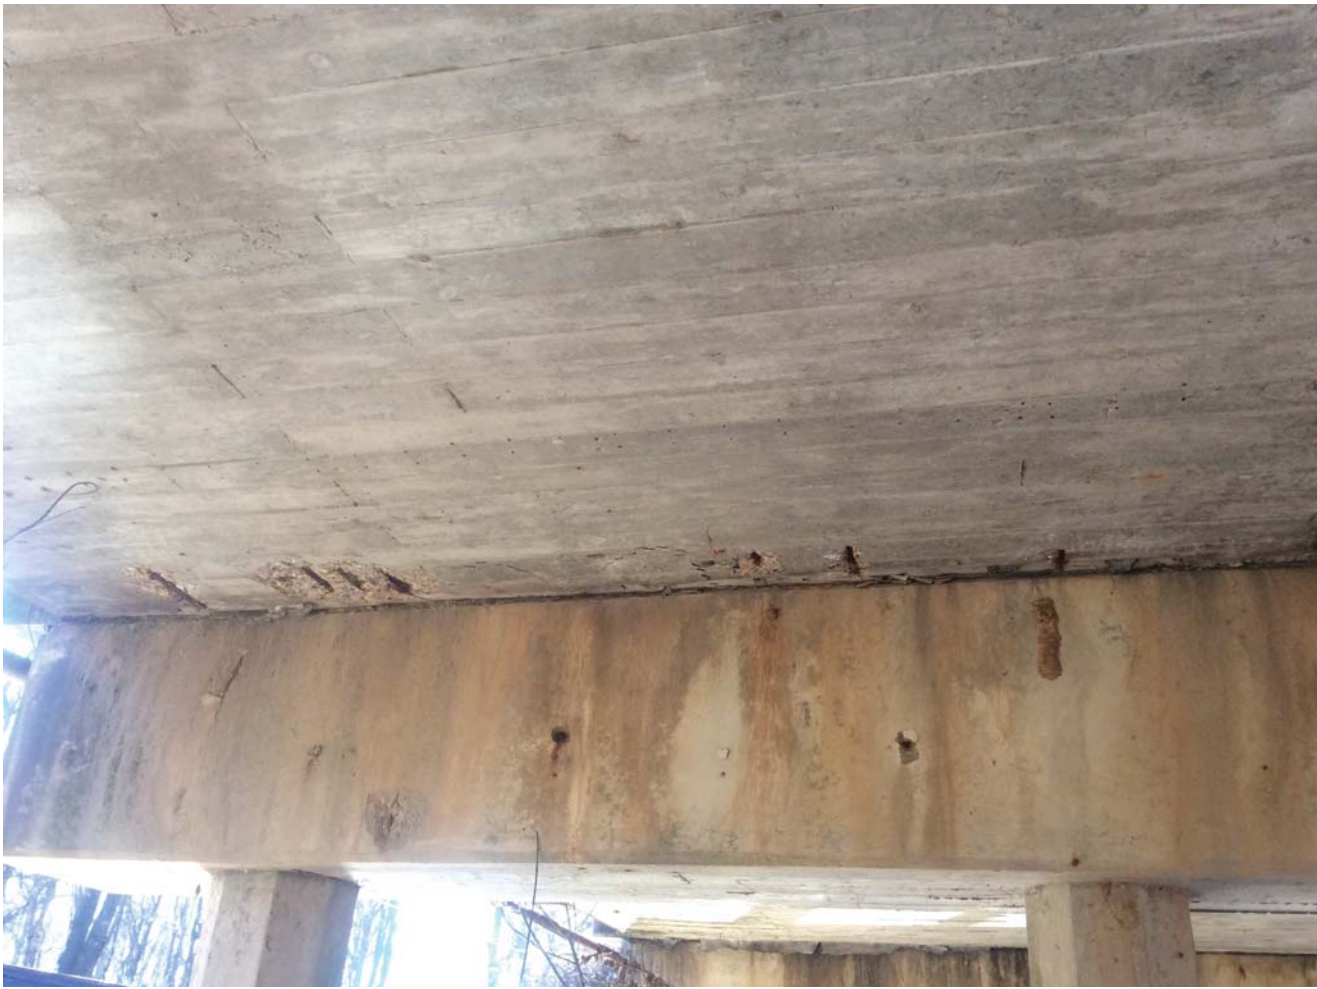
Soffit - Span 6 -
exposed rebar

Also on Span 5
and Bent 5 -
exposed rebar

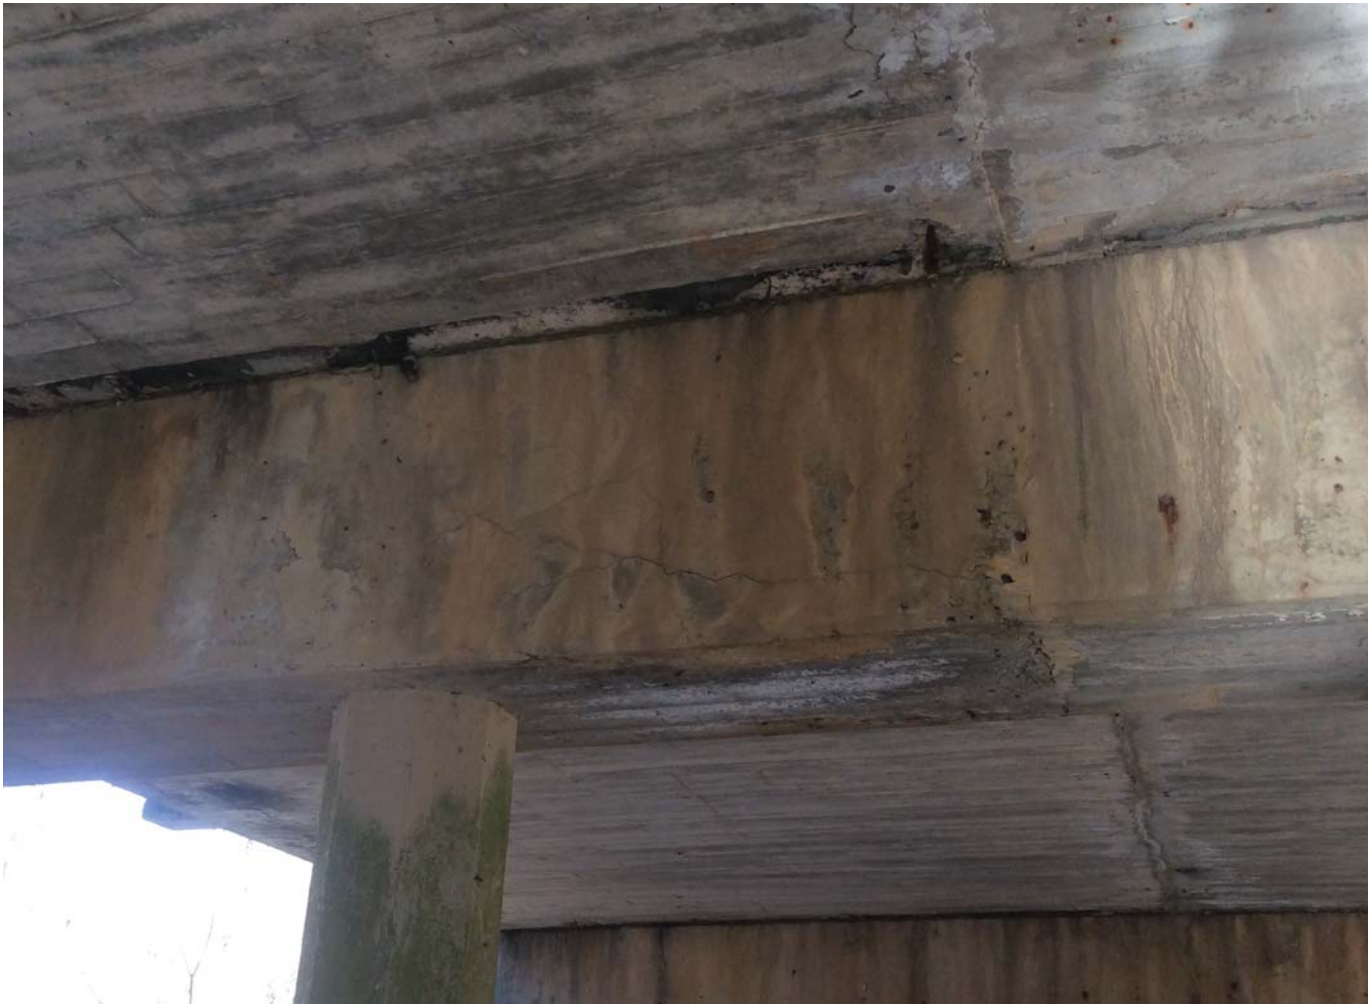
Bent 6 -
cracking

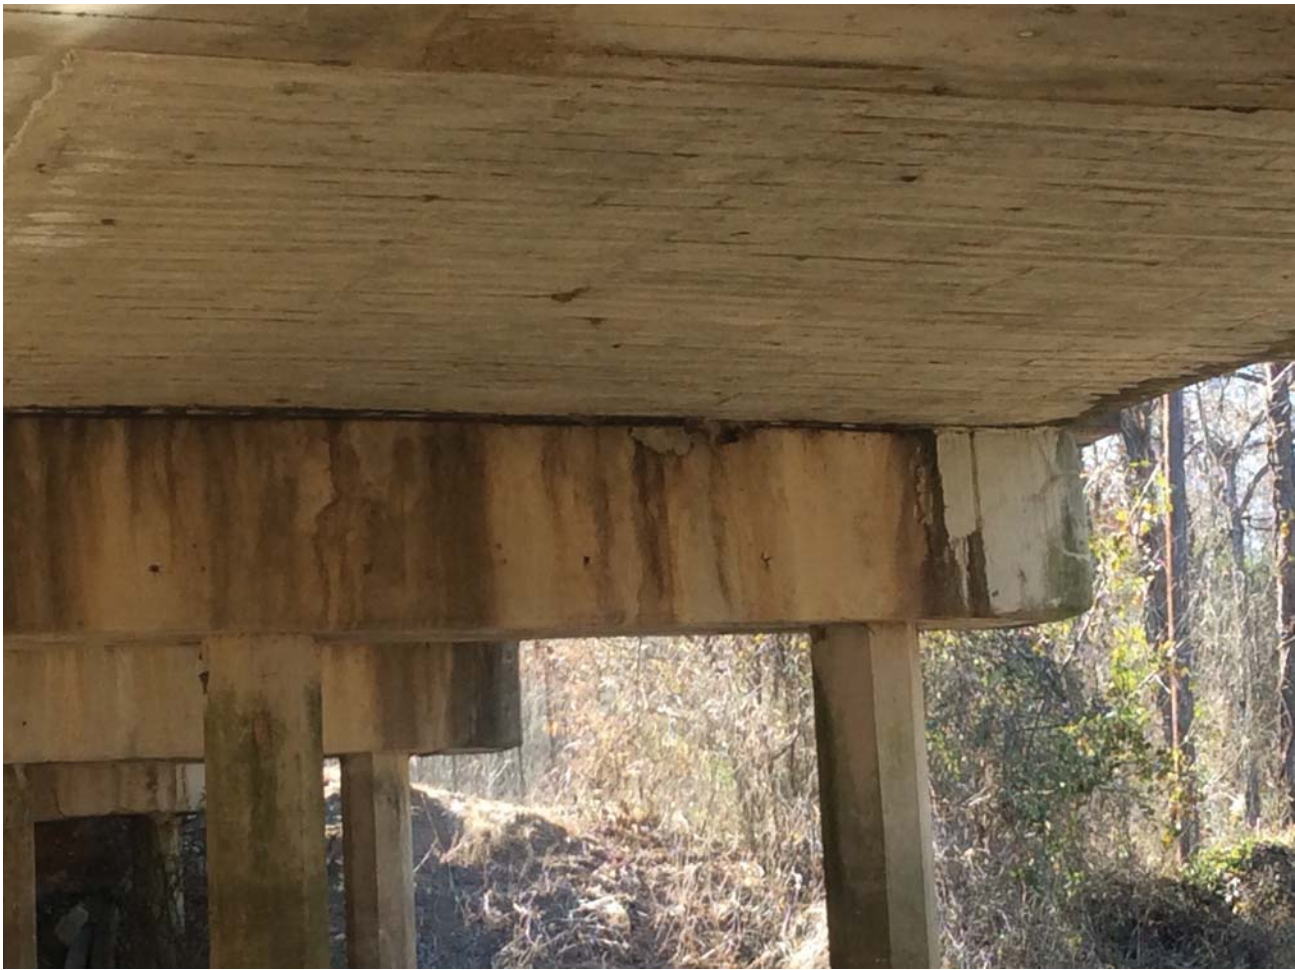
Bent 4 -
delamination

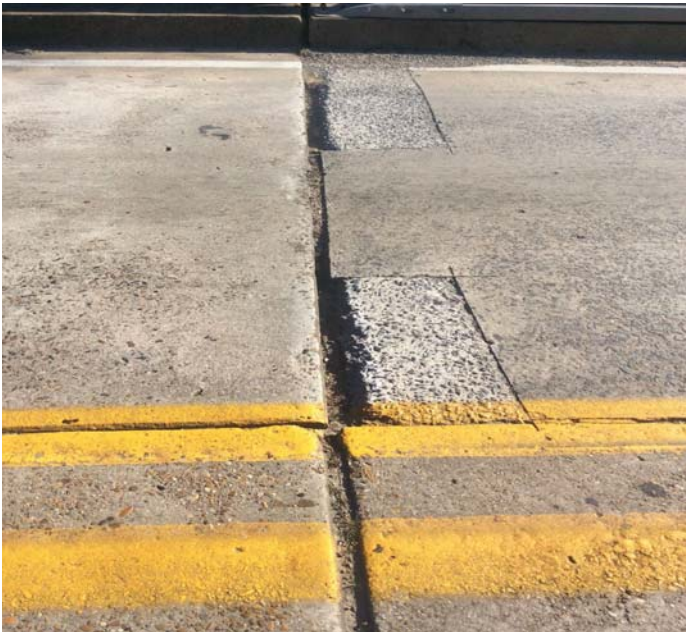
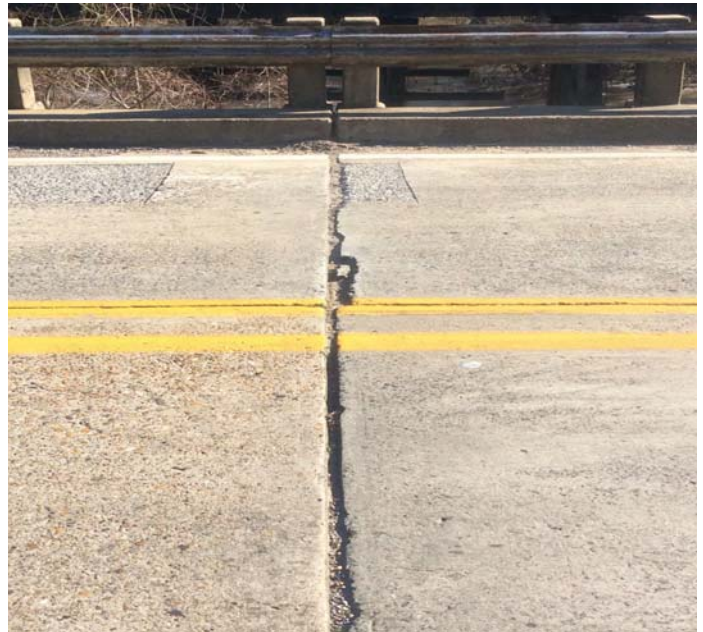
Joints – all bents:

No pourable joint seal in place. Joints impacted with dirt and debris.

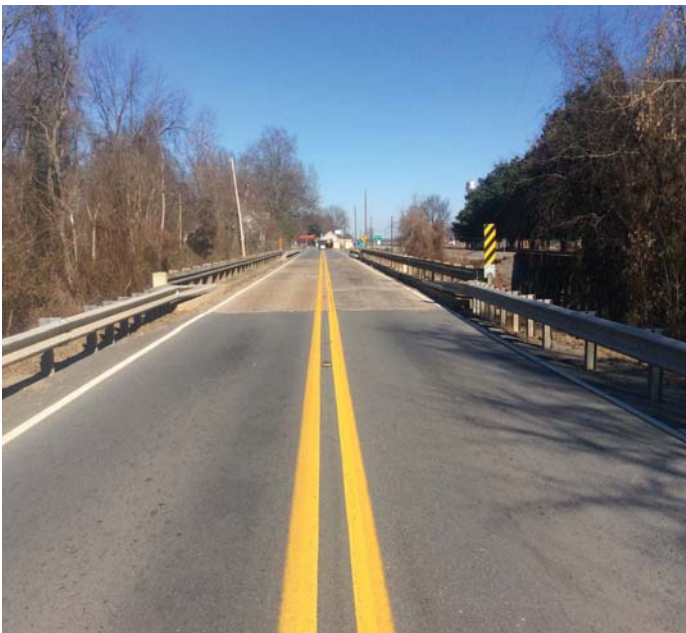
Signs - Bent 1 left and Bent 8 right: No object markers or posts in place.

PHOTO 1 Description Roadway view

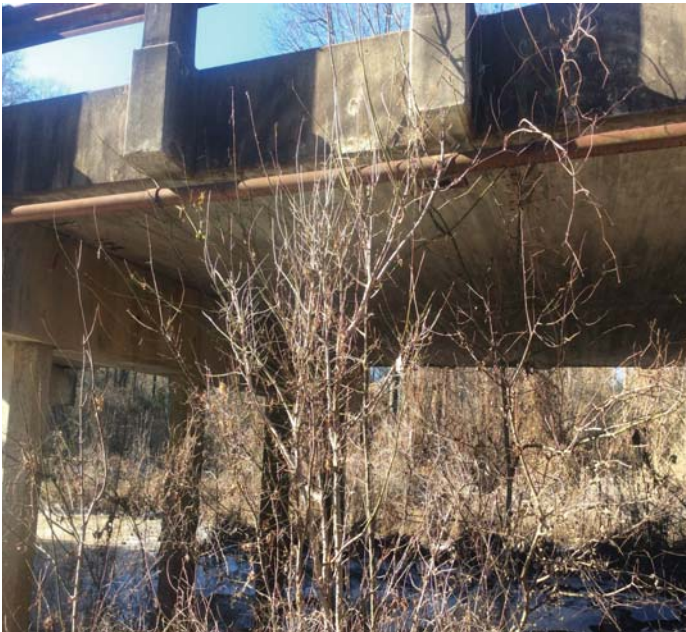
Endslopes - Bents 1 and 8: Small trees, bushes, and other vegetation growing up along edge of bridge with some vines growing up bents.

PHOTO 1 Description Endslope - Span 6 Right: Trees

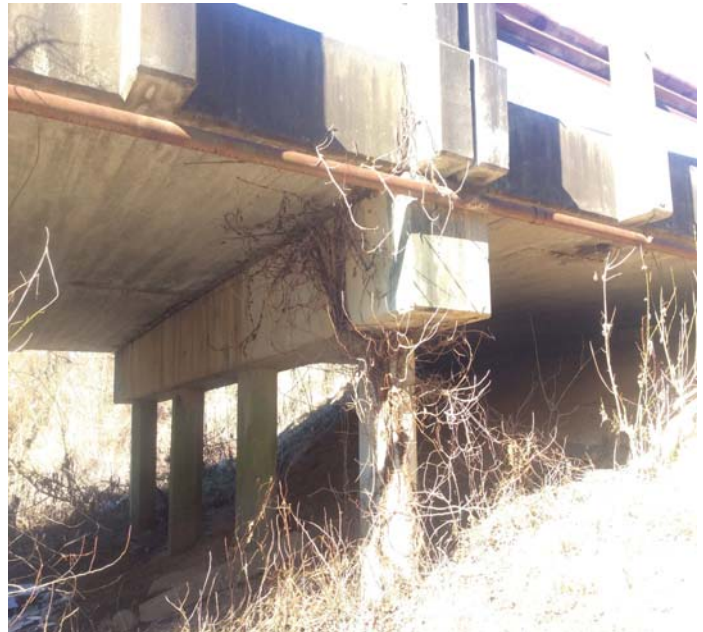
PHOTO 2 Description Endslope - Bent 7: Vegetation
