# Bridge Inspection Report

**M1911**  
**SH 130-06 LM 24.04**  
**over**  
**Holt Branch**

Structure Number: M1911

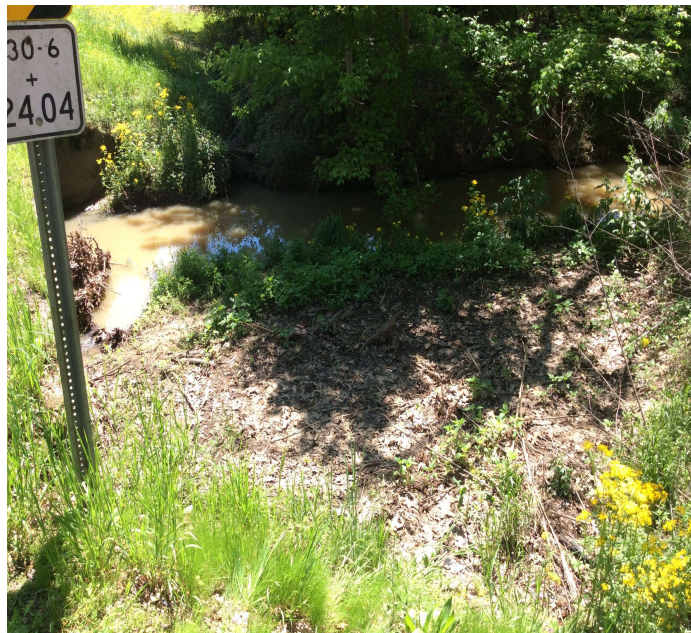
Channel – left & right sides: Minor to moderate build-up of silt inside wingwalls, restricting flow through Barrels 1 & 2.

PHOTO 1      Description      Channel - right side

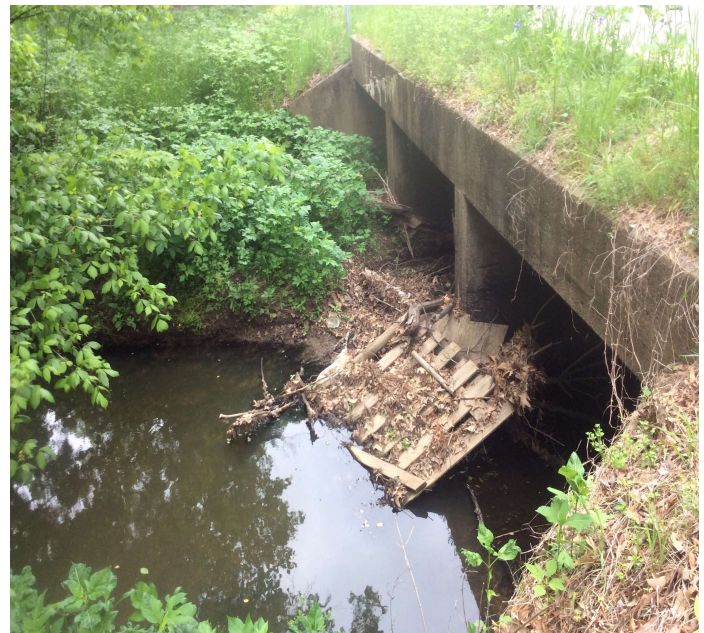
PHOTO 2      Description      Channel right side. Debris and silt

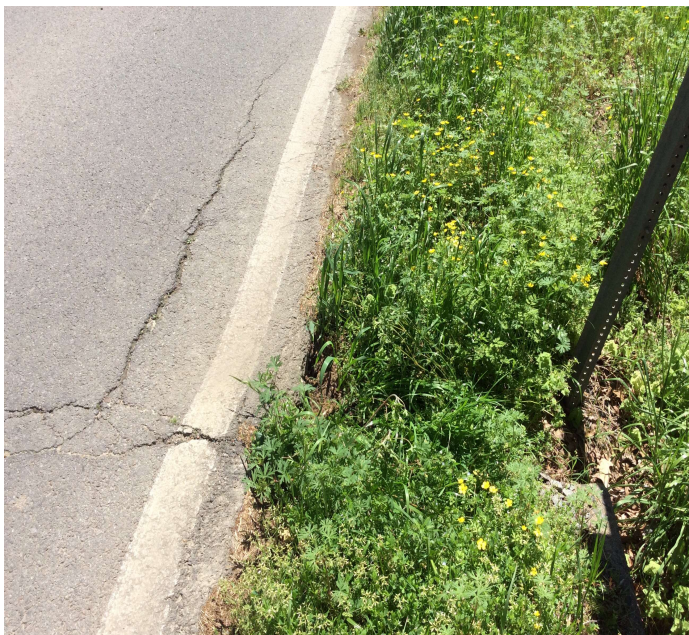
Roadway slope - right side: Area of minor settlement and erosion at Barrel 3 - at edge of pavement (just outside edge line).

PHOTO 1      Description      Roadway slope - Barrel 3 right

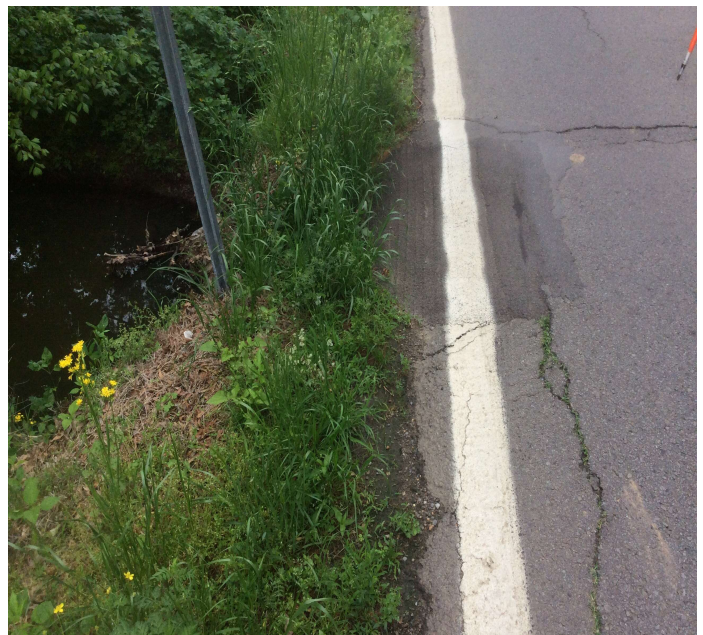
PHOTO 2      Description      Roadway - Barrel 3 right: Settlement at pavement edge
