Bridge Inspection Report

03199
SH 35-09 LM 2.47
over
Big Bayou

Structure Number: 03199

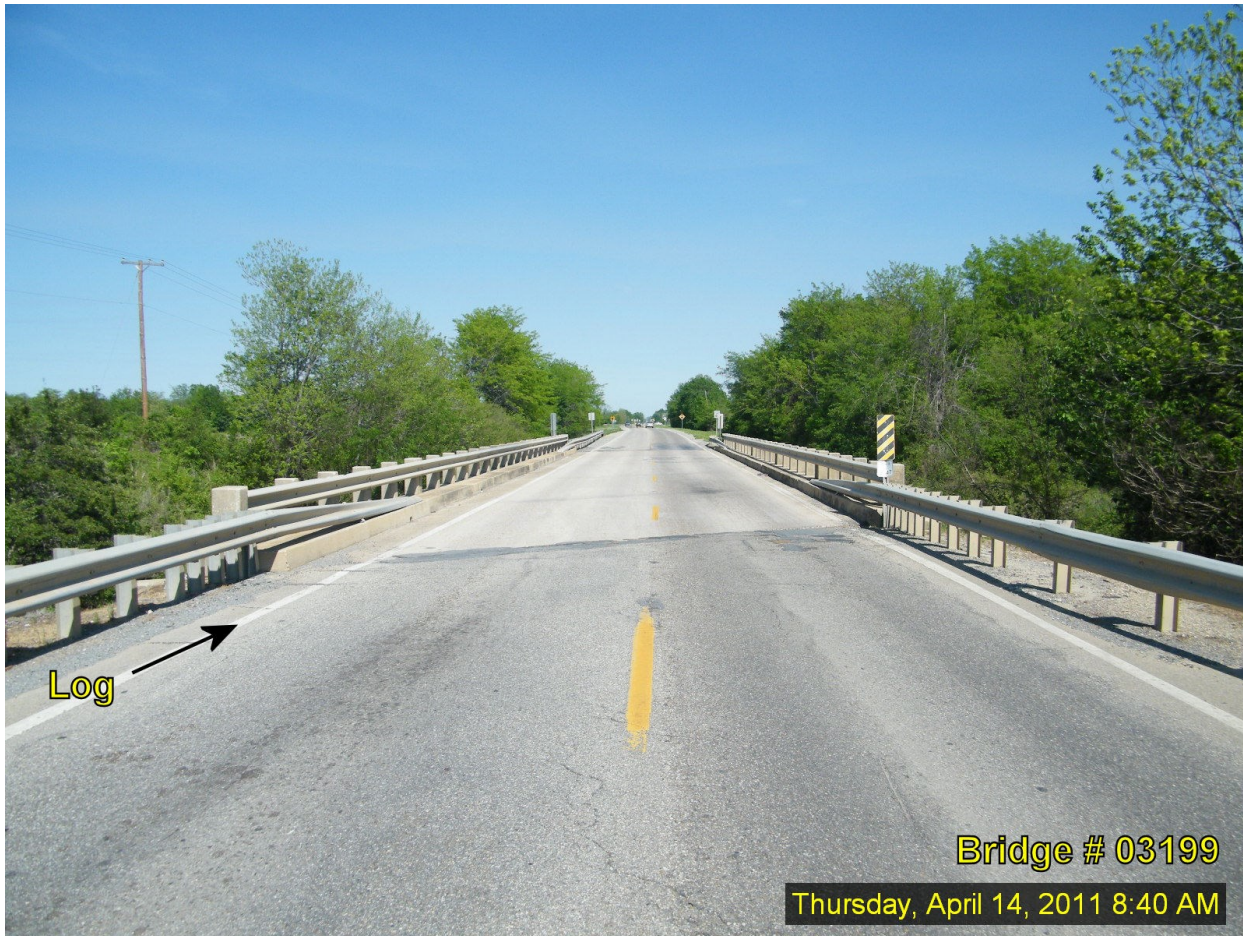
No overlay on the bridge.
