Bridge Inspection Report

02831

US 79B-09 LM 15.16

Main Ditch

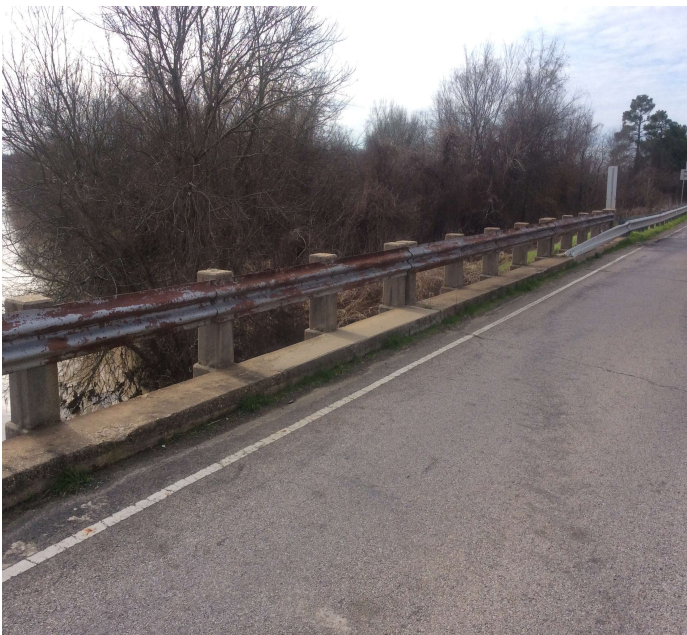
Gutterline – right side: Build-up of dirt, gravel, and other debris – with grass growing – blocking gutters and drains, restricting stormwater from flowing off bridge.

PHOTO 1 Description Gutterline - Spans 1-3 right (debris)

Cleaned by state forces

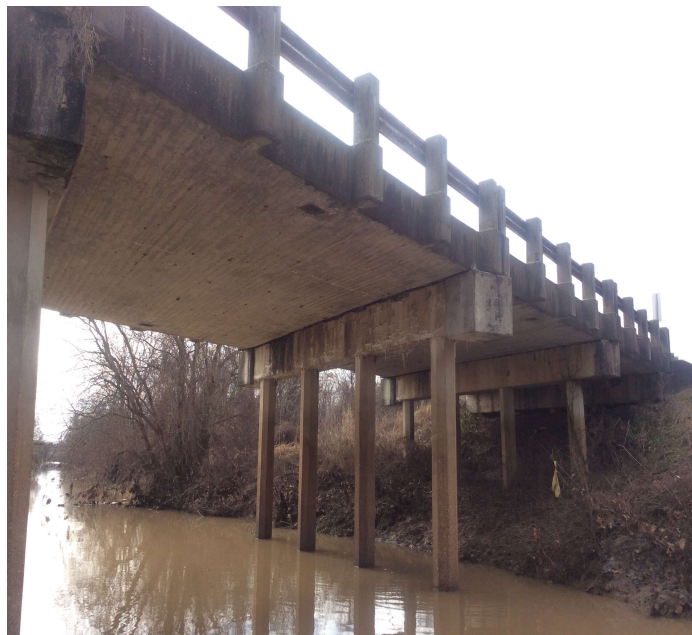
| | Environment | Total Quantity | Units | Condition State 1 | Condition State 2 | Condition State 3 | Condition State 4 |
|---|---|---|---|---|---|---|---|
| | Caps: 32' each (skewed) / Bents 2-5. Some small, scattered areas where concrete has spalled out with minor steel exposure on all caps. Bent 2 - right end: Spalling (repaired.) Bent 3 - left & right ends: Spalling (repaired.) Excessive horizontal cracking with heavy efflorescence on all faces of cap. | | | | | | |

Cap – Bent 3: Excessive horizontal cracking with heavy efflorescence on all faces of cap.
Some small, scattered areas where concrete has spalled out with minor steel exposure on remaining areas of all caps.

PHOTO 1 Description Cap - Bent 3 (efflorescence & patches)

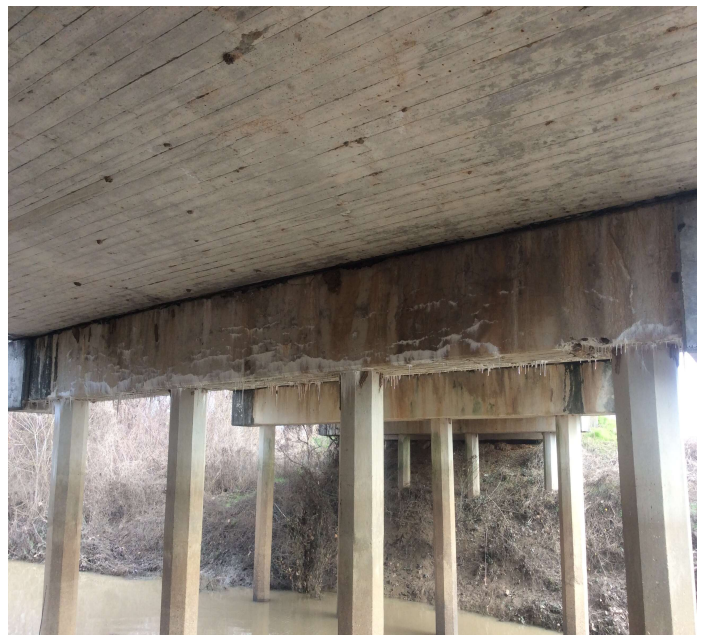
PHOTO 2 Description Cap - Bent 3 (efflorescence)

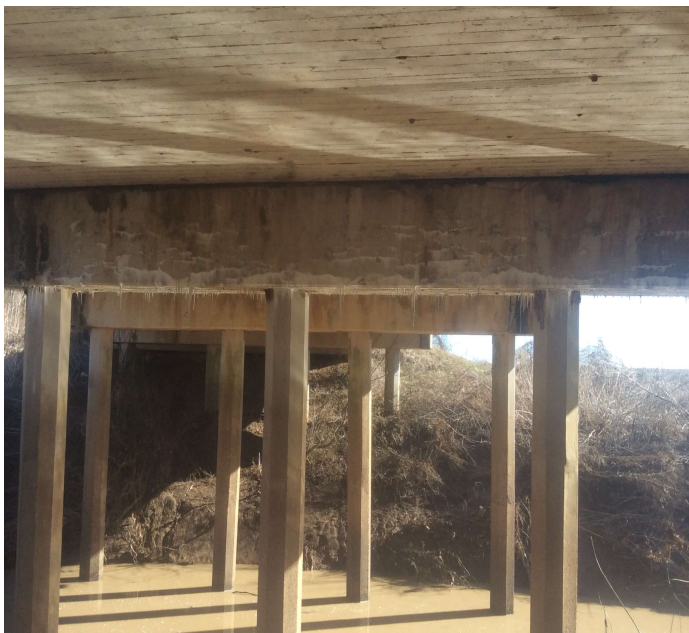
| PHOTO 3 | Description | Bent 3 cap has very excessive amounts of cracks with efflorescence the length of cap . |

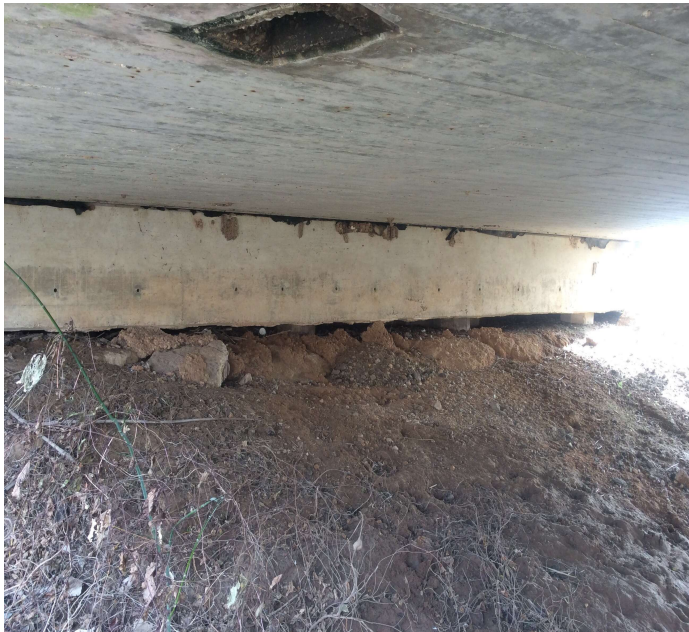
| | Environment | Total Quantity | Units | Condition State 1 | Condition State 2 | Condition State 3 | Condition State 4 |
|---|---|---|---|---|---|---|---|
| | Abutments: 38' each (skewed) / Bents 1 & 6. End slopes - Bents 1 & 6: Some minor to moderate settlement/erosion along full width and length of caps. (Bent 1 = 6-8" tall, Bent 6 = approximately 4") | | | | | | |

End slopes – Bents 1 & 6: Some minor settlement/erosion along full width and length of caps. (Bent 1 = 6-8" tall, Bent 6 = ~4")

PHOTO 1 Description End slope- Bent 6 (settlement)

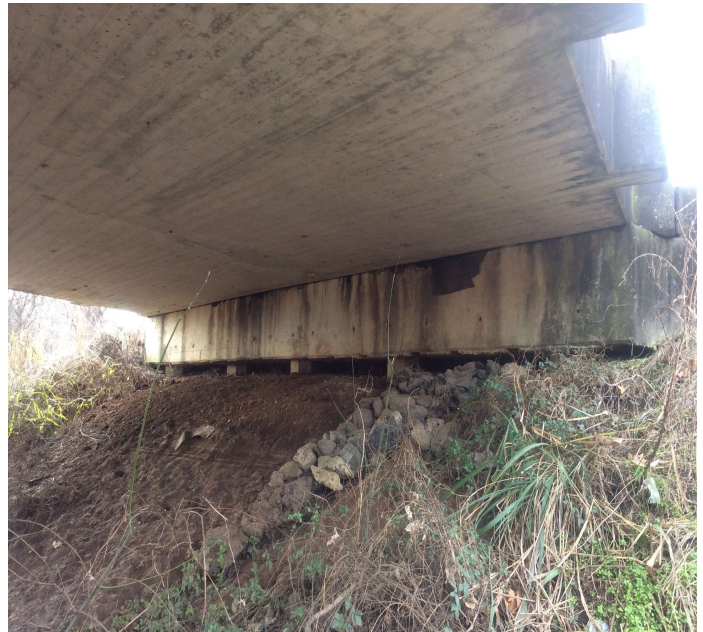
PHOTO 2 Description End slope - Bent 1 (settlement)

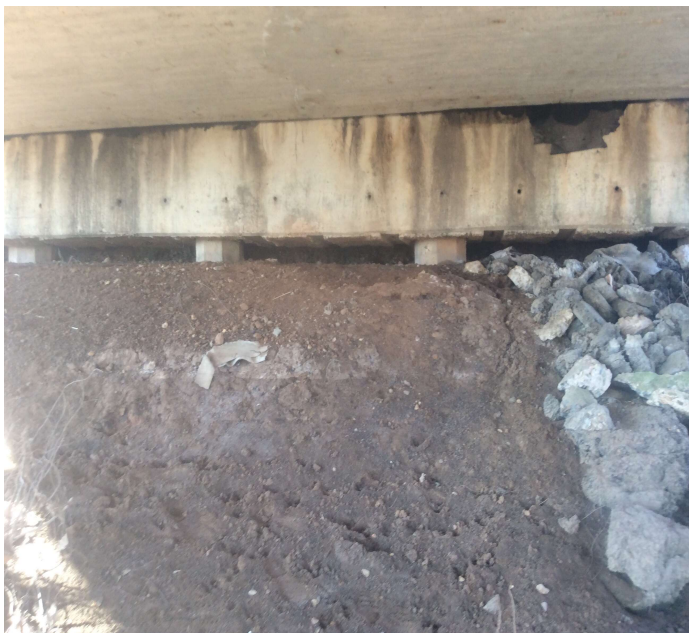
PHOTO 3 Description Erosion at bent 1 abutment under cap has exposed piles .
