# Bridge Inspection Report

**01823**  
**US 79C-11 LM 0.13**  
**over**  
**King Bayou Ditch**

Structure Number: 01823

Facility Carried: US 79C-11 LM 0.13

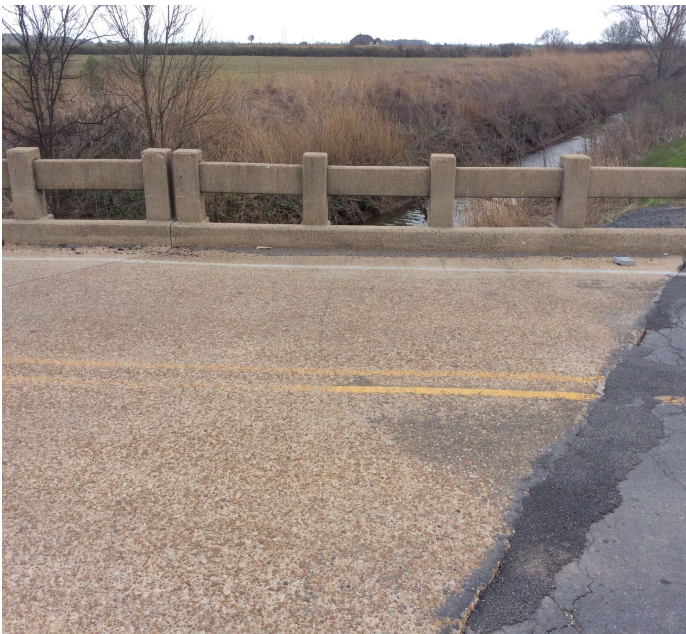
Deck, Unsealed moderate-sized transverse cracks every 4-6'.

PHOTO 1      Description      Deck - Span 1 right (cracking)

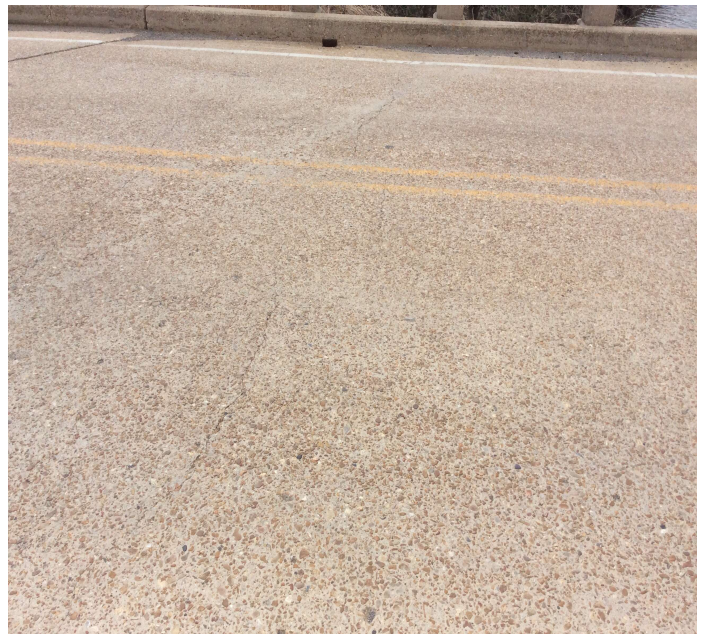
PHOTO 2      Description      Deck - Span 2 (cracking)

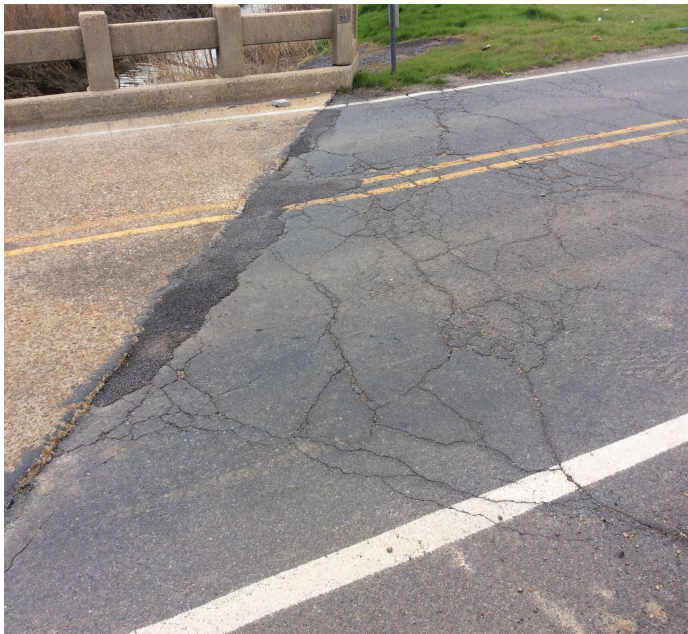
Approach roadway - Bents 1 & 4: Asphalt wearing surface is deteriorating and cracking with some minor settlement.

PHOTO 1      Description      Approach roadway - Bent 1  
(deterioration)

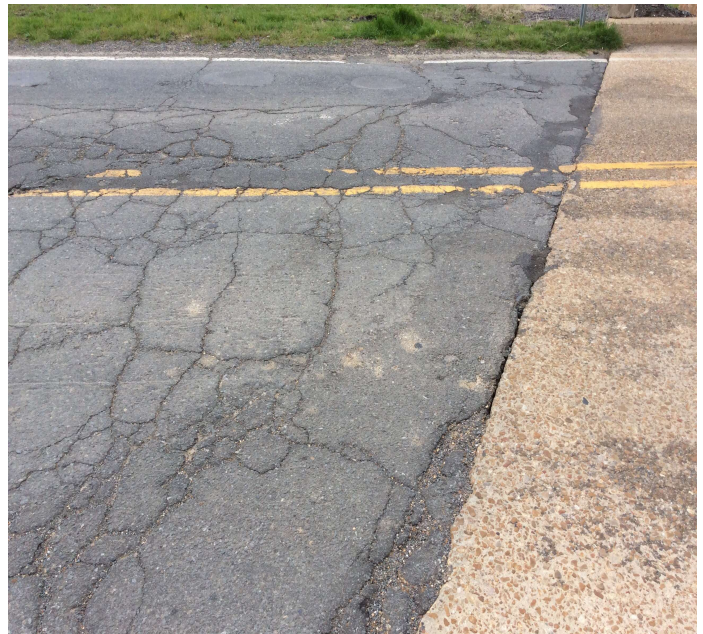
PHOTO 2      Description      Approach roadway - Bent 4  
(deterioration)

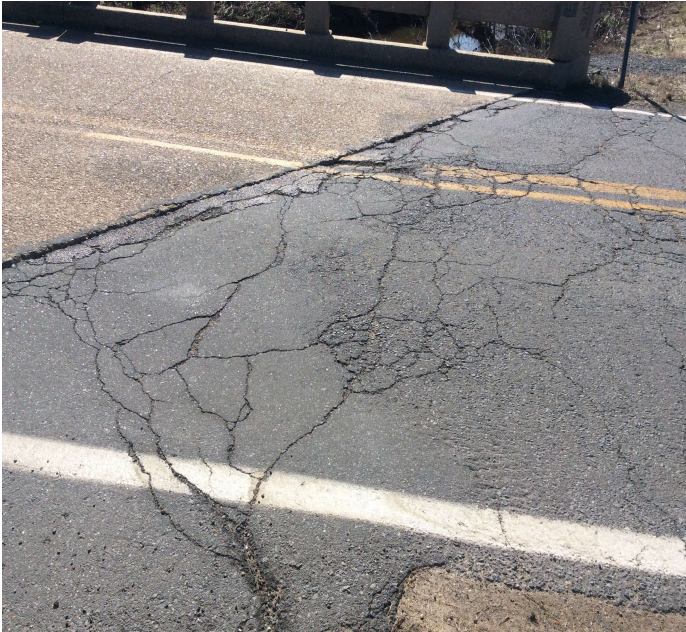
PHOTO 3    Description    Bent 1 - Approach Roadway:  
Deterioration/settlement

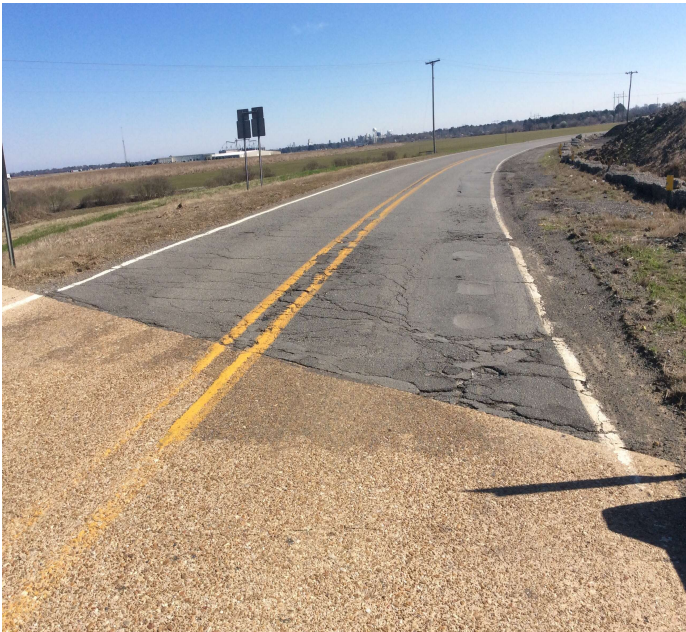
PHOTO 4    Description    Bent 4 - Approach Roadway:  
Deterioration
