Bridge Inspection Report

03538
SH 46-02 LM 8.75
over
Big Slough

Structure Number: 03538

Facility Carried: SH 46-02 LM 8.75

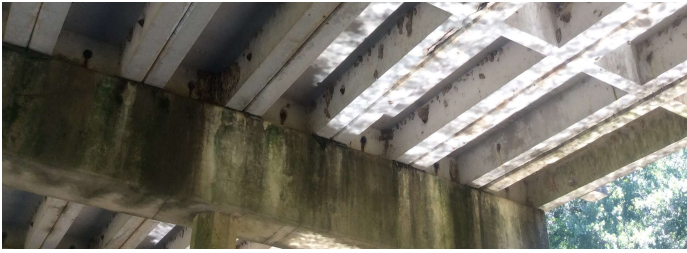
Channel beam units: Cracking and delaminations along bottom of legs at locations indicated:

- Span 5 Unit 4: Right leg at 55% point – 1' long.
- Span 5 Unit 5: Left leg at 1/3 point – 3' long.
- Span 5 Unit 5: Right leg at midspan – 5' long.
- Span 6 Unit 1: Right leg 1/3 point – 1' long.

PHOTO 1 Description Span 5 Unit 5 left (delamination)

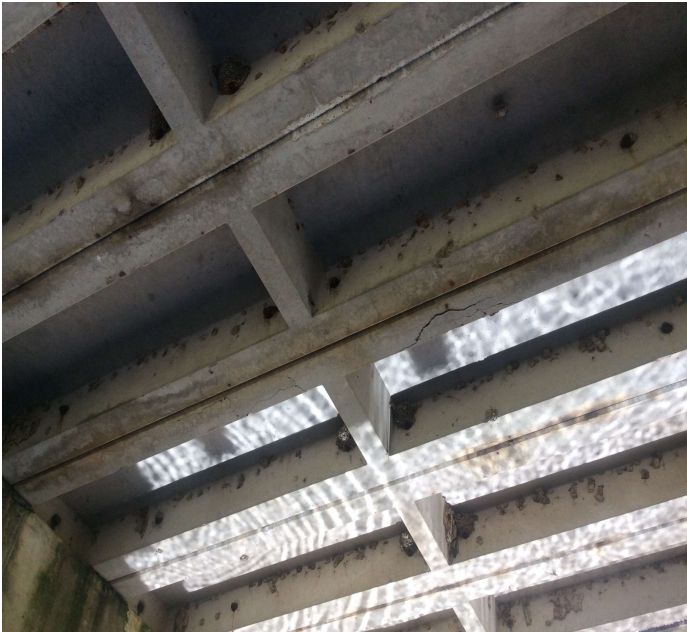
- Span 6 Unit 1: Right leg at midspan – 4' long.
- Span 6 Unit 5: Left leg at 1/3 point – 3' long.
- Span 6 Unit 5: Left leg at 55% point – 2' long.
- Span 7 Unit 1: Right leg 2/3 point – 3' long.

PHOTO 2 Description Span 6 Unit 5 left (delamination)

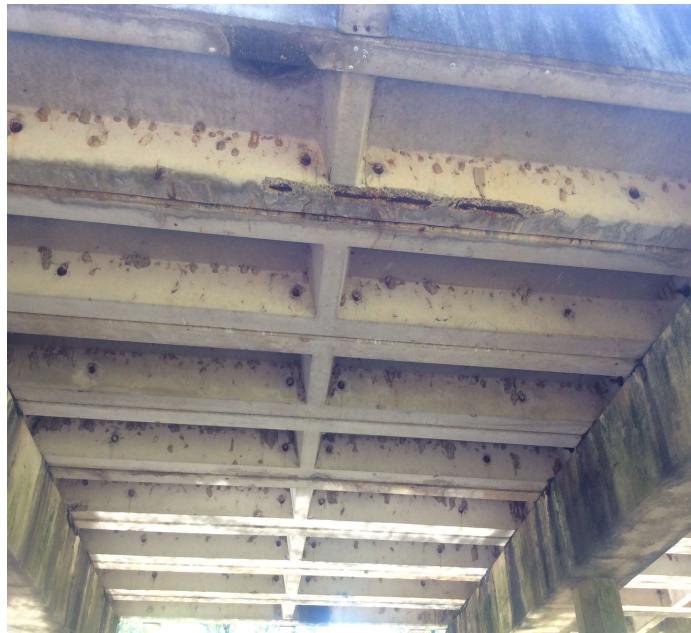
Channel beam units: Spalling with steel exposed (minor section loss) along bottom of legs at locations indicated:

- Span 1 Unit 2: Left leg at 1/4 point – 1' long.
- Span 2 Unit 1: Right leg at 50% point – 3' long.
- Span 3 Unit 1: Right leg at 40% point – 6' long.
- Span 4 Unit 5: Right leg at 40% point – 2' long.
- Span 4 Unit 8: Left leg at 1/4 point – 3' long.
- Span 4 Unit 1: Right leg at 40% point – 2' long.
- Span 5 Unit 5: Right leg at midspan – 2' long.
- Span 6 Unit 7: Right leg at 2/3 point – 2' long.
- Span 7 Unit 1: Right leg at 25% point – 1' long.
- Span 8 Unit 1: Right leg at 15% point – 1' long.
- Span 8 Unit 4: Right leg at 2/3 point – 2' long. (25' total)

PHOTO 1 Description Span 3 Unit 1 right (rebar exposed)

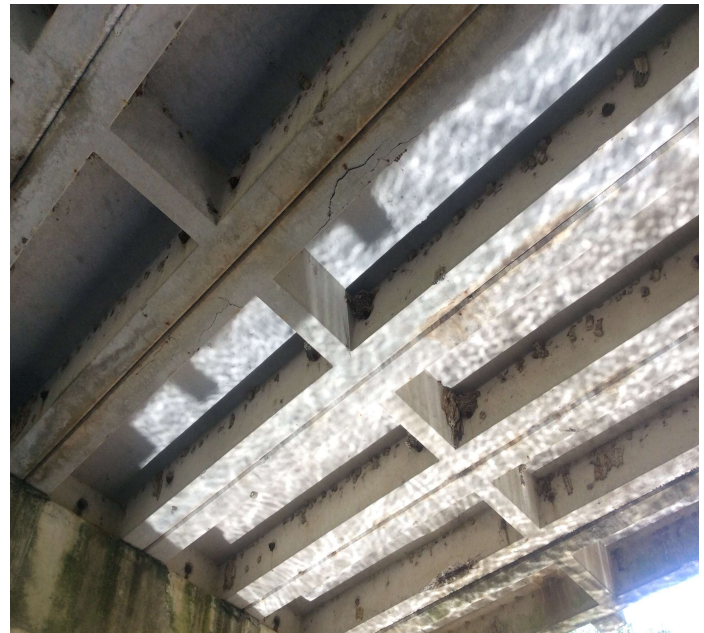
PHOTO 2 Description Span 6 Unit 7 right (rebar exposed)

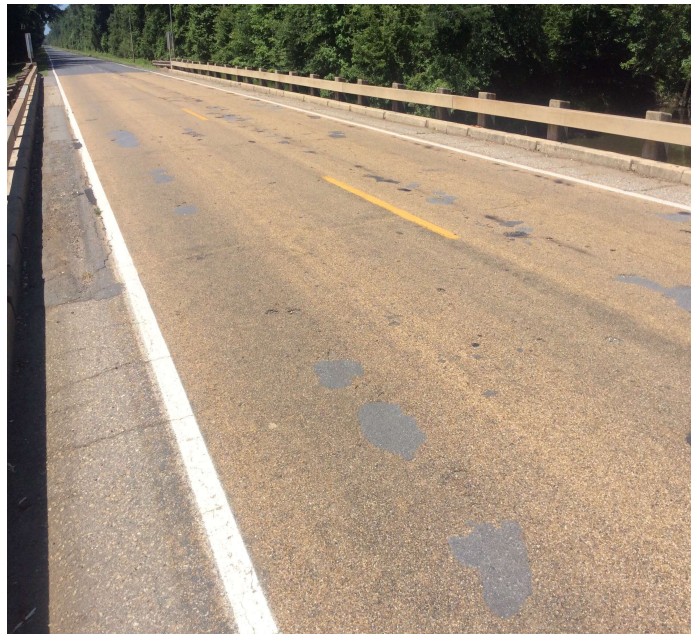
Asphalt wearing surface - all spans: Wearing surface is deteriorating with many small potholes and minor-sized transverse and longitudinal cracking along joints of units - large transverse crack/spall at Bent 4 left. Potholing is heaviest on left lane.

PHOTO 1 Description Wearing surface - Spans 6-8
(deterioration)

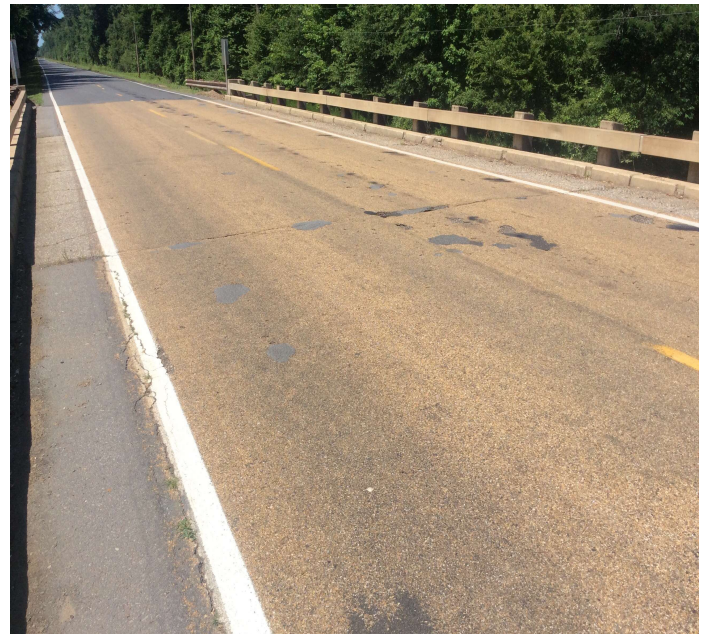
PHOTO 2 Description Wearing surface - Spans 3-4
(deterioration)

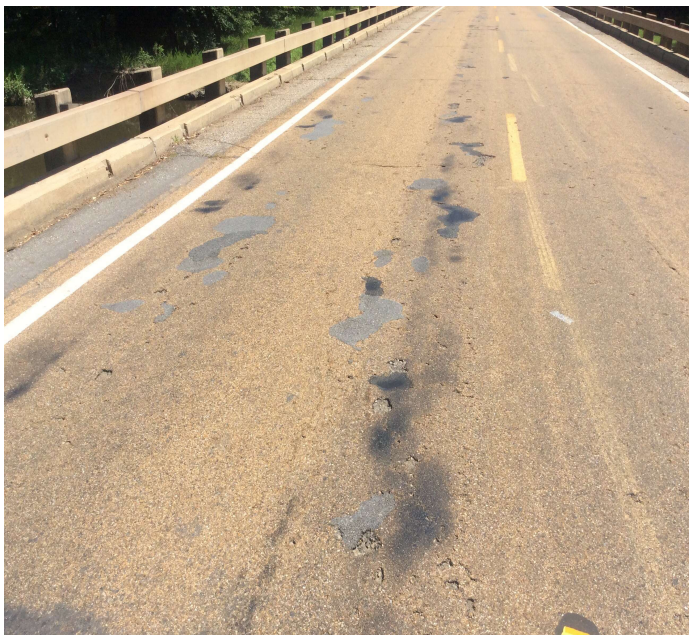
PHOTO 3 Description Wearing surface - Spans 1-2
(deterioration)
