Bridge Inspection Report

03540
SH 46-02 LM 13.80
over
Lost Creek

IDENTIFICATION		INSPECTIONS	
(1) STATE CODE	056 - Arkansas	(90) INSPECTION DATE	09/05/2017
(8) STRUCTURE NUMBER	03540	(91) DESIGNATED INSPECTION FREQUENCY	24

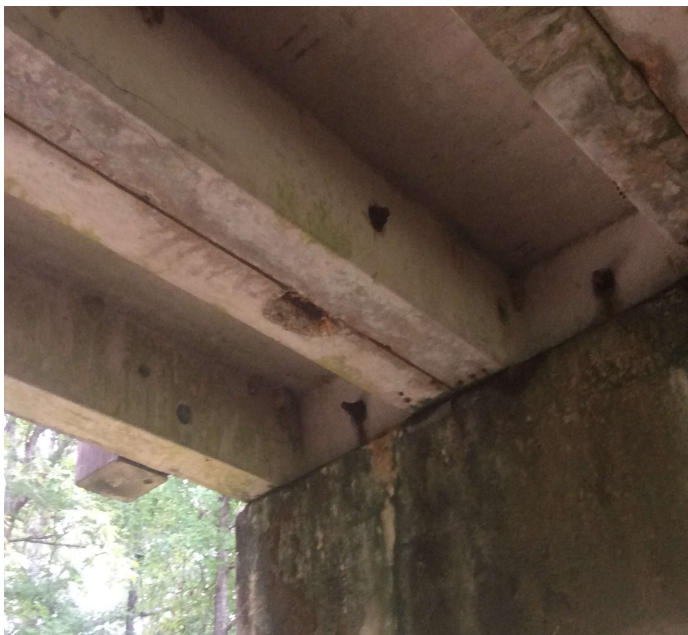
Channel units span 3,4,6,10-14 have spalls with exposed rebar and some section loss to rebar on legs various locations. (State forces have repaired previously documented spalling.)

PHOTO 1 Description Small spall with exposed rebar span 6 unit 8.

David: Do we need to look at replacing these?

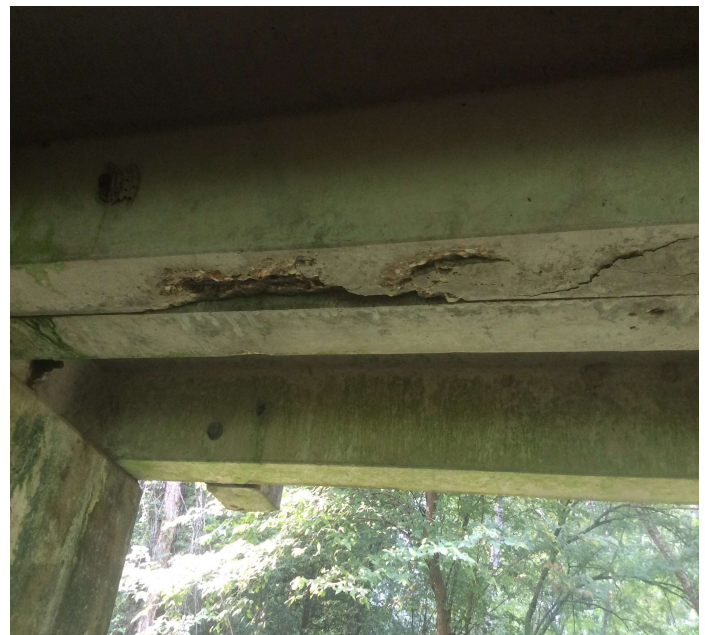
PHOTO 2 Description Span 10 unit 7 has spall with exposed rebar.

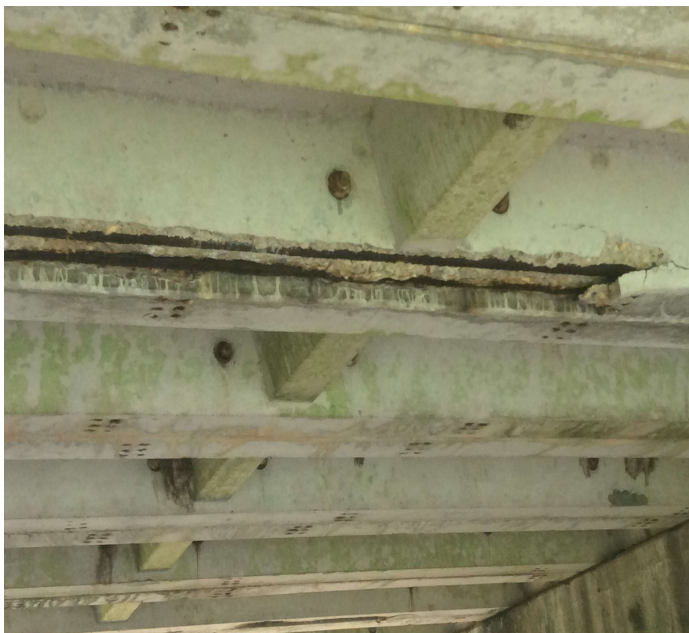
PHOTO 3 Description Span 12 unit 2&3 has large spall with exposed rebar but common on units 7&8.

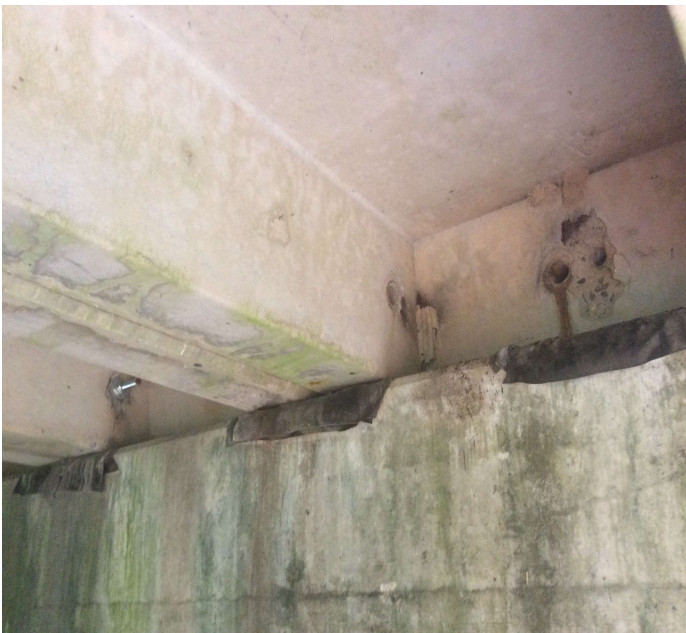
Various locations channel units not bolted transversely. Most common at units 1-2 and 7-8.

PHOTO 1 Description Span 3 unit 7-8 are not bolted together.

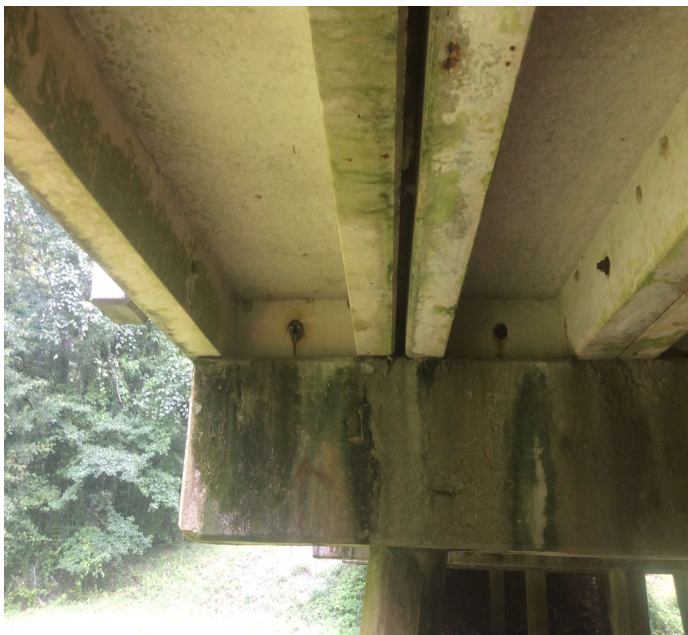
Span 10-11 unit 1 is misaligned due to previous traffic impact with enlarged grouted key ways and some loss of bearing area to channel legs at span 11.

PHOTO 1 Description Span 11 units 1 has separated due to not being bolted and traffic impact.

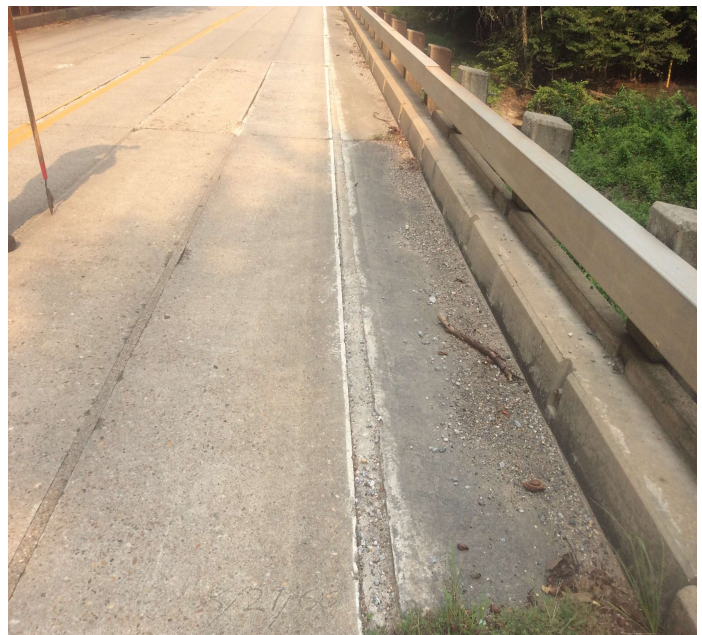
PHOTO 2 Description Grouted keys at span 10 & 11 units 1 & 2 note excessive amount of grout in key due to unit 1 moving from traffic .

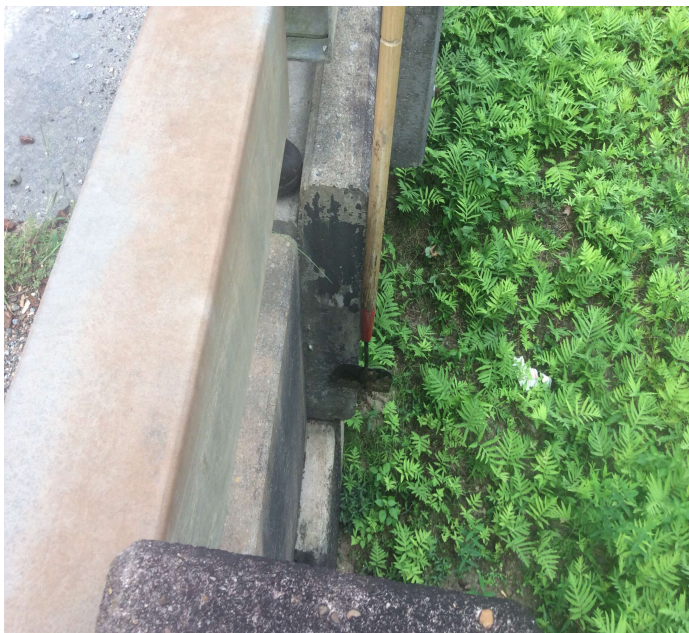
PHOTO 3 Description Bent 12 unit 1 back has moved on cap due to not being bolted and traffic impact.

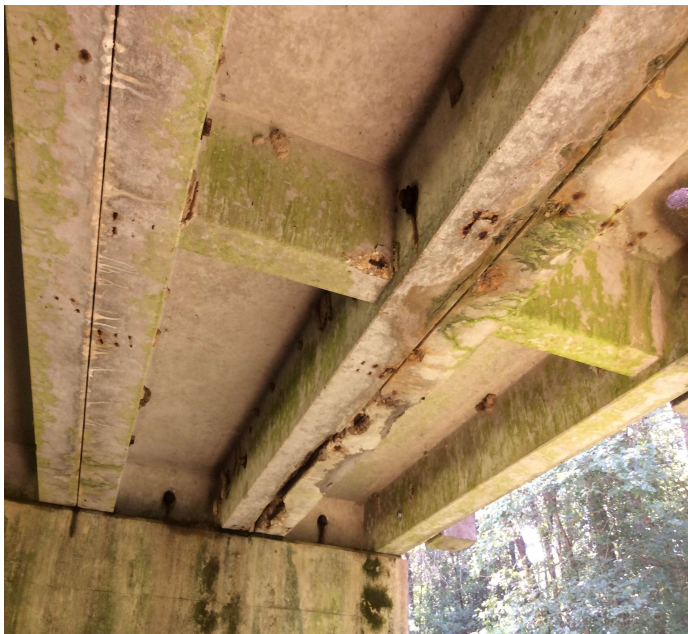
PHOTO 1 Description Span 13 Unit 8 left

Channel beam units: Spalling with steel exposed (minor section loss) along bottom of legs at various locations.

NOTE: State maintenance forces have cleaned and applied rust-inhibitor to reinforcing steel and have grouted-over exposed steel in many places; however, condition still exists in several locations throughout bridge.

Many units have been repaired by state forces.

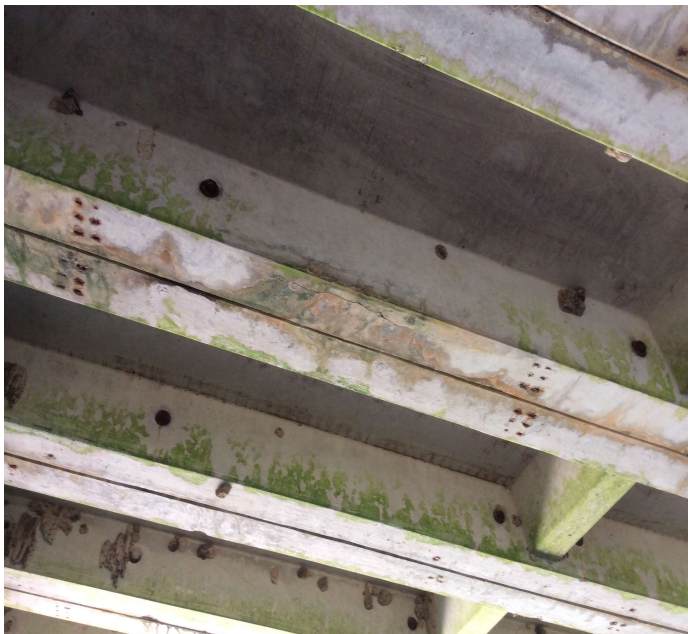
PHOTO 1 Description Span 7 Unit 5 left

Channel beam units: Cracking and delaminations along bottom of legs at various locations.

NOTE: State maintenance forces have cleaned and applied rust-inhibitor to reinforcing steel and have grouted-over exposed steel in many places; however, condition still exists in several locations throughout bridge.

Repaired by state forces.

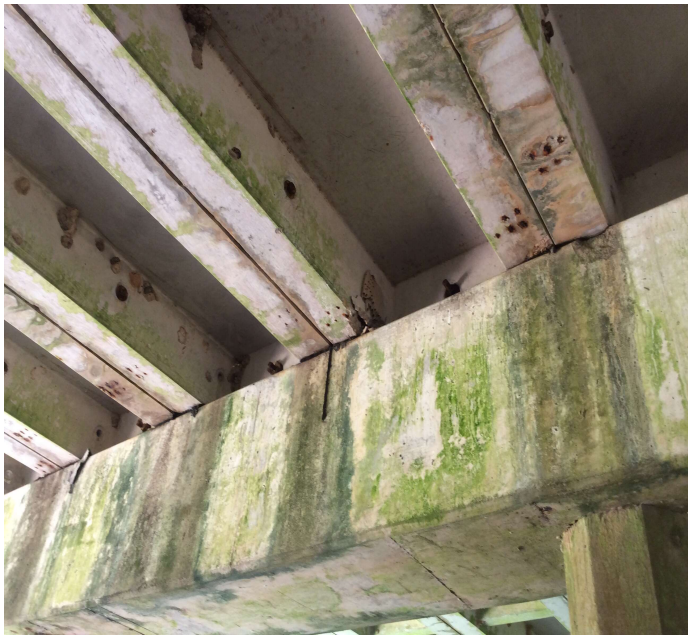
PHOTO 1 Description Span 7 Unit 4 left

Channel beam units: Spalling with steel exposed (minor section loss) along bottom of legs at various locations. Spalling is at anchorage point of reinforcing steel and ability to carry loads may be beginning to be reduced.

NOTE: State maintenance forces have cleaned and applied rust-inhibitor to reinforcing steel and have grouted-over exposed steel in many places; however, condition still exists in several locations throughout bridge.

Repaired by state forces.

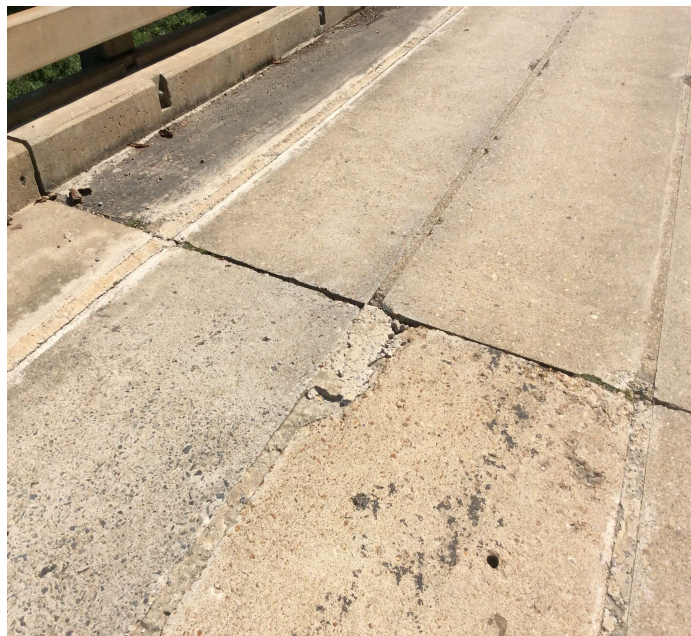
PHOTO 1 Description Deck - Span 10 Unit 3

Deck - Span 10 Unit 3: Cracking and spalling on left side at Bent 11 - small pieces of concrete coming loose and could become hazard for traffic.

(Note this has become a small spall near the grouted key way with no loose material remaining.2017)

repair asap

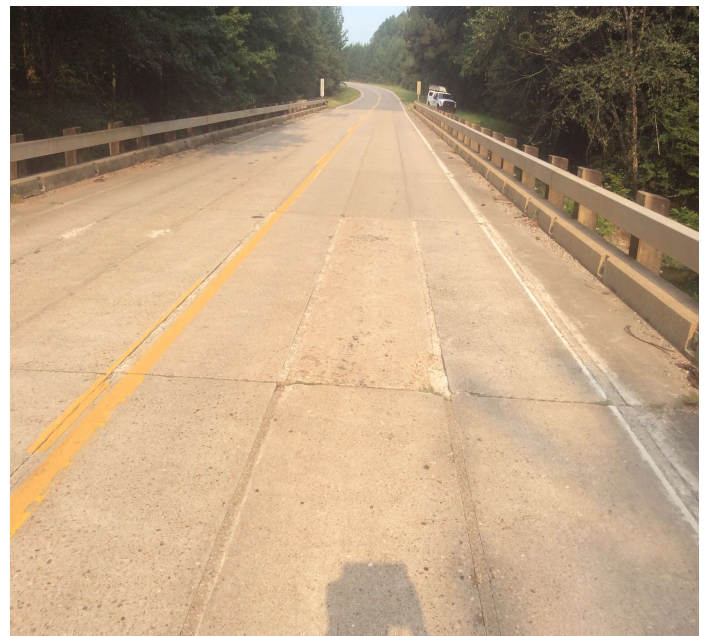
PHOTO 2 Description Some grout missing between channel units near midspan .
