# Bridge Inspection Report

03541

SH 46-02 LM 13.97

Lost Creek Relief

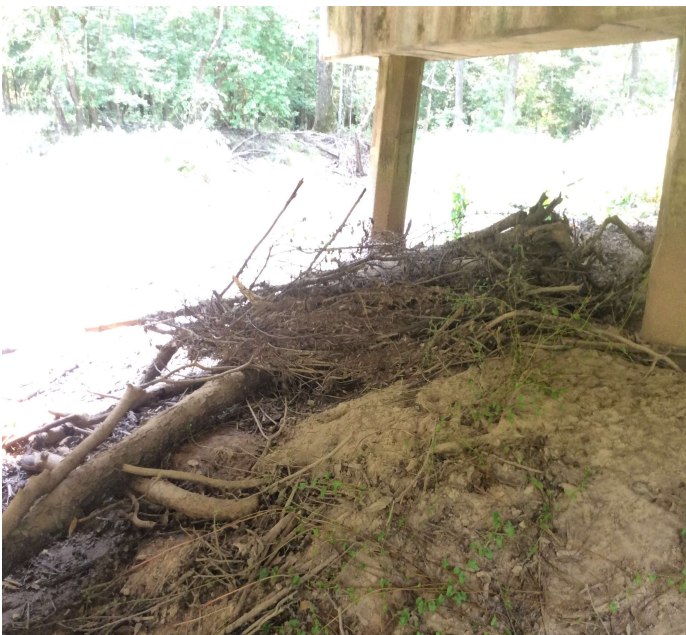
PHOTO 1    Description    Channel - Bent 3 Pile 3

Channel - Span 3: Moderate build-up of logs, limbs, and other debris again Bent 3 Pile 3 (under bridge) stretching under Span 3 towards Bent 4.

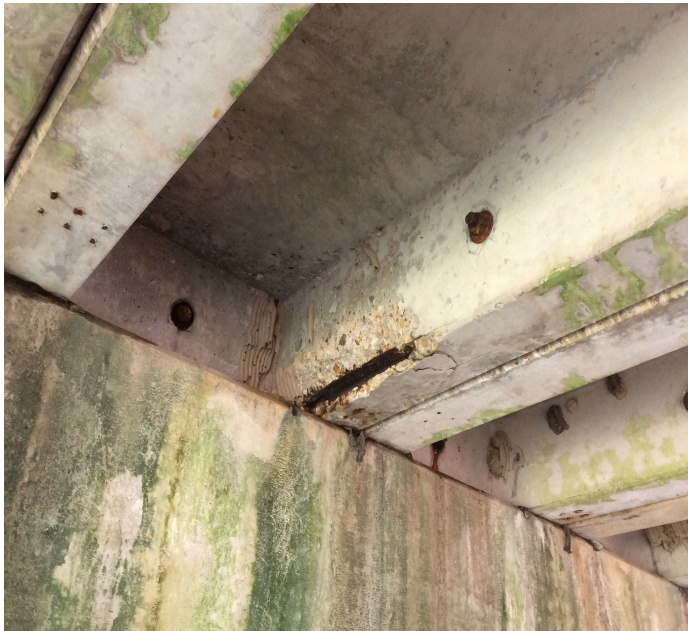
PHOTO 1      Description      Span 6 Unit 3 right

Channel beam units: Spalling with steel exposed (minor section loss) along bottom of legs at locations indicated:

Span 6 Unit 3: Right leg at end of span – 2' long.

NOTE: Spalling is at anchorage point of reinforcing steel and ability to carry loads may be beginning to be reduced.

David: this one concerns me more with the location of the spalling and slight section loss of the longitudinal steel. I know these are still 19' units, but this needs to be looked at asap

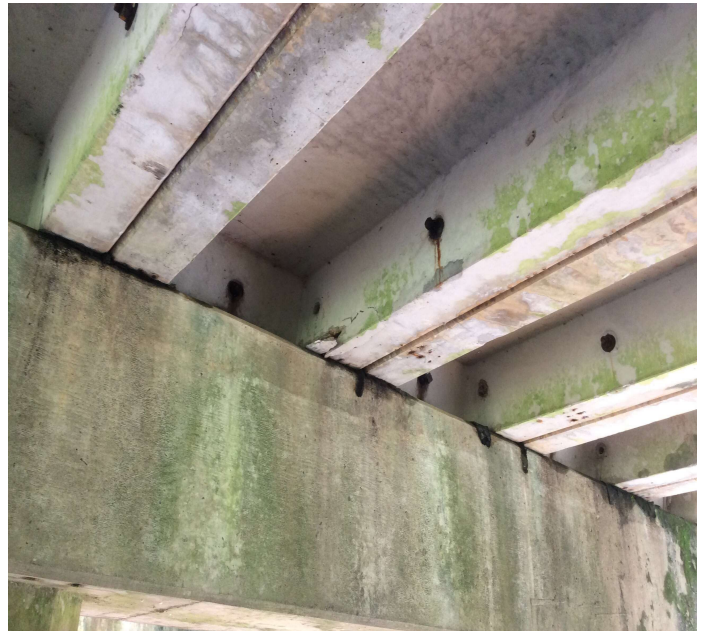
PHOTO 2      Description      Span 3 Unit 5 right

Span 3 Unit 5: Right leg at beginning of span – 2' long.

Span 3 Unit 5: Right leg at end of span – 2' long.

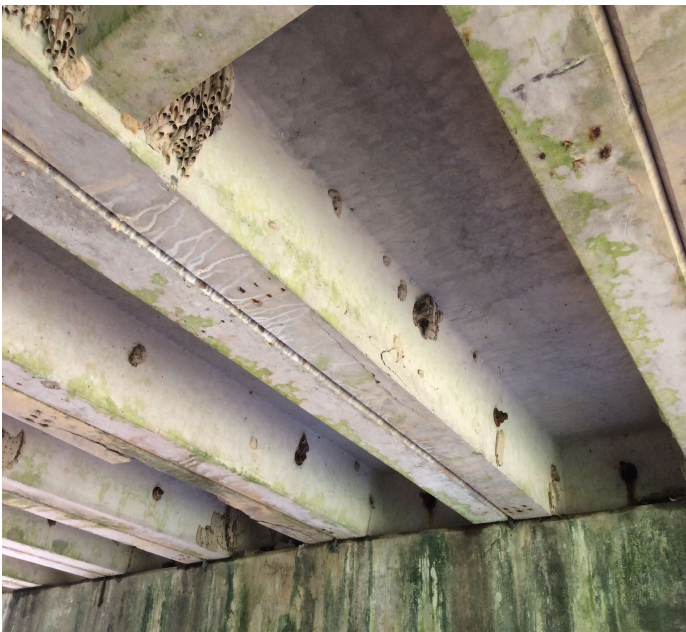
Span 6 Unit 3 right

Channel beam units: Cracking and delaminations along bottom of legs at locations indicated:

- Span 1 Unit 8: Left leg at 40% point – 2' long.
- Span 1 Unit 7: Right leg at 2/3 point – 4' long.
- Span 3 Unit 3: Right leg at 1/4 span – 3' long.
- Span 3 Unit 3: Right leg at midspan – 2' long.
- Span 3 Unit 3: Right leg at 80% point – 3' long.
- Span 3 Unit 4: Left leg at 1/4 point – 6' long.
- Span 3 Unit 4: Right leg at 20% point – 3' long.
- Span 4 Unit 2: Right leg at 2/3 point – 1' long.
- Span 4 Unit 5: Right leg end of span – 2' long.
- Span 5 Unit 1: Right leg at midspan – 4' long.
- Span 5 Unit 1: Right leg at 90% point – 2' long.
- Span 5 Unit 3: Right leg at 45% point – 1' long.
- Span 6 Unit 3: Right leg at 1/3 span – 3' long.
- Span 6 Unit 5: Left leg at 90% point – 3' long.
- Span 7 Unit 3: Right leg at 1/3 span – 1' long.

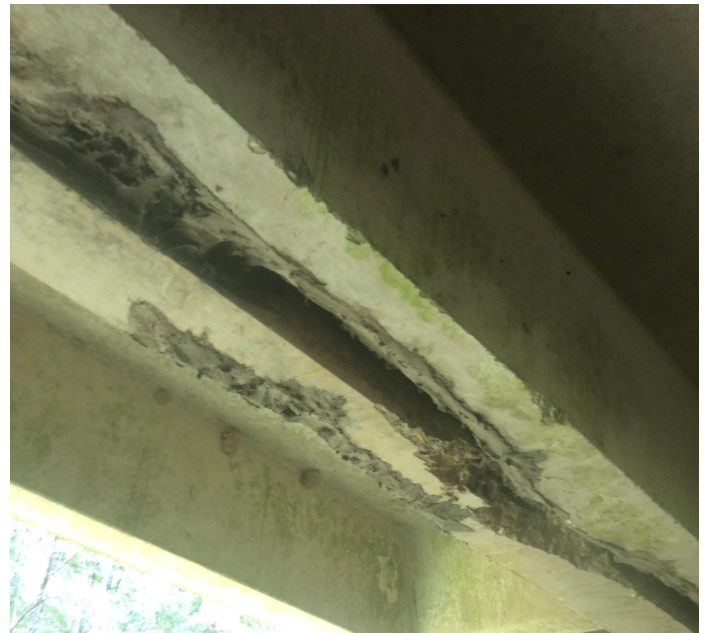
PHOTO 4 Description Span 1 units 7&8 have spalls with exposed rebar.

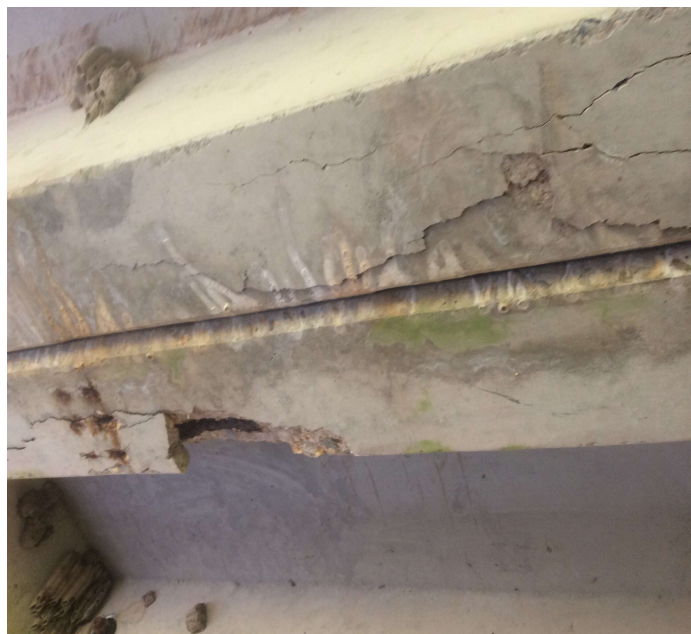
PHOTO 3 Description Span 3 units 3-4 have cracks, delams and spalls with exposed rebar to legs. Common units 5-7 this span.

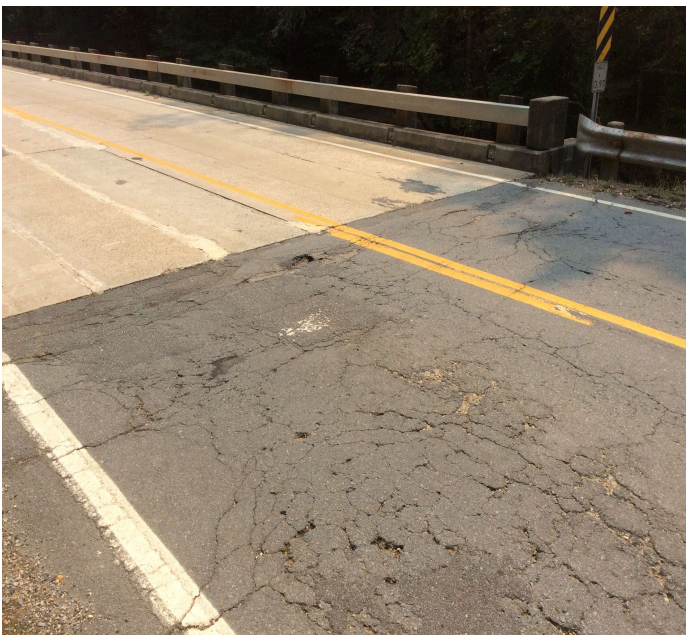
PHOTO 1      Description      Approach roadway - Bent 1

Approach roadway – Bent 1: Asphalt is cracked and broken up with some shallow spalling (potholes) and minor settlement.
