Bridge Inspection Report

A6966
US 65-17 SB 4.7
over
Walnut Lake

Structure Number: A6966

Facility Carried: US 65-17 SB 4.7

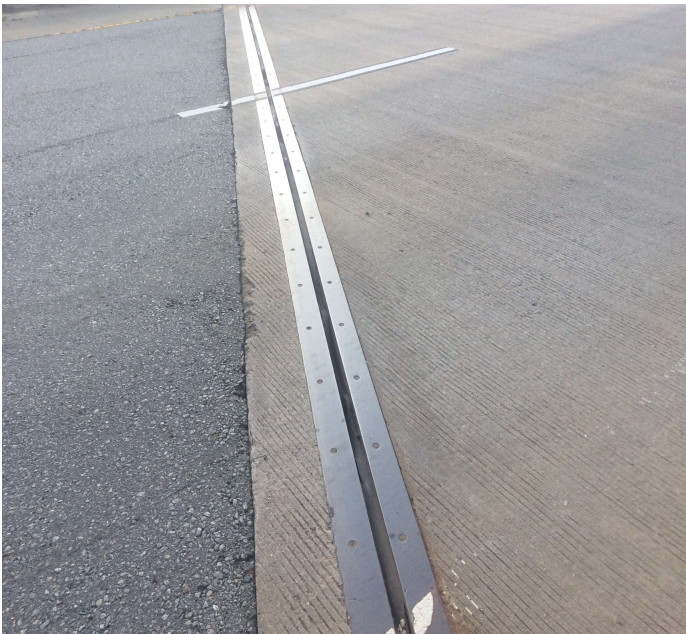
43.5' each. abutments 1 and 5. Bents 1 & 5: Pourable joint material is deteriorating in several places - a couple of moderate sized holes and some sagging at both bents with leaking.						
2310 - Leakage		30			30		
2320 - Seal Adhesion		25				25	
2330 - Seal Damage		6					6
310 - Elastomeric Bearing	1- Ben.	30	each	30			
	6 per bent bents 1 - 5.						
331 - Reinforced Concrete Bridge Railing	1- Ben.	500	ft.	500			
	250' each side left and right side.

Joints – Bents 1 & 5: Pourable joint material is deteriorating in several places – a couple small holes and some sagging at both bents.

PHOTO 1 Description Bent 1 abutment pourable joint seal has loss of adhesion and are leaking .

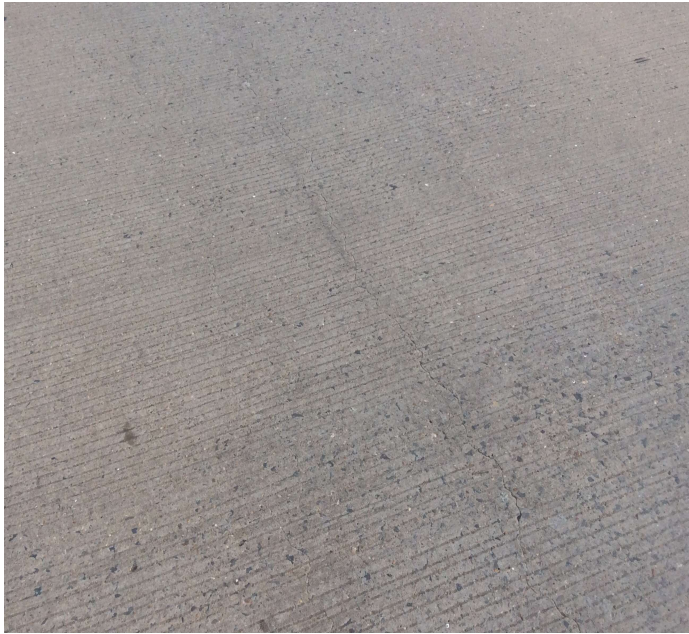
Environment	Total Quantity	Units	Condition State 1	Condition State 2	Condition State 3	Condition State 4
12 - Reinforced Concrete Deck	1- Ben.	10178	sq. ft.	9177	1001	0	0
	Deck: 250.7' x 40.6'. All spans: Hairline- to minor-sized unsealed, longitudinal cracks, mainly on each side of Girders 4 & 5 (in travel lanes).						
1130 - Cracking (RC and Other)		1001			1001		
107 - Steel Open Girder/Beam	1- Ben.	1488	ft.	1488			
	6 beams at 248' each. The two outer girders are dark in color on outer sides exposed to light.						
515 - Steel Protective Coating		11284	sq. ft.	10344	940	0	0
3430 - Oxide Film Degradation Color/Texture Adherence(Steel Protective Coatings)		940			940		
215 - Reinforced Concrete Abutment	1- Ben.	92	ft.	86	6	0	0
	46' each. Abutments 1 and 5. Both abutments have small vertical cracks with efflorescence.						
1120 - Efflorescence/Rust Staining		6			6		
227 - Reinforced Concrete Pile	1- Ben.	21	each	20	1	0	0

Deck – all spans: Small to moderate sized unsealed, longitudinal cracks, mainly on each side of Girders 4 & 5 (in travel lanes).

PHOTO 1	Description	Longitudinal deck cracking at bent 4 near mid span in right lane but common on all spans .
---------	-------------	--

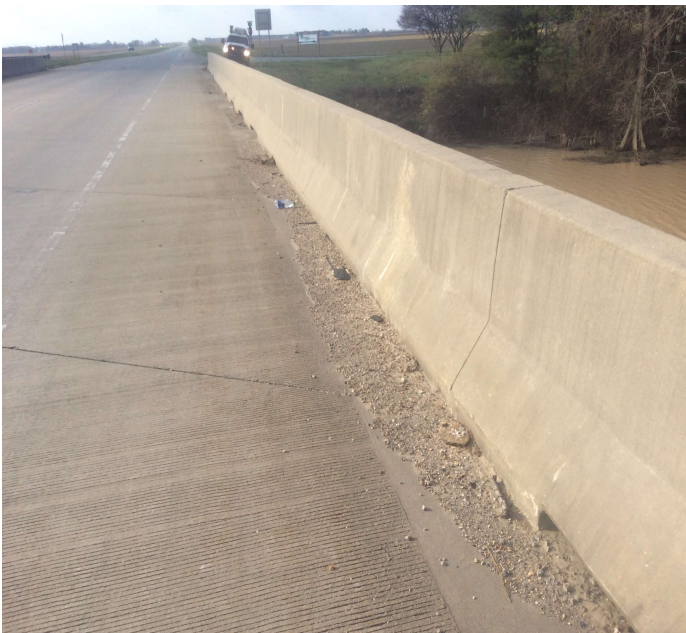
Sediment and debris impeding waters flow off of deck . Mainly on west side of deck by drains .

PHOTO 1 Description Gutter line have debris impeding waters flow mainly on right side of deck .
