Bridge Inspection Report

B6966
US 65-17 NB 9.62
over
Walnut Lake

Structure Number: B6966

Facility Carried: US 65-17 NB 9.62

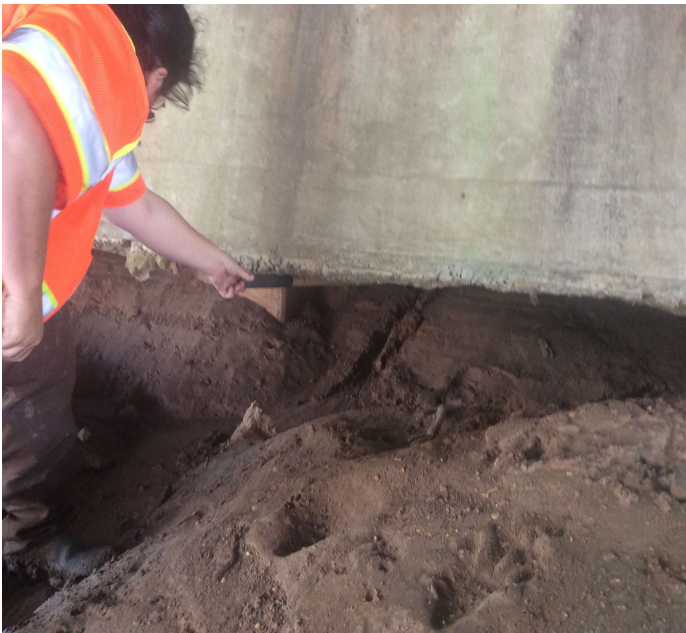
End slopes – Spans 1 Some erosion under the abutment and down the slope, with a couple of piling and the bottom of the cap exposed from girders 2-5 back to roadway embankment.

Stormwater runoff is causing considerable erosion to end slopes on the left side of the bridge under drains – a couple large holes eroded right alongside of bridge.

PHOTO 1	Description	Erosion under abutment at bent 1 between girders 2 -5(is 4' back is exposing pile and to approach roadway .)
---------	-------------	---

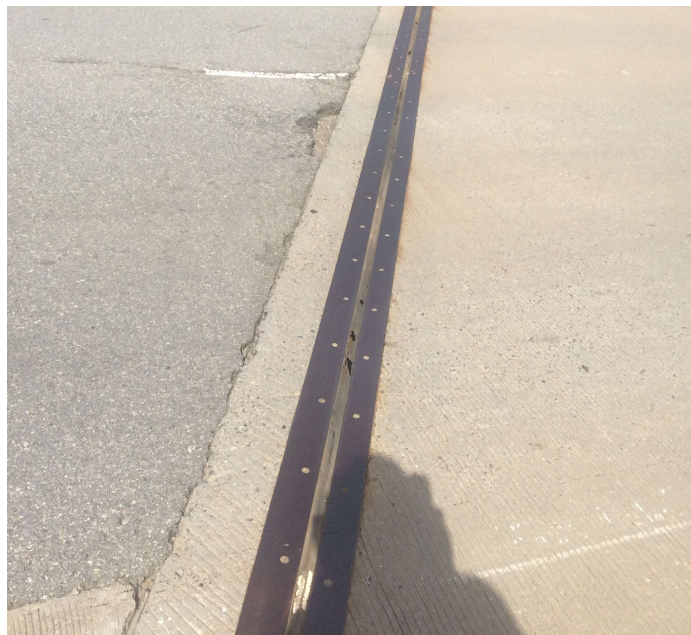
Joints – Bents 1 & 5:

Pourable joint material is deteriorating in several places – a couple small holes in joint at Bent 5.

PHOTO 1 Description Bent 5 expansion joint has loss of adhesion and leaking . (Common at all expansion joints)

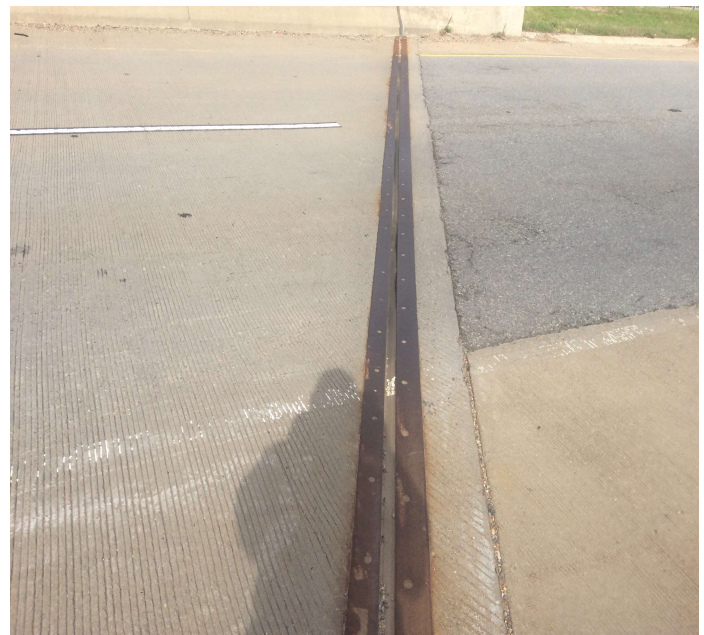
PHOTO 2 Description Expansion joint at bent 1 has some loss of adhesion , debris impact and leakage .

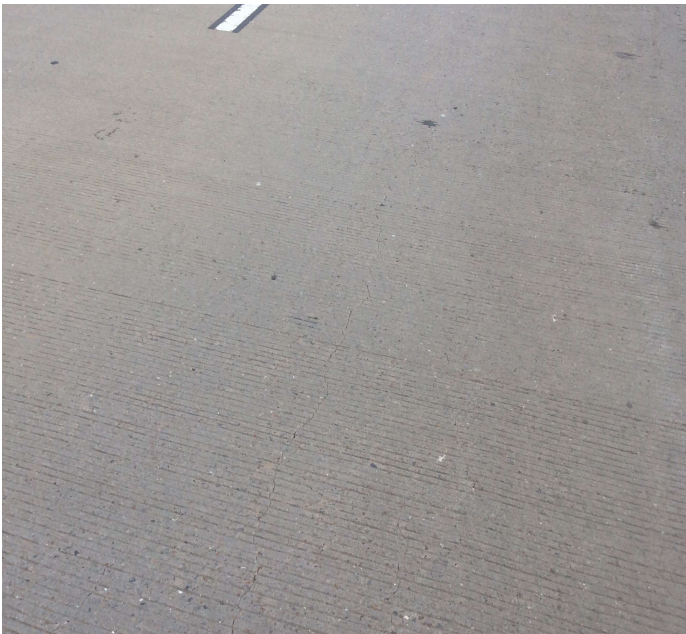
Deck – all spans: Moderate to minor-sized unsealed, longitudinal cracks, mainly on each side of Girders 3, 4, & 5 (in travel lanes).

PHOTO 1 Description Longitudinal cracking at span 4 but common on all deck spans .

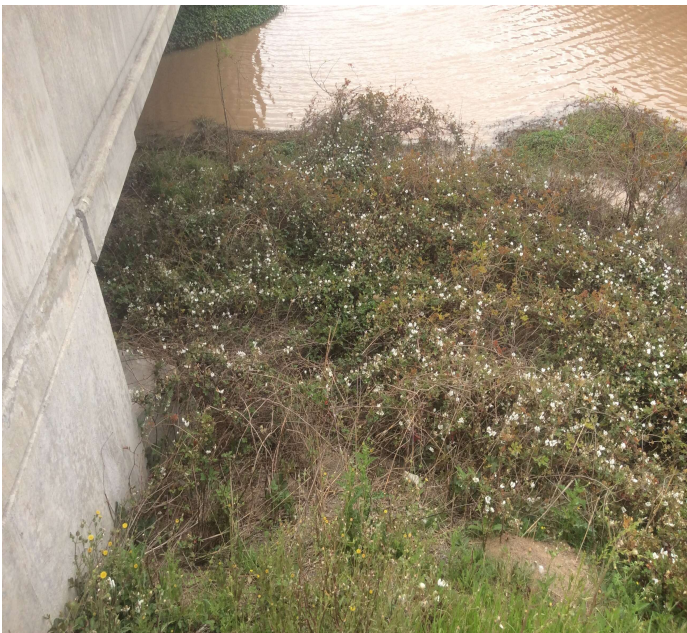
Both sides of bridge at bent 1 have. Vines and vegetation growing along side and on bridge.

PHOTO 1 Description Bent 1 both sides of bridge Vines and vegetation growing along side .

Desha: Remove and advise me when complete

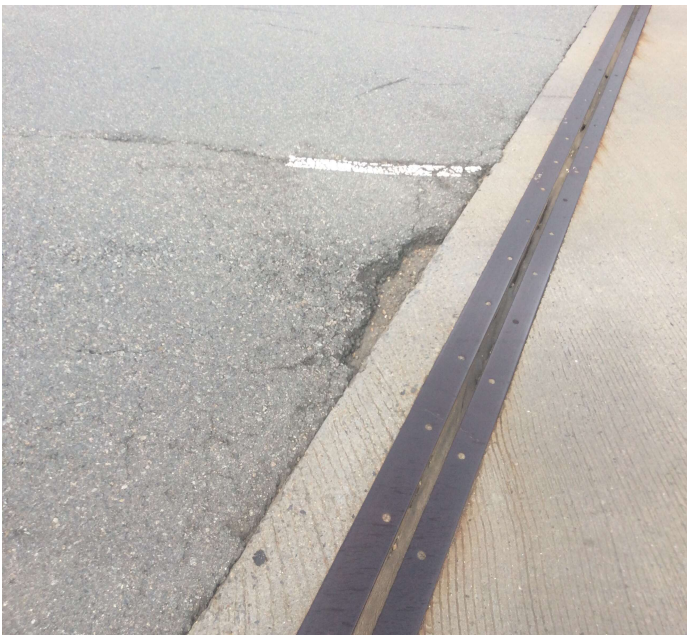
Pot hole at south end of deck in right lane as approach

PHOTO 1 Description Pot hole on south end of approach in right lane heading north .
