Bridge Inspection Report

A7113
US 65-17 LM 1.55SB
over
Kerch Canal

Structure Number: A7113

Facility Carried: US 65-17 LM 1.55SB

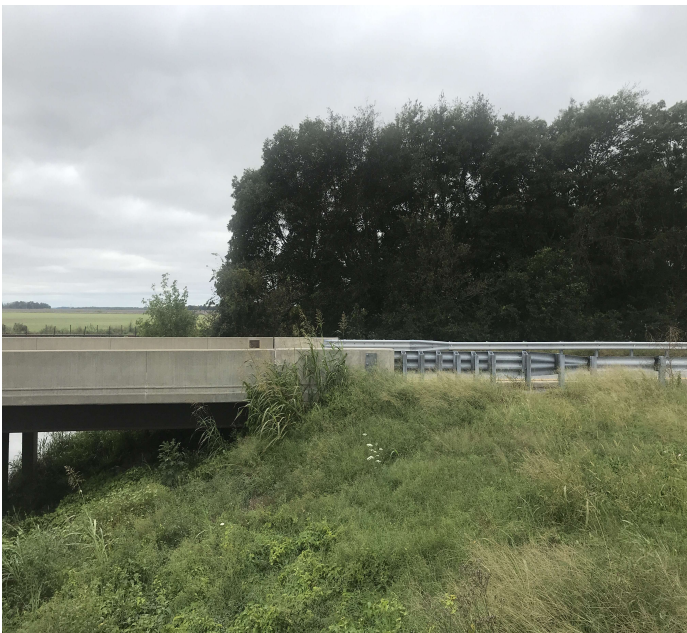
Log mile sign - Bent 1 right: No sign, object marker, or post in place (65-17 1.55).

PHOTO 1 Description Bent 1 - No sign

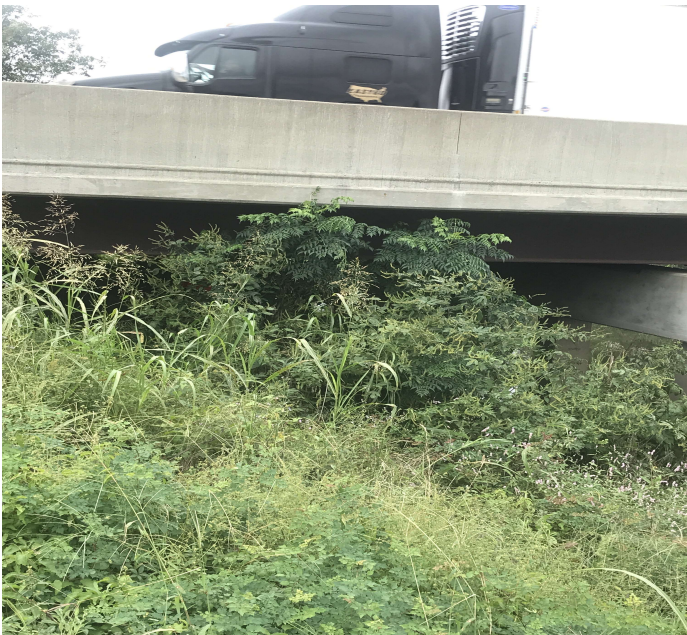
End-slope - Bent 4: Small trees, bushes, and other vegetation growing up under bridge.

PHOTO 1 Description End-slope - Bent 4 left : Vegetation
