# Bridge Inspection Report

**B7113**  
**US 65-17 LM 1.55NB**  
**over**  
**Kerch Canal**

Structure Number: B7113

Facility Carried: US 65-17 LM 1.55NB

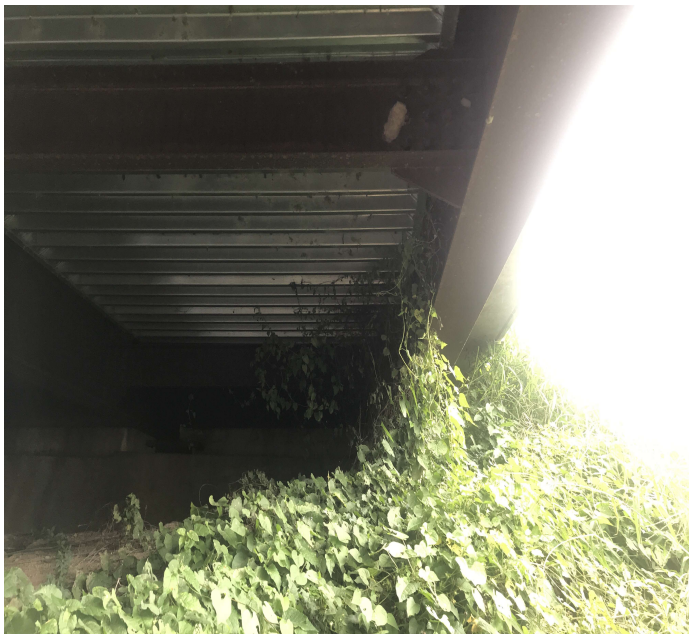
End-slopes - Spans 1 & 3: Small trees, bushes, vines, and other vegetation growing up under bridge.  
Vines growing through joint and onto bridge deck at Bent 4 right (09-27-2018)

PHOTO 1      Description      End-slope - Bent 4 right: Vegetation

Desha: remove trees and advise when complete

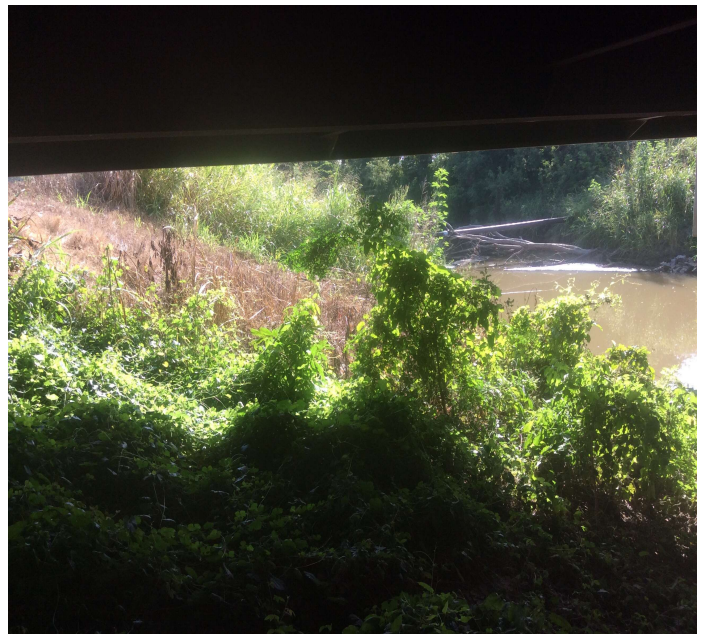
PHOTO 2      Description      Both ends of bridges need spraying under bridges.

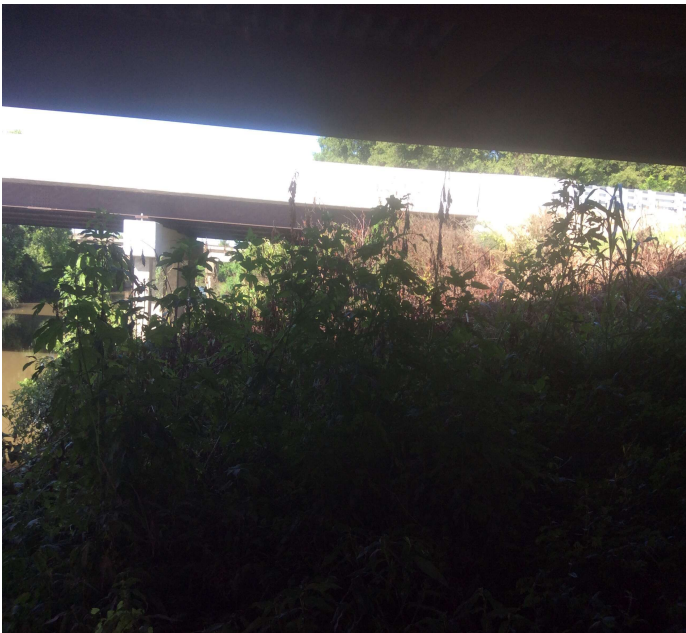
PHOTO 3      Description      Vegetation on all ends of bridge , under the bridges.Outside of the bridges have been sprayed by highway forces Just not under the bridges.

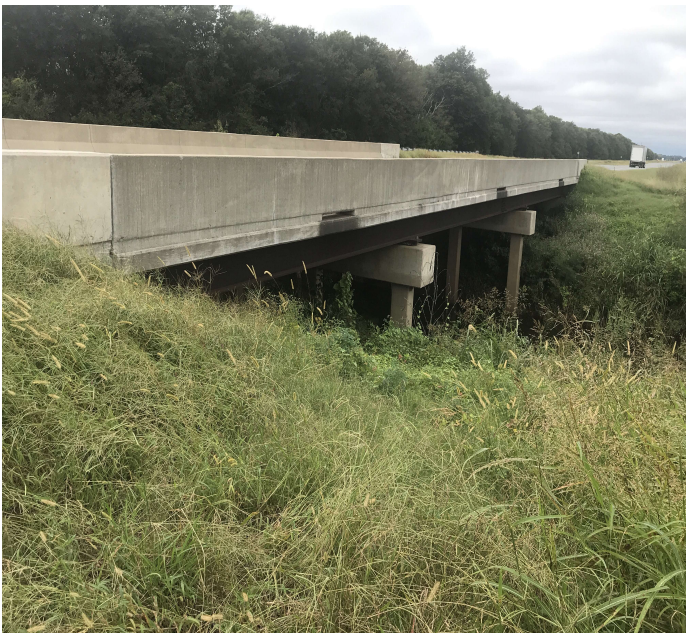
Log mile sign - Bent 4 left: No sign, object marker, or post in place (65-17 1.55).

PHOTO 1    Description    Left side view

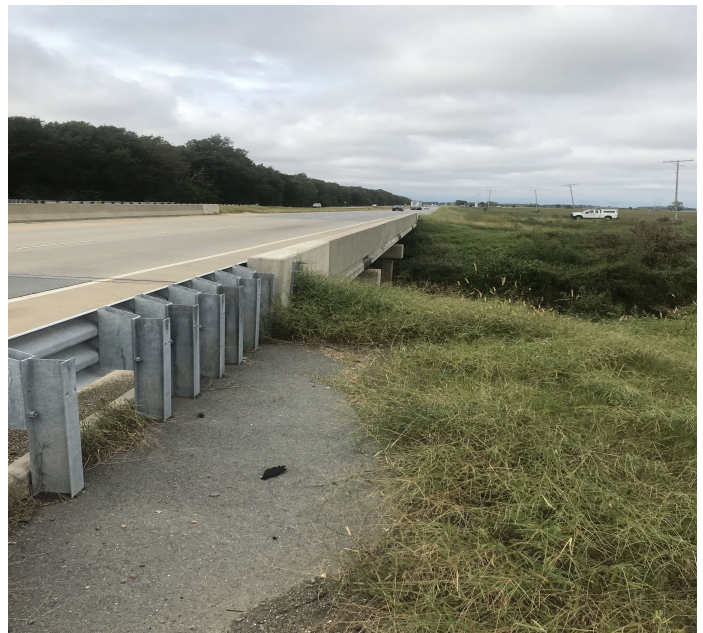
PHOTO 2    Description    Bent 4 - No sign

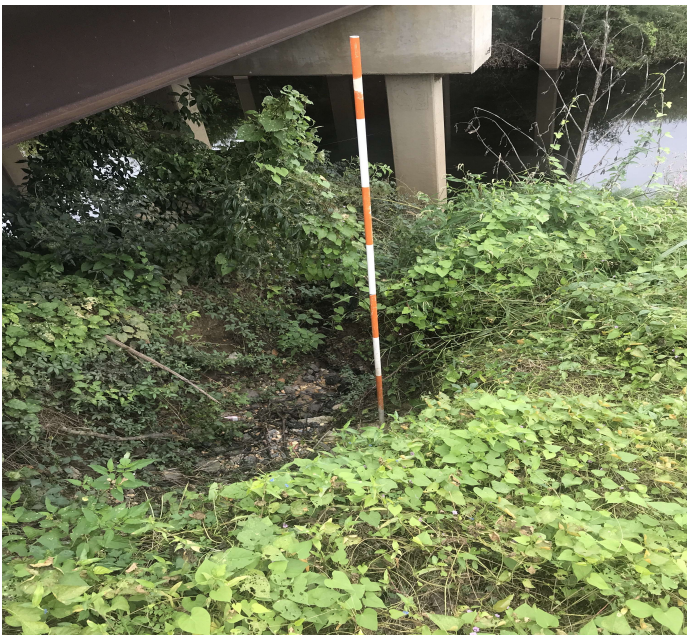
End-slopes - Spans 1 & 3 left: Stormwater is eroding holes in slopes - under drains in parapet railing.

PHOTO 1    Description    End-slope - Span 3 left : Erosion
