Bridge Inspection Report

M0416
US 63-14 LM 7.39
over
Creek (Old pond)

Structure Number: M0416

Facility Carried: US 63-14 LM 7.39

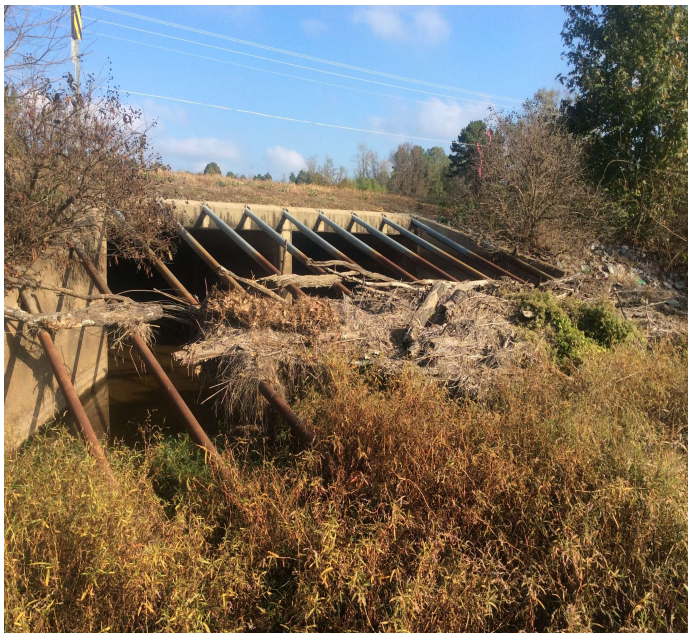
Channel – left (inlet) end: Build-up of sticks, limbs, and other debris on top of end protection bars.

PHOTO 1 Description Channel - left end (debris build-up)

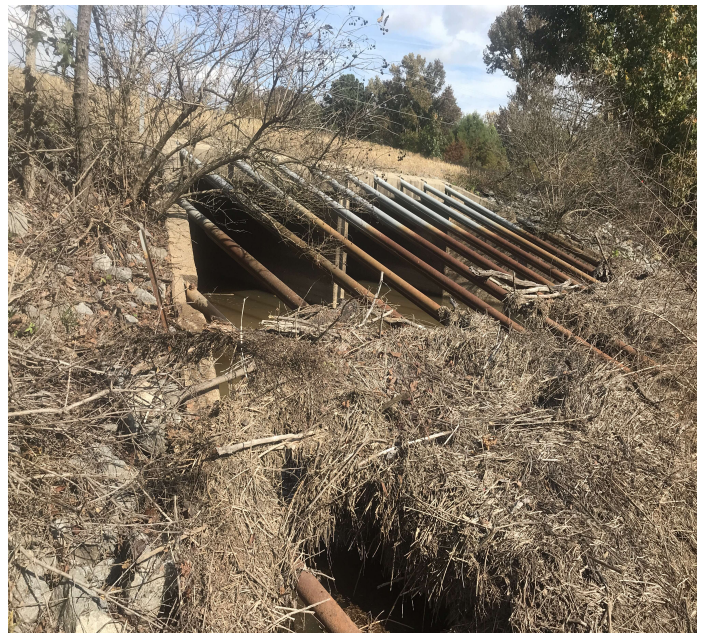
PHOTO 2 Description Left side view

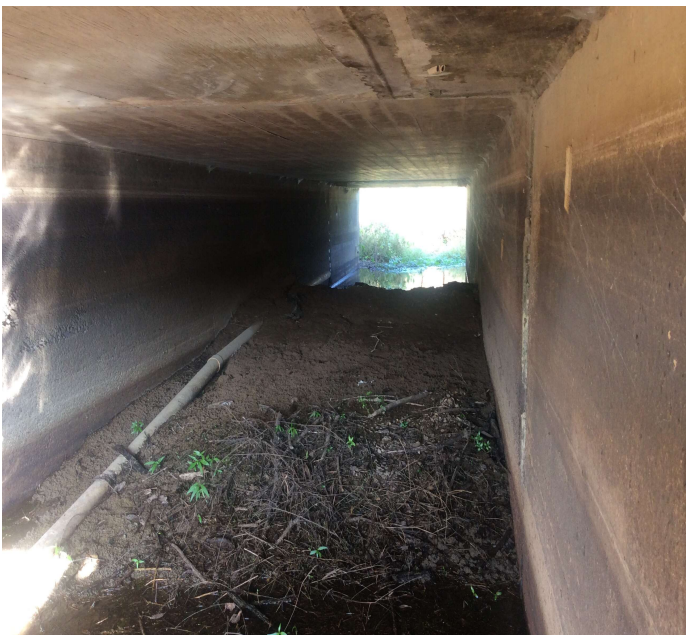
Barrel 2 – near centerline: Build-up of sticks, limbs, dirt, and other debris across bottom of barrel (2' tall – about 25% blockage).

PHOTO 1 Description Channel - Barrel 2 (silt build-up)

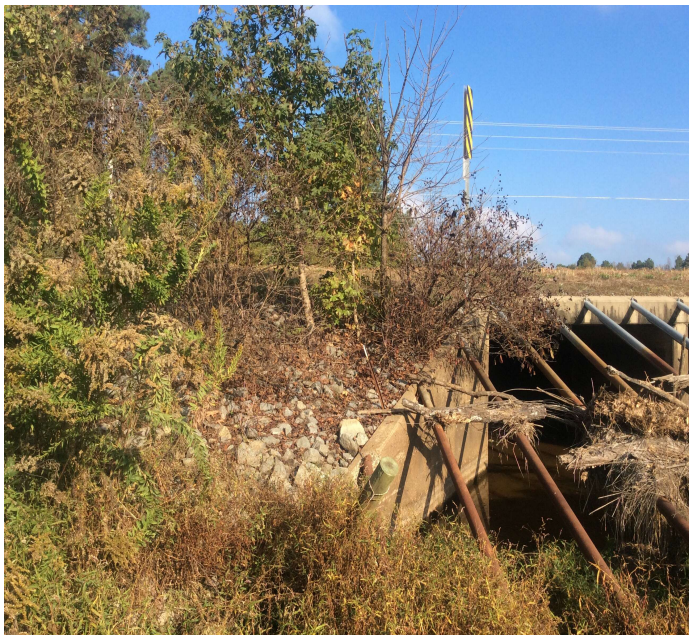
Roadway slope – left side: Several trees/small bushes growing up just behind wingwalls.

PHOTO 1 Description Roadway slope - left side (vegetation)

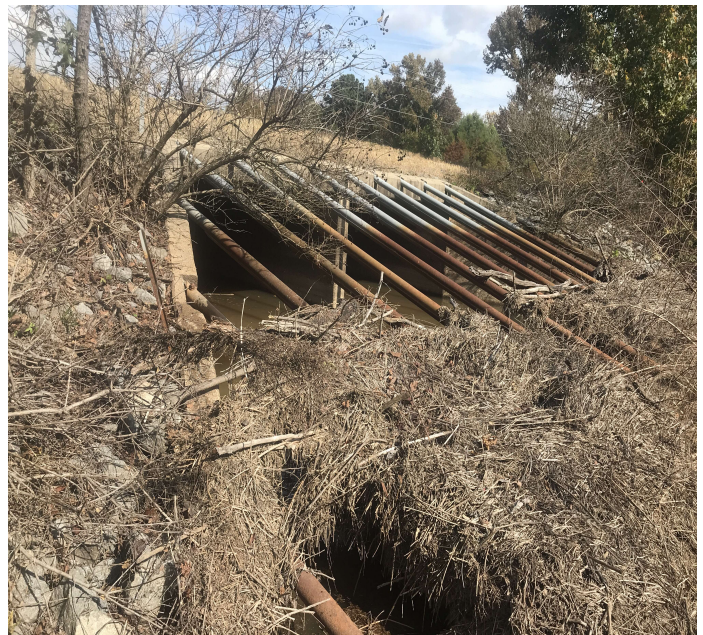
PHOTO 2 Description Left side view
