# Bridge Inspection Report

**06446**  
**US 65-19 LM 6.45**  
**over**  
**SH 1 and UPRR**

Structure Number: 06446

Facility Carried: US 65-19 LM 6.45

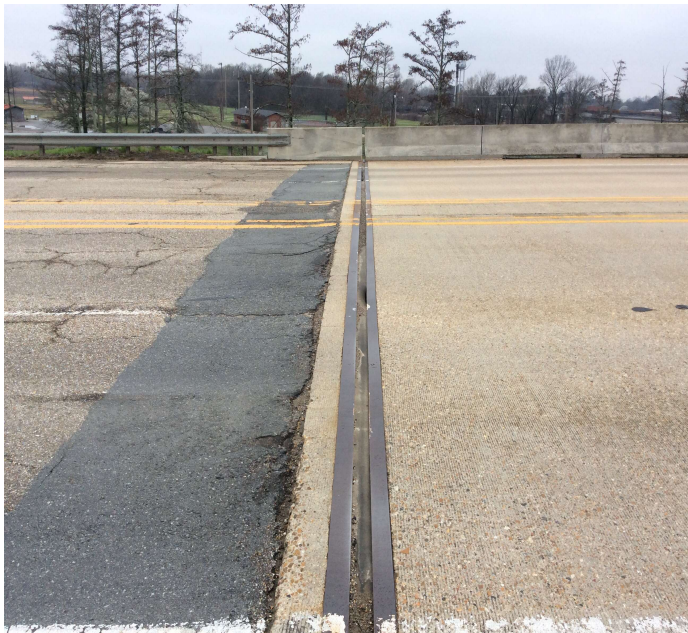
Bent 14: Material loose and drooping down - 3' left lane at skip line & 12' right outside lane.

PHOTO 1      Description      Joint - Bent 14

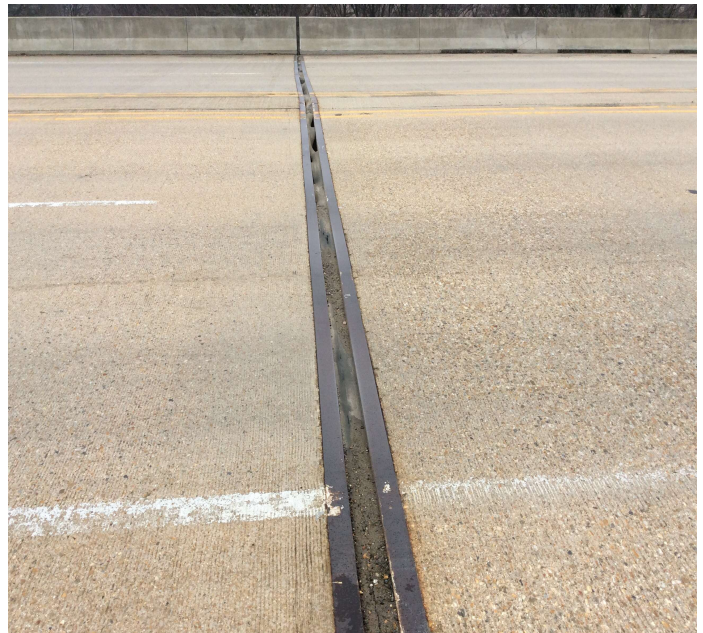
Bent 10: Material has come loose and is drooping down across most of joint (50').

PHOTO 2      Description      Joint - Bent 10

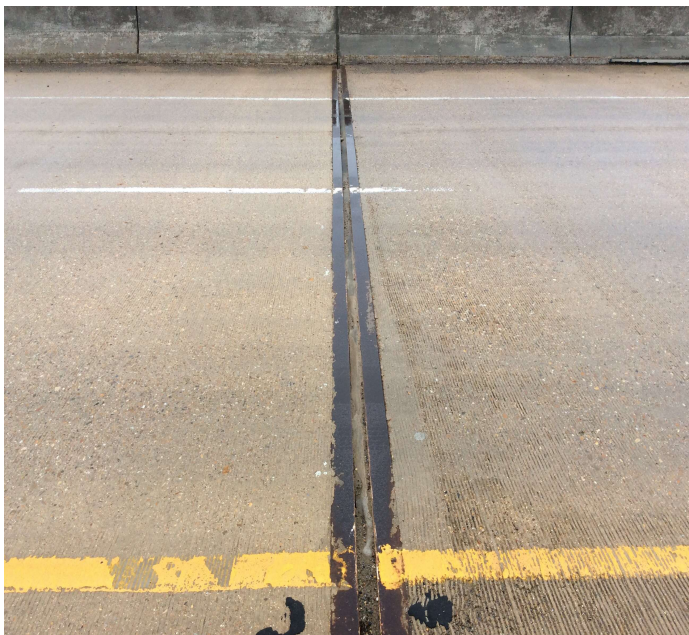
Bent 7: Material is beginning to come loose and is allowing stormwater to leak through onto ends of girders, bearing, and caps, mainly on right side (30')

PHOTO 3    Description    Joint - Bent 7 right

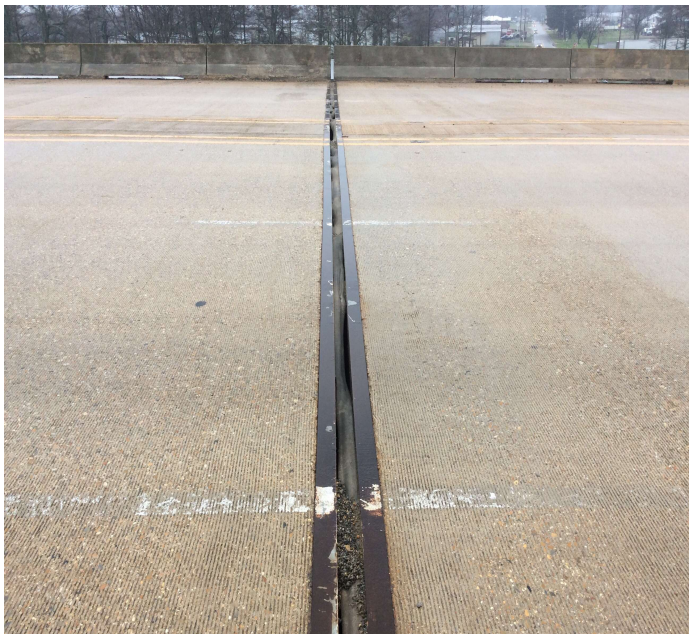
Bent 4: Material has come loose and is drooping down across most of joint (50').

PHOTO 4    Description    Joint- Bent 4

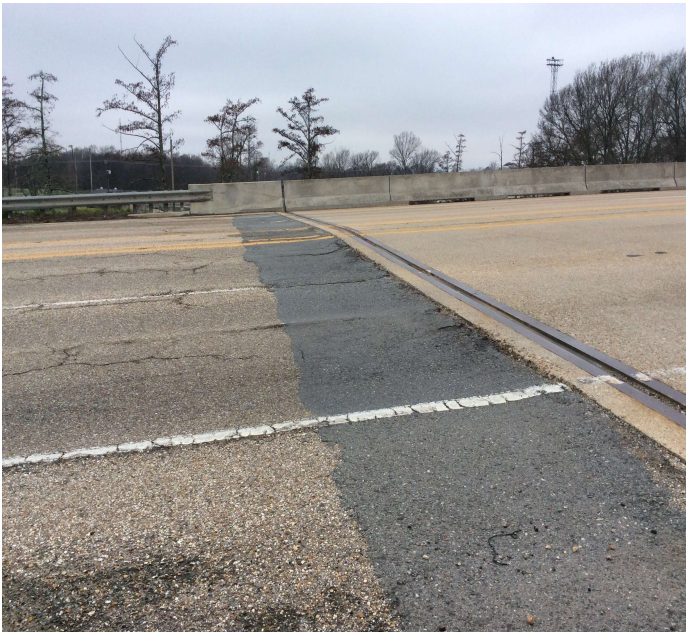
Approach roadway - Bents 1 & 14: Some minor settlement right at bridge ends, causing a bump for traffic going onto and off of bridge.

PHOTO 1    Description    Approach- Bent 14

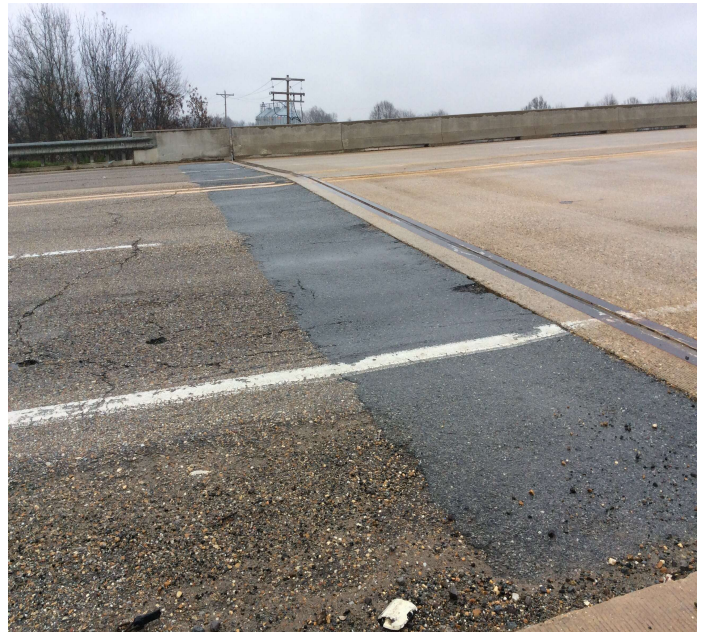
PHOTO 2    Description    Approach - Bent 1

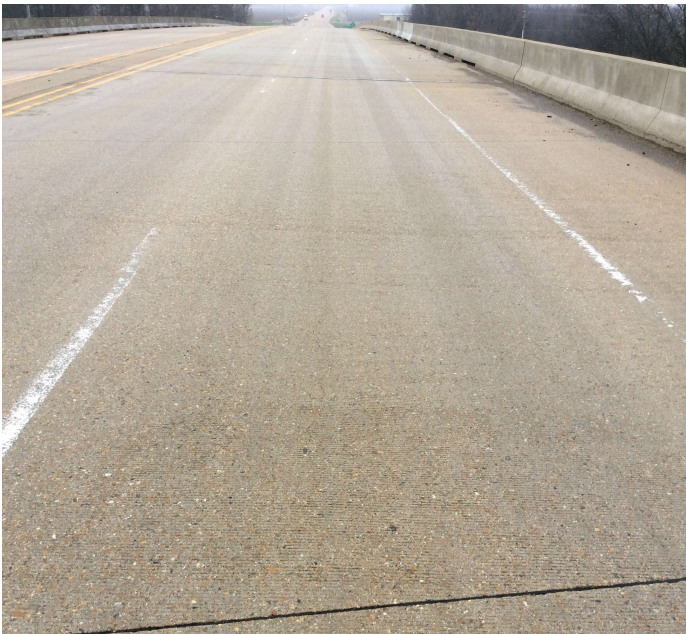
Deck - all spans: Unsealed, hairline- to minor-sized transverse cracks - with reflective efflorescence on soffit between Girders 5 & 6 - and some hairline- to minor-sized longitudinal cracks beginning to form in the outside lanes along the edges of girders.

PHOTO 1      Description      Deck - Span 9 left

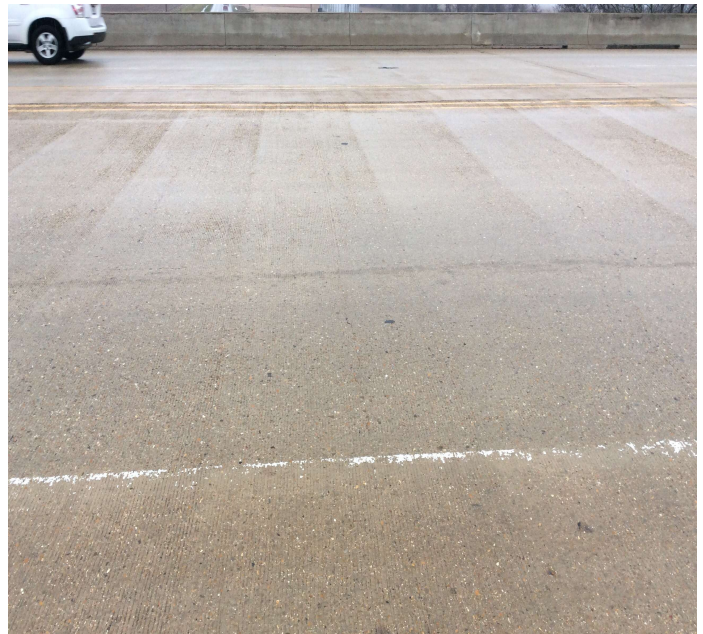
PHOTO 2      Description      Deck - Span 2 right
