# Bridge Inspection Report

**A6811**  
**US65-19 LM 9.46 SB**  
**over**  
**Black Pond Slough**

Structure Number: A6811

Facility Carried: US65-19 LM 9.46  
SB

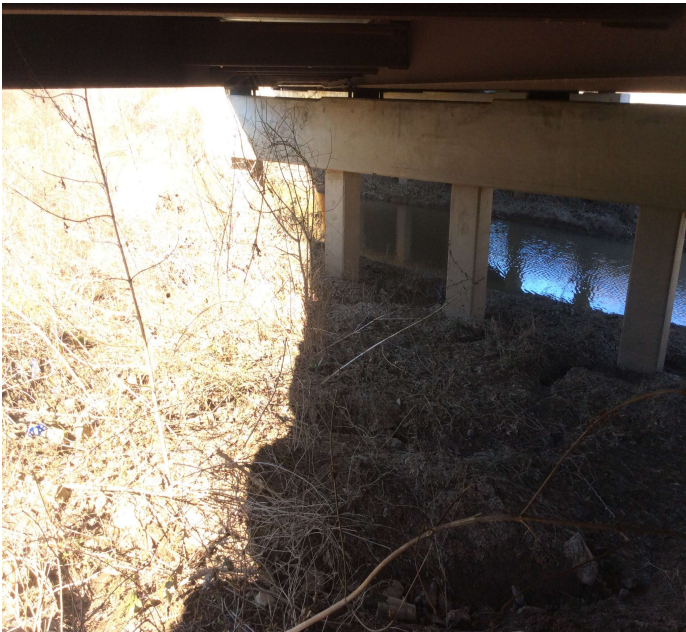
Endslopes - Spans 1 & 3: Both sides have vines and vegetation growing under bridge.

PHOTO 1    Description    Endslope - Span 3 right (vegetation)
