Structure Number: 03840

Facility Carried: SH 208-03 LM 2.54

## Bridge Inspection Report

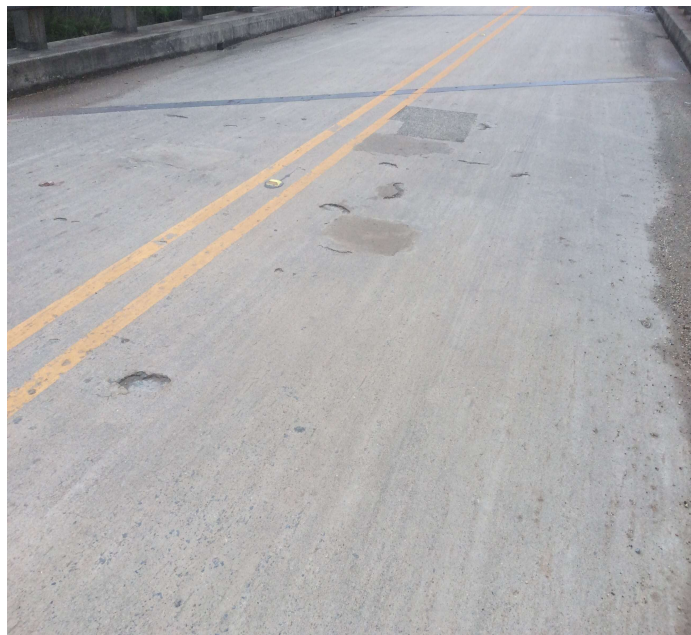
Numerous areas of delaminations, spalling, and patches - especially on Spans 3, 4, 6, & 7.

Several spalls are deeper than 1" or greater than 6" in diameter (CS3) and some have been patched with asphalt mix.

PHOTO 1 Description Span 1 small spalls in deck.

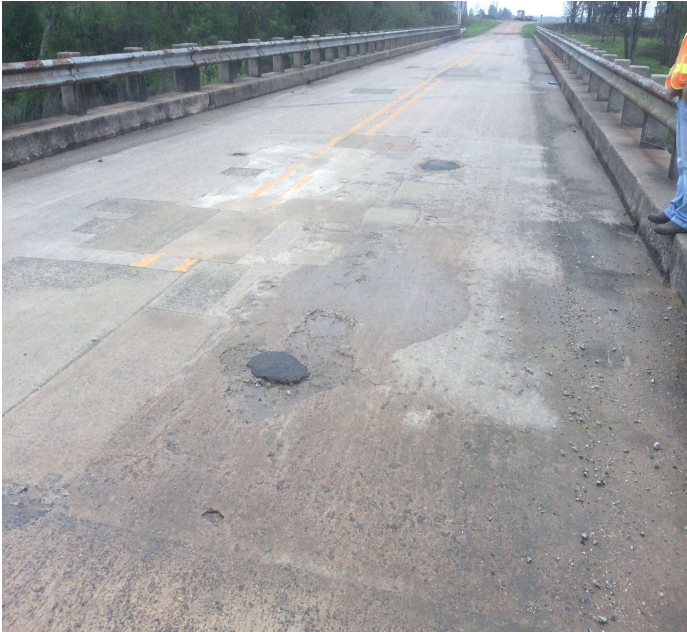
PHOTO 3      Description      Span 3 spalls and spalls filled with asphalt.

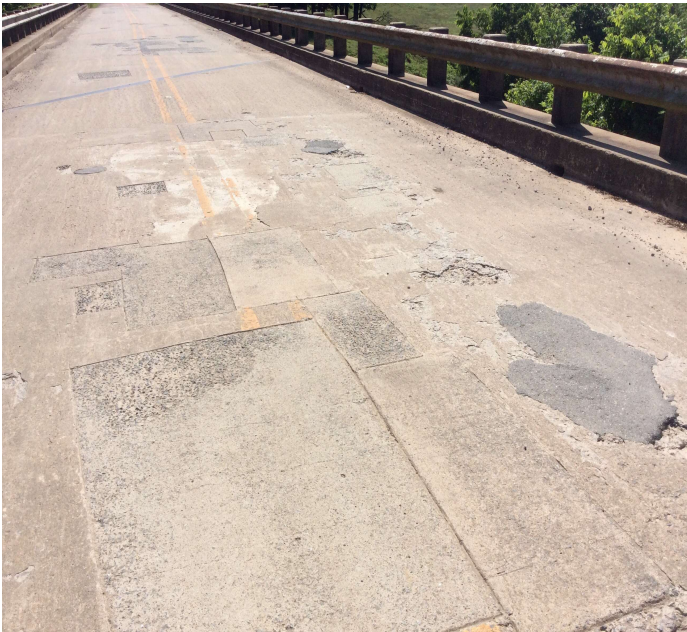
PHOTO 4      Description      Deck - Span 3: Spalling

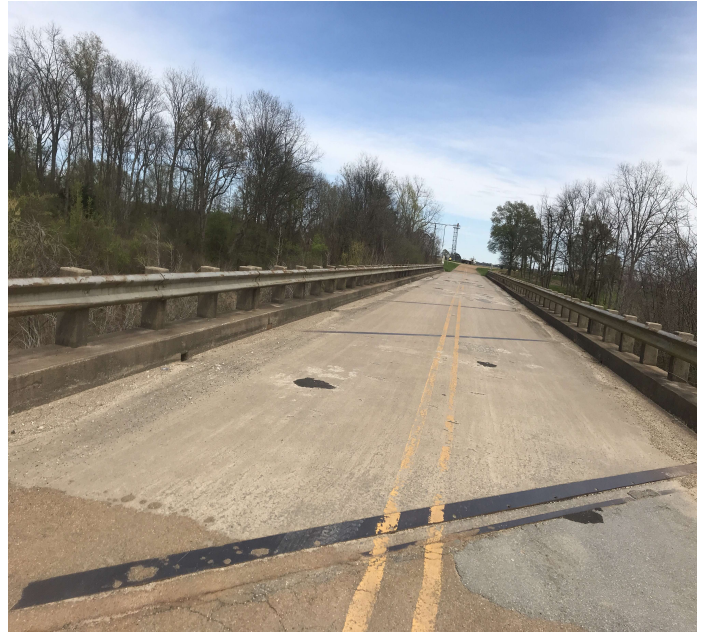
PHOTO 5      Description      Deck overview.

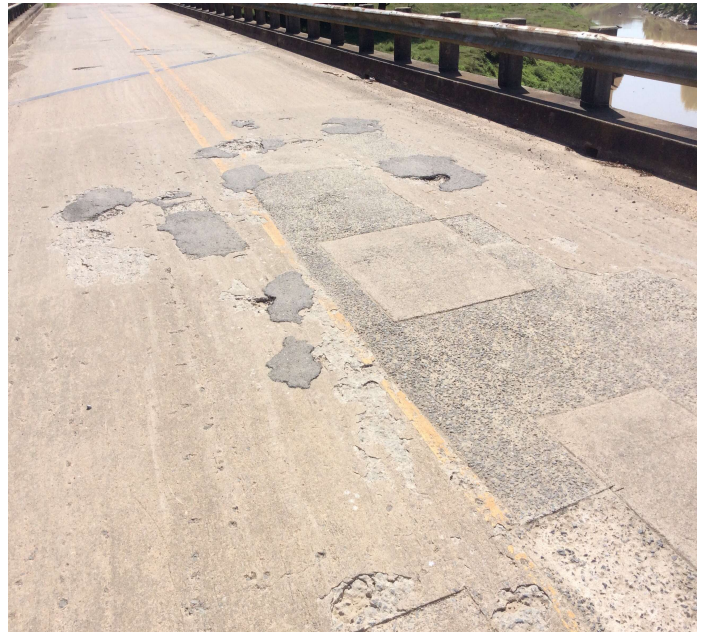
PHOTO 6      Description      Deck - Span 4: Spalling

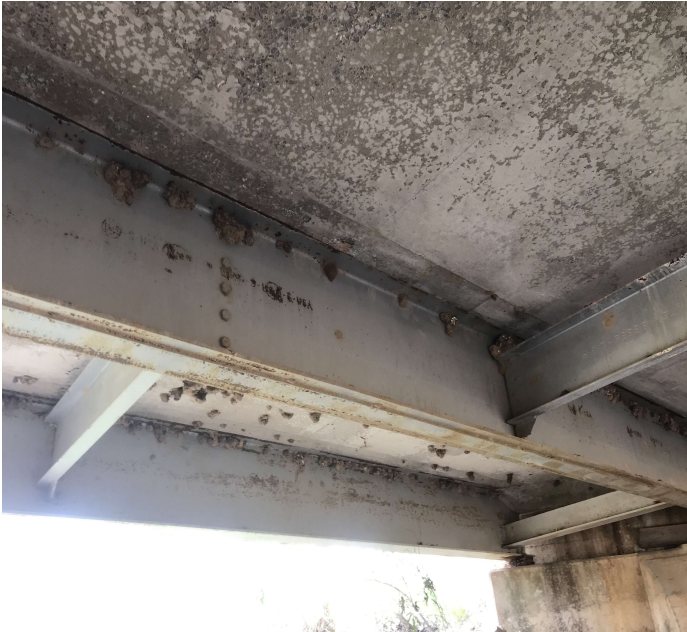
PHOTO 7 Description Typical paint condition of girders.

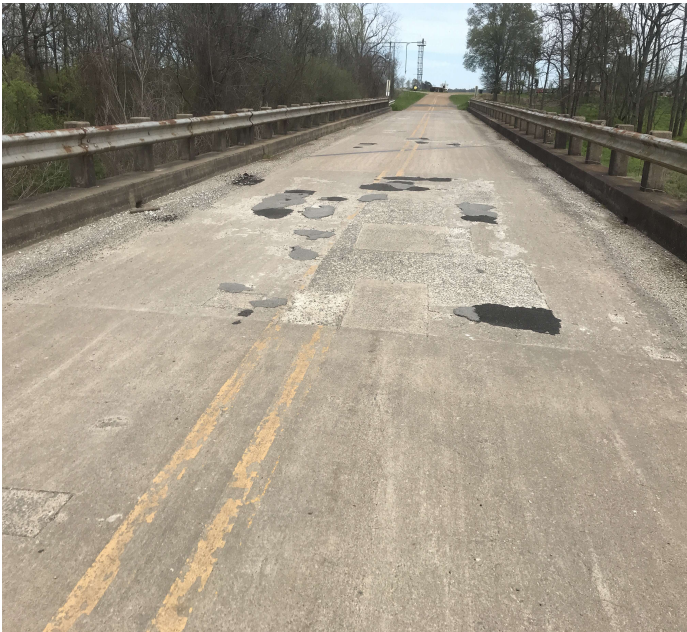
PHOTO 8 Description Deck span 4 many spall delams and patched areas.

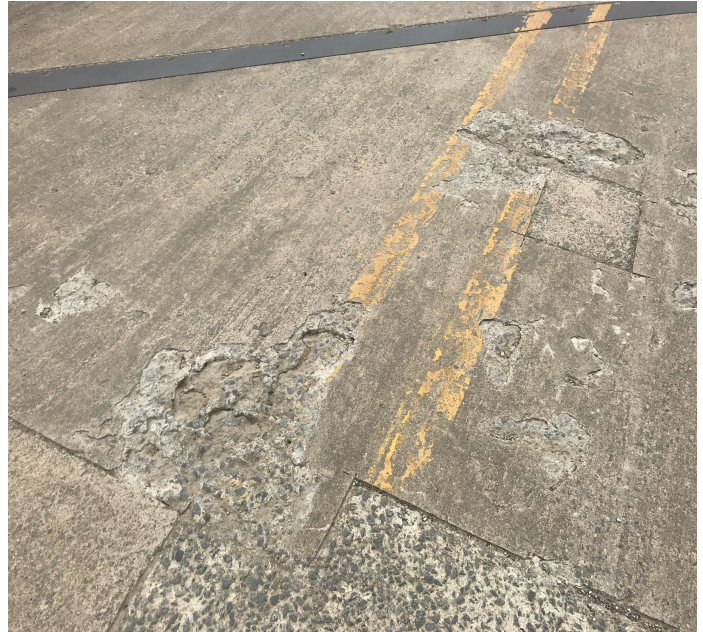
PHOTO 9 Description Deck span 7 has spalls.

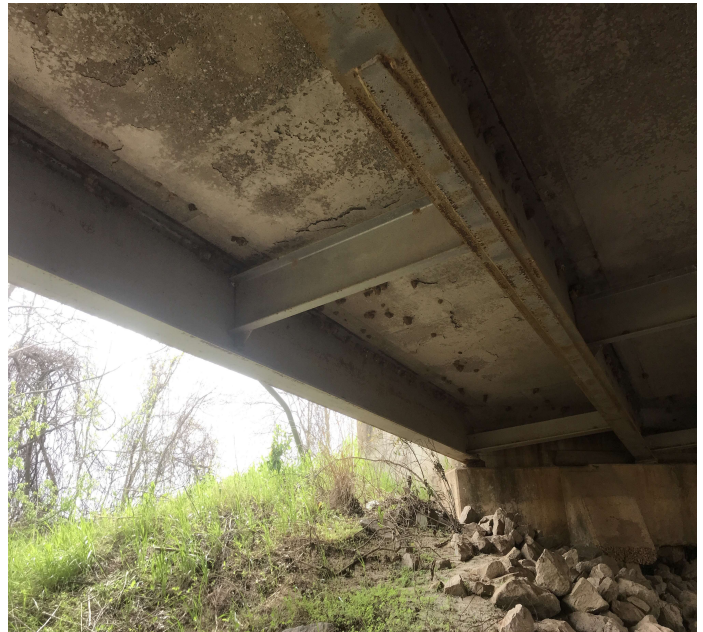
PHOTO 10 Description Span 1 bay 4 has some delams in soffit area. Common bay 1 this span.

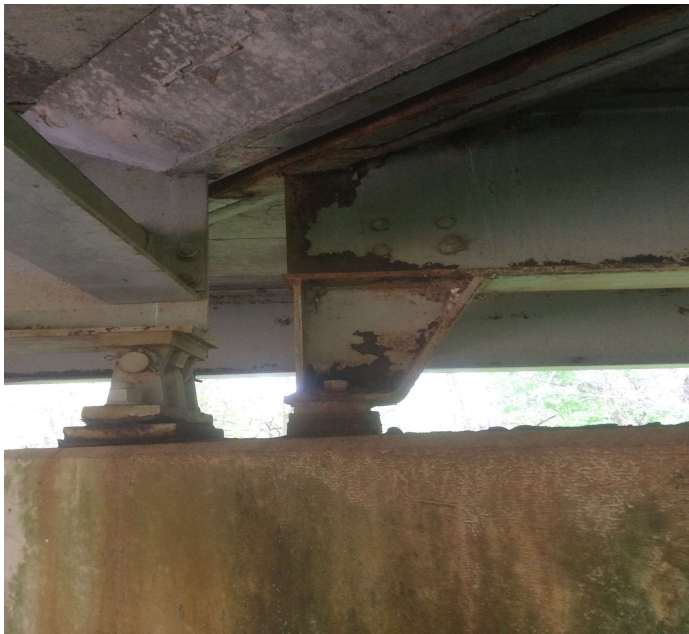
Girders - all spans: Some scattered surface rust with areas of heavier surface corrosion, some light pitting, and minor flaking at ends.

PHOTO 1      Description      Typical of beam ends.

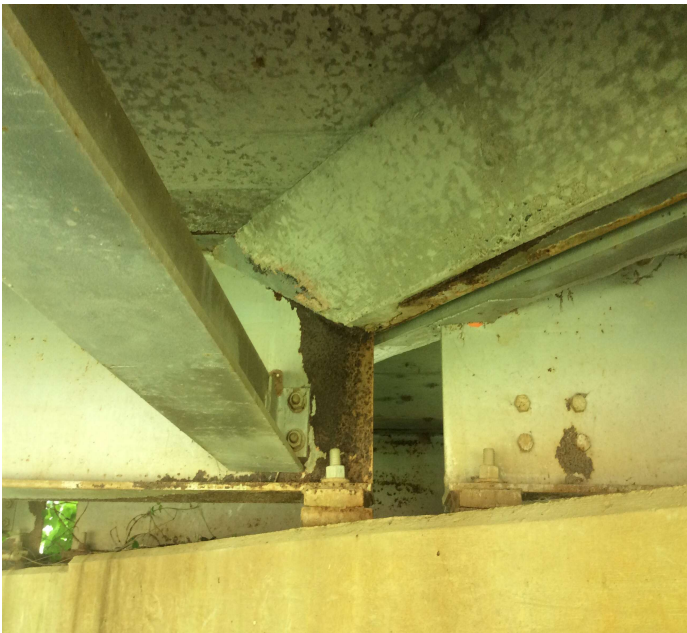
PHOTO 3      Description      Span 6 Girder 2 right @ Bent 7:  
Corrosion

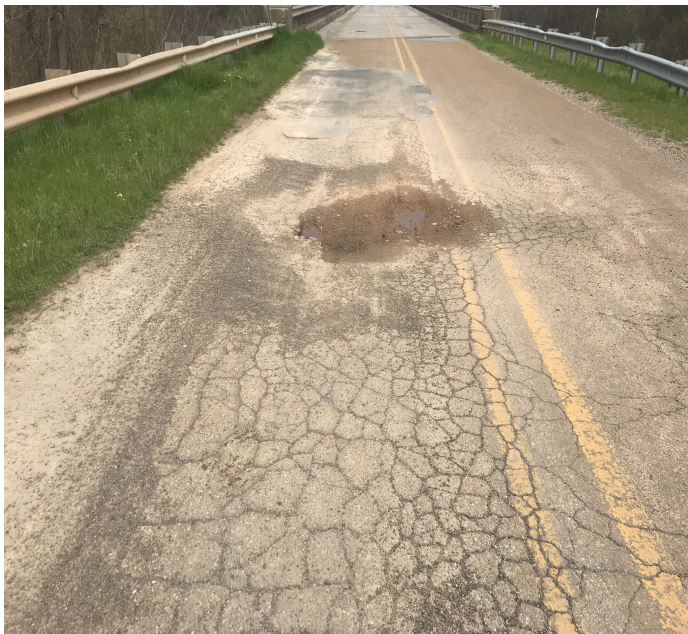
Approach roadway - Bent 1 (south end): Settlement causing impact to bridge end. Small pothole and heavy cracking. Changed from "G" to "D" 4/01/2019 SDH

PHOTO 1      Description      Approach roadway has potholes and heavy cracking to asphalt.

Chicot: take your bobcat down and mill out this bridge end. Use a string line and re-establish the correct grade when laying ACHM back in.

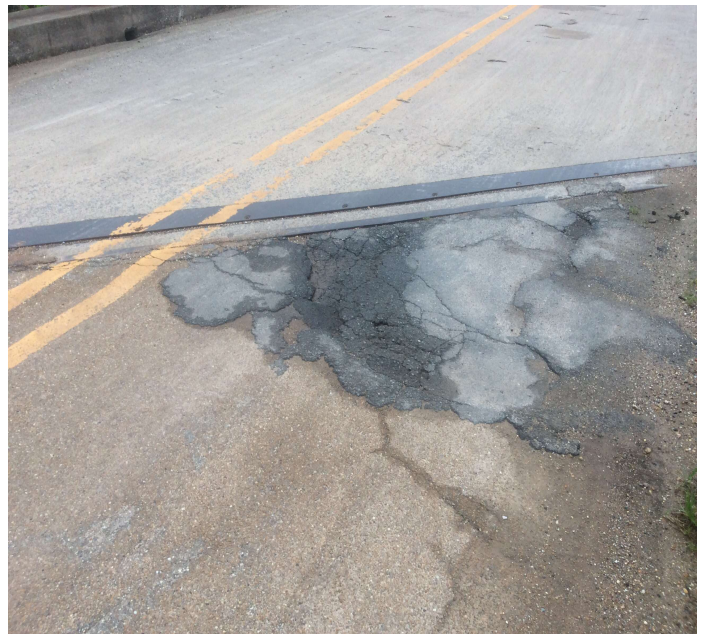
PHOTO 2      Description      Approach roadway settlement.

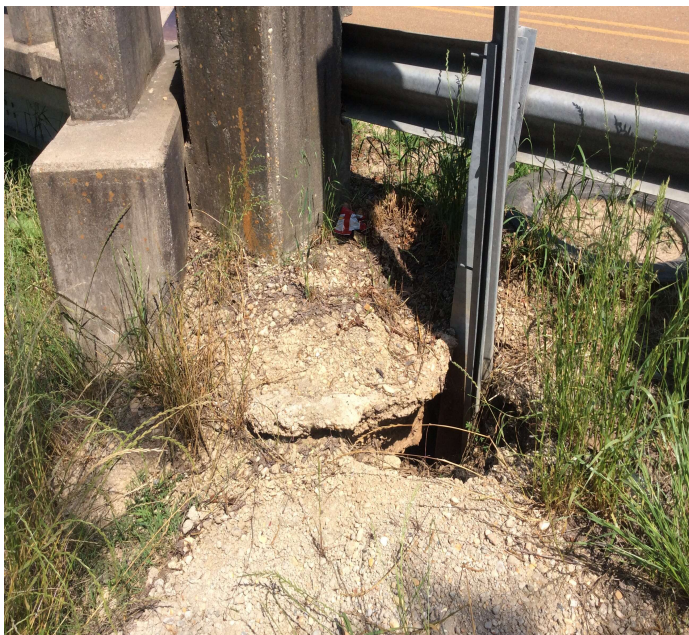
Approach roadway & endslope - Bent 8: Some erosion (a few scattered holes) behind approach railing on right, allowing stormwater to flow into fill material and behind abutment, and eroding endslope under bridge.

PHOTO 1      Description      Approach roadway - Bent 8 right:  
Erosion

Repaired by State Forces.

Chicot: pack with soil cement advise when complete

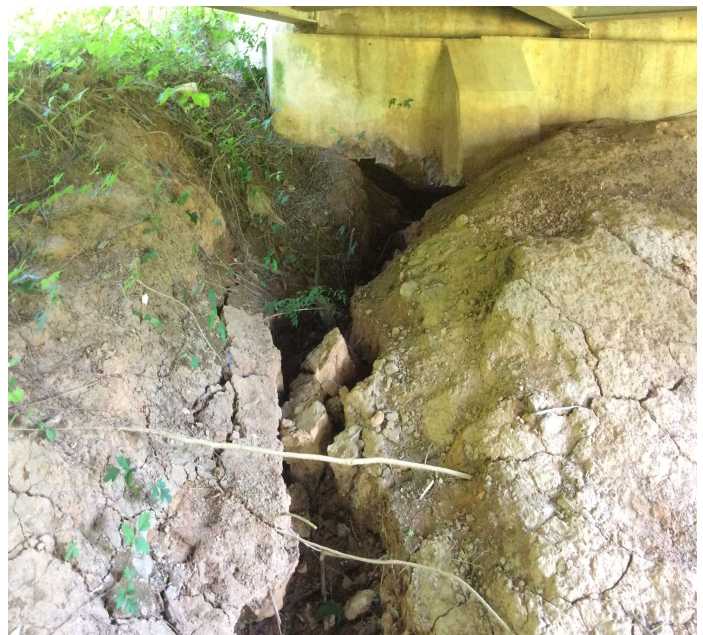
PHOTO 2      Description      Endslope - Bent 8: Erosion

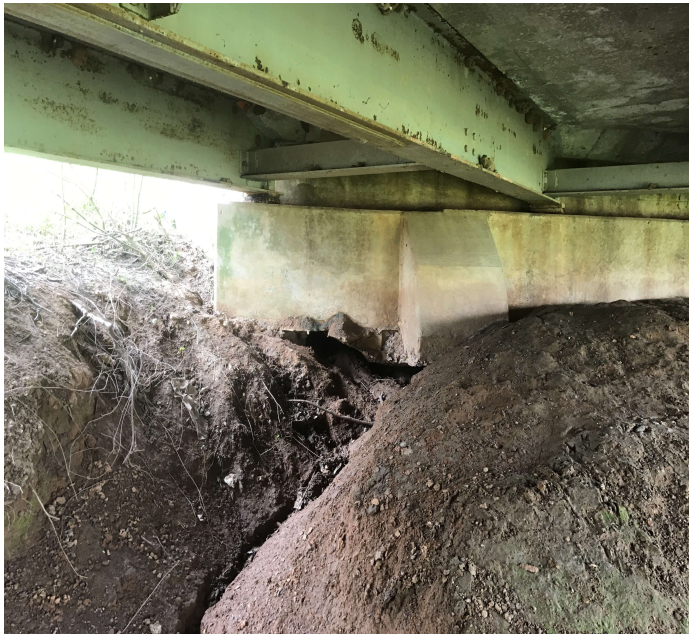
Bent 1 end slope erosion with rip rap added.  
Bent 8 end slope erosion exposing pile 1.

PHOTO 1 Description Bent 8 end slope right has erosion under cap exposing pile1.

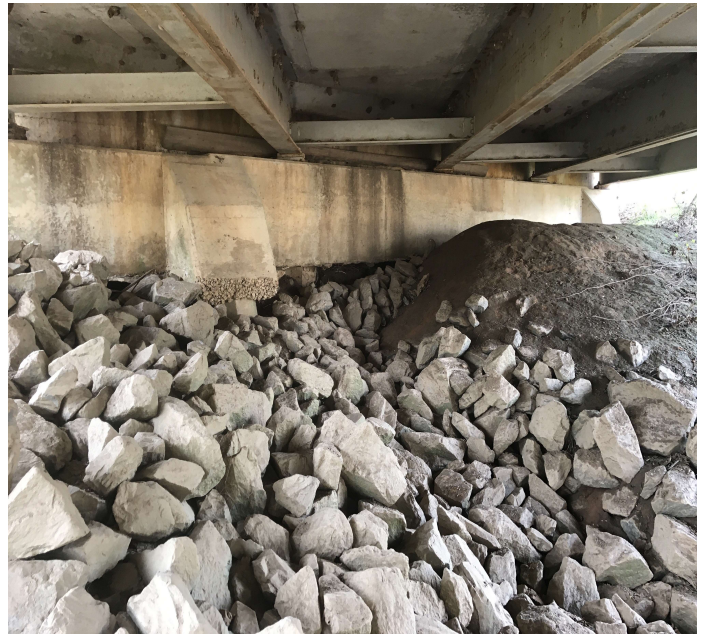
PHOTO 2 Description Bent 1 End slope erosion with rip rap in place.

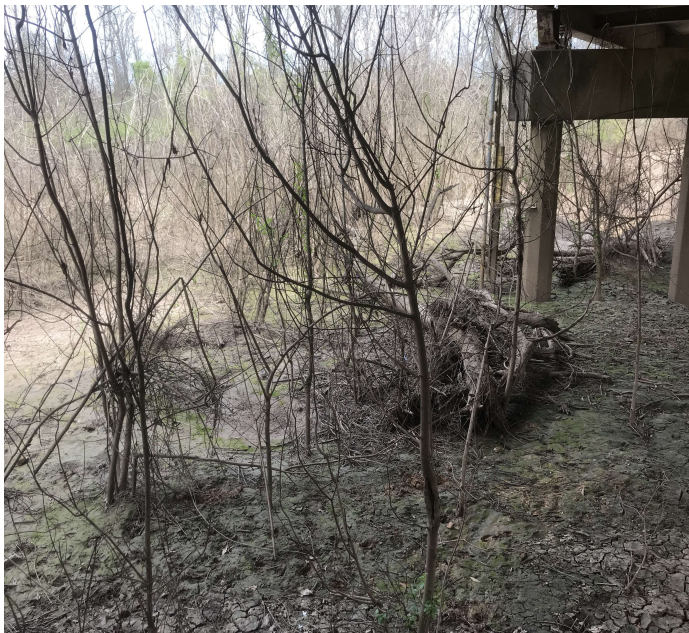
Spans 1-2 and 5-7 have small trees and vegetation growing under bridge.

PHOTO 1      Description      Small trees growing under bridge.

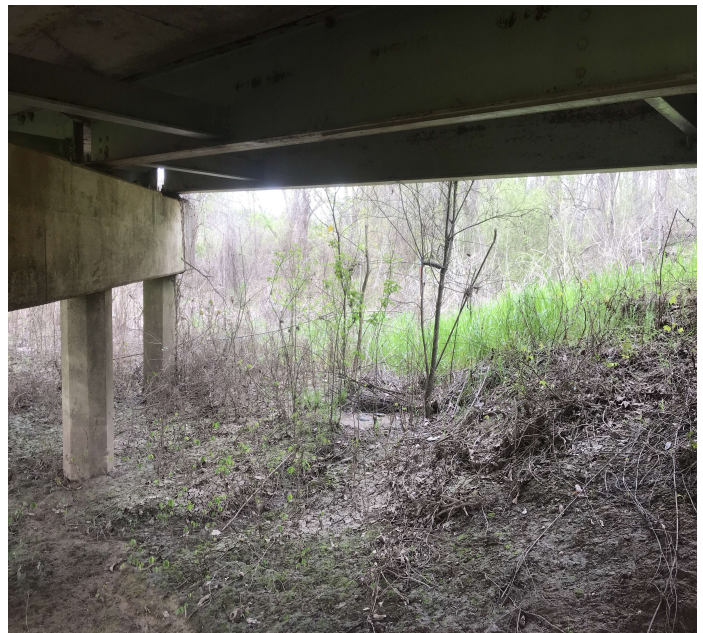
PHOTO 2      Description      Span 7 trees growing under bridge.
