# Bridge Inspection Report

**03842**  
**SH 208-03 LM 5.78**  
**over**  
**Clay Bayou**

### Bridge Inspection Report

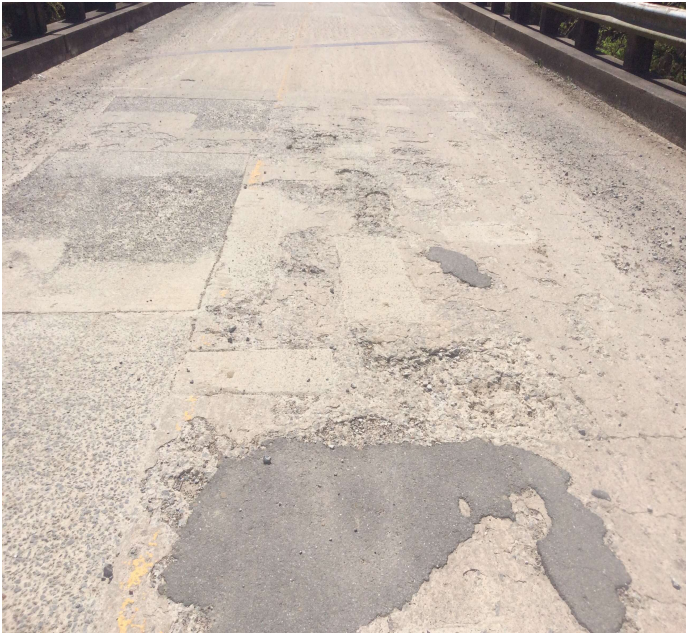
Deck – all spans: Large areas of light scaling, delaminating, and spalling with some minor-sized transverse cracking – heaviest on Span 1 with reflective efflorescence showing on soffit (a couple spalls with reinforcing steel exposed with some rust and initial section loss on steel). Soffits on Spans 2 & 3 show a couple areas of cracking and delaminating  
NOTE: State forces have previously repaired and patched numerous areas of the deck with concrete and asphalt.  
See photos.

PHOTO 1      Description      Deck span 1 spalls and spalls filled with asphalt.
