# Bridge Inspection Report

**A0963**  
**SH 365-14 LM 14.13**  
**over**  
**Caney Bayou**

Structure Number: A0963

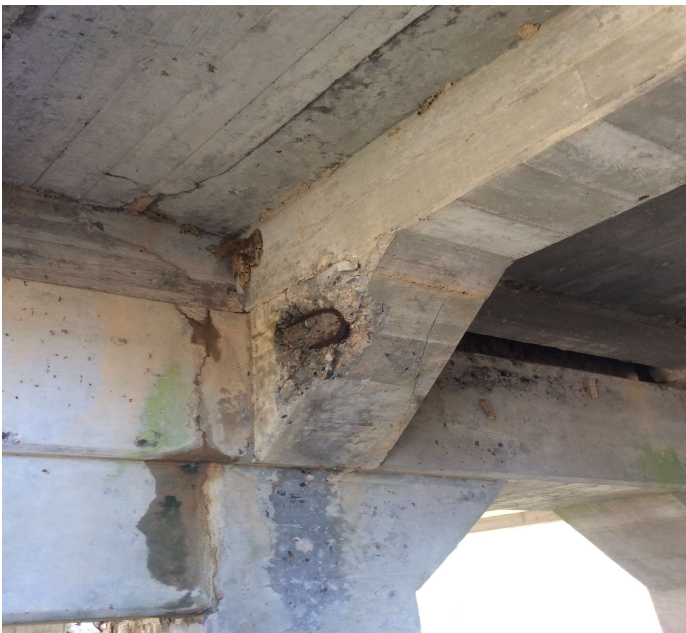
Cap – Bent 3 ahead: Cracking and delaminations/ spall on seats of Girders 2 & 4.

PHOTO 1      Description      Span 3 Girder 4 @ Bent 3: Exposed rebar

Stage: Monitor

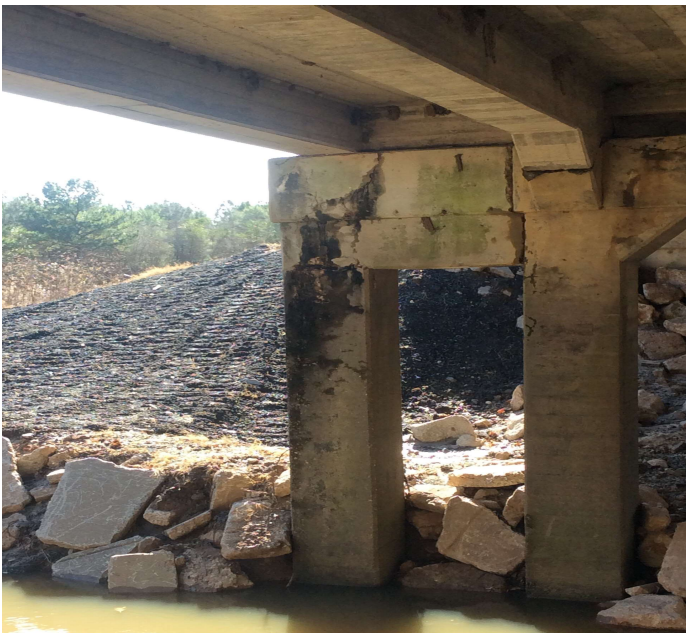
Bent 3 Column 1 & cap above: Cracking, delaminations, & spalling with steel exposed on back side.

PHOTO 1      Description      Bent 3 - Column 1: Steel exposed

Stage: Monitor

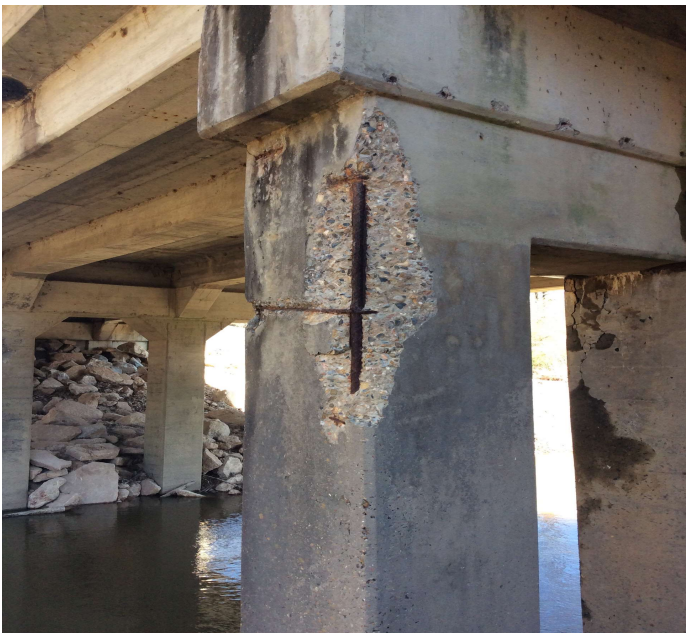
Bent 3 Column 5: Spalling with steel exposed on right ahead corner beginning at cap down 4'.

PHOTO 1      Description      Bent 3 - Column 5: Exposed rebar

Stage: Monitor

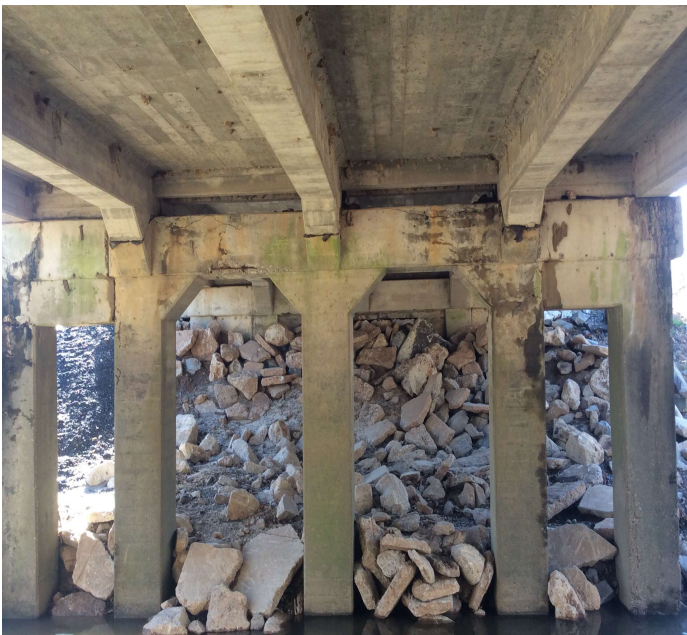
Cap – Bent 3 back: Spalling with some steel exposed on bottom corner between Columns 2 & 3.

PHOTO 1      Description      Cap - Bent 3: Cracking/exposed rebar

Stage: Monitor
