# Bridge Inspection Report

**02377**  
**US 270-10 LM 0.63**  
**over**  
**Little Creek**

Structure Number: 02377

Facility Carried: US 270-10 LM 0.63

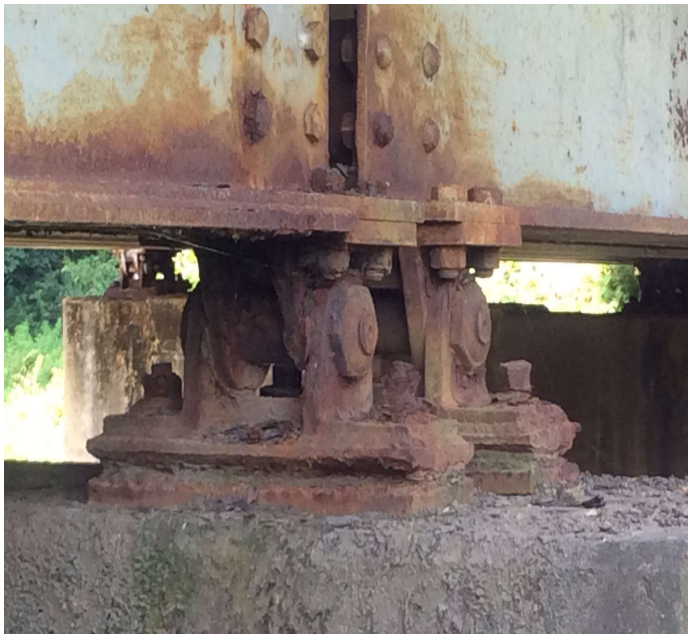
Bearings – various locations: Most movable bearings have heavy pack rust between rocker and masonry plate, restricting movement. Remaining bearings are covered with rust and pitting and have pack rust and section loss in various locations.

PHOTO 1      Description      Bent 3 Bearings 1A & 1B (corrosion)

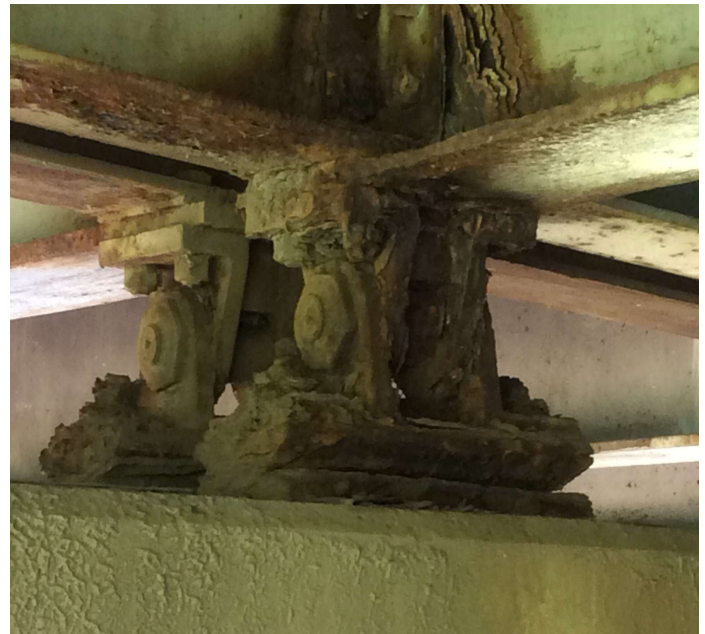
PHOTO 2      Description      Bearings 4A & 4B @ Bent 3 (corrosion)

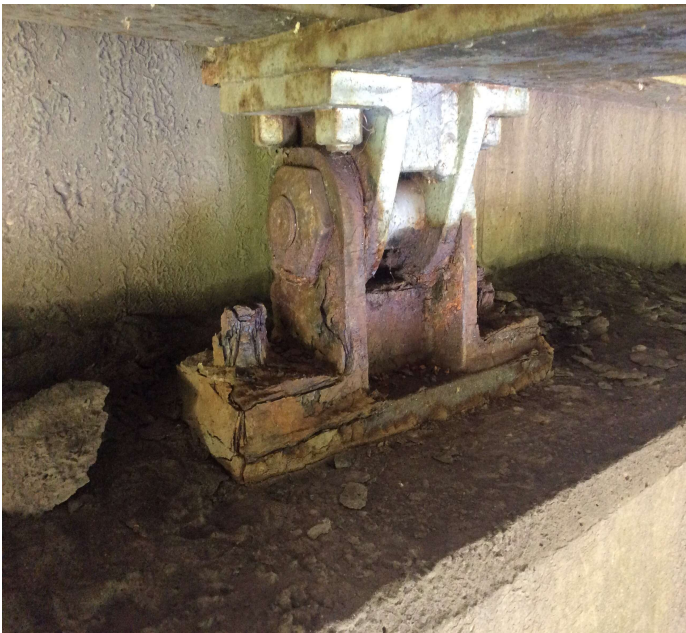
PHOTO 3      Description      Bent 1 Bearing 3 (corrosion)

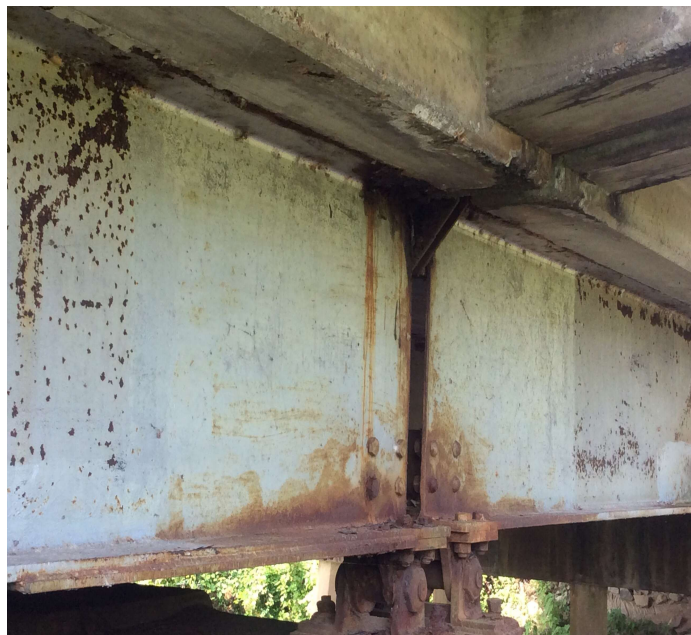
Girders – All spans: Rust with some section loss on the webs at the ends of most girders at the haunches and around the diaphragm connections.

Some rust on the bottom flanges at various locations.

Some scattered freckled rust forming, mainly on the outsides of Girders 1 & 5.

NOTE: Some spot-painting has been done on ends of girders with plates welded over web in a few places to cover section loss on webs and flanges of girders, but rust is reappearing.

PHOTO 1      Description      Girder 1 left @ Bent 3 (corrosion)

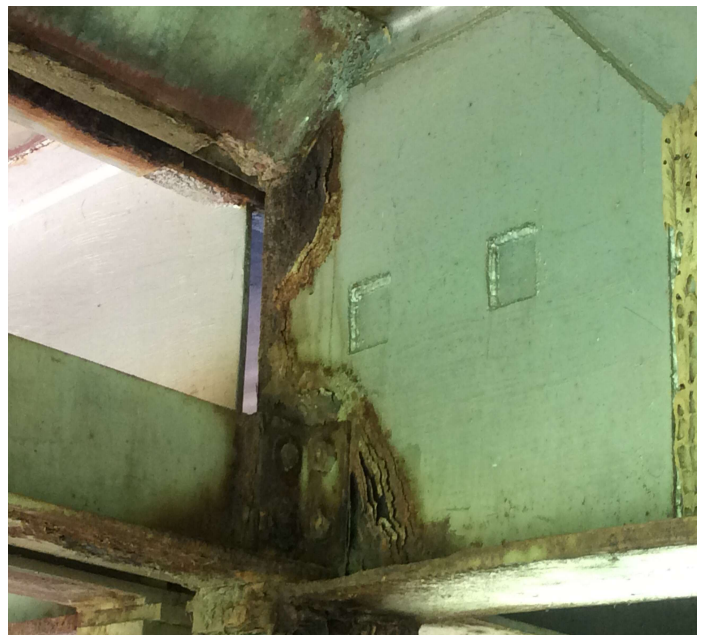
PHOTO 2      Description      Span 3 Girder 4 right (corrosion)

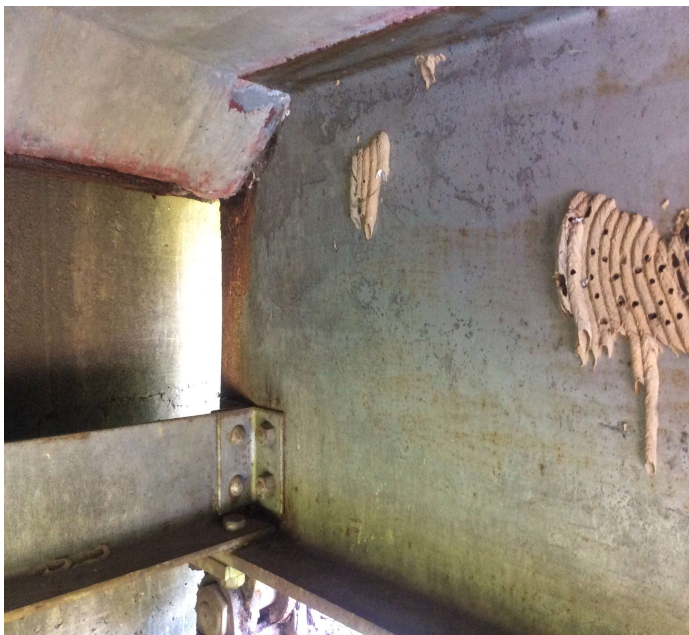
PHOTO 3    Description    Span 1 Girder 1 right @ Bent 1  
(corrosion)

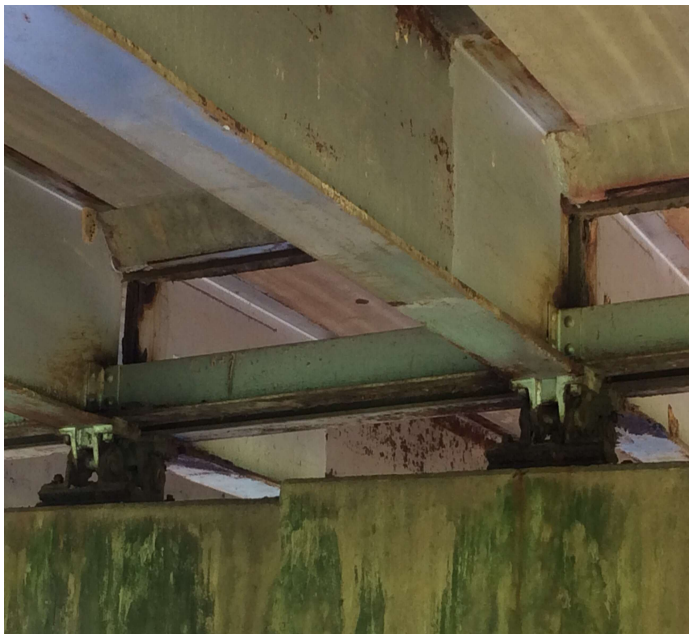
PHOTO 4    Description    Girders 2-3 @ Bent 2 (corrosion)
