Bridge Inspection Report

02378

US 270-10 LM 3.42

Hurricane Creek

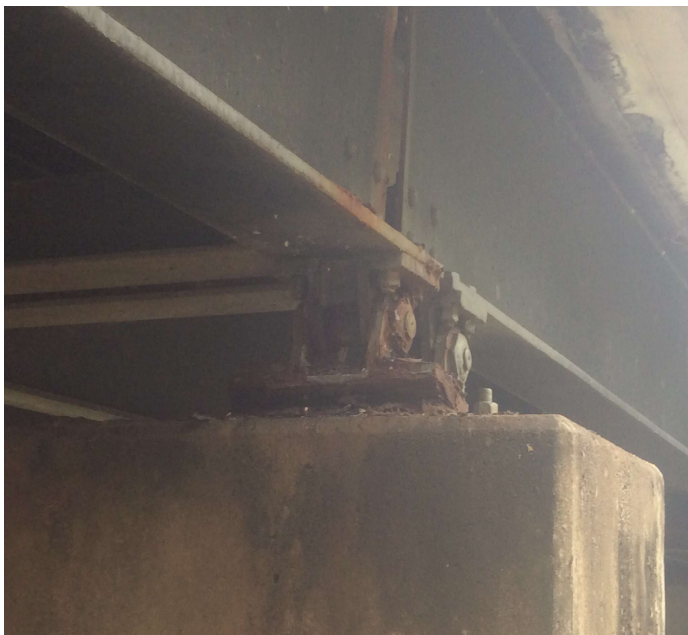
Bearings most locations have heavy flaking rust, pack rust and section loss to masonry plates and bearings. Bent 14 bearing 2 is also at full tilt.

PHOTO 1 Description Bent 14 bearing 5 back has heavy flaking rust with pack rust.

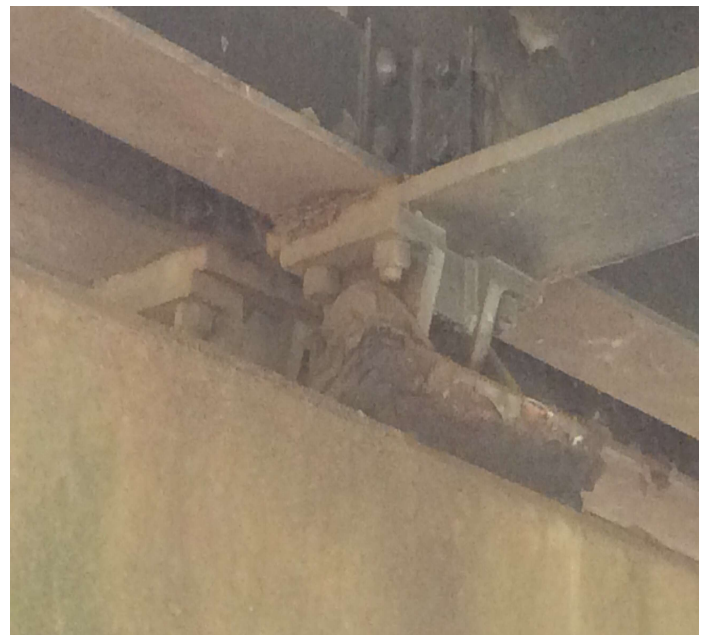
PHOTO 2 Description Bent 14 bearing 2 heavy flaking rust and froze at full tilt.

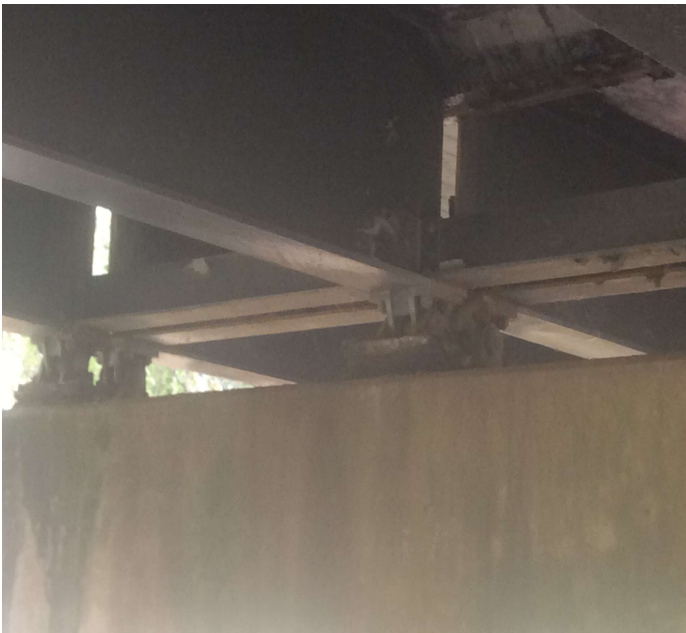
PHOTO 3 Description Bent 14 bearings 1-2 misalignment.

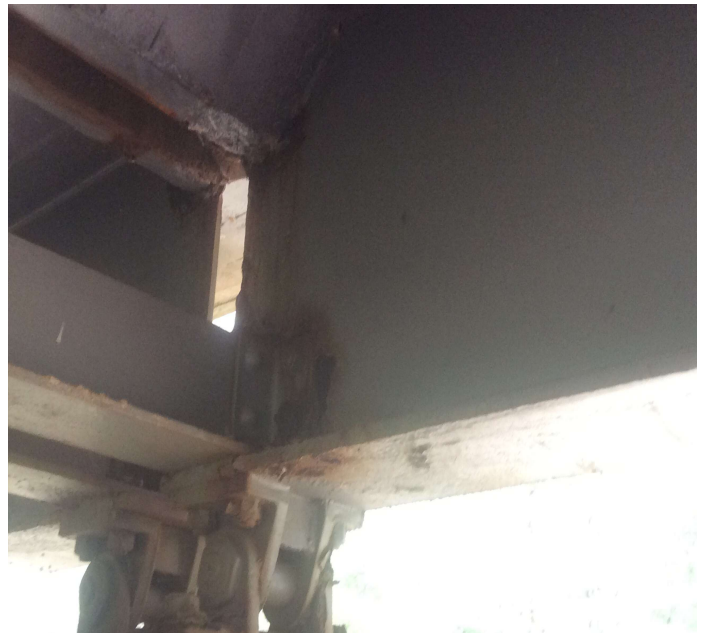
PHOTO 5 Description Span 10 at bent 11 girder 5 has some flaking rust with minor section loss.

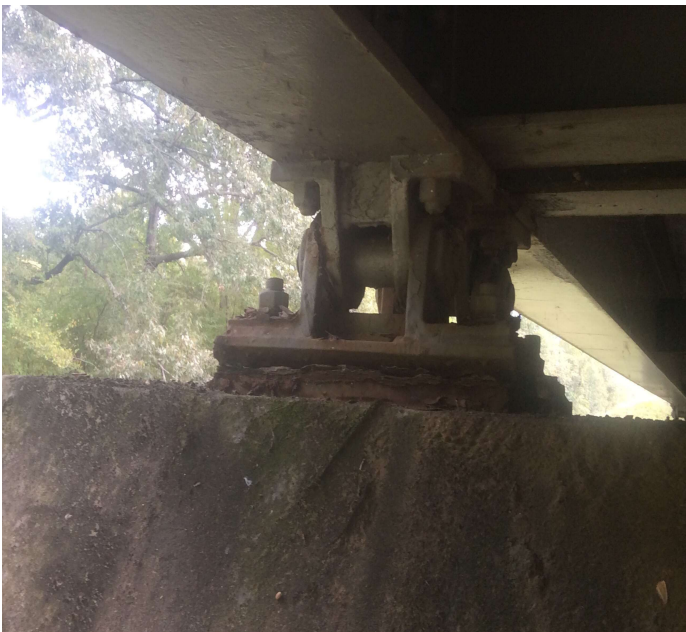
PHOTO 4 Description Bent 11 bearing 1 has heavy corrosion to bottom of bearing and masonry plate. Common all bearing this bent.

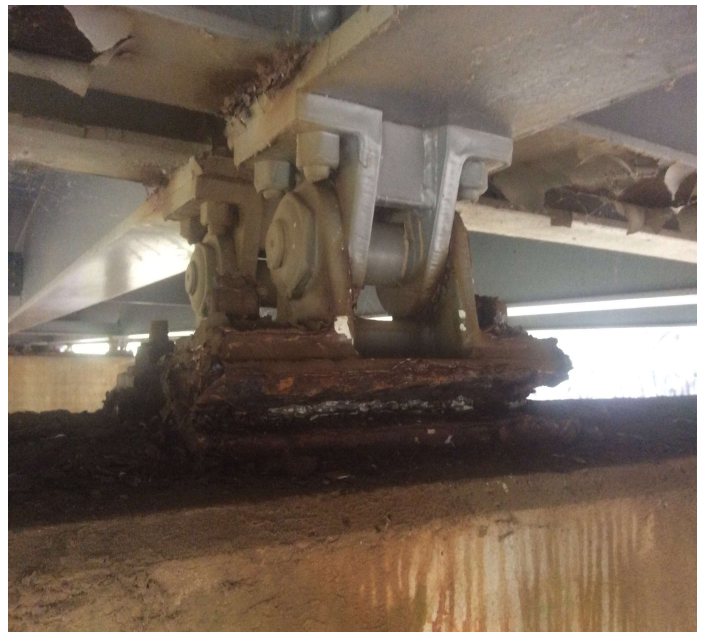
PHOTO 6 Description Bent 12 bearing 3 heavy flaking rust with pack rust.

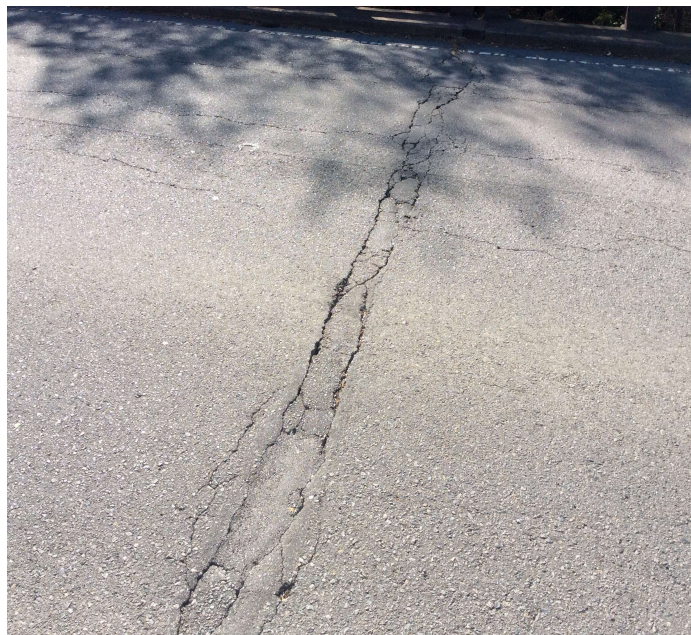
Deck – Bents 1-16: Large transverse cracking in asphalt wearing surface at each bent. Stormwater is leaking down through cracks and onto ends of girders and onto bearings and caps.

PHOTO 1 Description Wearing surface - Bent 2 (cracking)

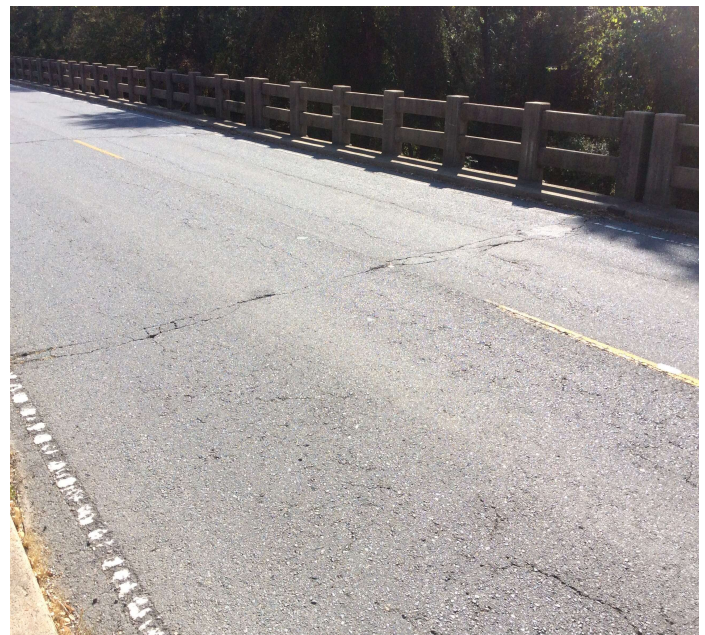
PHOTO 2 Description Wearing surface - Bent 5 (cracking)

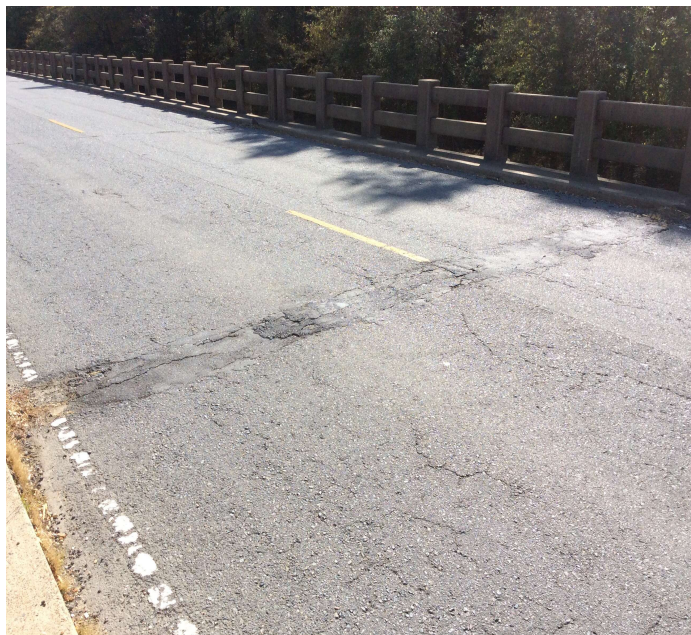
PHOTO 3 Description Wearing surface - Bent 10 (cracking)

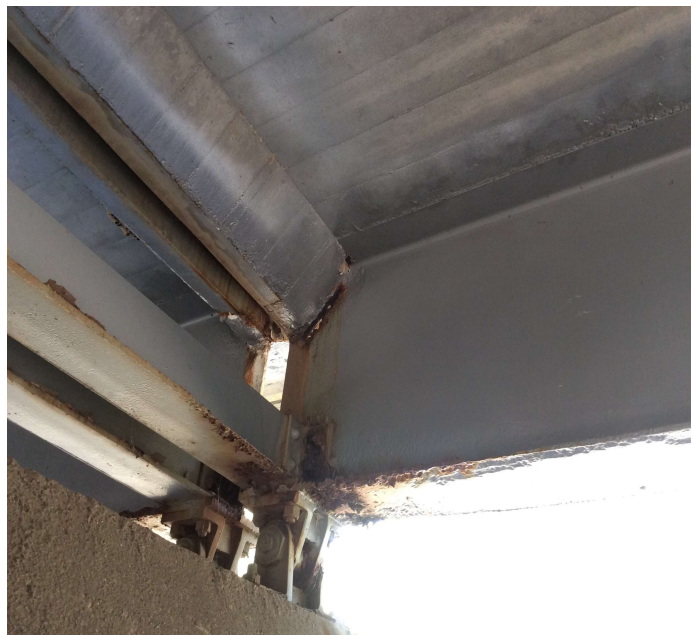
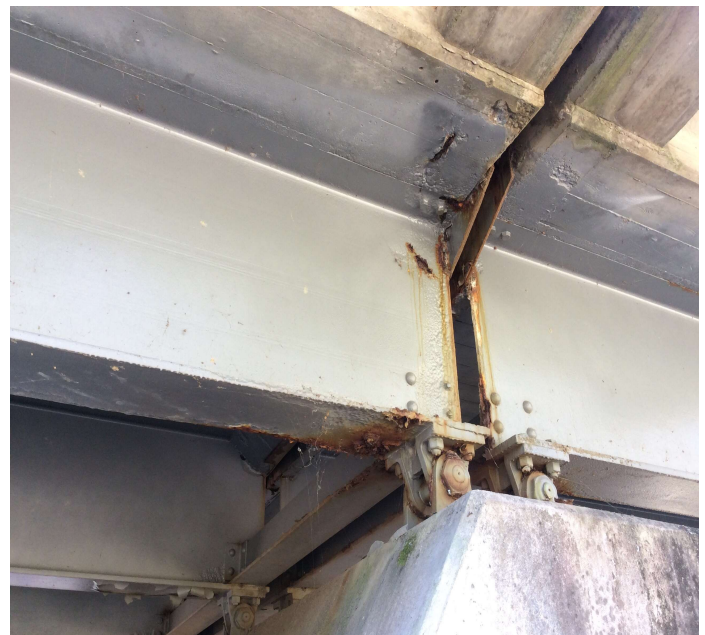
Span 6 Girder 1 @ Bent 6: Hole (1/2" x 2") rusted in top of web at haunch. Rust with flaking and section loss on web and bottom flange of girder. Several girders have some flaking rust to haunch area with minor section loss.

PHOTO 1 Description Span 6 Girder 1 @ Bent 6 (corrosion)

PHOTO 2 Description Span 6 Girder 1 @ Bent 6 (corrosion)

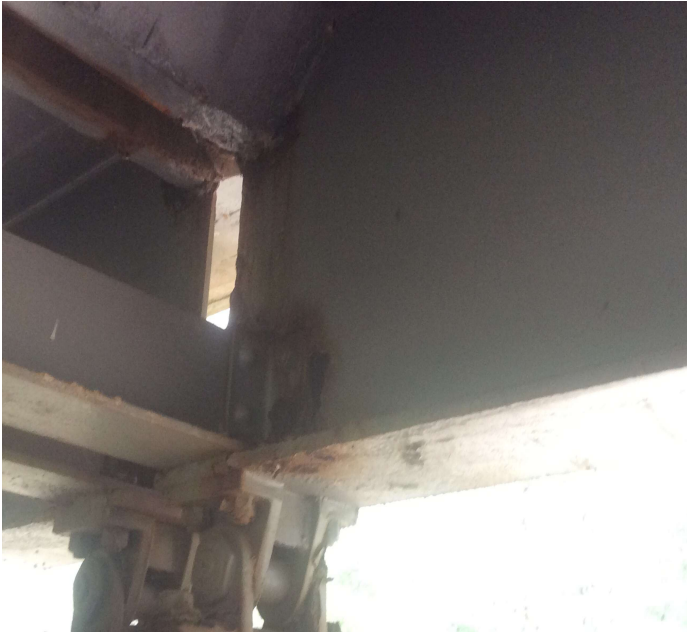
PHOTO 3 Description Span 10 at bent 11 girder 5 has some flaking rust with minor section loss.

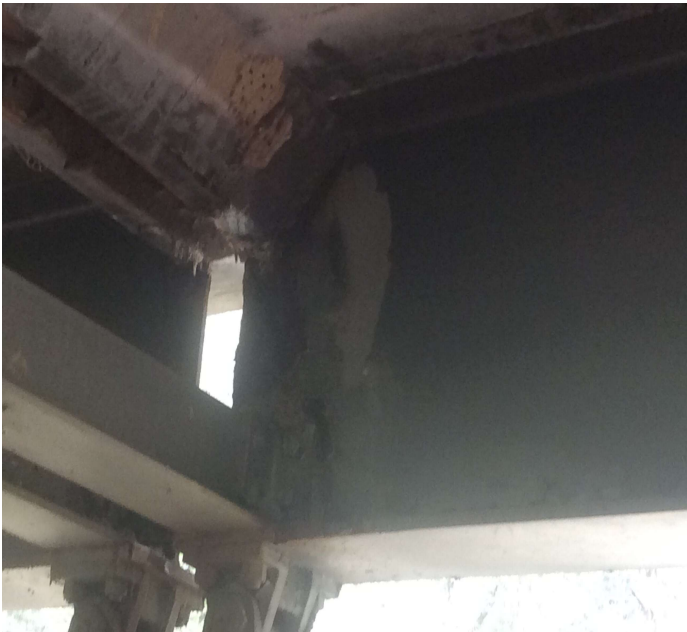
PHOTO 4 Description Span 12 at bent 13 girders 5 has flaking rust to girder end.

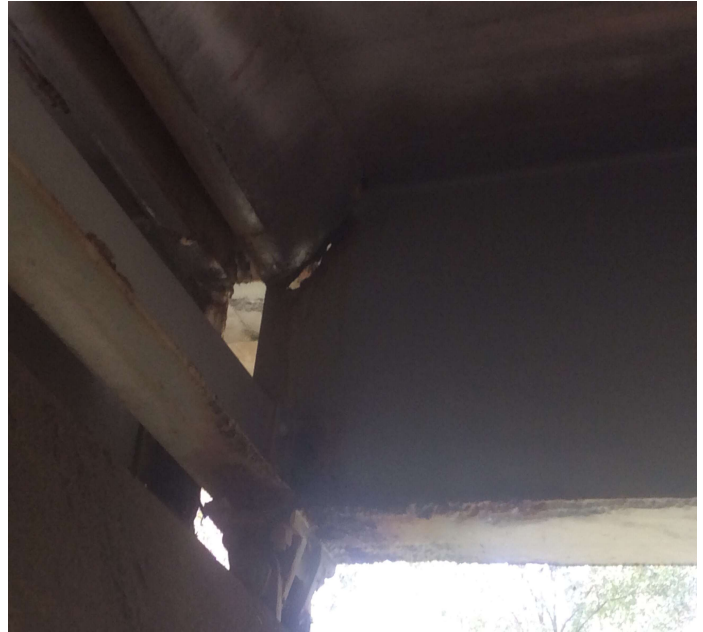
PHOTO 5 Description Span 6 bent 6 girder 1 has small hole in web at haunch with heavy flaking rust and section loss to lower flange at bearing area 2'.

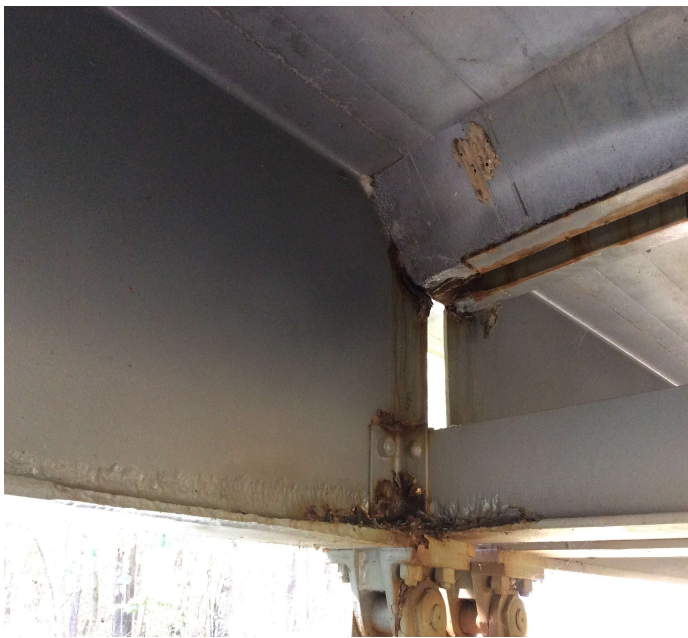
Girders - various locations: Some rust and minor section loss, especially at ends of girders at haunches and around diaphragm connections.

PHOTO 1 Description Span 2 Girder 5 @ Bent 2 (corrosion)
