# Bridge Inspection Report

**02379**

**US 270-10 LM 3.72**

**Hurricane Creek Relief**

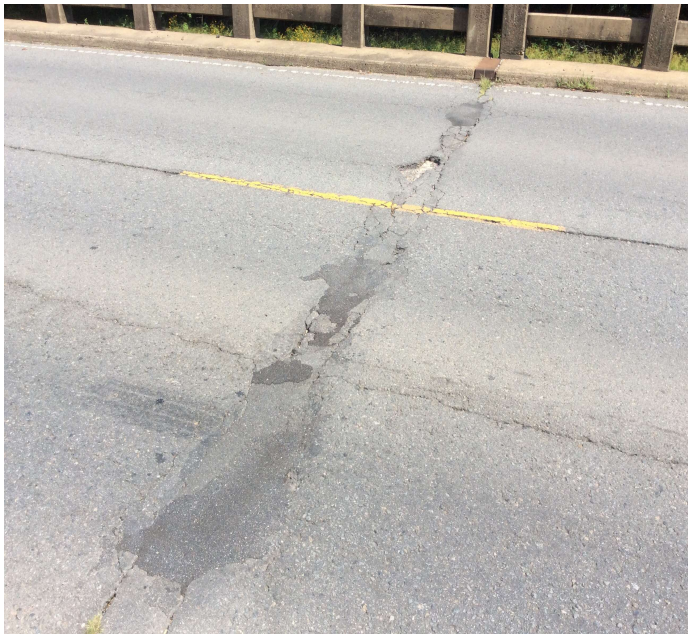
Deck - Asphalt wearing surface: Large-sized, heavy cracking and delaminations at joints with some small potholes beginning to appear. (Some areas have been previously patched.)

PHOTO 1      Description      Wearing surface - Bent 11 (spalling)

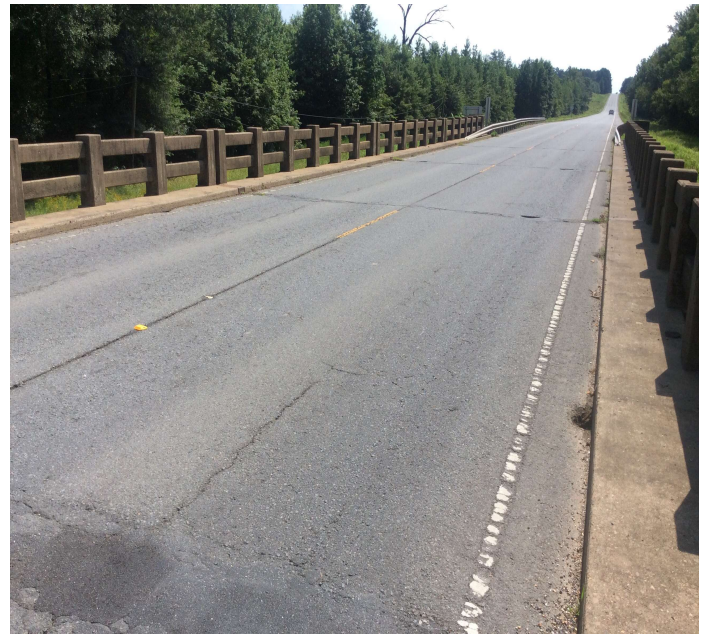
Remaining of asphalt wearing surface is cracking with a couple small potholes appearing, especially in wheel ruts.

PHOTO 2      Description      Wearing surface - Spans 8-10 right (cracking)

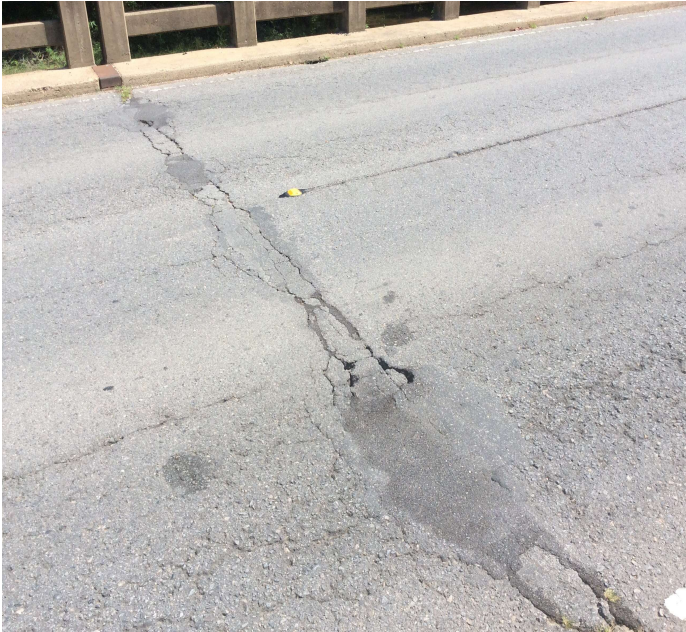
PHOTO 3 Description Wearing surface - Bent 6 (patches)

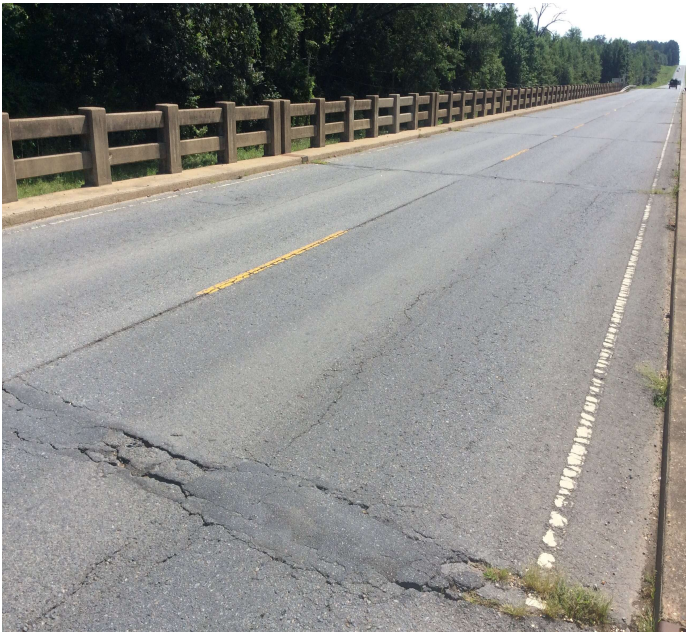
PHOTO 4 Description Wearing surface - Span 2 (cracking)

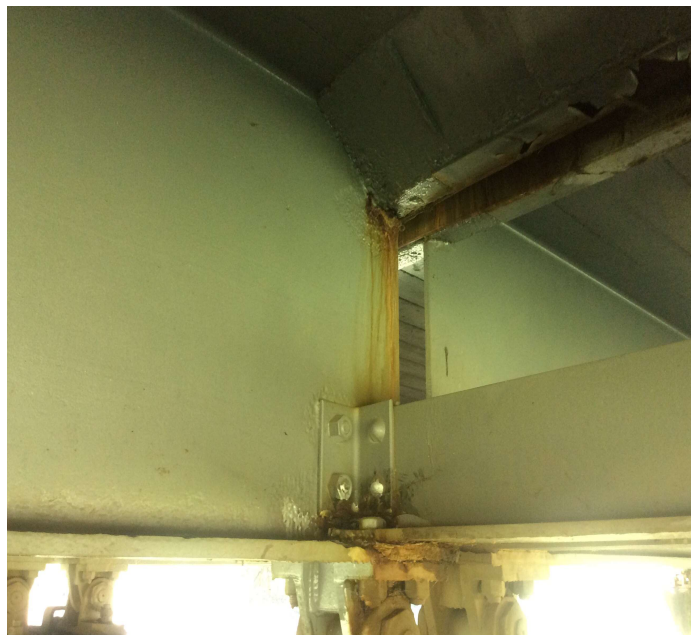
Girders – various locations: A few scattered spots of rust with some old section loss on web at haunches and on top of bottom flange and on bottom flange in various locations.

PHOTO 1 Description Span 5 Girder 3 left @ Bent 5 (corrosion)

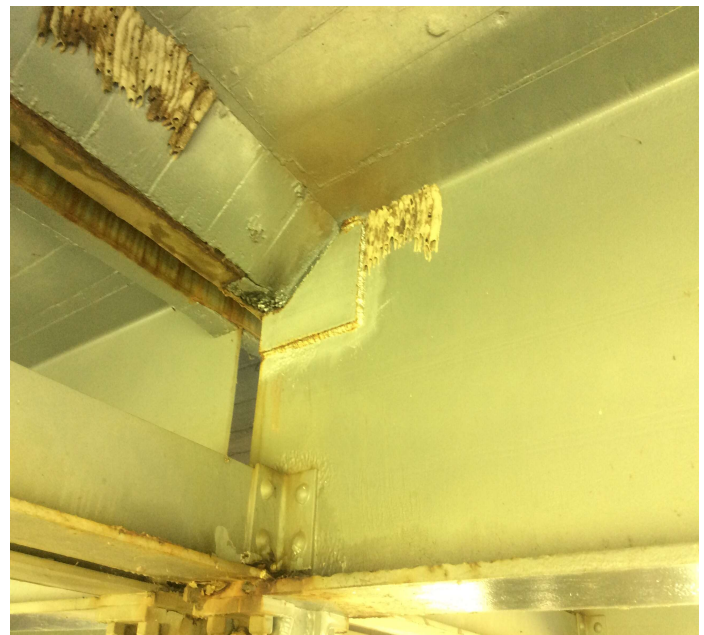
PHOTO 2 Description Span 2 Girder 3 right @ Bent 2 (corrosion)

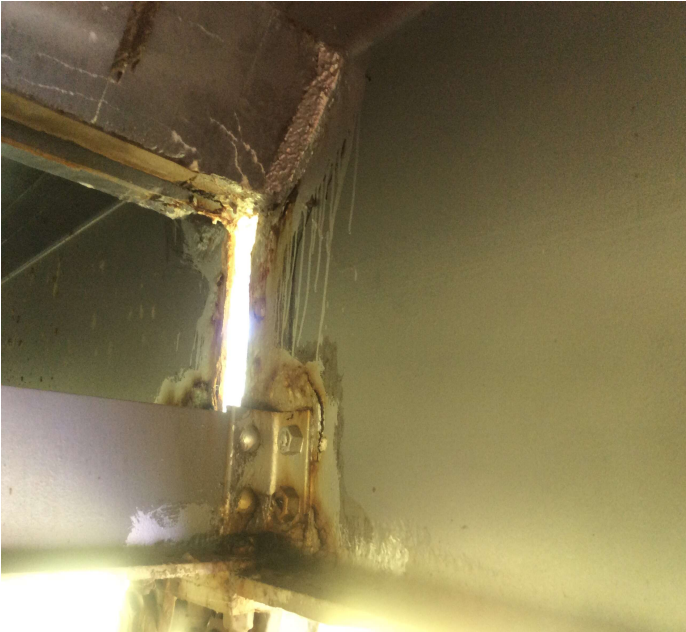
PHOTO 3      Description      Span 6 Girder 1 right @ Bent 6  
(corrosion)

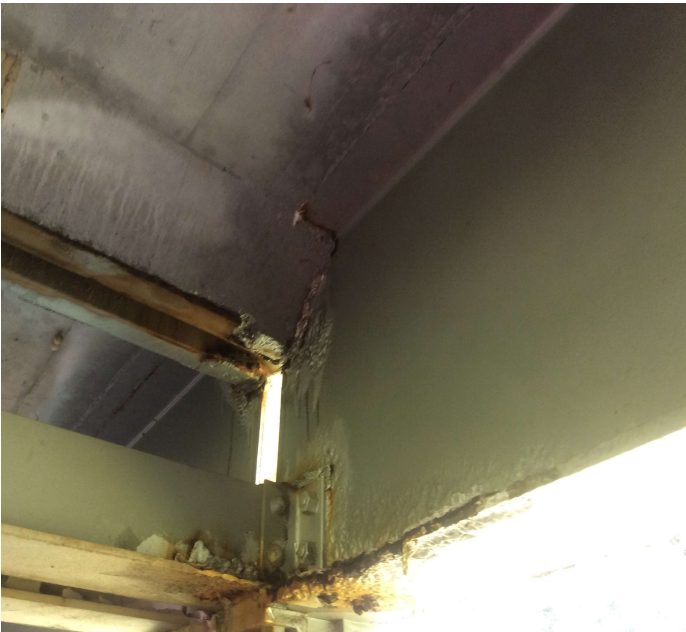
Heaviest section loss is to Span 10 Girder 1 on right side – some loss at haunch, along bottom of web and bottom flange (knife-edged).

PHOTO 4      Description      Span 10 Girder 1 @ Bent 10  
(corrosion)

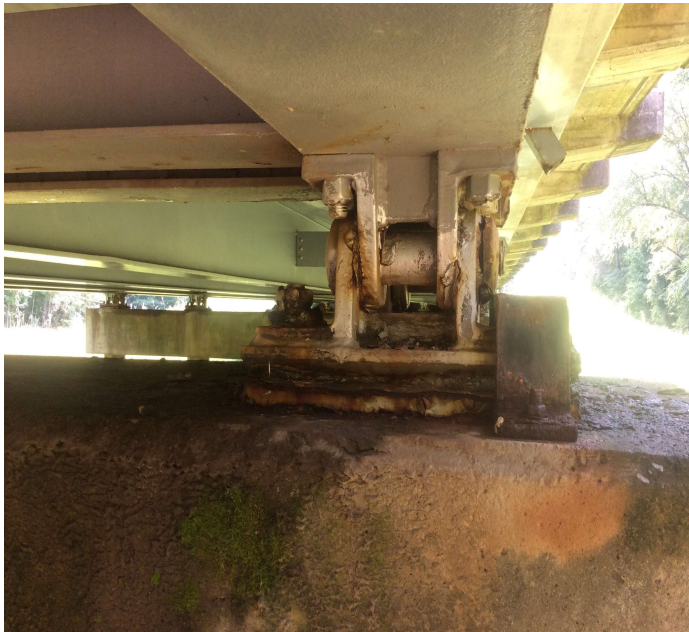
Bearings – various locations: Most movable bearings have heavy pack rust between rocker and masonry plate, restricting movement. Remaining bearing have some scattered rust and minor section loss in various locations.

PHOTO 1      Description      Bent 9 Bearing 5 back (corrosion)

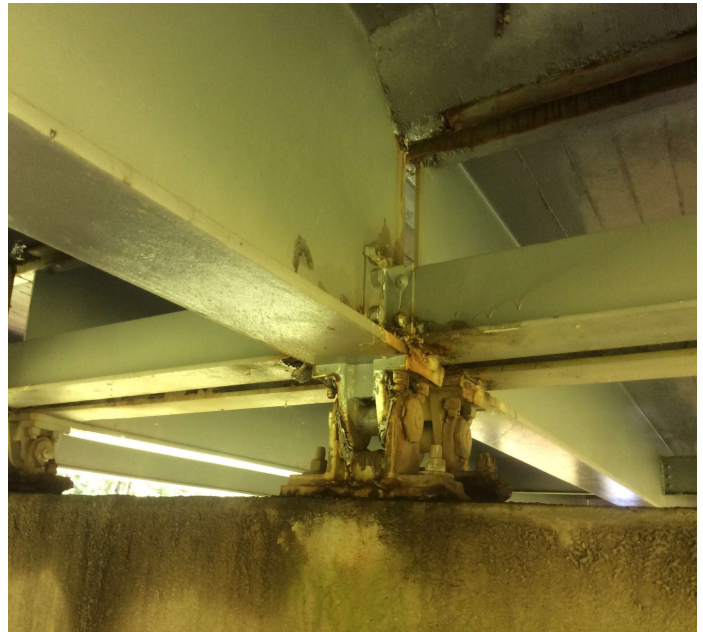
PHOTO 2      Description      Bent 10 Bearing 3 ahead (corrosion)

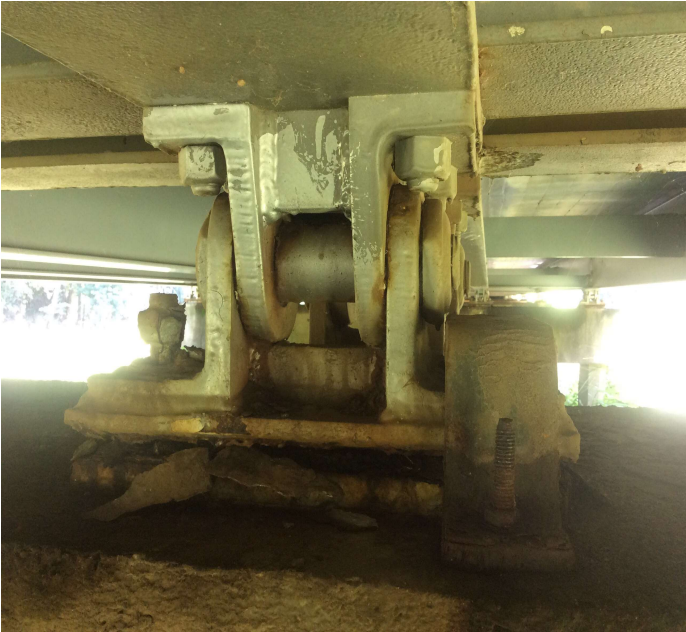
PHOTO 3 Description Bent 5 Bearing 4 back (corrosion)

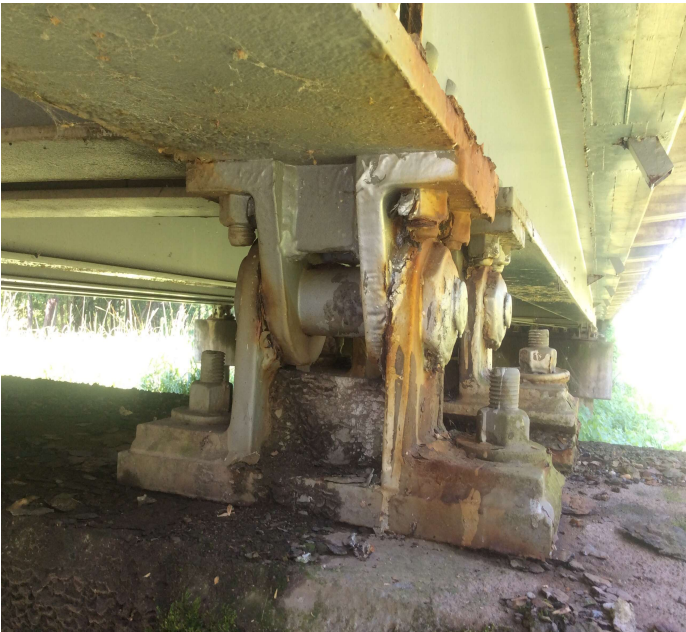
PHOTO 4 Description Bent 6 Bearing 1 ahead (corrosion)
