Bridge Inspection Report

02405
US 270-10 LM 2.54
over
Hubbard Creek

Facility Carried: US 270-10 LM 2.54

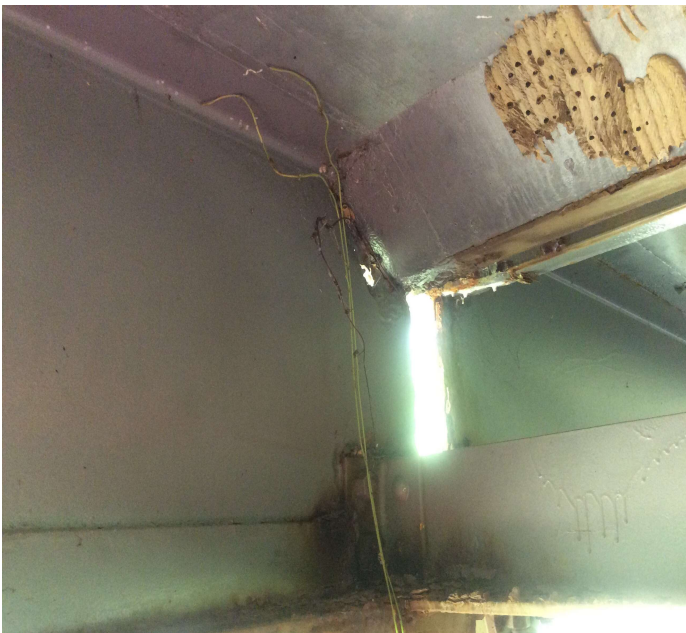
| | Environment | Total Quantity | Units | Condition State 1 | Condition State 2 | Condition State 3 | Condition State 4 |
|---|--|---|---|---|---|---|---|
| | Girders: 5 per span / 90' total. Coating: 5.7 square feet / linear feet of girder. Span 3 - Girder 5 @ Bent 3: Hole (2.5" x 1.25") rusted through web at haunch. (1') Span 2 - Girder 2 @ Bent 2: Old section loss to bottom of web and to bottom flange. (2') Girders - All spans: Scattered rust with minor section loss on the webs at the ends of some girders at the haunches and around the diaphragm connections. (18' total) Diaphragm rusted through - Span 2 Girder 1 @ Bent 2 right. | | | | | | |

Span 3 – Girder 5 @ Bent 3: Hole (2.5" x 1.25") rusted through web at haunch.

PHOTO 1 Description Span 3 Girder 5 @ Bent 3
(corrosion/hole rusted)

Priority: C - Important

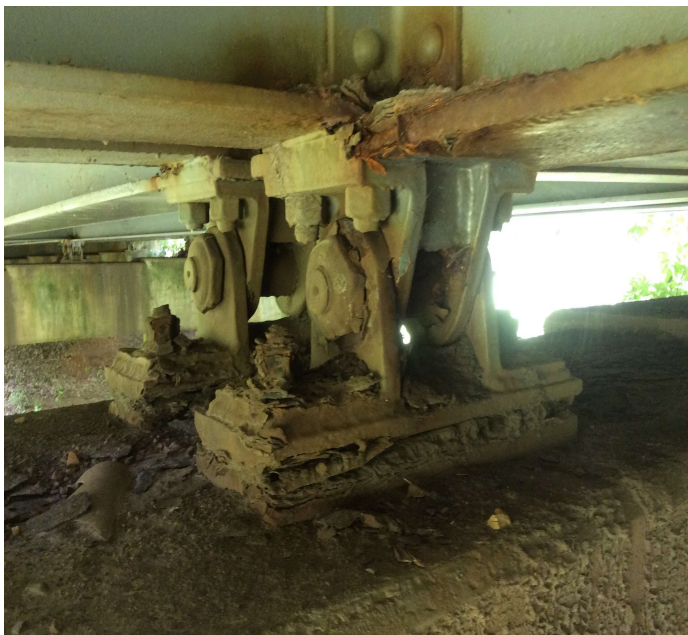
| | Environment | Total Quantity | Units | Condition State 1 | Condition State 2 | Condition State 3 | Condition State 4 |
|---|--|---|---|---|---|---|---|
| | Moveable bearings: 5 per bent / Bent 2 back, Bent 3 back & ahead. Coating: 2 square feet each. Most bearings have heavy pack rust between rocker and masonry plate, restricting movement. Remaining bearing have some scattered rust and minor section loss in various locations. | | | | | | |

Bearings – various locations: Most movable bearings have heavy pack rust between rocker and masonry plate, restricting movement. Remaining bearing have some scattered rust and minor section loss in various locations.

PHOTO 1 Description Bearings 4A & 4B @ Bent 3 (corrosion)

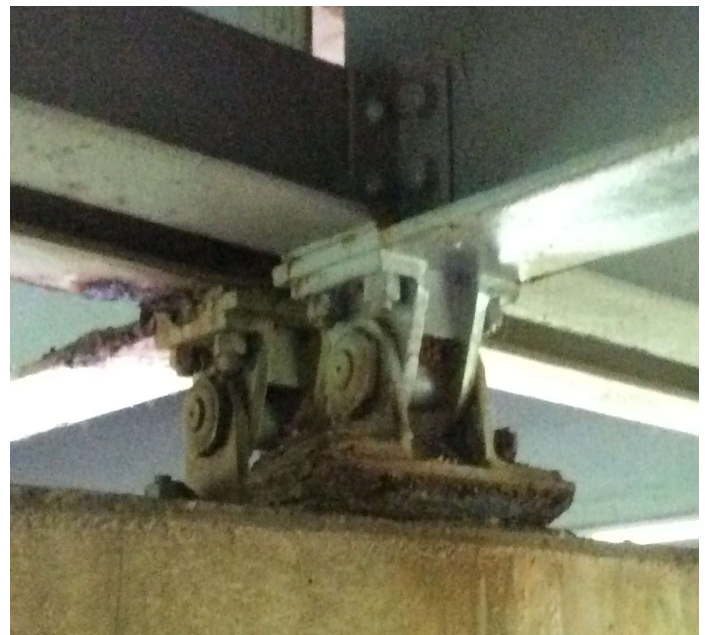
PHOTO 2 Description Bearings 3A & 3B @ Bent 2 (corrosion)

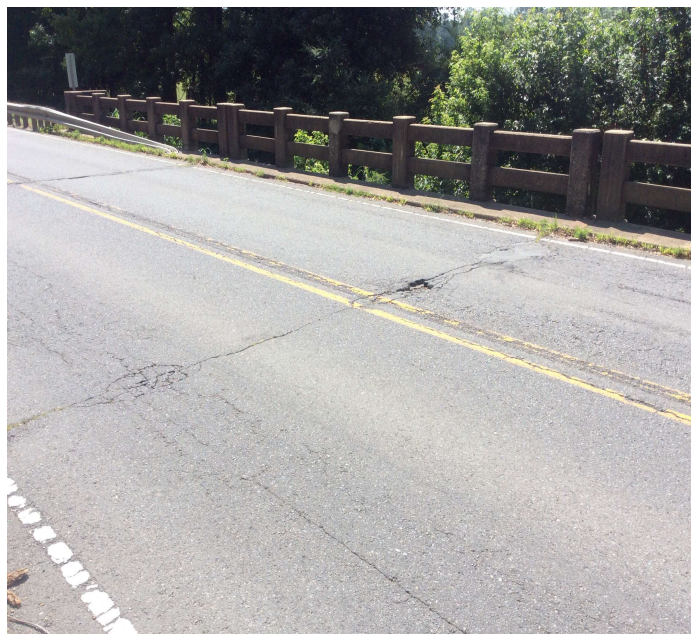
Deck – asphalt wearing surface: Large-sized, heavy cracking at joints with some small potholes beginning to appear. Chunks of asphalt are beginning to come loose and may become a hazard to traffic.

Remaining of asphalt wearing surface is beginning to crack with a couple small potholes appearing, especially in wheel ruts at Span 3 left.

PHOTO 1 Description Wearing surface - Bent 2 (potholes)

Grant: repair as you have time

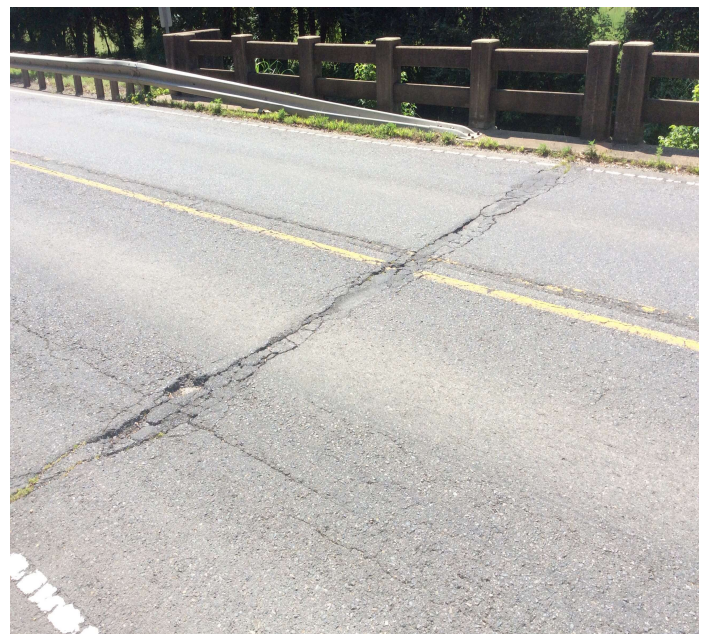
PHOTO 2 Description Wearing surface - Bent 3 (potholes)

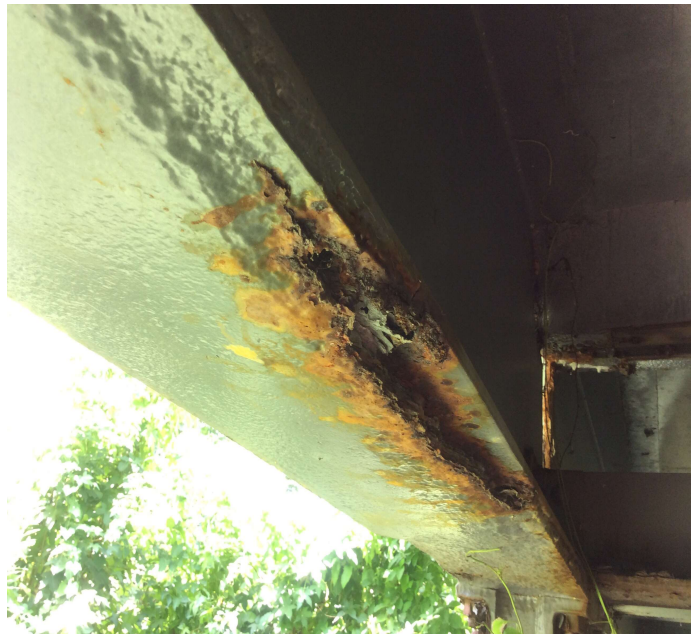
Girders – All spans: Scattered rust with minor section loss on the webs at the ends of some girders at the haunches and around the diaphragm connections.

PHOTO 1 Description Span 3 Girder 5 @ Bent 3 (corrosion of bottom flange)

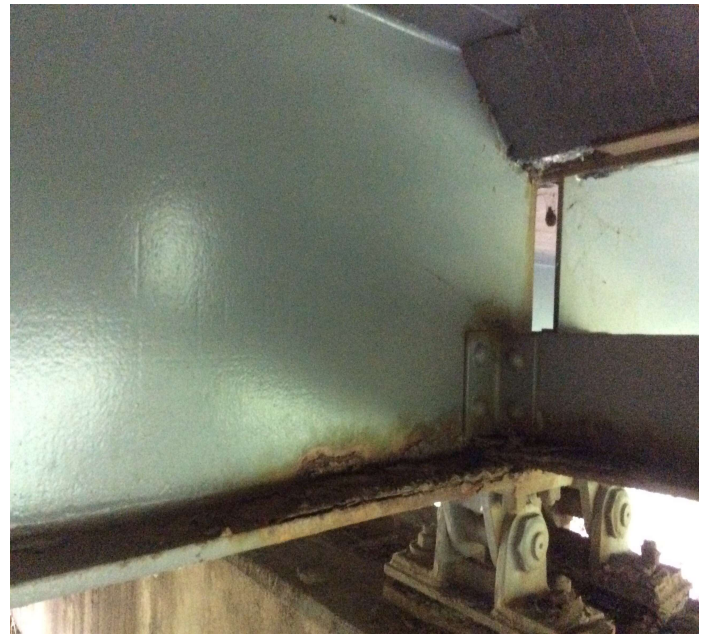
PHOTO 2 Description Span 3 Girder 2 @ Bent 3 (corrosion)

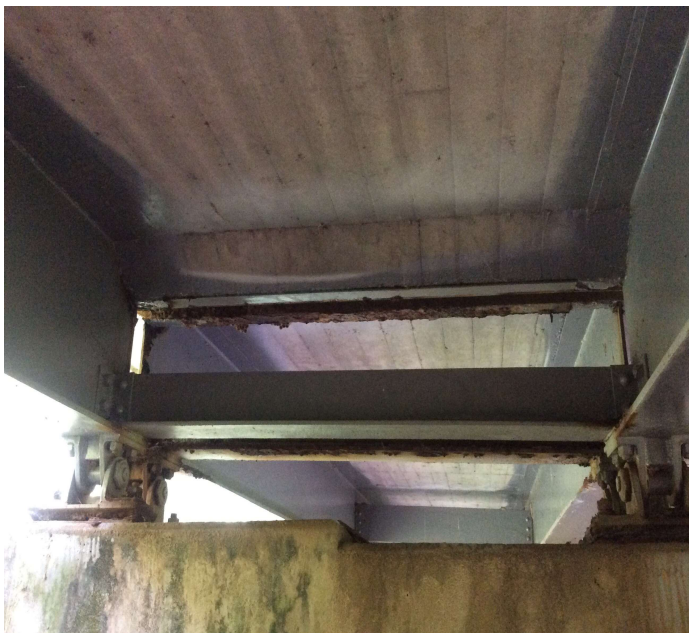
Diaphragm rusted through – Span 2 Girder 1 @ Bent 2 right.

PHOTO 3 Description Girders 1-2 @ Bent 2 (corrosion)
