Bridge #05423(Routine, Fracture Critical, Under Record Clearance)

US 65-14B LM 6.46 over Nebraska St, SLSW/UNPAC

Team Lead: Greg Loomis **Inspection Date:** October 06, 2020

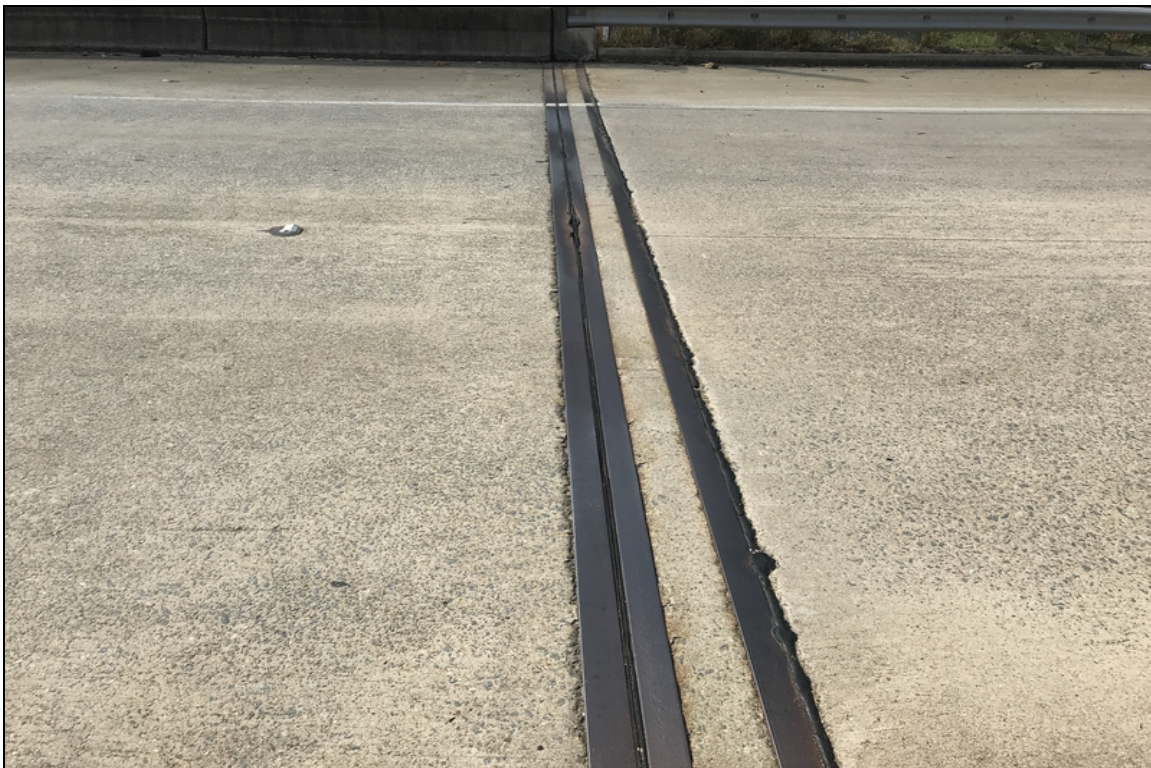
Joint - Bent 1 right: Damage

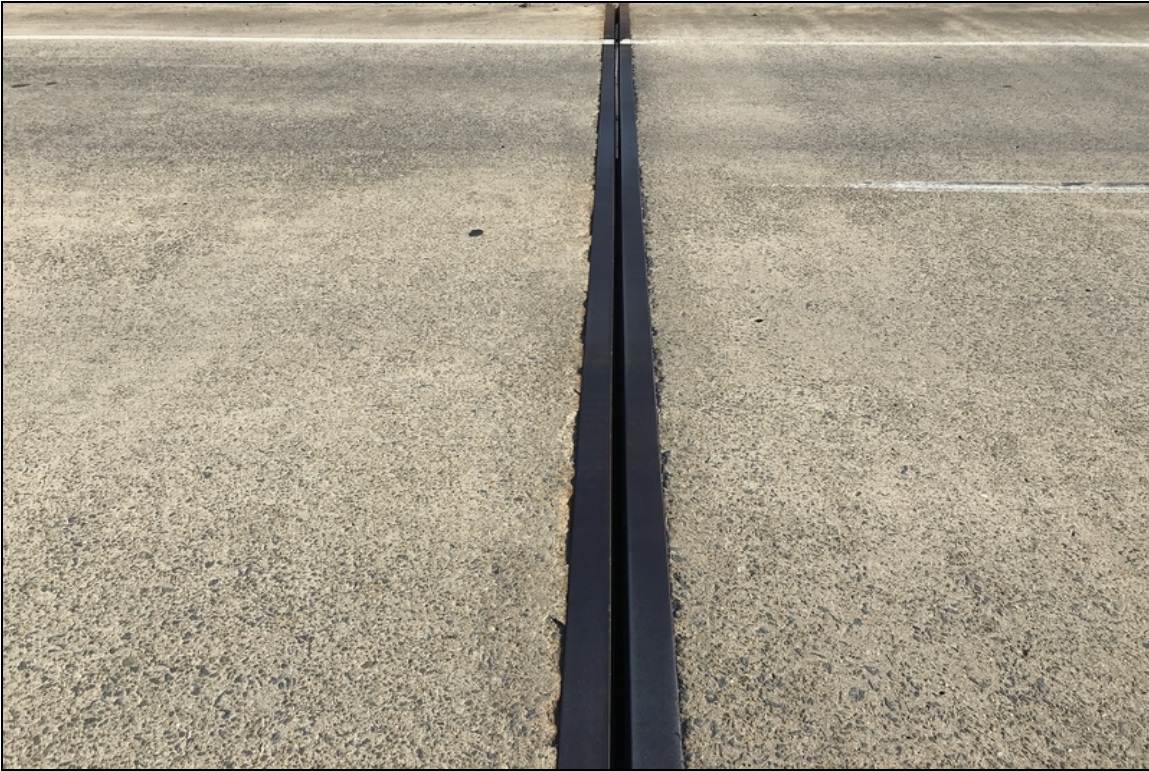
Joint - Bent 4 left: Material missing

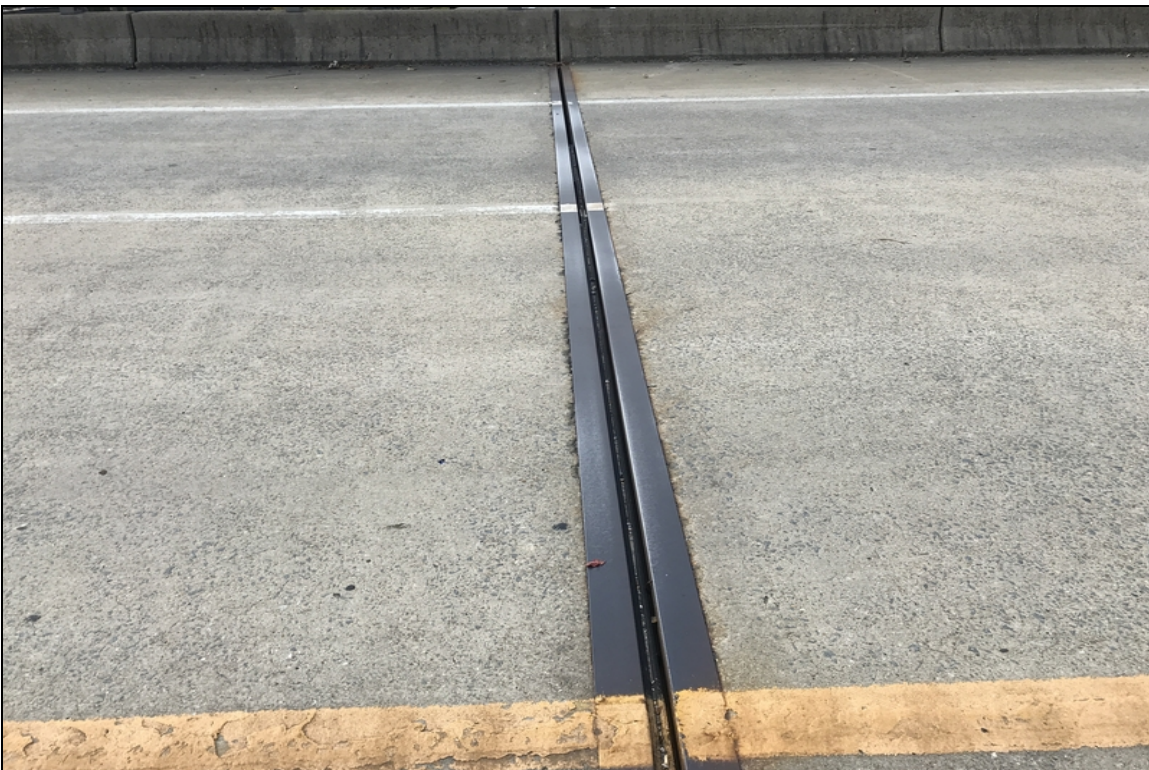
Joint - Bent 7 right: Loss of adhesion/spalling of adjacent deck

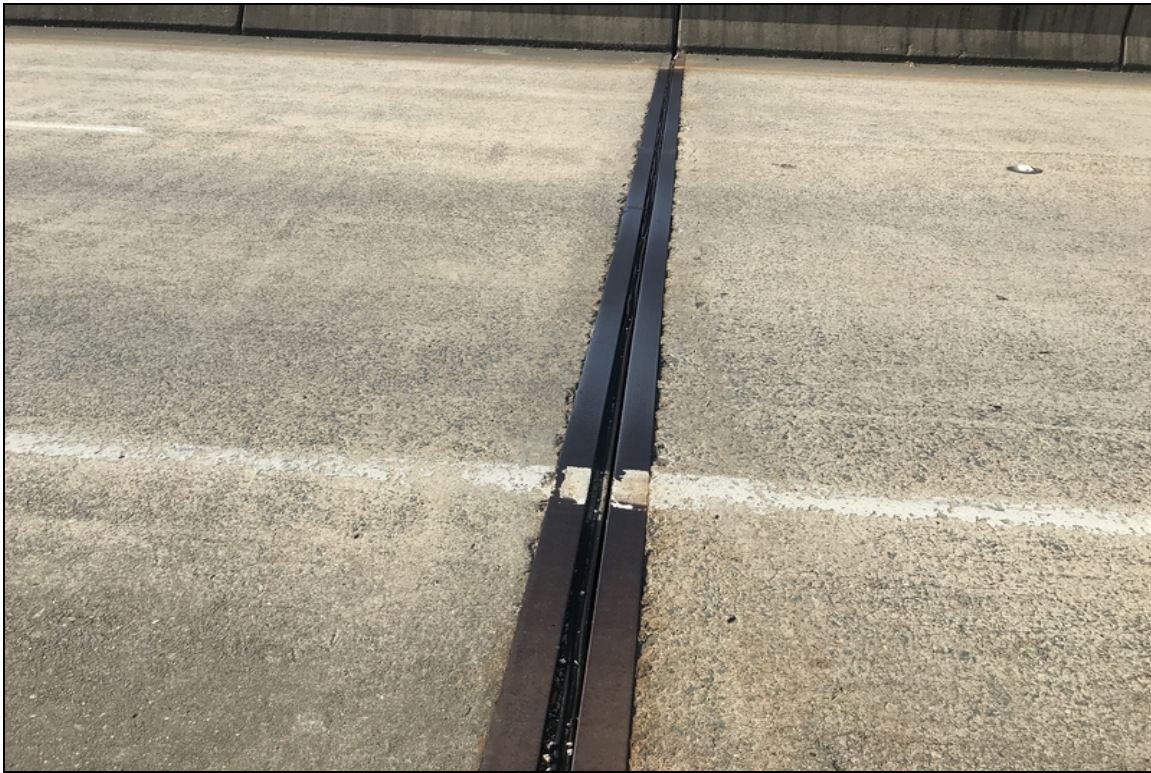
Joint - Bent 7 left: Loss of adhesion/adjacent deck Spalling (deck Cracking)

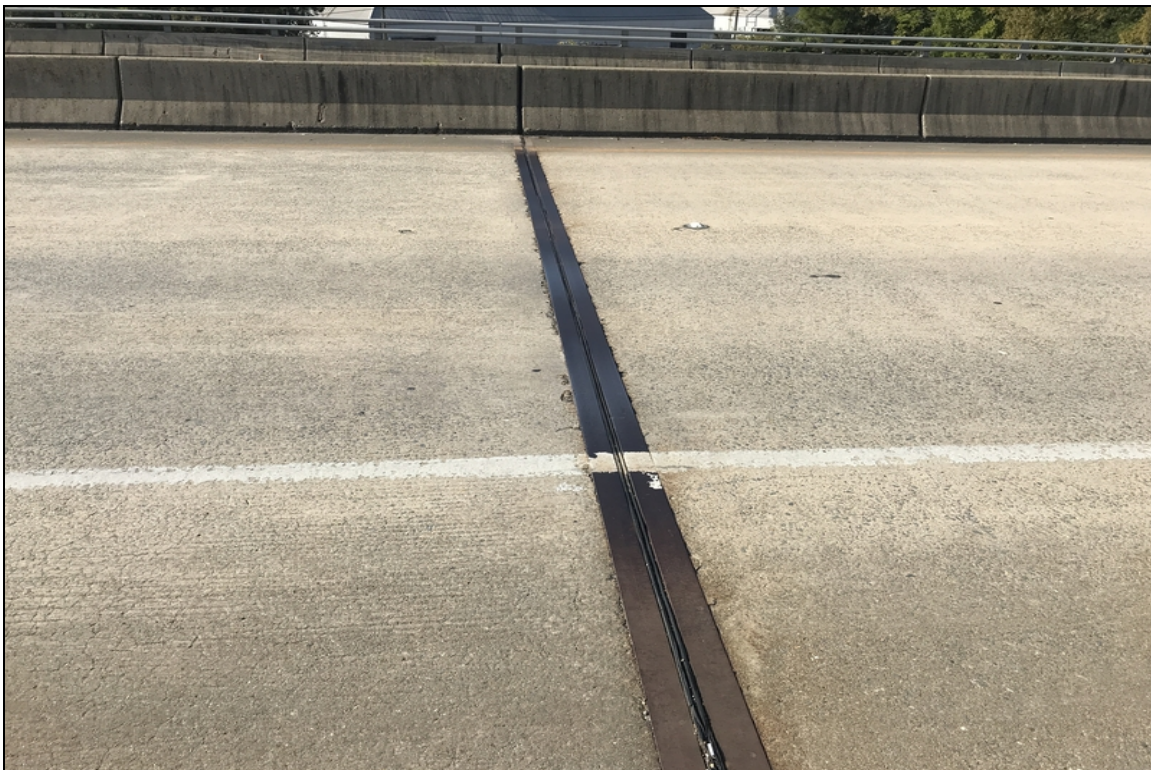
Joint - Bent 8 left: Adjacent deck spalling

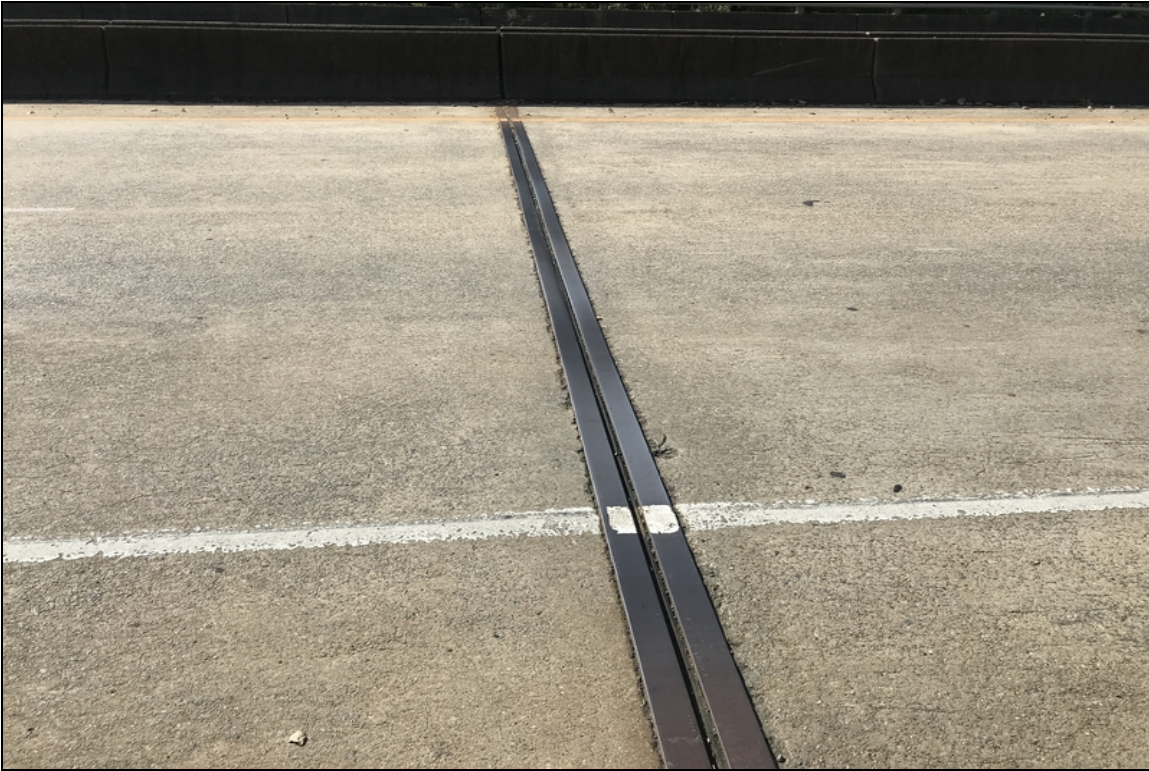
Joint - Bent 26 left: Adjacent deck spalling

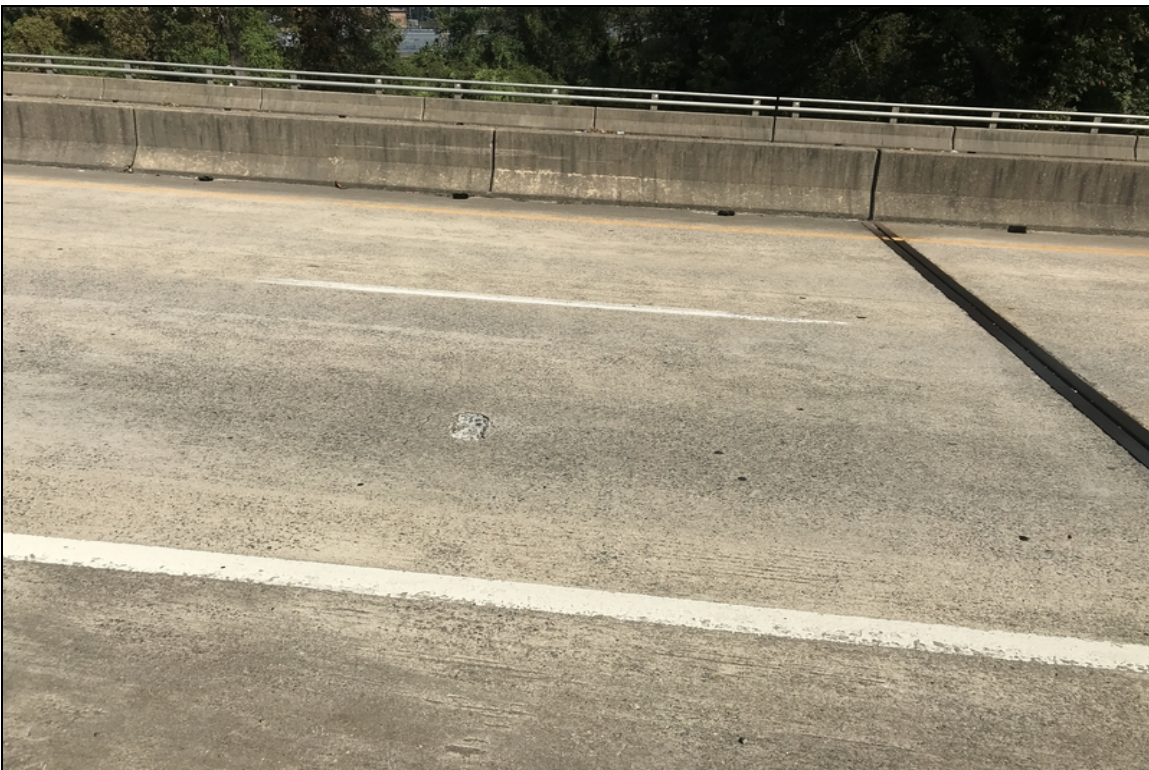
Deck - Span 25 right: Cracking/spalling

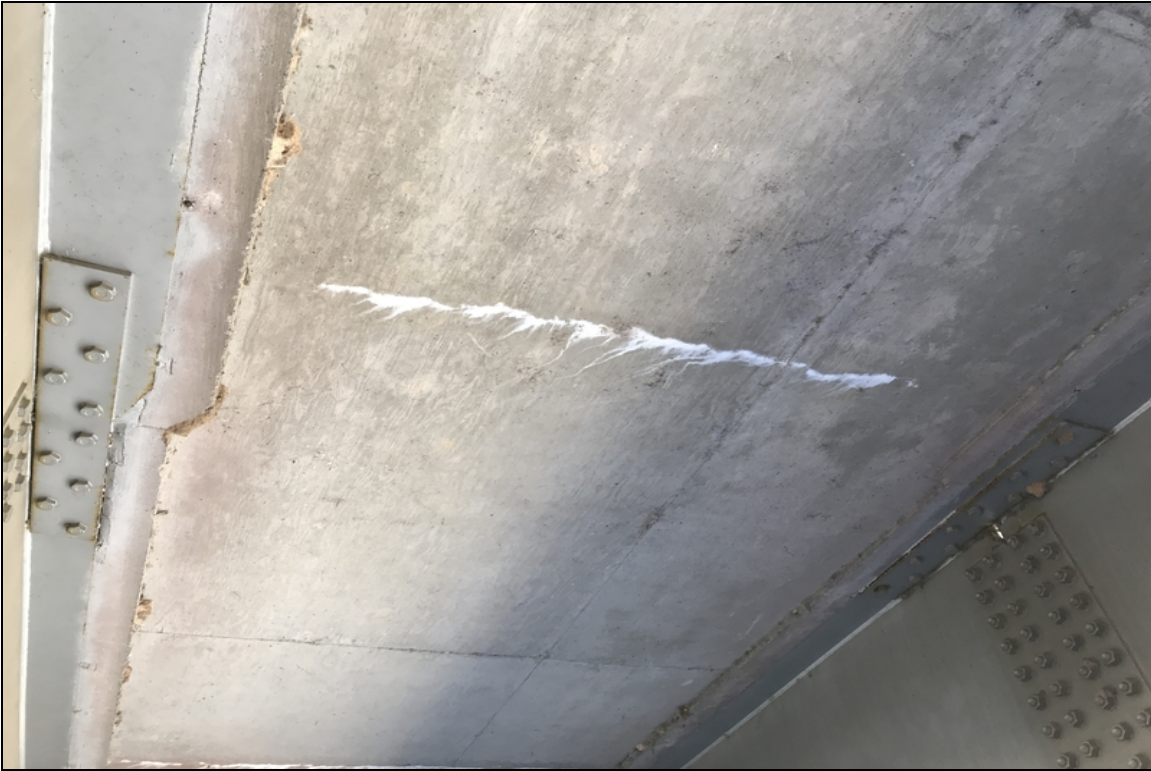
Soffit - Span 4 Bay 2: Efflorescence

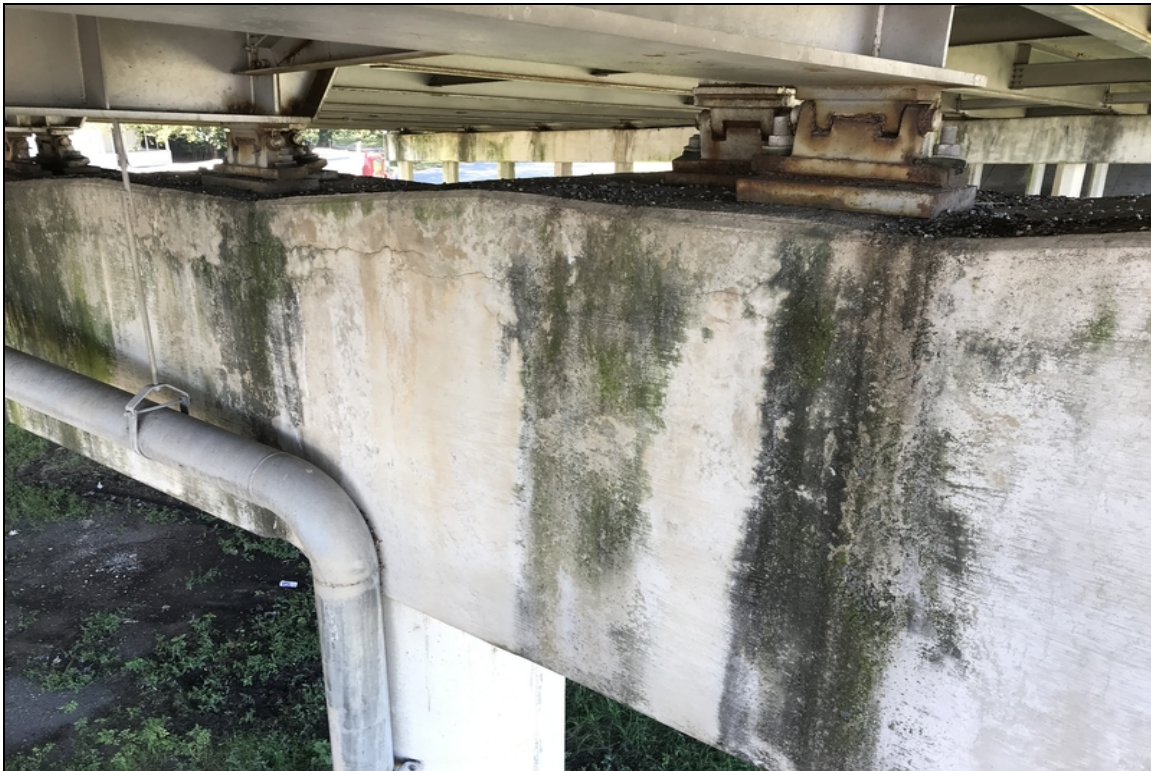
Cap - Bent 4 ahead: Cracking on top

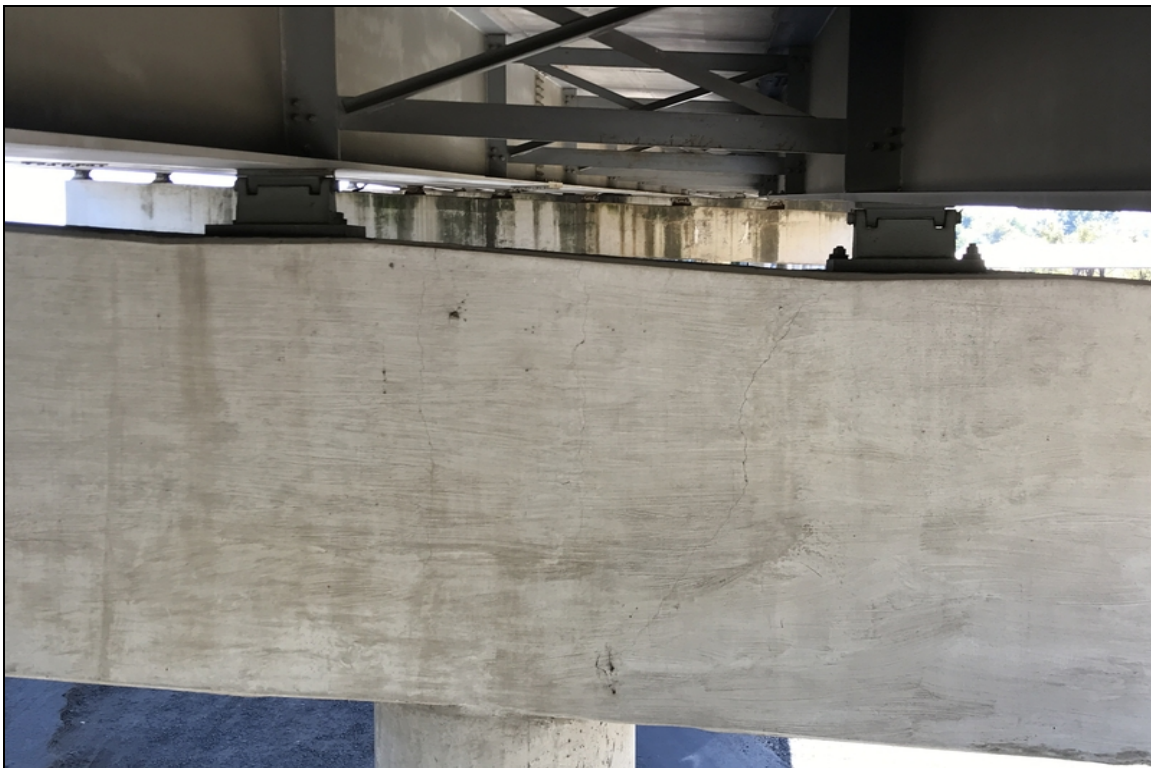
Cap - Bent 5 back: Cracking

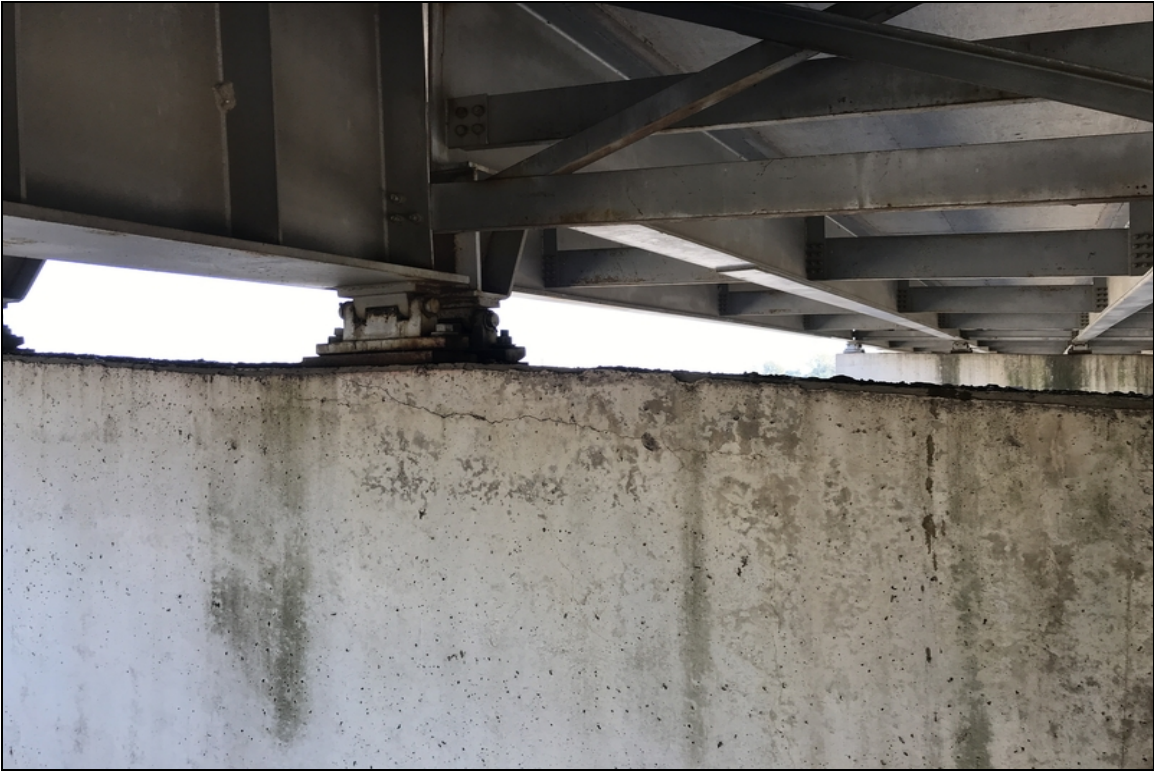
Cap - Bent 6 back left: Cracking

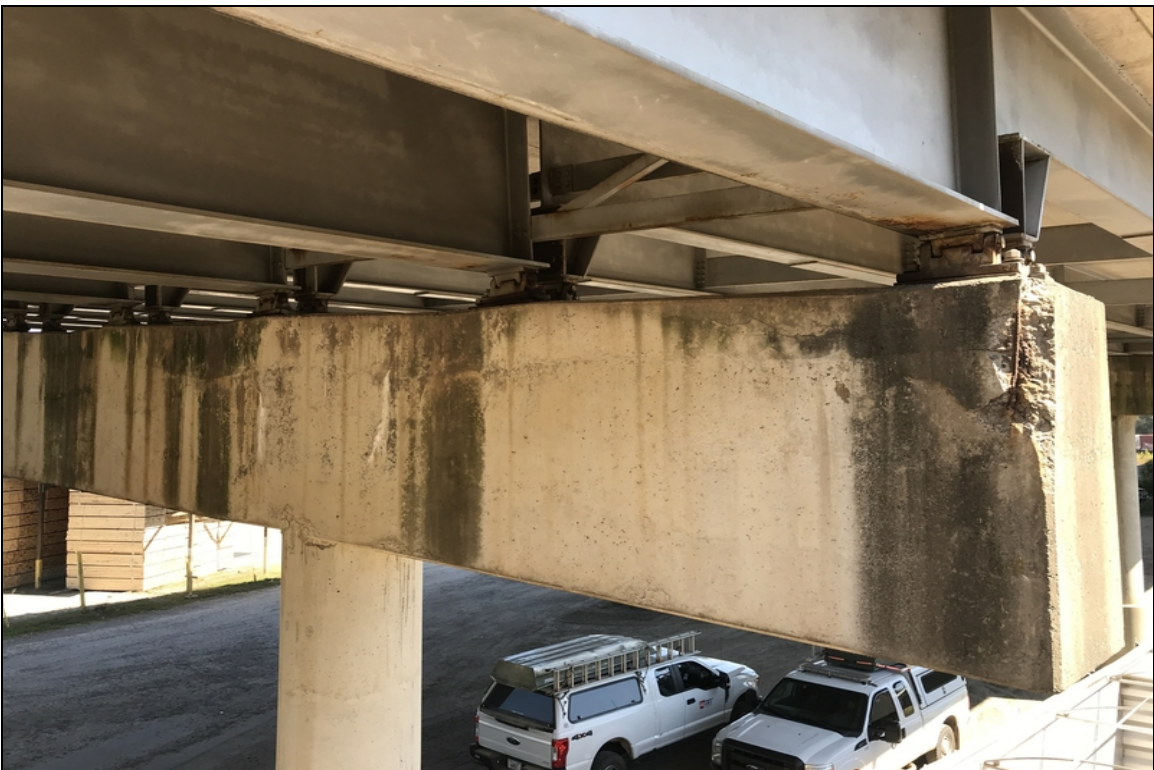
Cap - Bent 6 back right: Rebar exposed/efflorescence

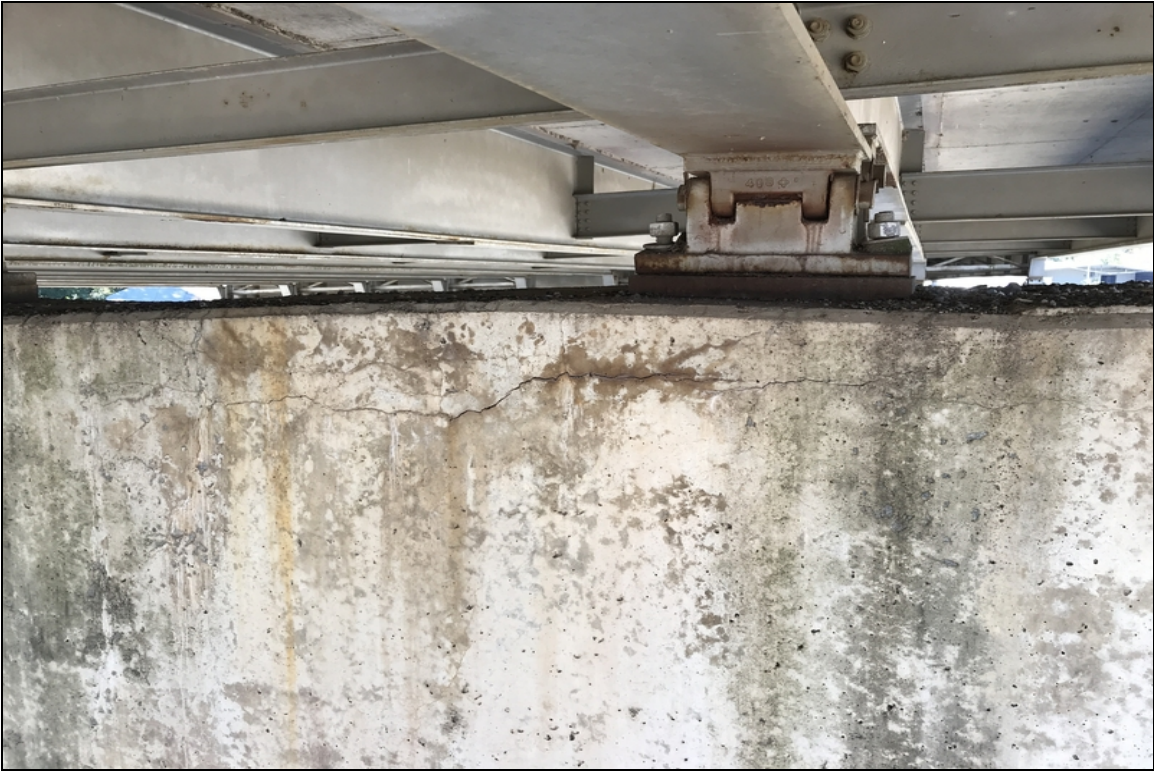
Cap - Bent 7 ahead left: Cracking

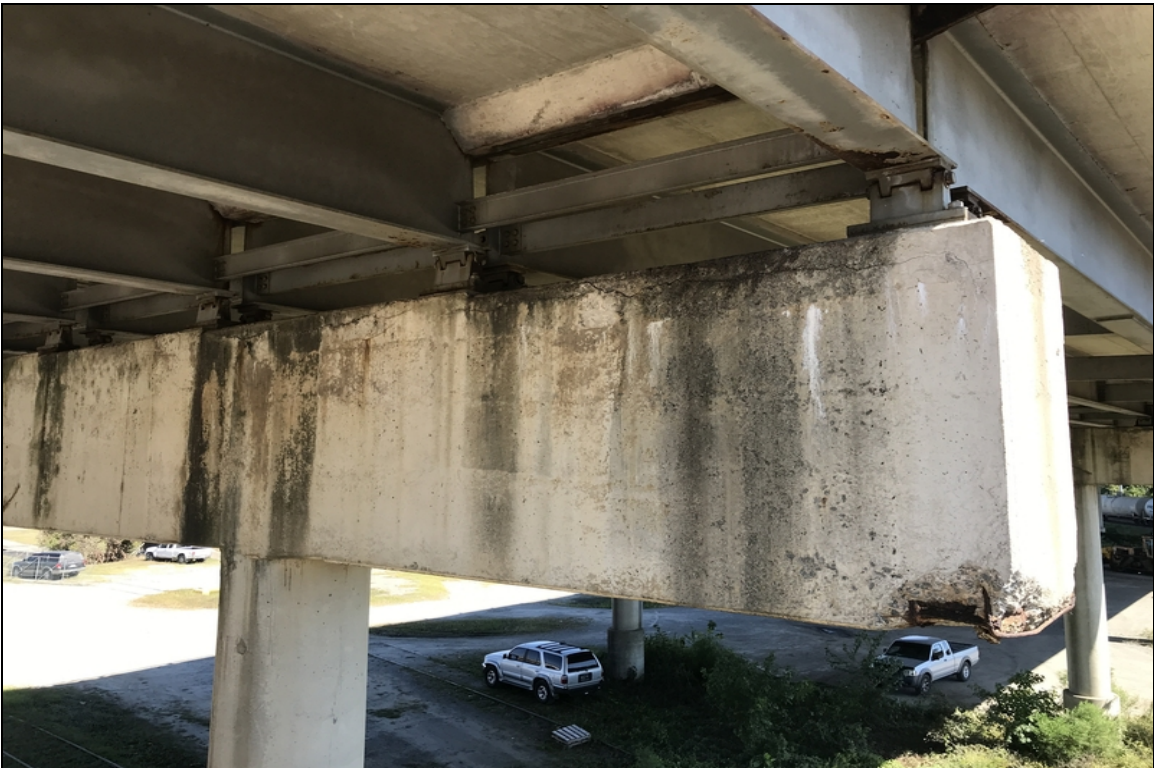
Cap - Bent 9 back right: Rebar exposed/efflorescence

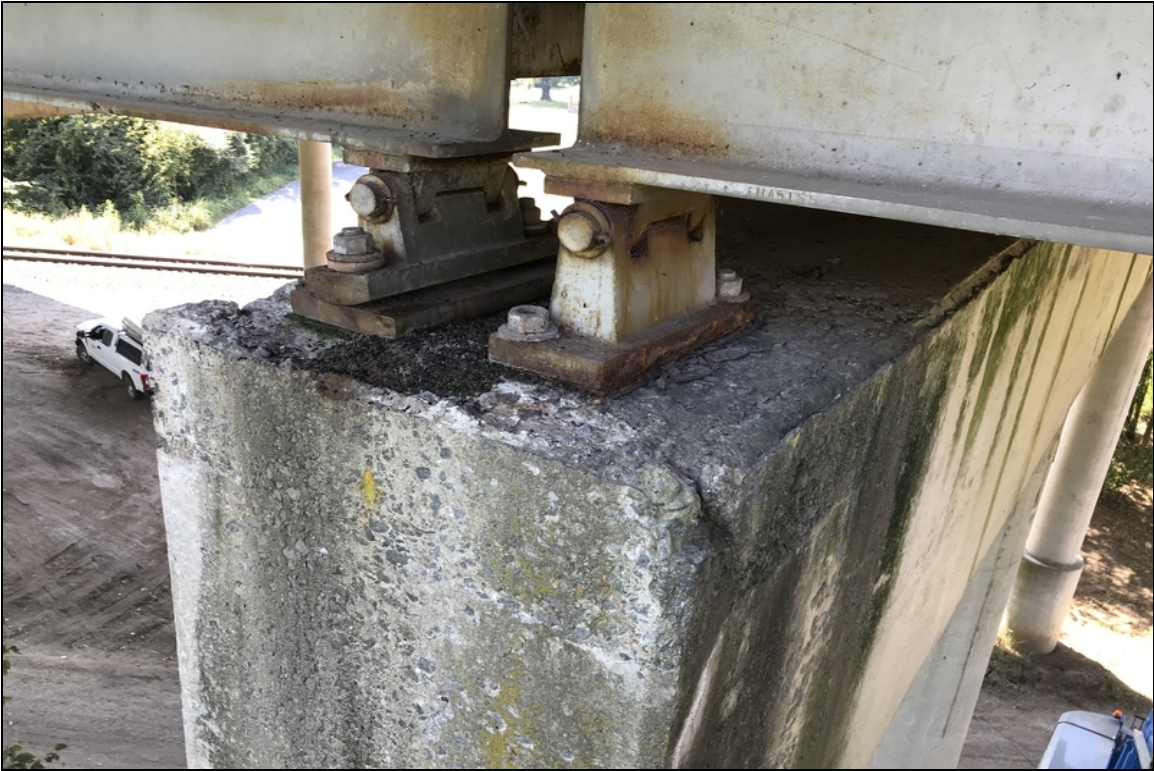
Cap - Bent 20 top face @ Bearings 1: Abrasive wear

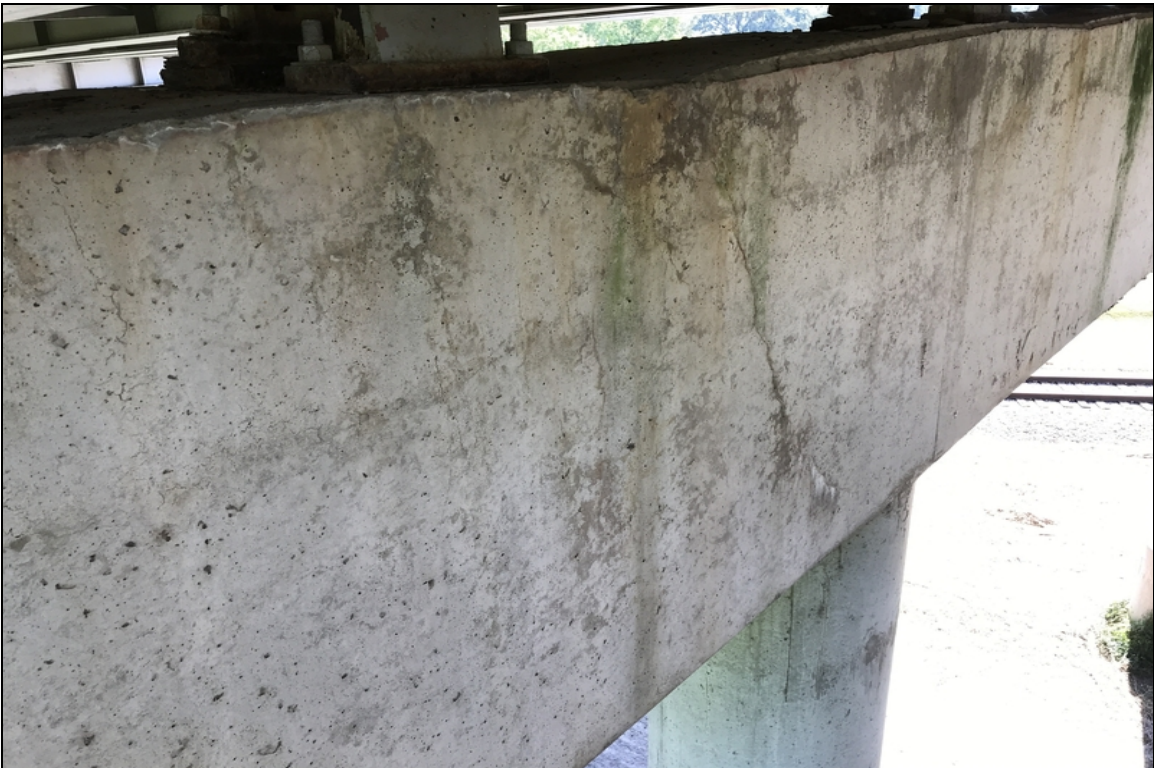
Cap - Bent 21 back left: Cracking

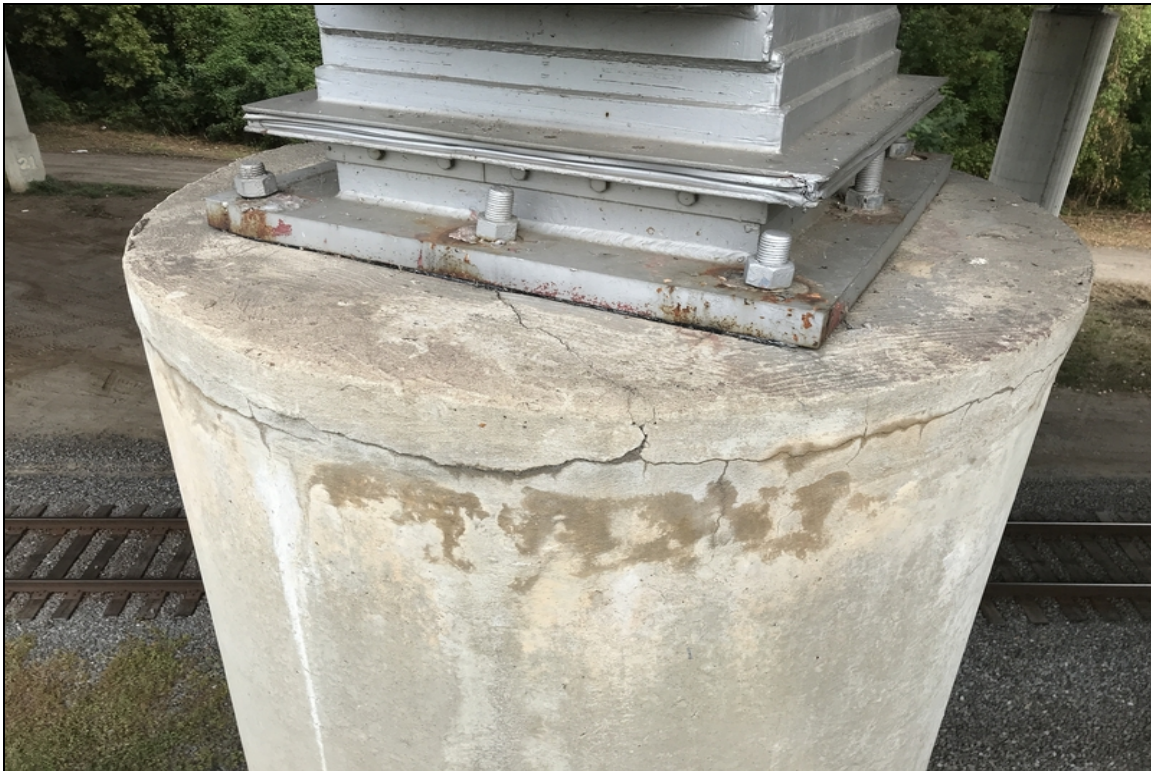
Bent 22 Column 2 right: Cracking

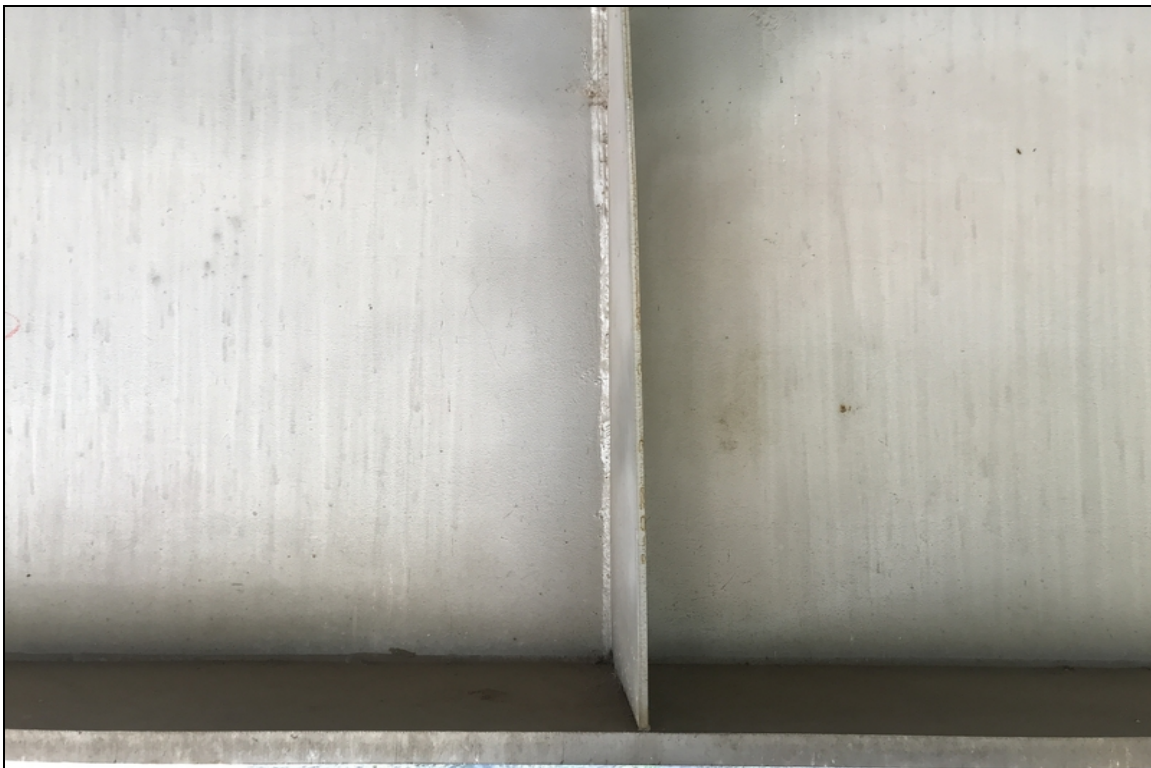
Cap - Bent 15 back @ Girder 6: Stiffener twisted to right at bottom

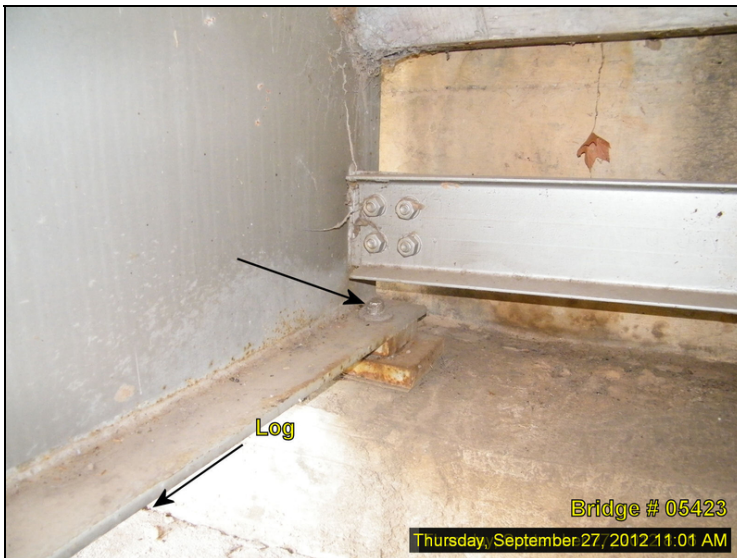
Nuts missing on anchor bolts -

05423 09-27-2012 Bent 1 girder 11 - missing nut left side

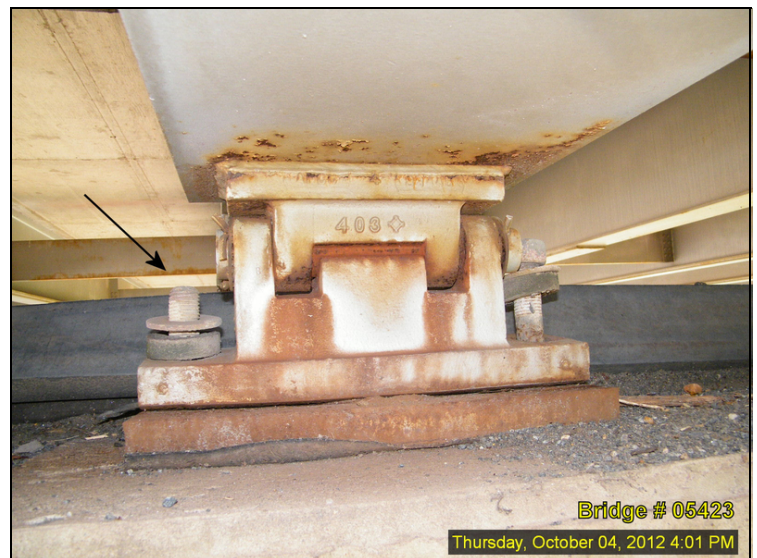
05423 09-27-2012 Bent 16 Girder 3 Bearing 3 - nut missing

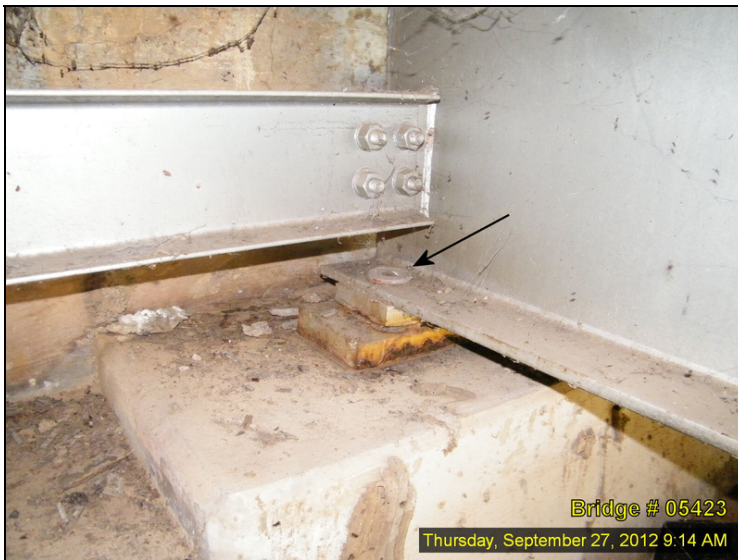
Anchor bolts broke off – no nuts -
Bent 32 Bearing 8 left & right.

05423 09-27-2012 Bent 32 - Girder 8 anchor bolts
missing

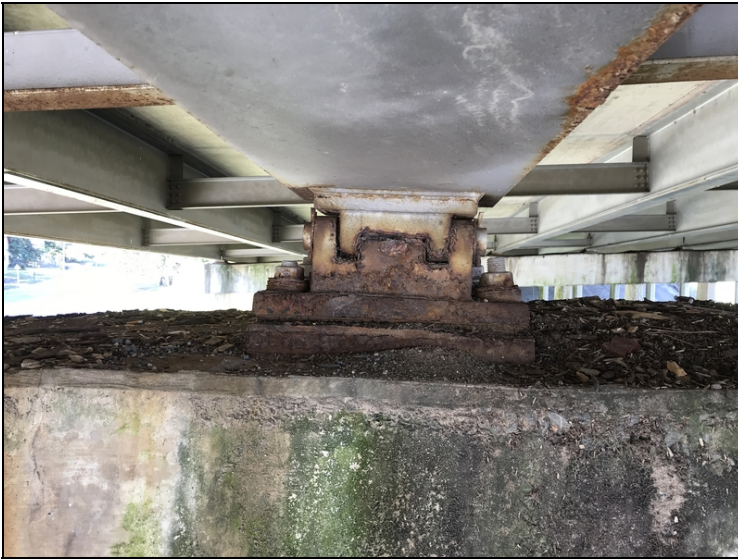
Girders & bearings – various locations: Some light surface rust on webs & flanges of girders and masonry plates of bearings, mainly at bents with open joints.

Bent 4 Bearing 8 ahead: Corrosion

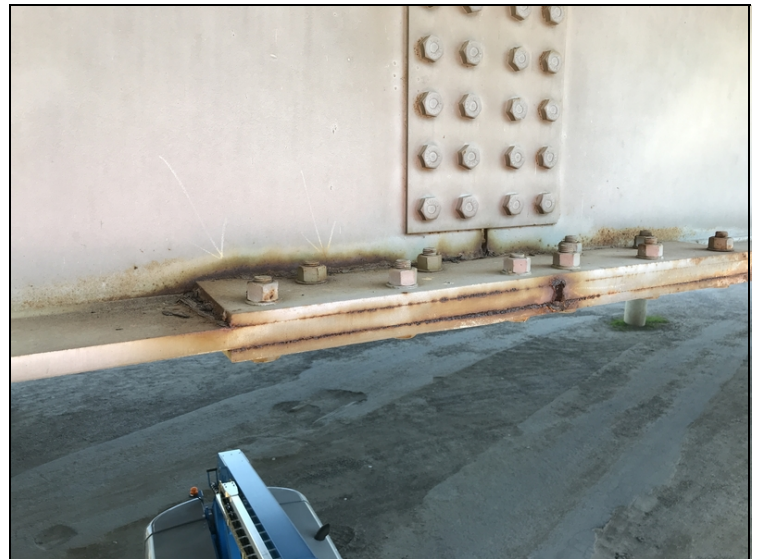
Span 5 Girder 10 right @ Splice: Corrosion

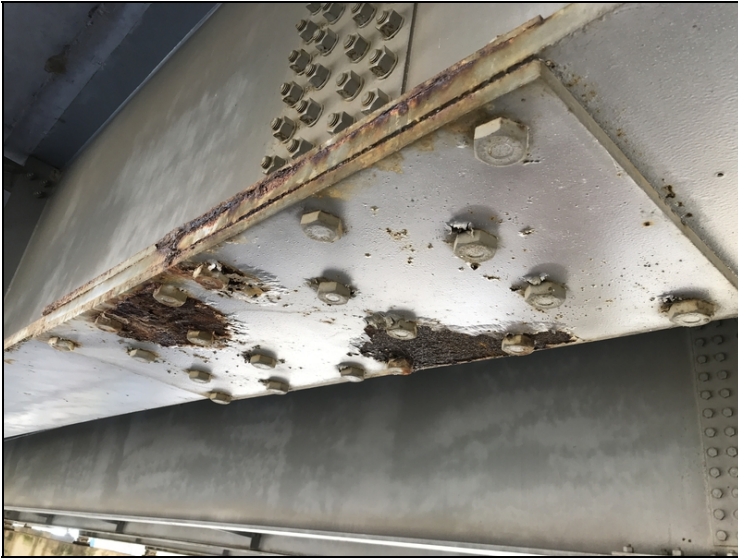
Span 5 Girder 5 @ splice: Corrosion

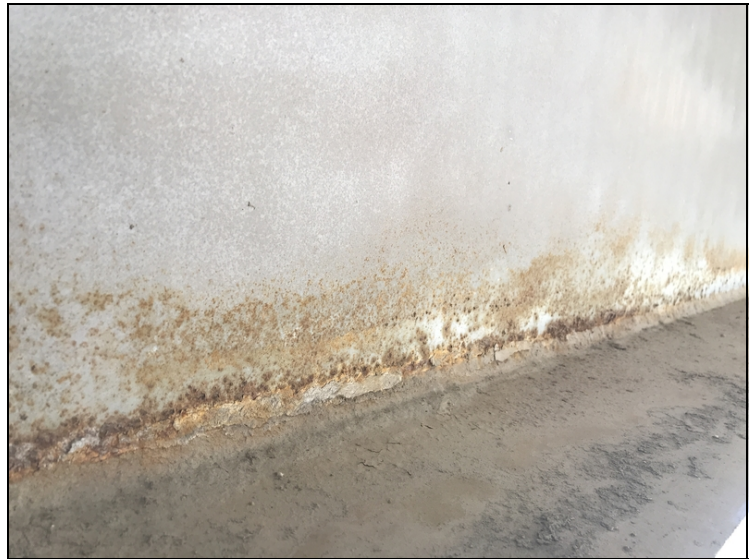
Span 5 Girder 10 left: Corrosion on bottom of web

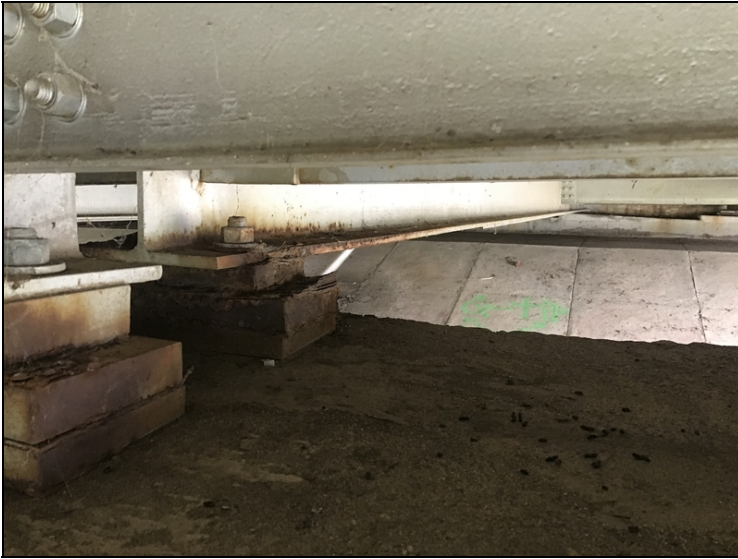
Span 31 Girder 7 right @ Bent 31: Corrosion

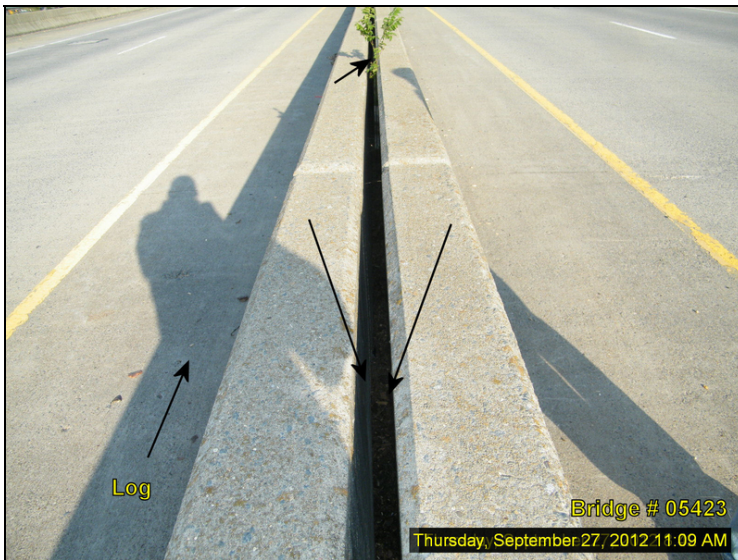
Bents 14, 15, 22, & 23 - center-line: Build-up of dirt and debris between center walls on top of integral cap. Small vine/bush growing up at Bent 15.

05423 09-27-2012 Bent 15 - center walls - debris
on top of Bent 15 Cap

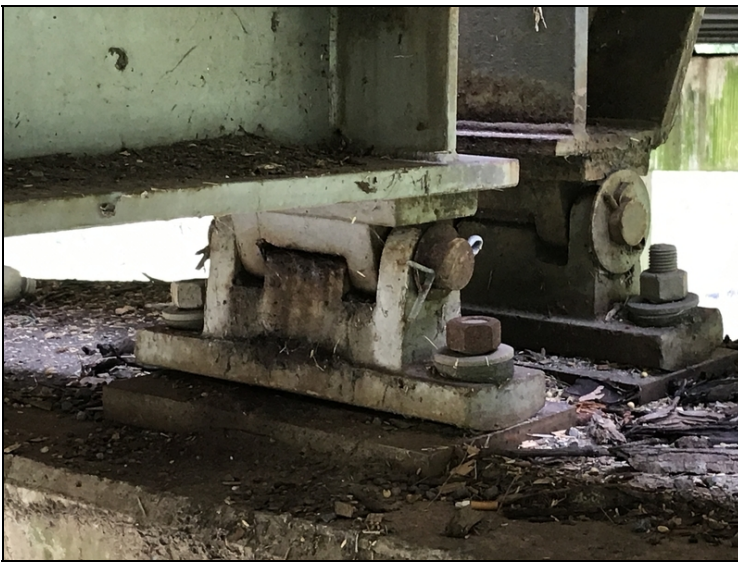
CORRECTED - Bent 24 Bearings 1, 8, & 10 back: Cotter pins missing and pin may be beginning to work out.

CORRECTED - Bent 24 Bearing 8 back: New
cotter pin

Repaired by State Forces.

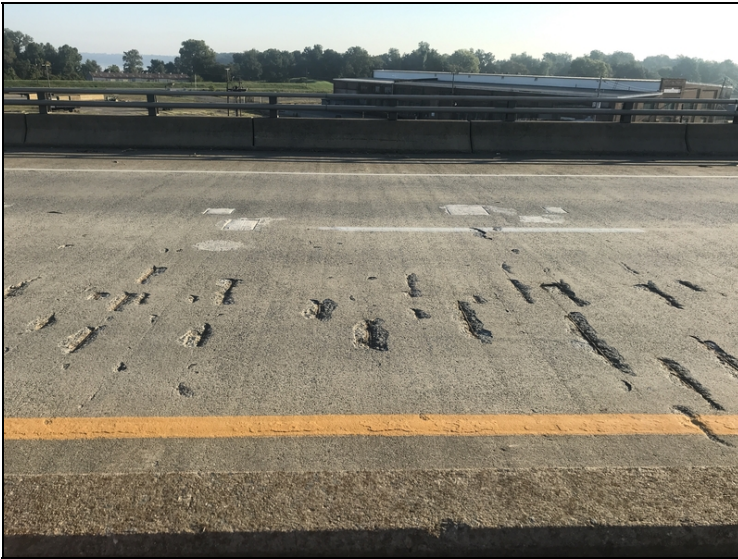
Deck – Span 14 left lane: Large area (18' wide x 30' long) of spalls with steel exposed.

Span 14 north bound lanes have many small spalls with exposed rebar.

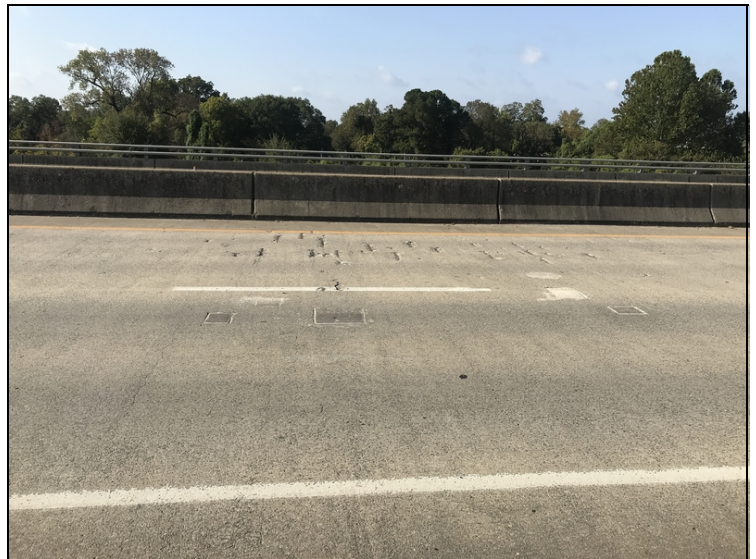
Deck - Span 14 left: Rebar exposed

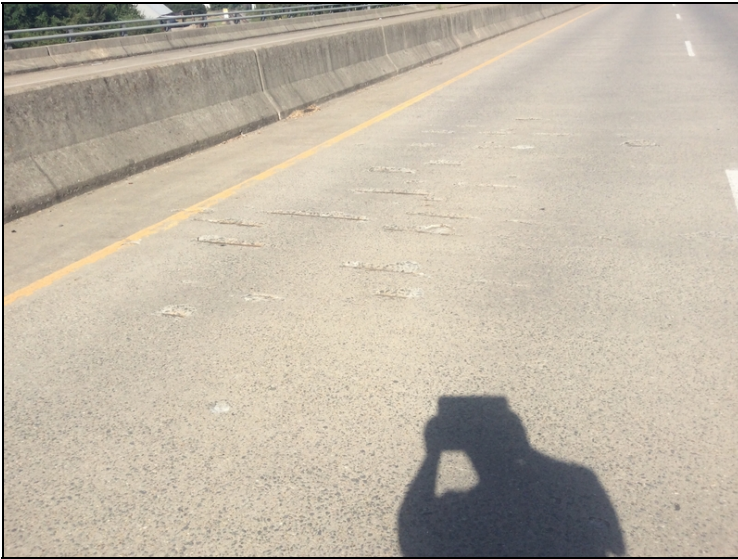
CORRECTED - Deck – Spans 17, 19, 22, 23, 25, 27, & 28 left lane & Spans 7, 9, 14, 15, & 19 right lane: Small spalls.
(some with steel exposed with minor section loss).

Span 14 north bound left lane spalls with exposed rebar.

Patched spalls with rapid set cement.

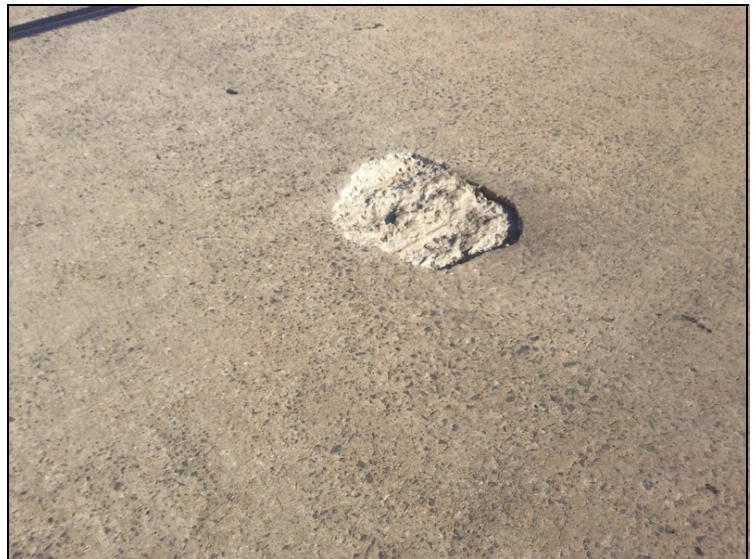
Span 9 spall with exposed rebar.

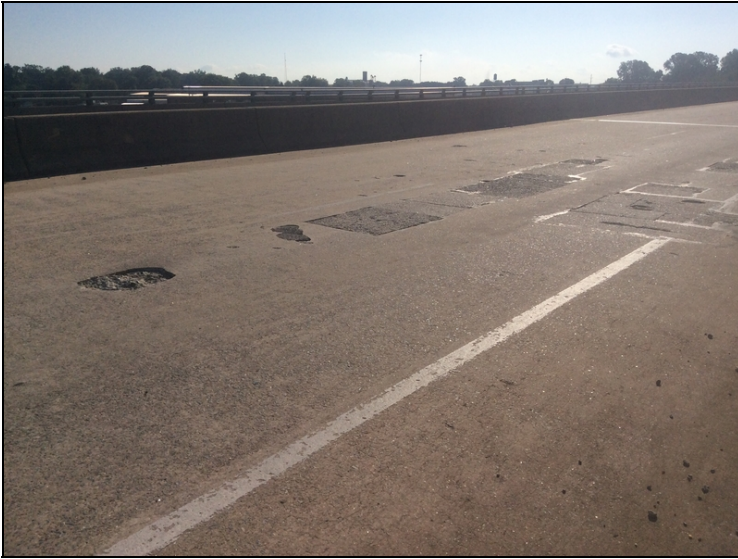
Span 9 deck has large spalls with some rebar exposed, asphalt patches and concrete patched areas. Approx 72'

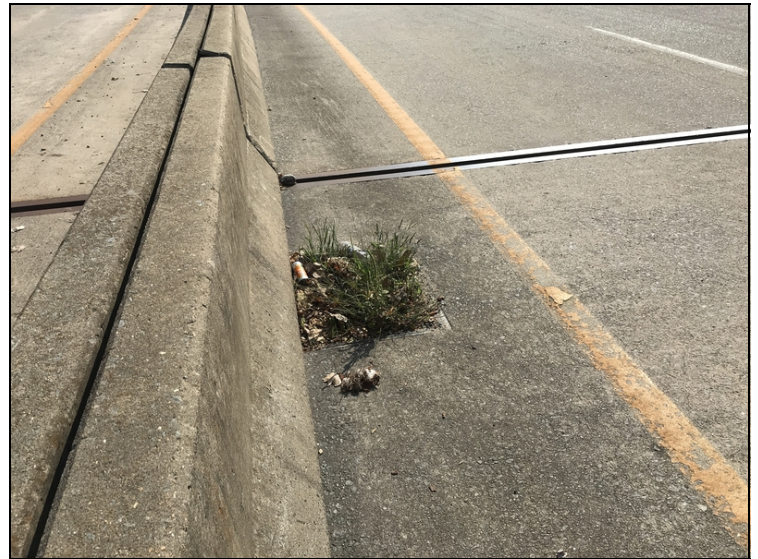
Drain - Span 24 right (inner gutterline): Stopped up
