Bridge #05423(Routine, Fracture Critical, Under Record Clearance)

US 65-14B LM 6.46 over Nebraska St, SLSW/UNPAC

Team Lead: Greg Loomis **Inspection Date:** October 06, 2020

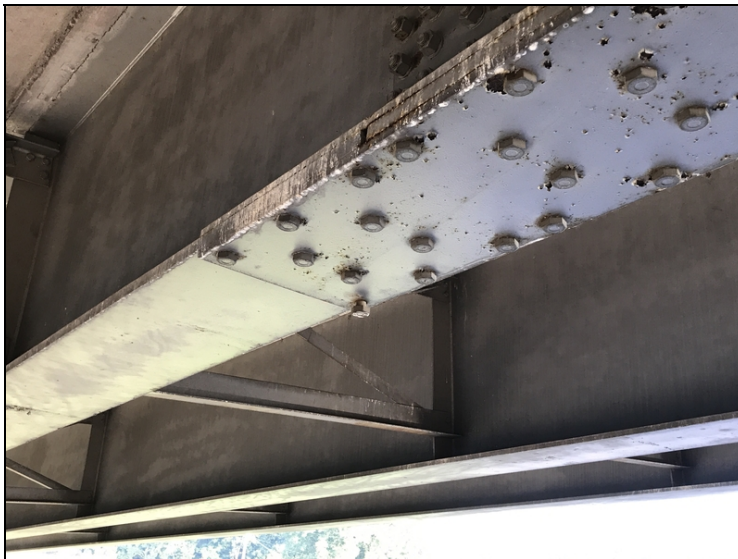
Span 4 girder 3 first splice plate near midspan has loose bolt.

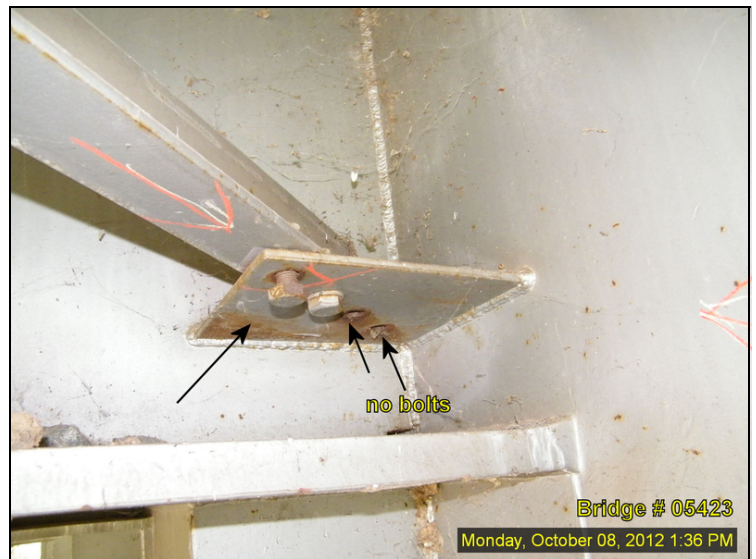
05423 09-27-2012 Bent 22 Cap - loose bolt at connection plate

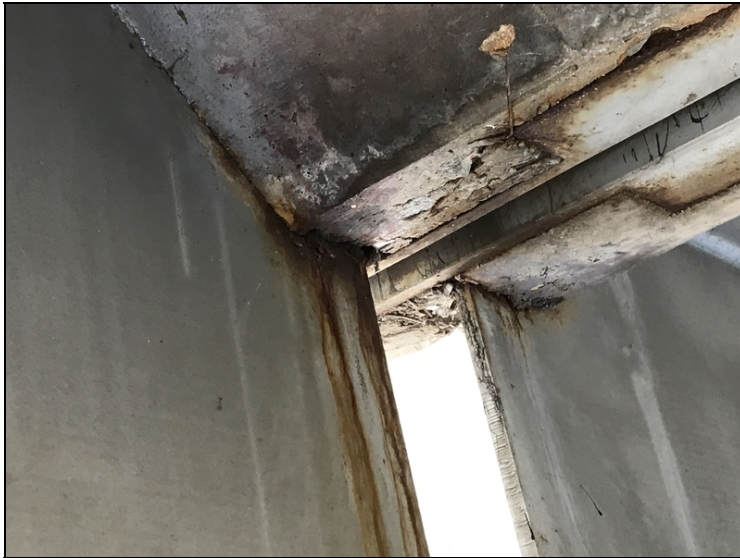
Some rust on side of web @ haunch with 20-30% section loss -
Span 3 Girder 3 right @ Bent 3, Span 9 Girder 6 right @ Bent 10, Span 11 Girders 3 & 8 right @ Bent 11, Span 16 Girder 8 left @ Bent 17, & Span 26 Girder 7 right @ Bent 26 and various other locations.

Typical haunch area with rust forming. Common throughout bridge.

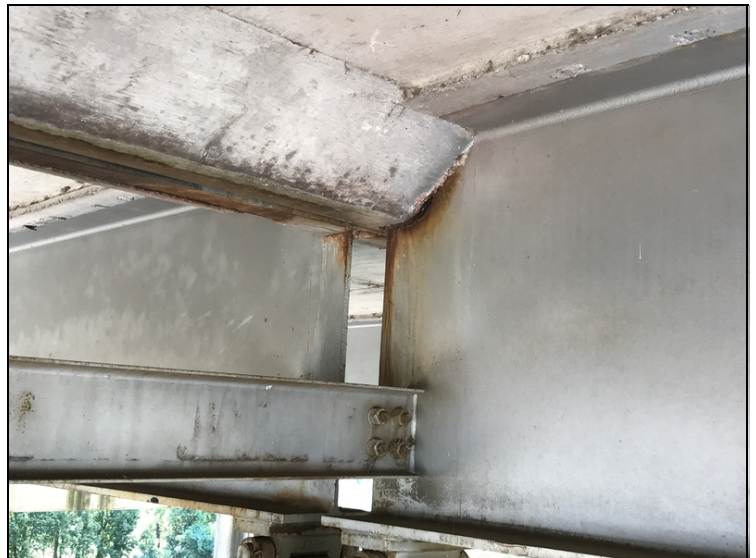
Span 16 Girder 2 left @ Bent 17: Corrosion @ haunch

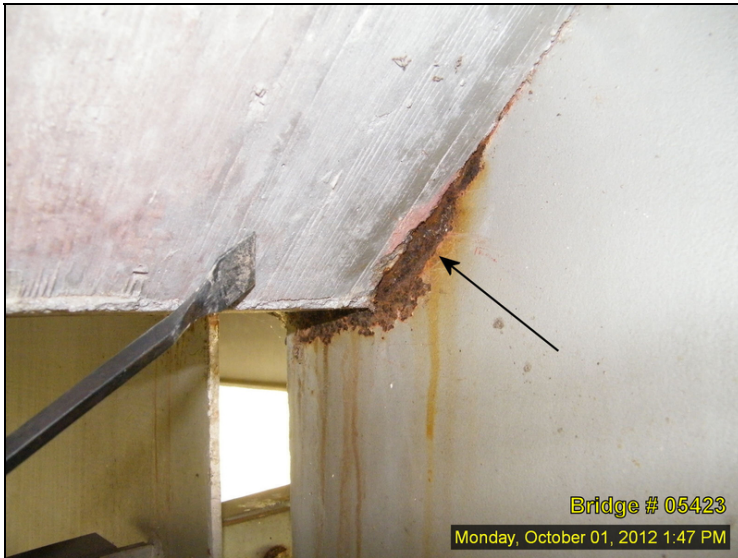
05423 09-27-2012 Bent 3 Girder 3 right side -
some sec loss at the haunch area 10-15%

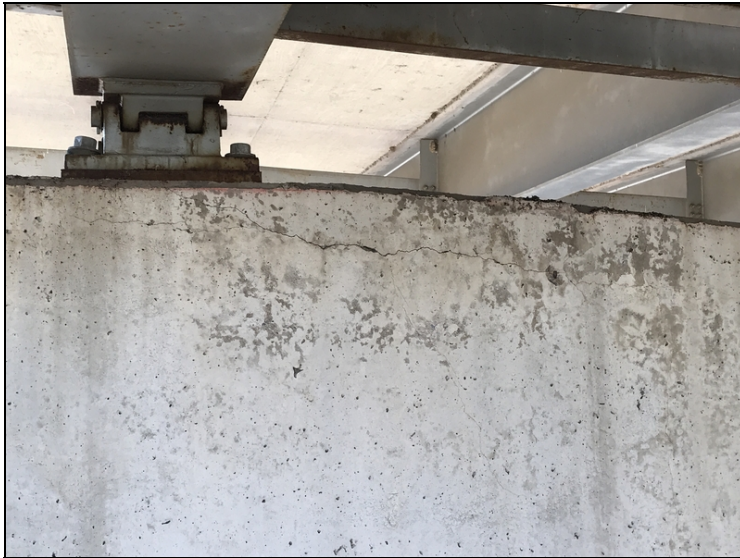
Bent 6 cap back has horizontal Crack under bearing 2. common bent 6 ahead at bearing 5,8 & 9.

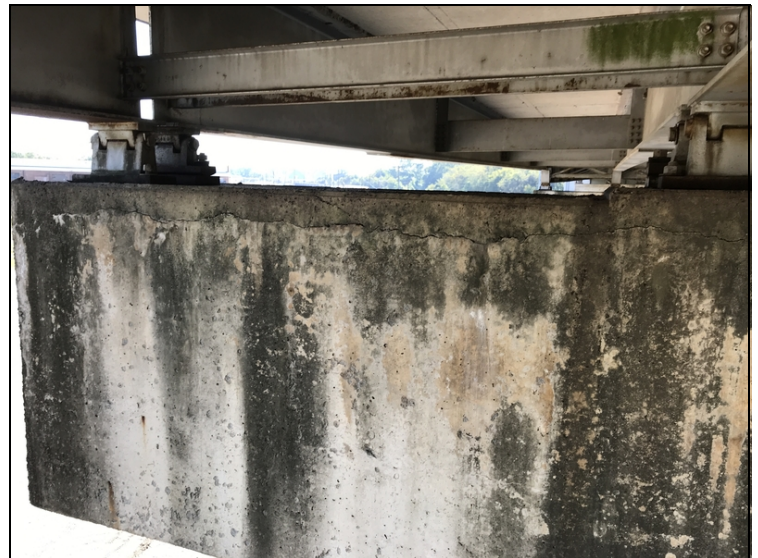
Bent 11 cap left side has large cracks from girder 1 -3.

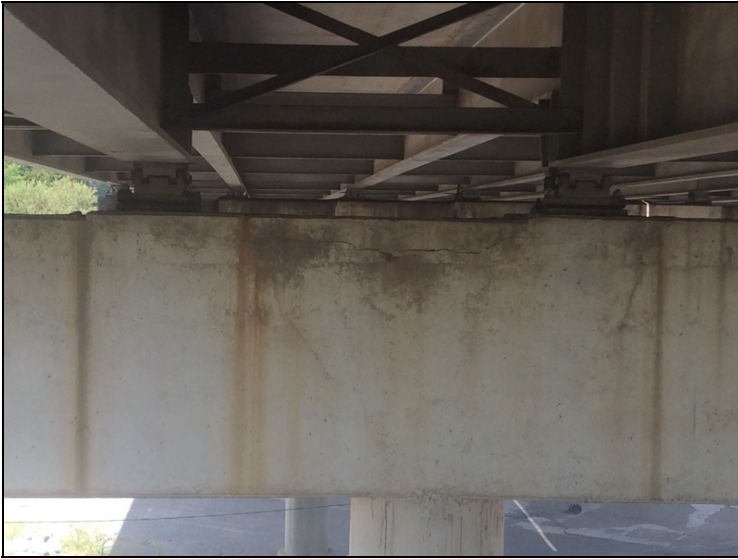
Bent 12 cap ahead Delams. under beam 2 and
beams 8,9 , ends of cap

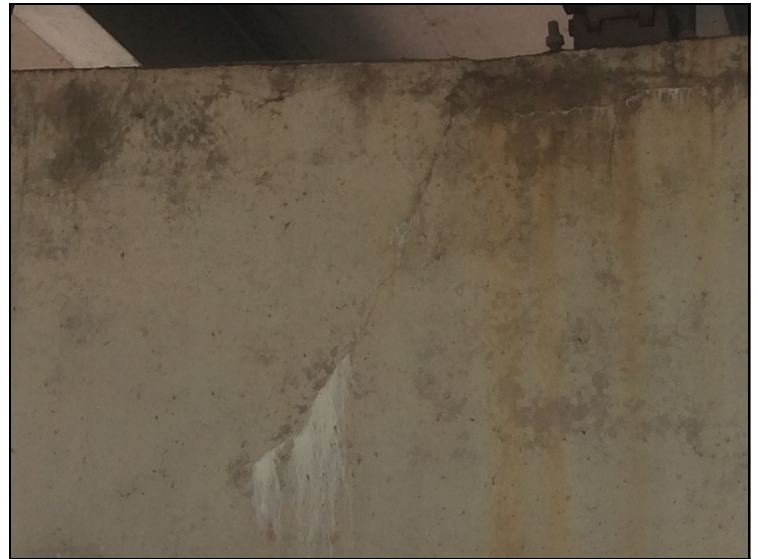
Bent 21 ahead ,
under beam 2 crack with efflorescence about 3 ft
long

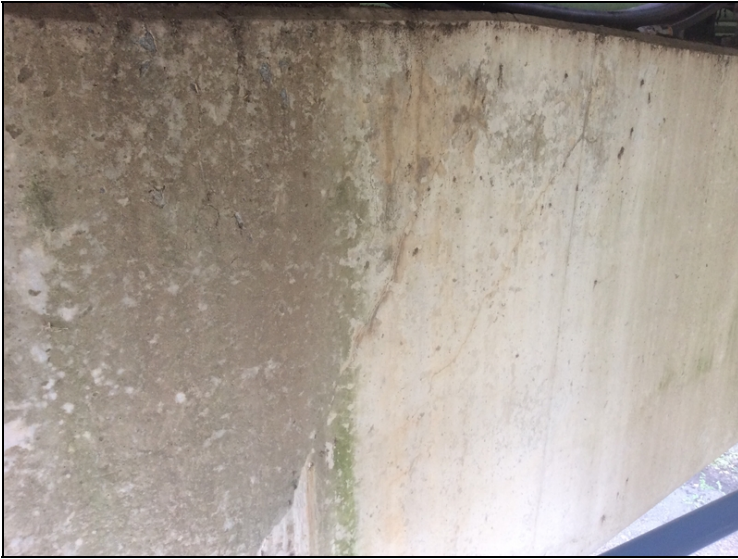
Bent 24 ahead has cracks with some light efflorescence. Common bent 25 back.

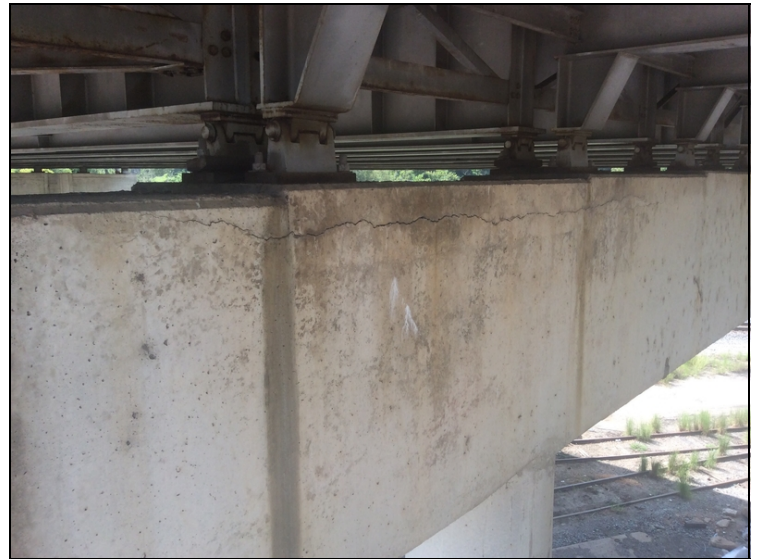
Bent 12 back crack in cap under beams 2-3

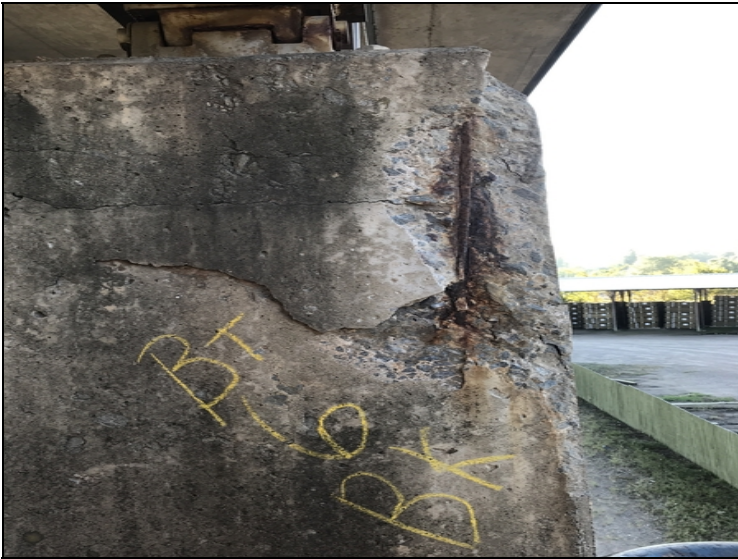
Bent 6 cap back has spalls with exposed rebar.

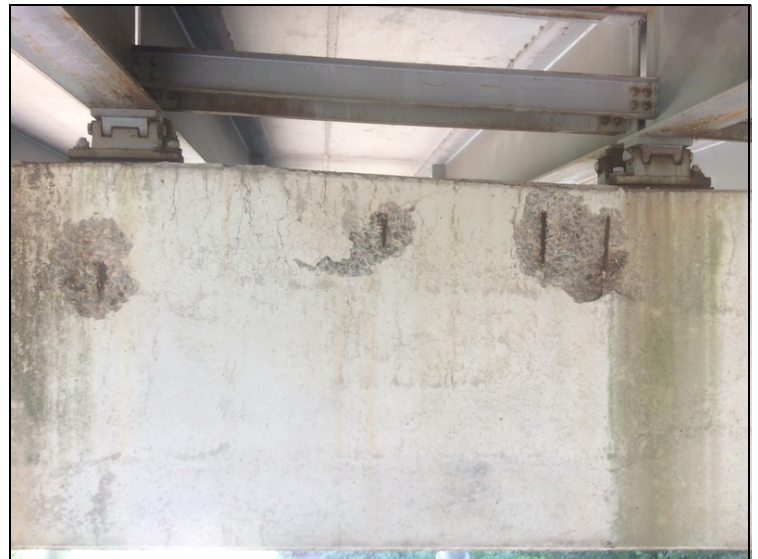
Bent 20 ahead about 5 ft of exposed rebar on cap

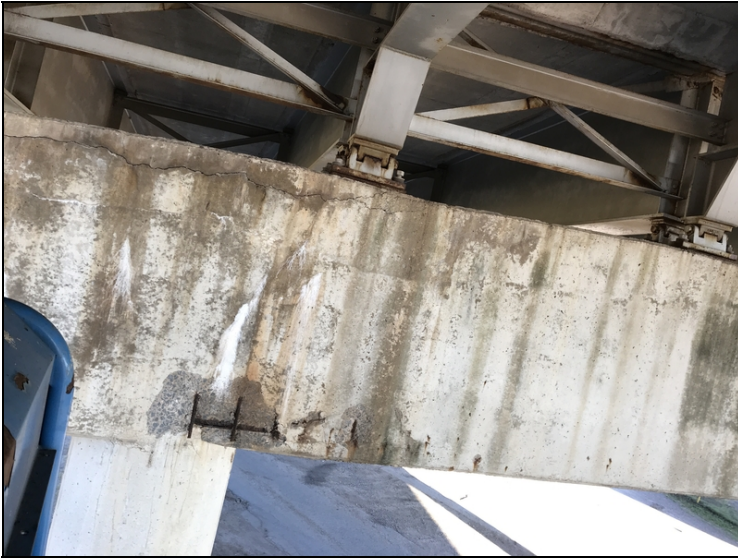
Bent 6 ahead has spalls with exposed rebar, cracking and cracking with efflorescence.

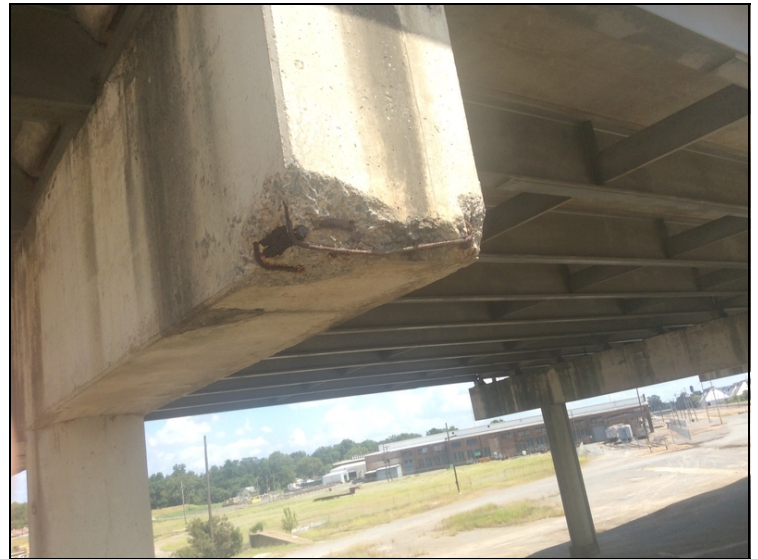
Large spall with exposed rebar on right side of cap 9 . Common on bents 4,5&6 all on the right sides .

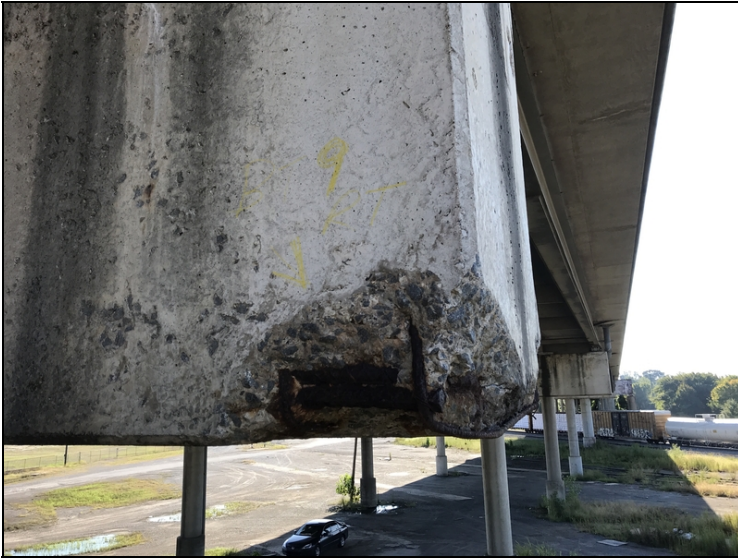
Bent 9 cap right side has spall with exposed rebar.

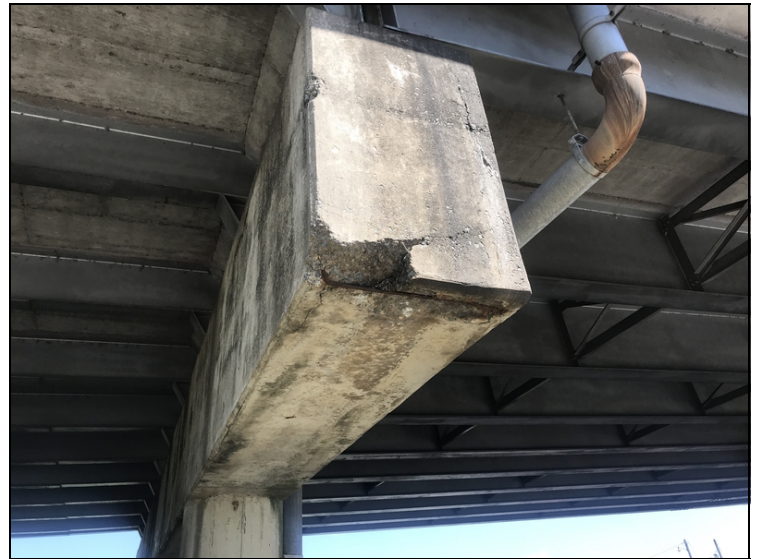
Bent 4 cap right side has spall with exposed rebar.

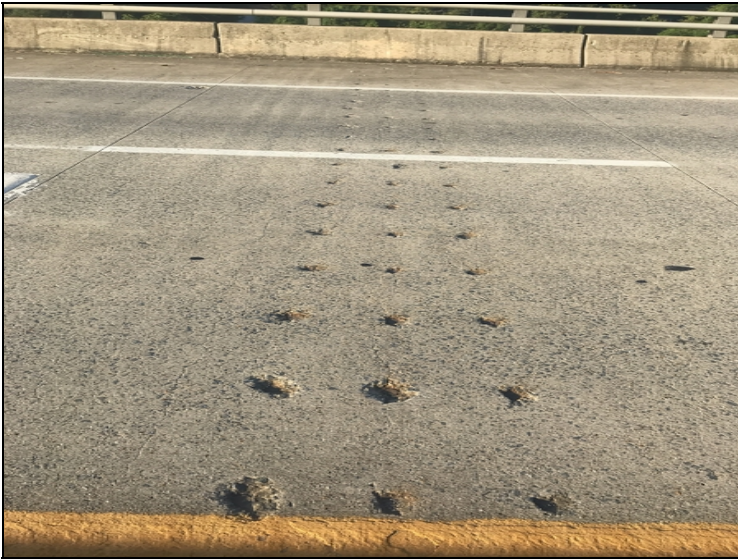
Deck – Bents 14, 15, & 22: Small spalls over tops of shear connectors to cap with some transverse cracking along edges of integral cap..

Deck bent 14 south bound small spalls at shear connectors of cap. Common bent 14 north bound.

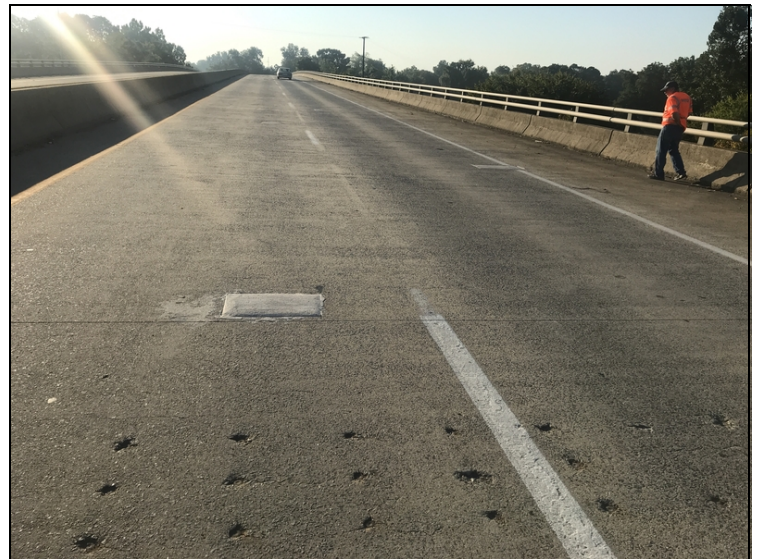
Deck overview spans 14-15. Common bent 15 south bound, bent 22 north bound.

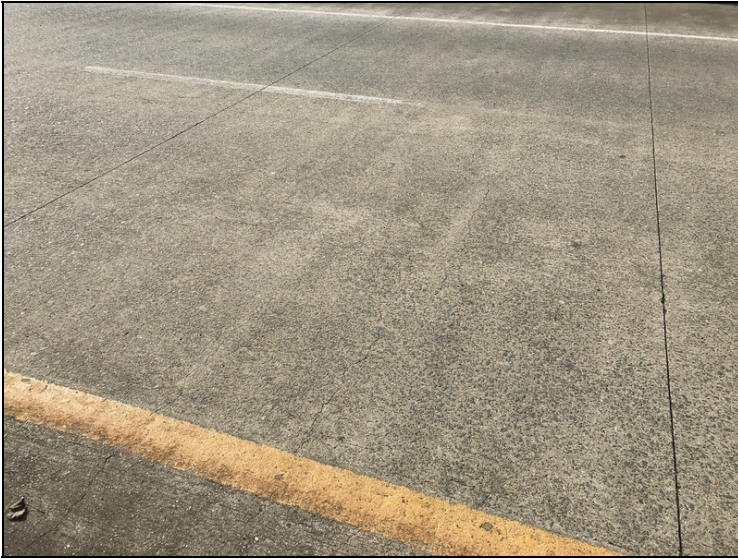
Deck @ Bent 23 right: Cracking along integral cap

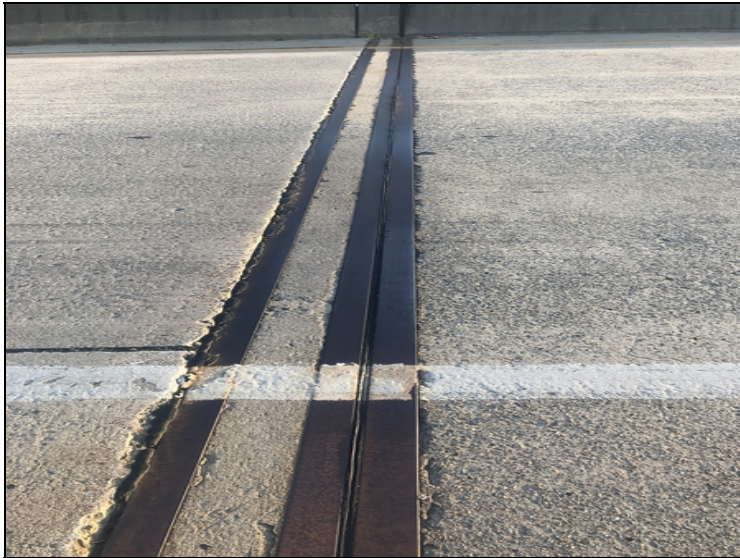
Joint material has completely fallen out or is loose and sagging in numerous locations..

NOTE: Missing joint material is allow dirt and other debris to build up on caps, bearings, and ends of girders in these locations, retaining moisture and contributing to damage and decay.

Bent 1 south bound joint seals are cracked torn and leaking. Typical bent 2,3,6,8,9,10,12,18,20,21,25,26,27,28,29,30,31 & 32 south bound. North bound lanes 1,2,3,7,8,9,11,12,19,20,21, 25,26,27,28,29,30,31 & 32.,

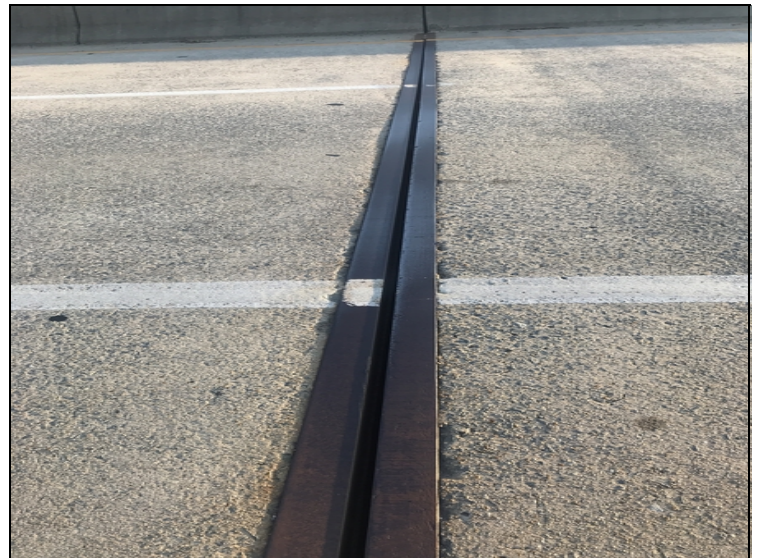
Bent 4 joint seal missing south bound lanes. Common at bent 11,16,17,19 & 24 south bound. North bound lanes 4,16,18 & 24.

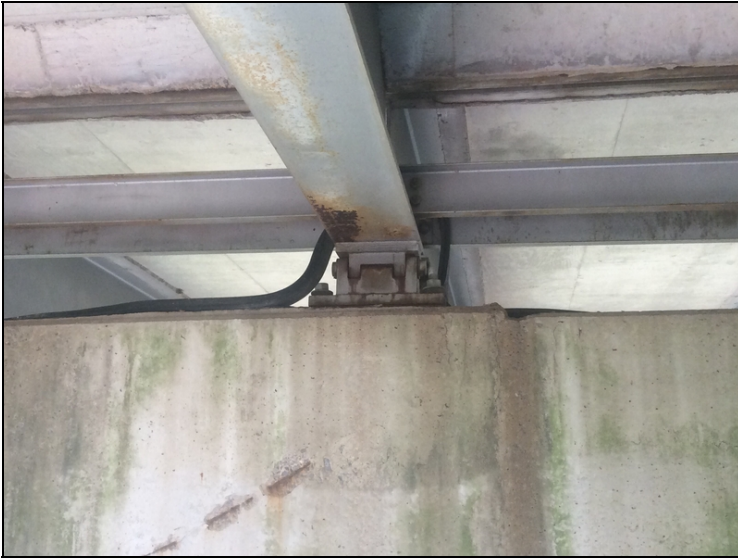
Bent 19 has some of the joint material missing, laying on cap from center line right. Common bent 18 left of center line.

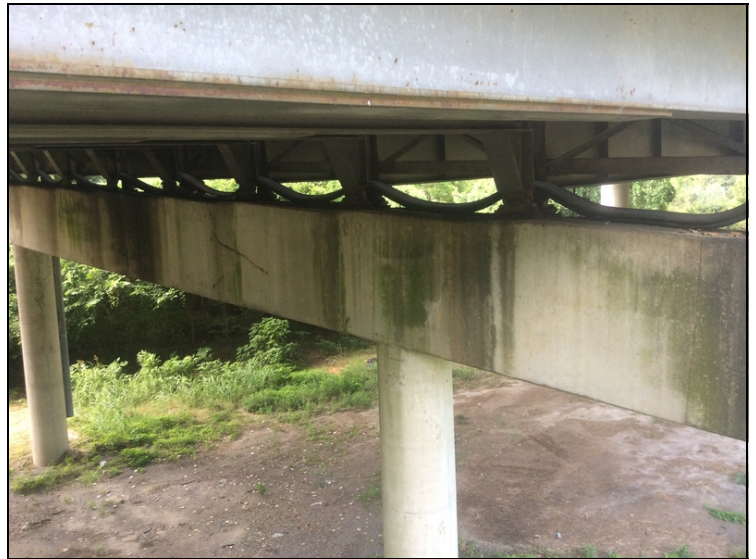
Bent 24 joint seal has fallen completely out and is laying on cap/ bearings.

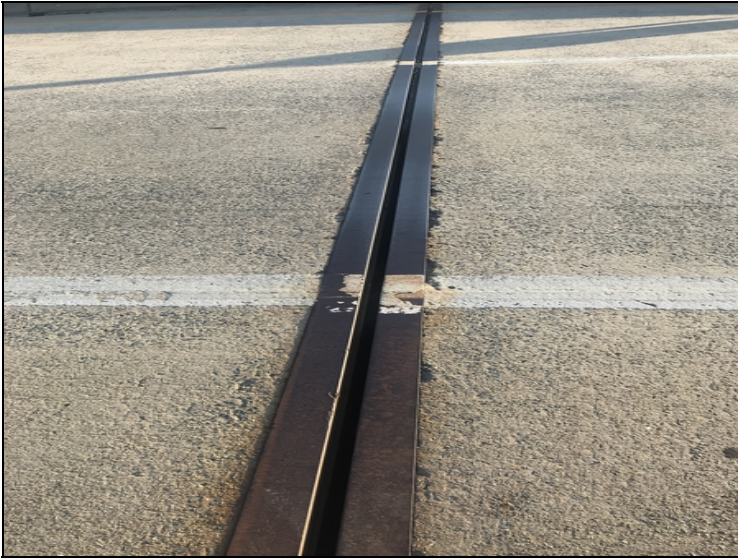
Bent 7 south bound lanes have some joint seal missing and some torn and cracking. Common north bound bent 6, 10,17.

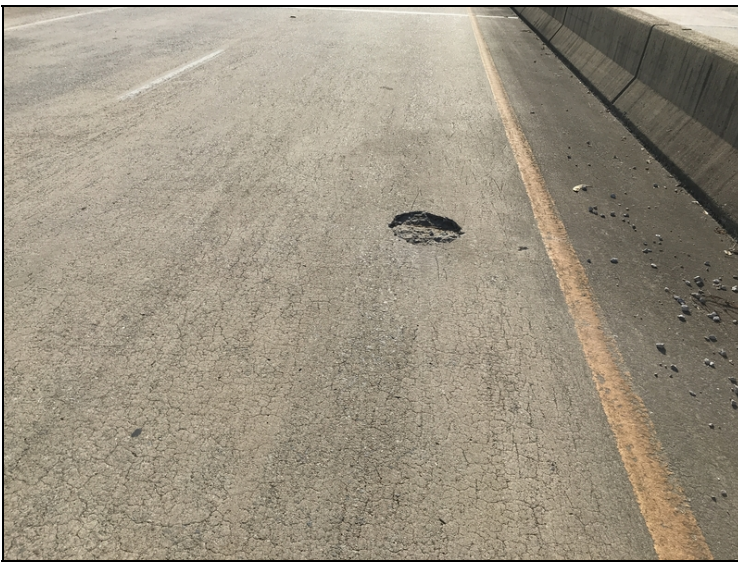
Deck - various locations: A few scattered small spalls (some with rebar exposed), especially Spans 7 & 9 right.

Deck - Span 6 left: Spall

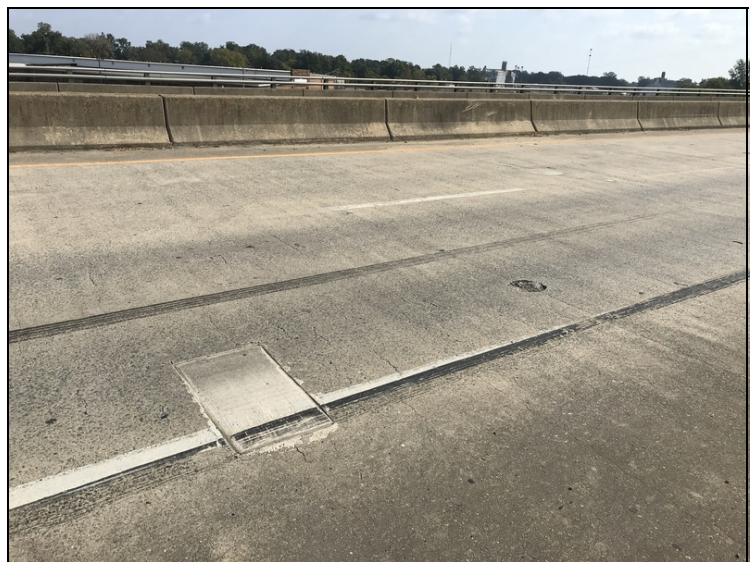
Deck - Span 14 right: Cracking/patch/rebar exposed

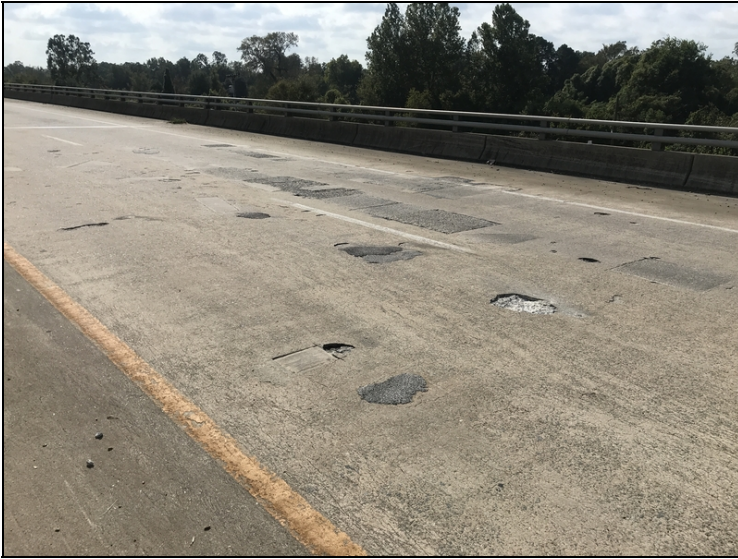
Deck - Span 9 right: Spalling/patches/rebar exposed

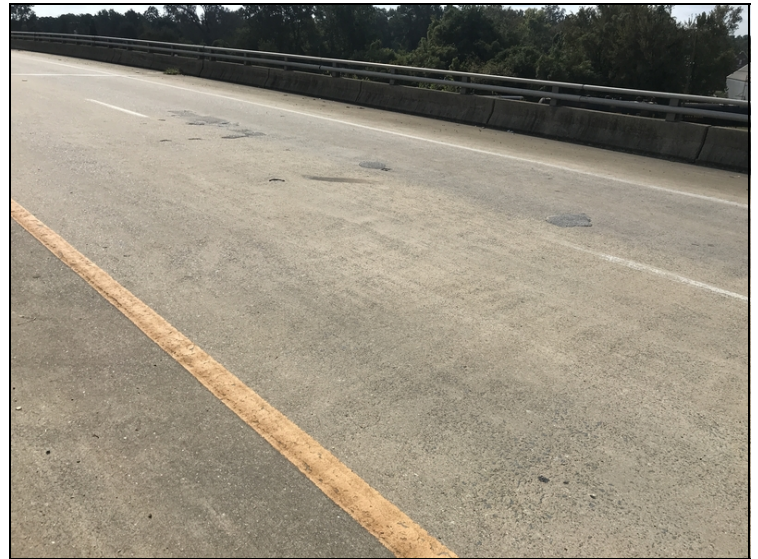
Deck - Span 7 right: Spalling/patches

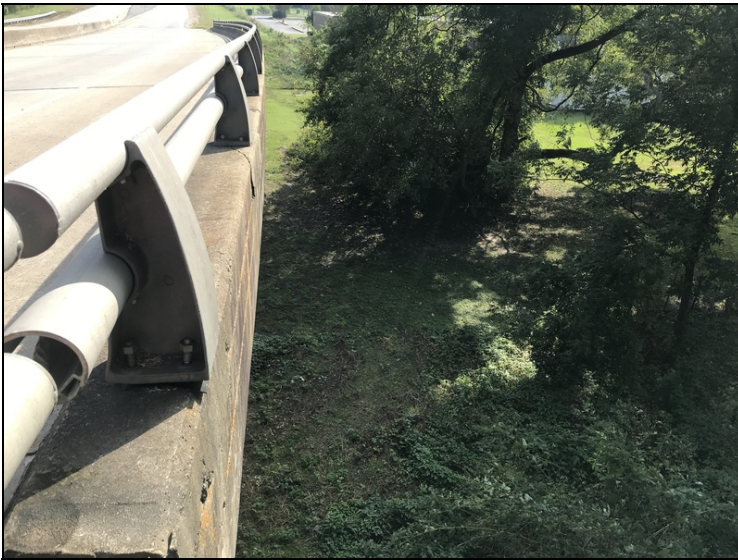
Railing - Spans 26 right: Minor impact damage to railing and posts (bolts with loose nuts/cracked concrete).

Railing - Span 26 right: Damage

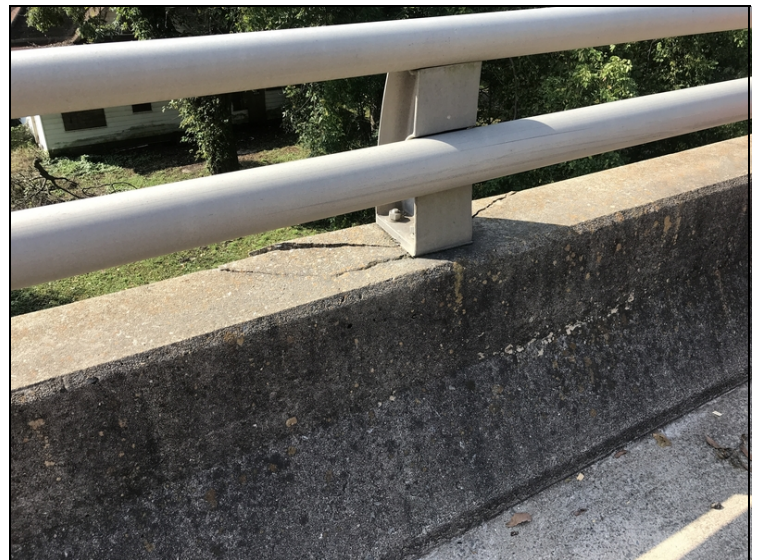
Railing - Span 26 right: Damage

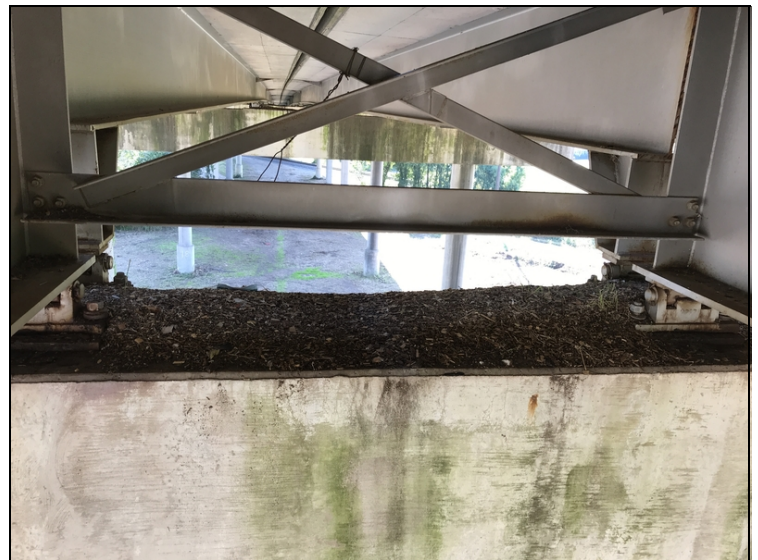
Cap - Bent 16 @ centerline: Debris build-up

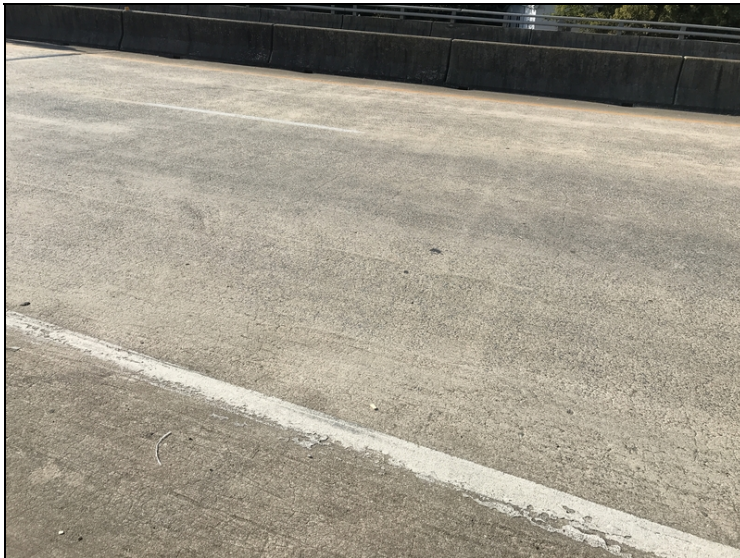
Unsealed, minor map-cracking & scattered minor- to moderate-sized transverse cracks with some reflective efflorescence on soffit, especially in outside lanes.

Deck - Span 2 left: Cracking

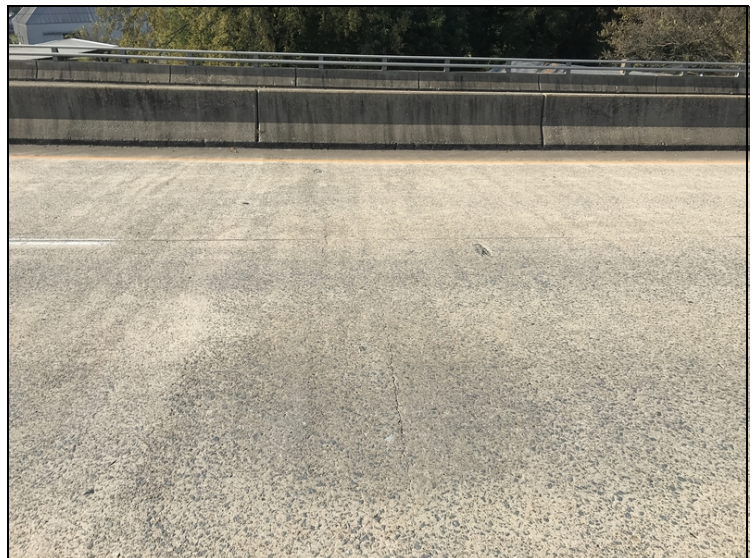
Deck - Span 5 left: Cracking/spalling

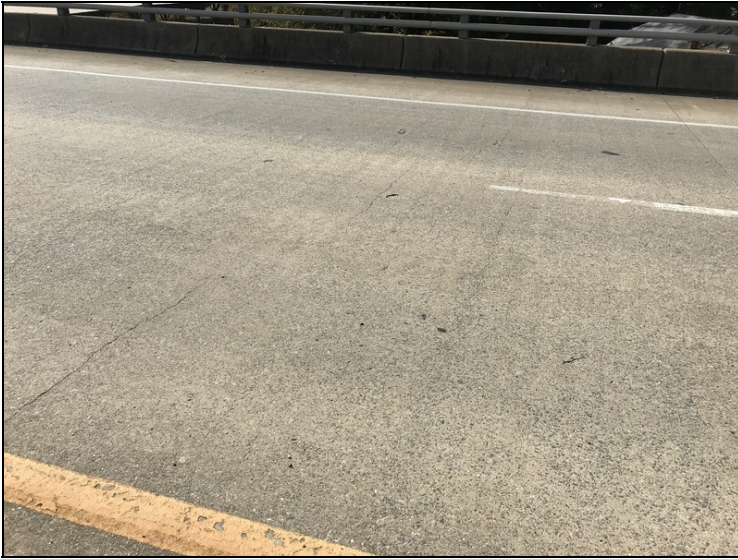
Deck - Span 5 right: Cracking
