Bridge #05429(Routine)

US 65-14B LM 5.94 over Imbeau Bayou Outlet

Team Lead: Sharon Hooks Inspection Date: September 21, 2020

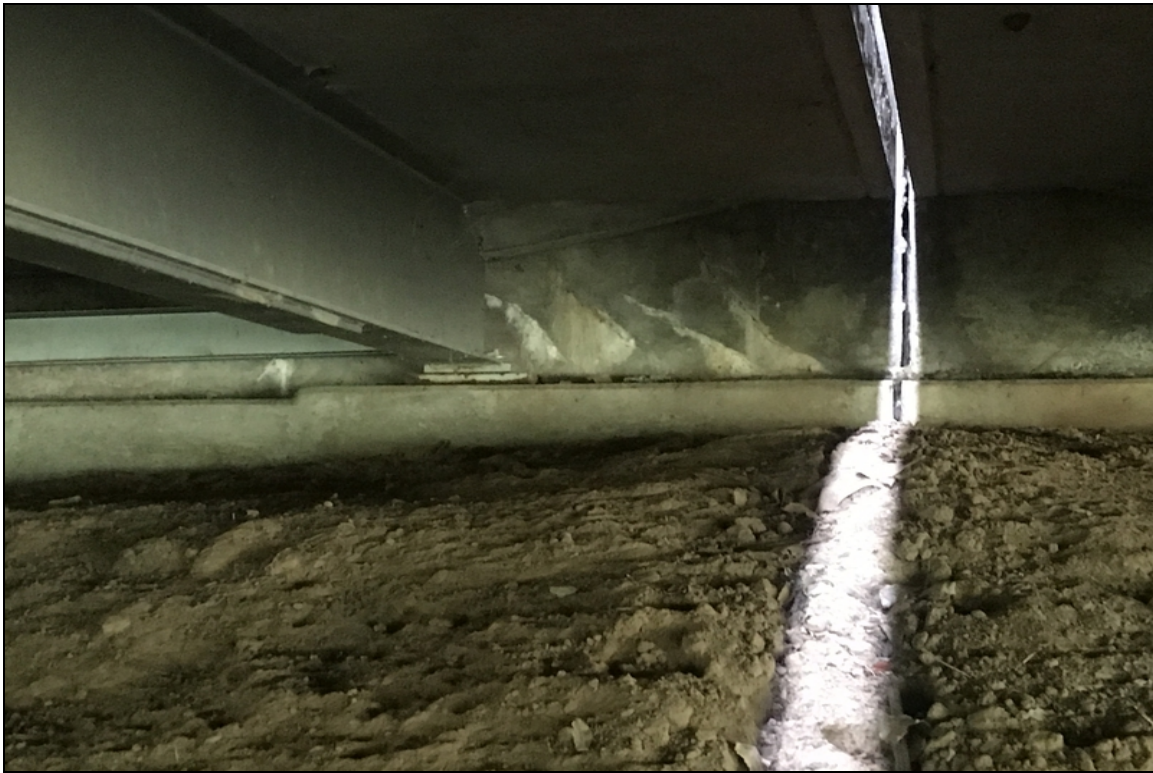
Bent 30 back wall has cracking with efflorescence.

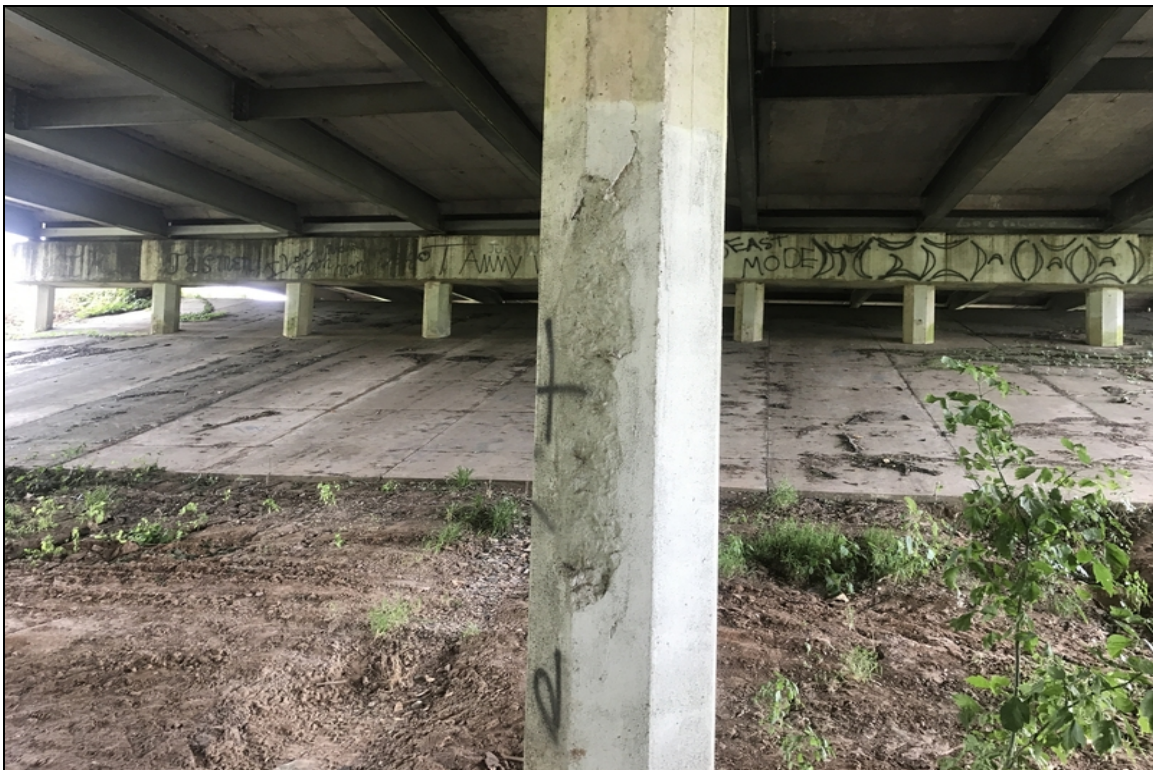
Bent 24 pile 5 has been repaired in past.

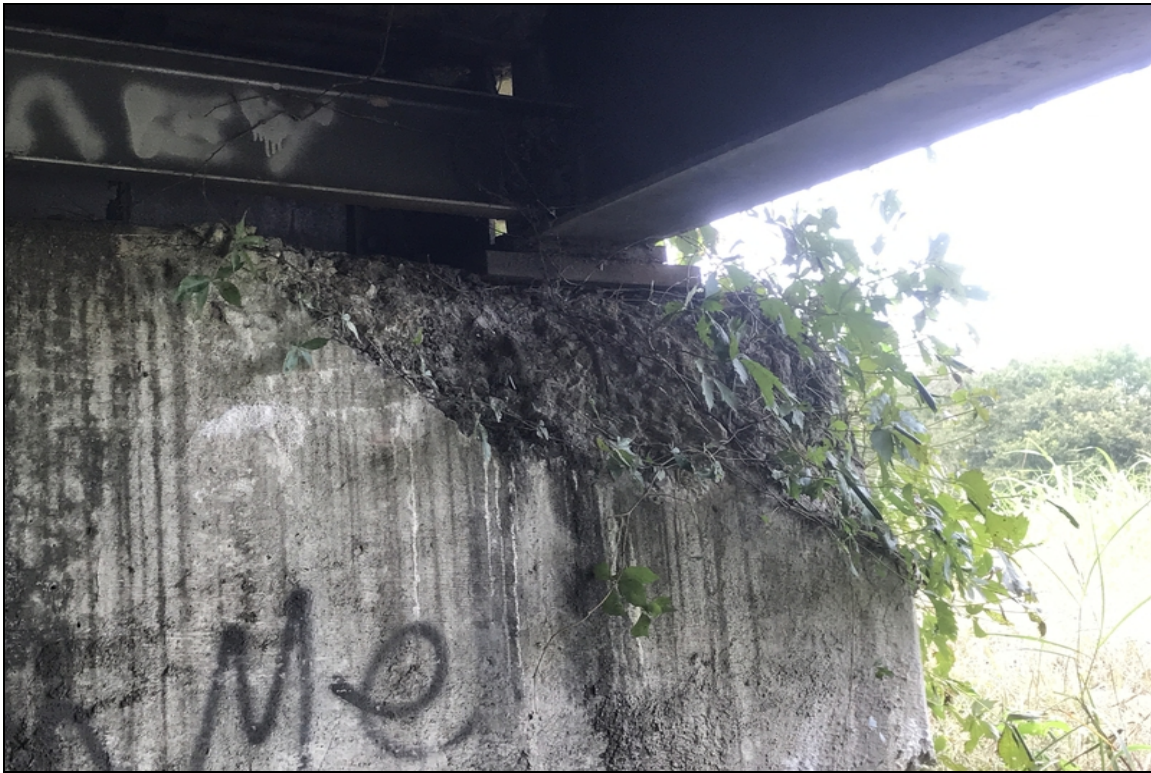
Bent 23 ahead face left end has large spall with exposed rebar encroaching on bearing area.

Cap – Bent 23: Spalling with rebar exposed (some section loss) along the top ahead corner and left end of the cap - approximately 1/3 loss of bearing area under Bearing 1 ahead.

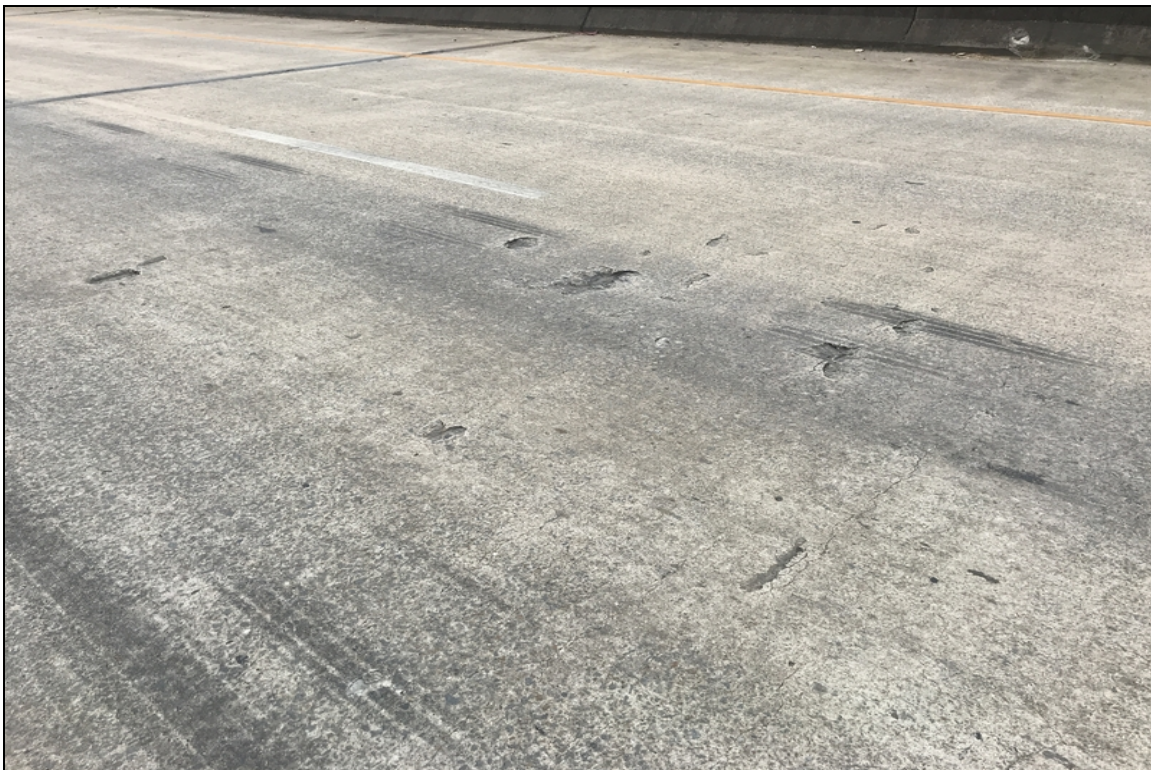
Span 4 north bound has small spall in deck.

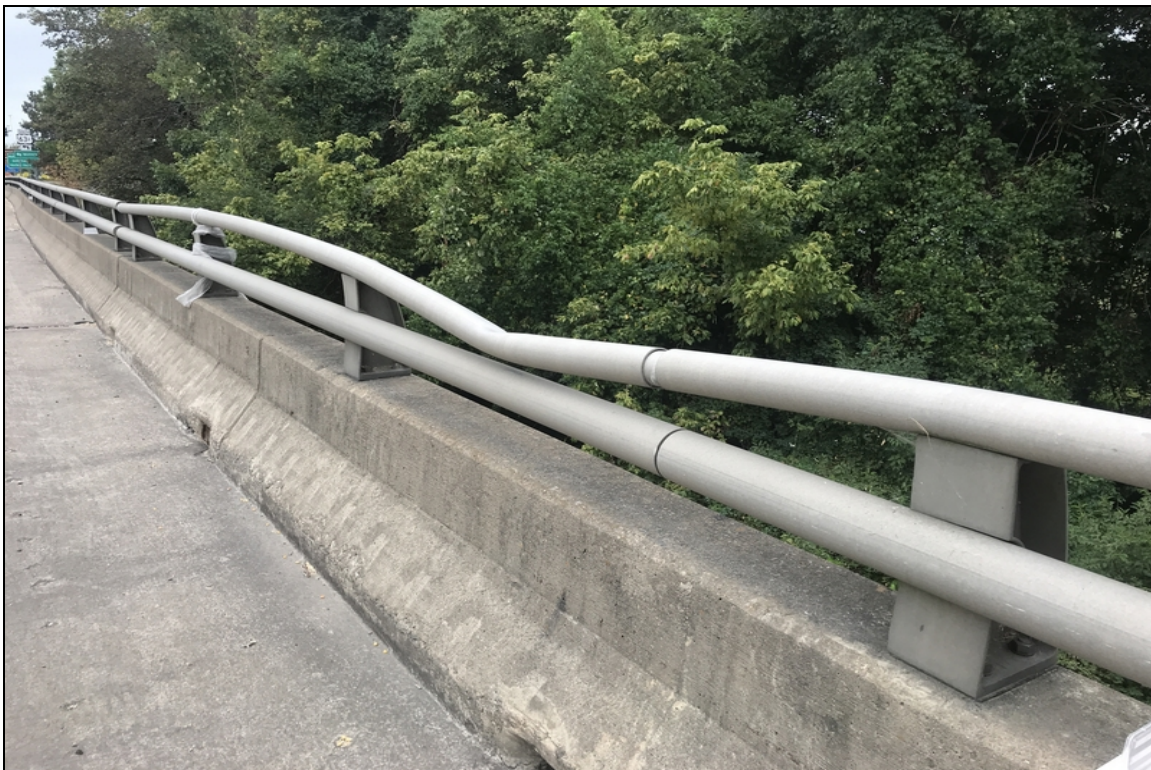
Span 5 north bound metal bridge rail damage.

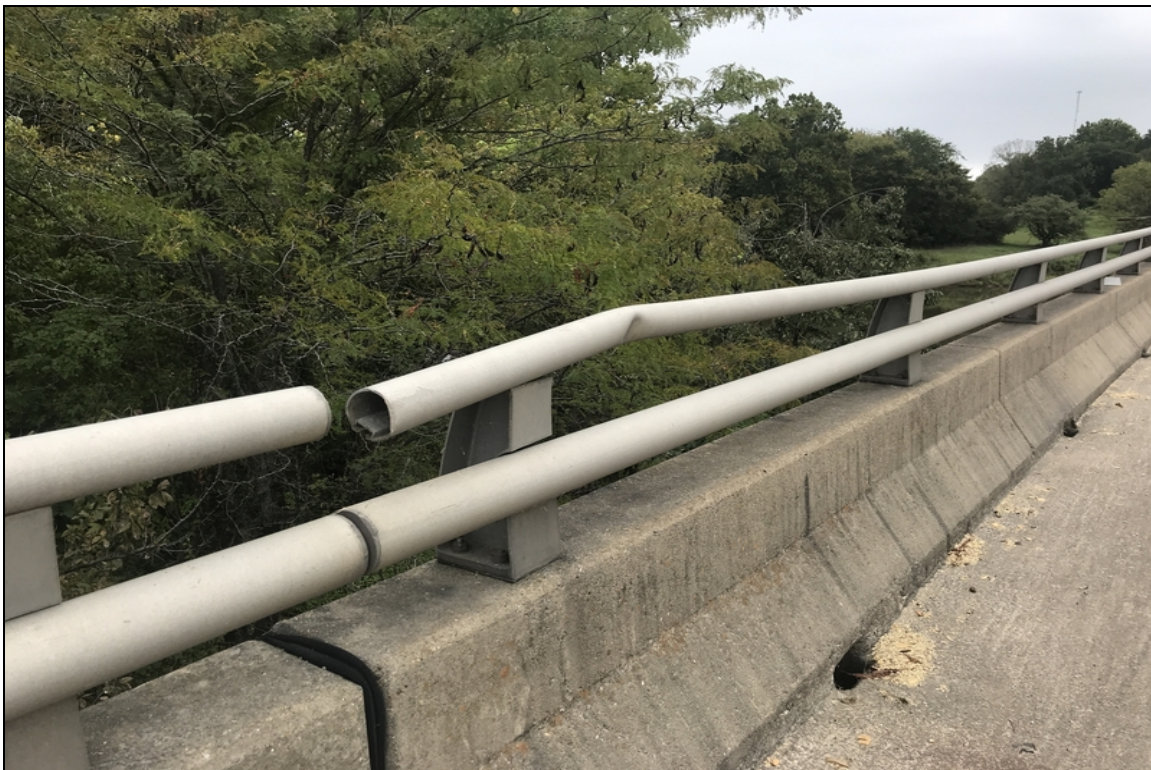
Span 13 metal rail damage north bound.

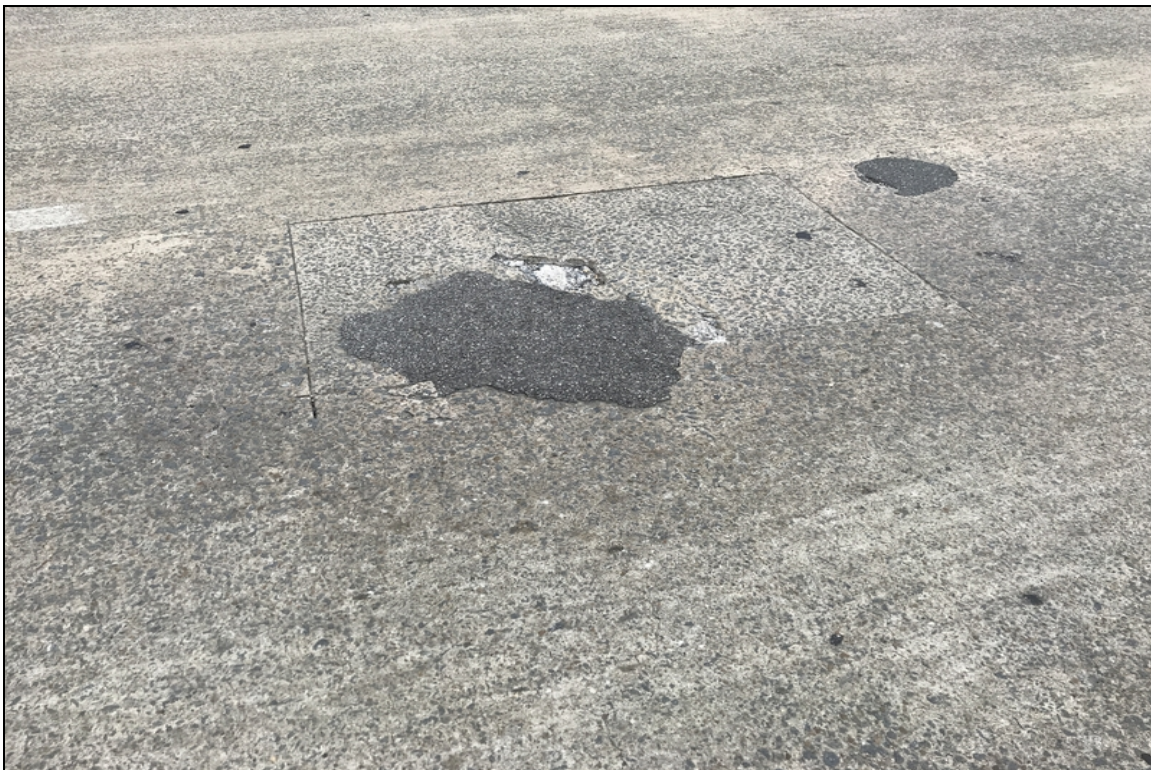
Deck span 25 north bound has spalling.

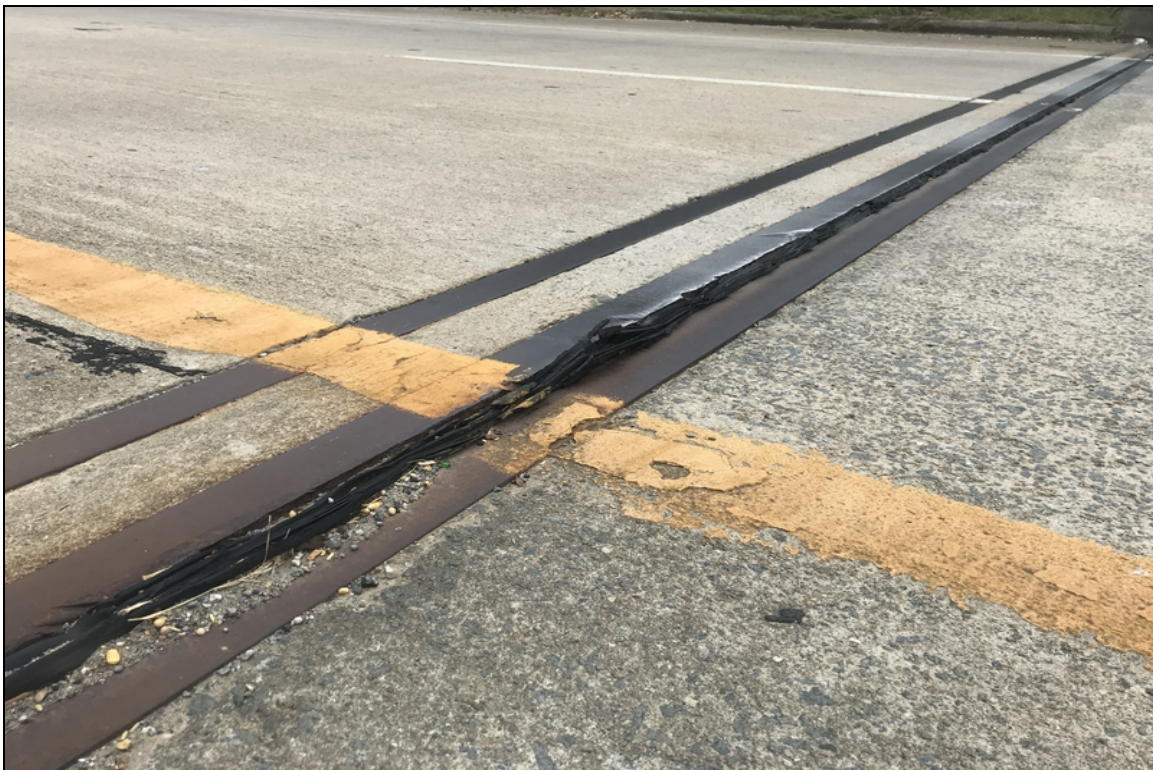
Back wall bent 30 south bound is higher than bridge deck

Joint/abutment - Bent 30: Backwall is 1/2-1" higher than adjacent deck, resulting in a slight bump going onto or off of bridge
- largest height difference is in two interior lanes.

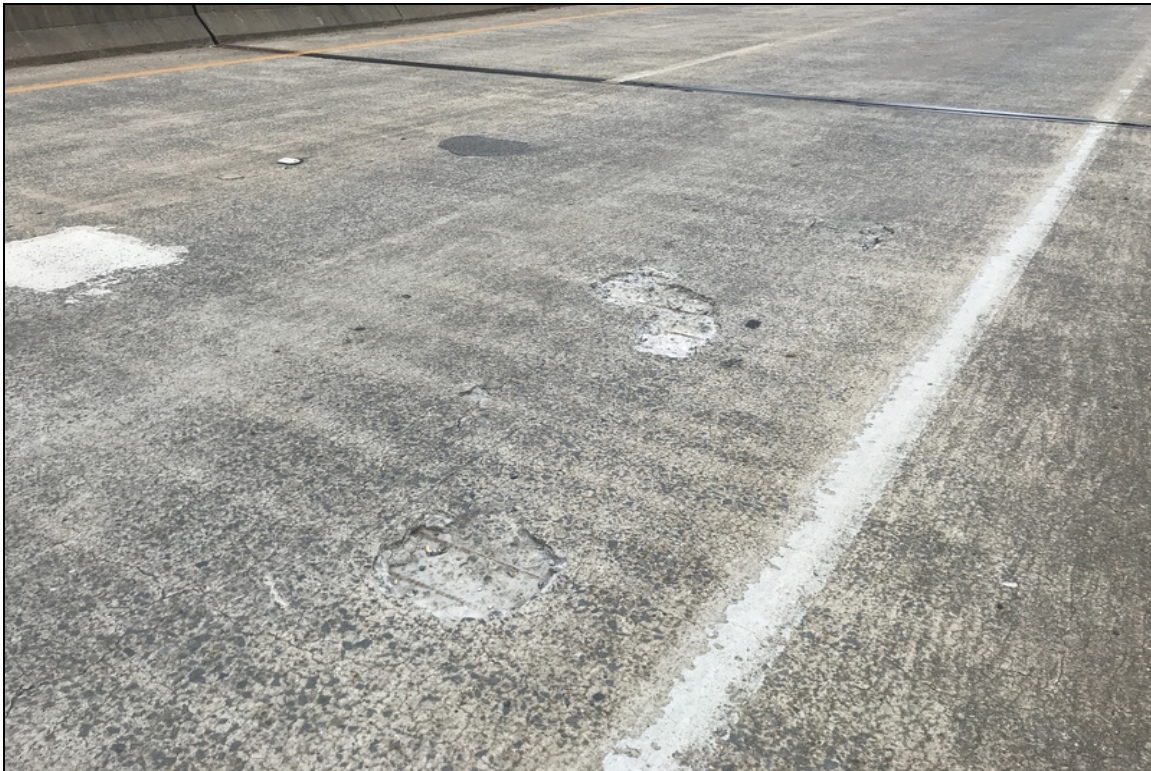
Deck span 27 right lane south bound has spalls with exposed rebar.

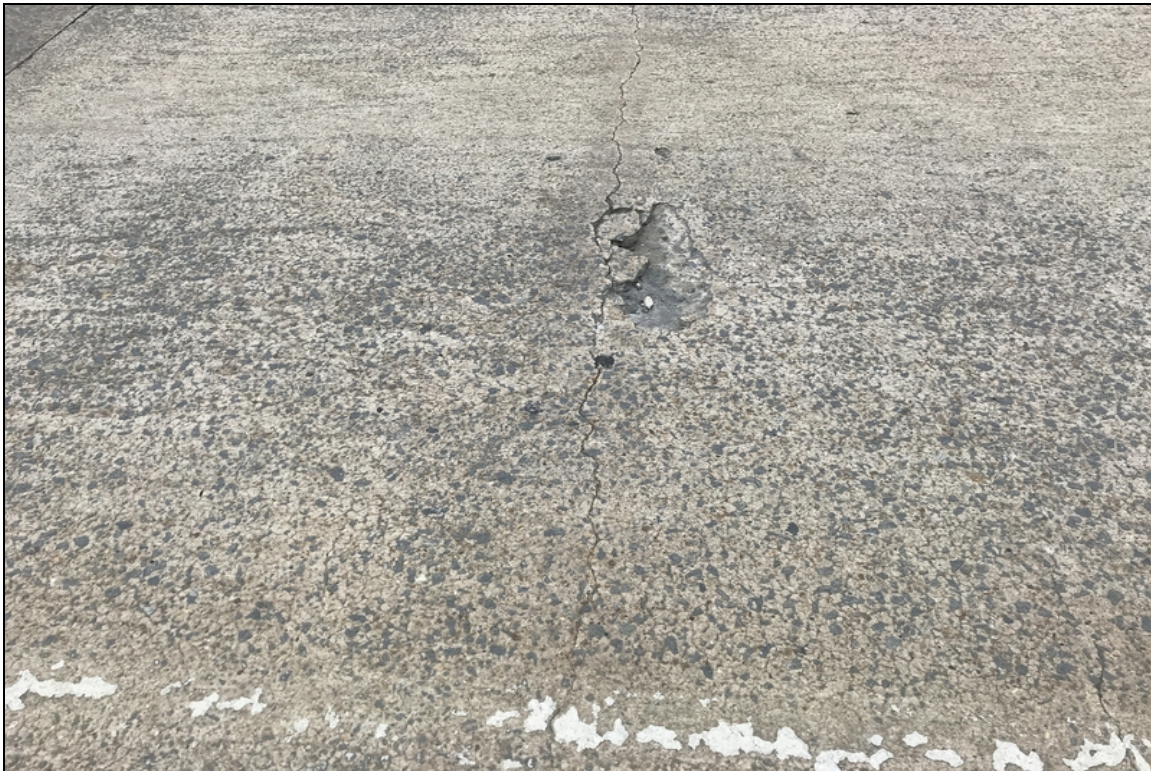
Deck span 19 south bound out side lane has 1' by 1' spall.

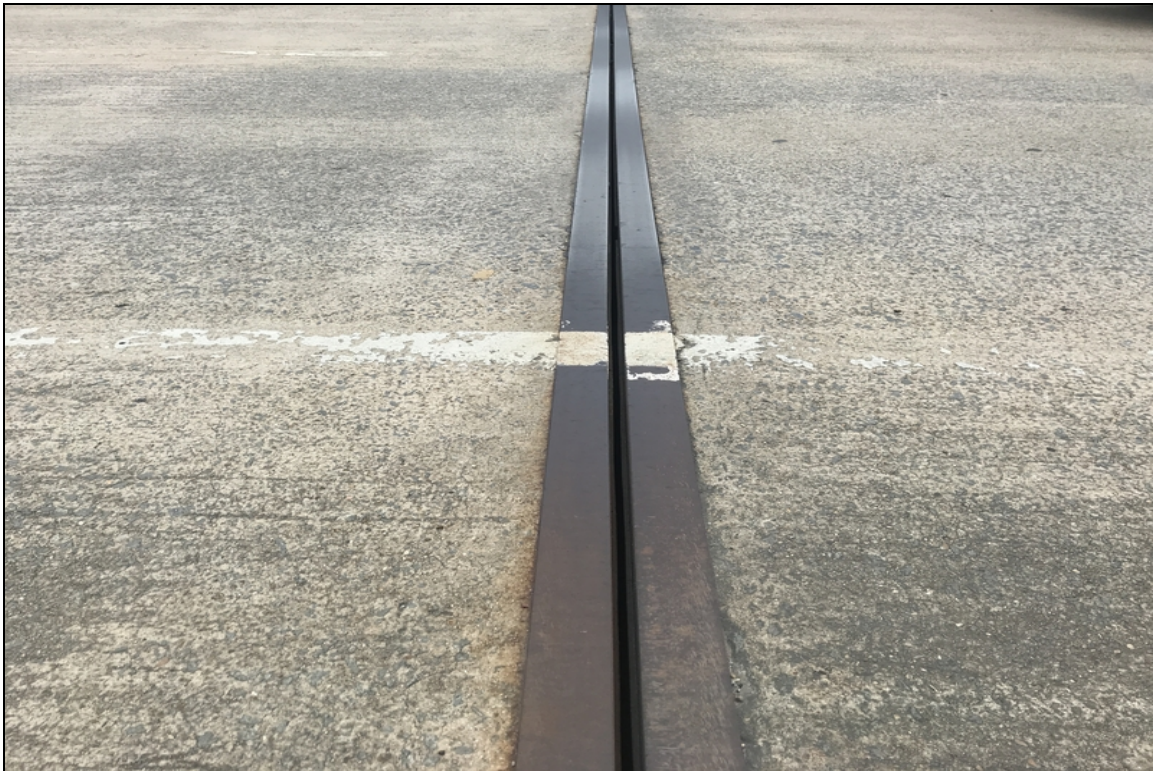
Bent 17 joint seal material missing.

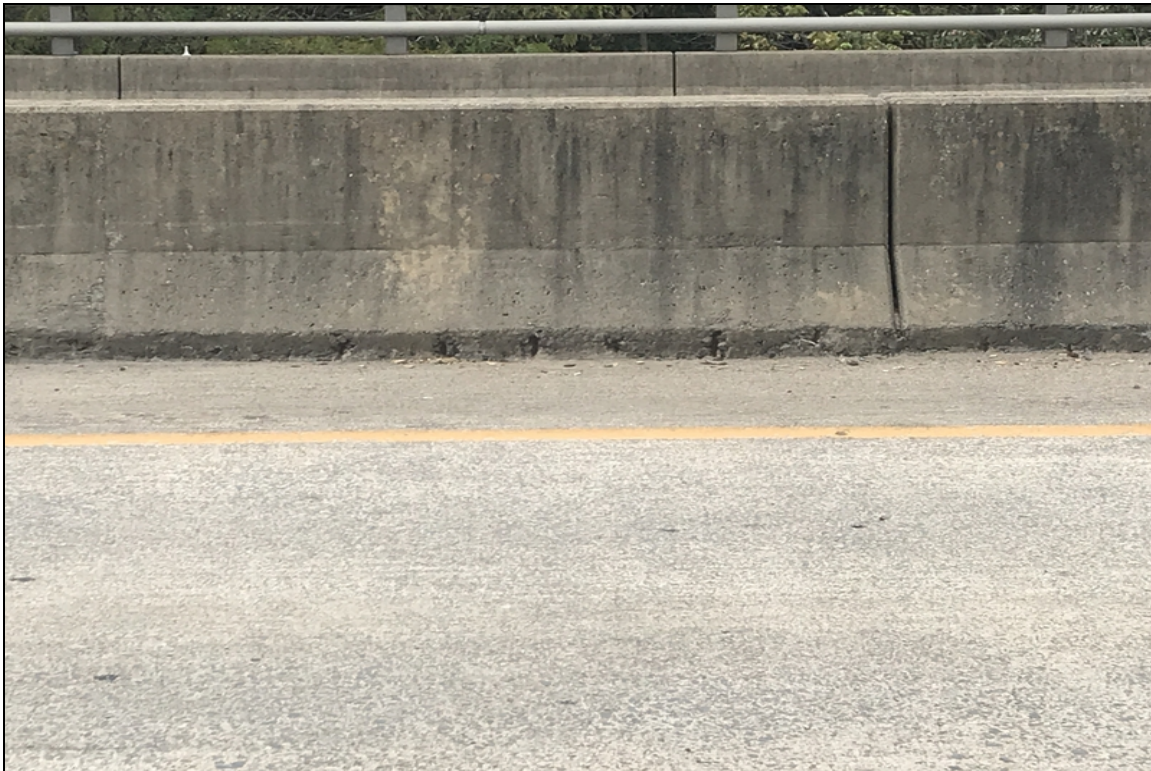
Span 13 median wall has spalls with exposed rebar. Common various locations.

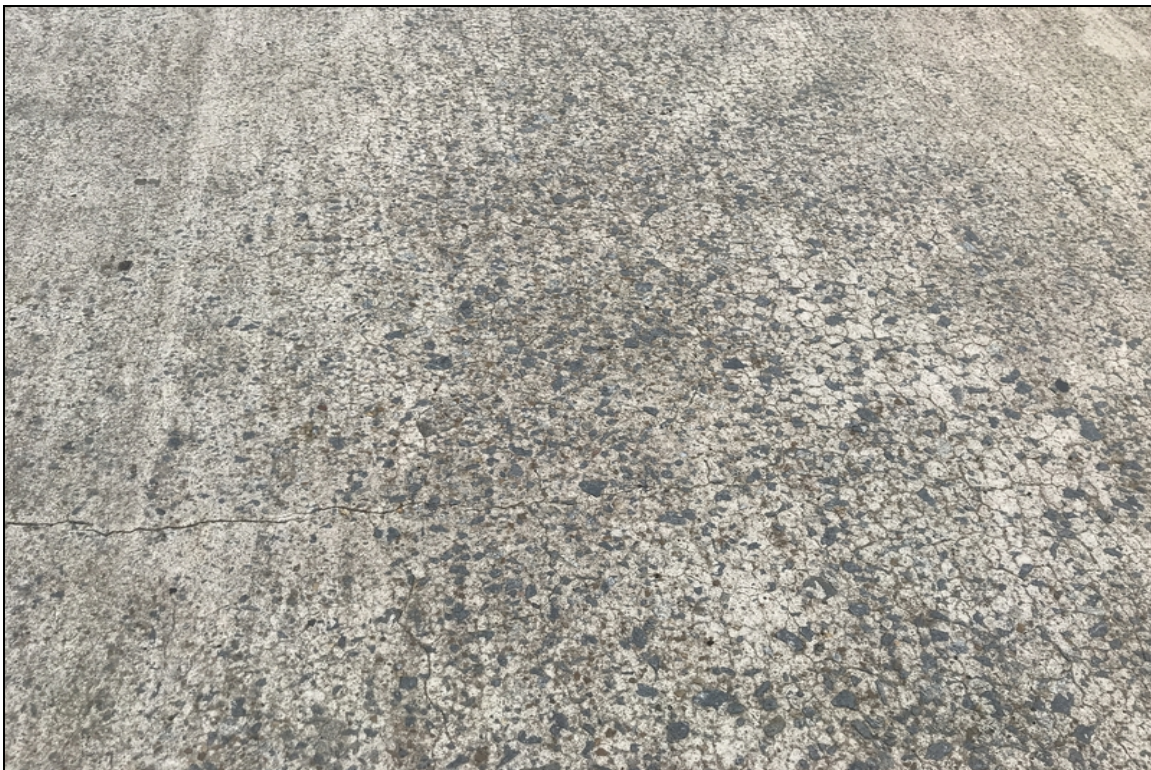
Deck span 11 map cracking.

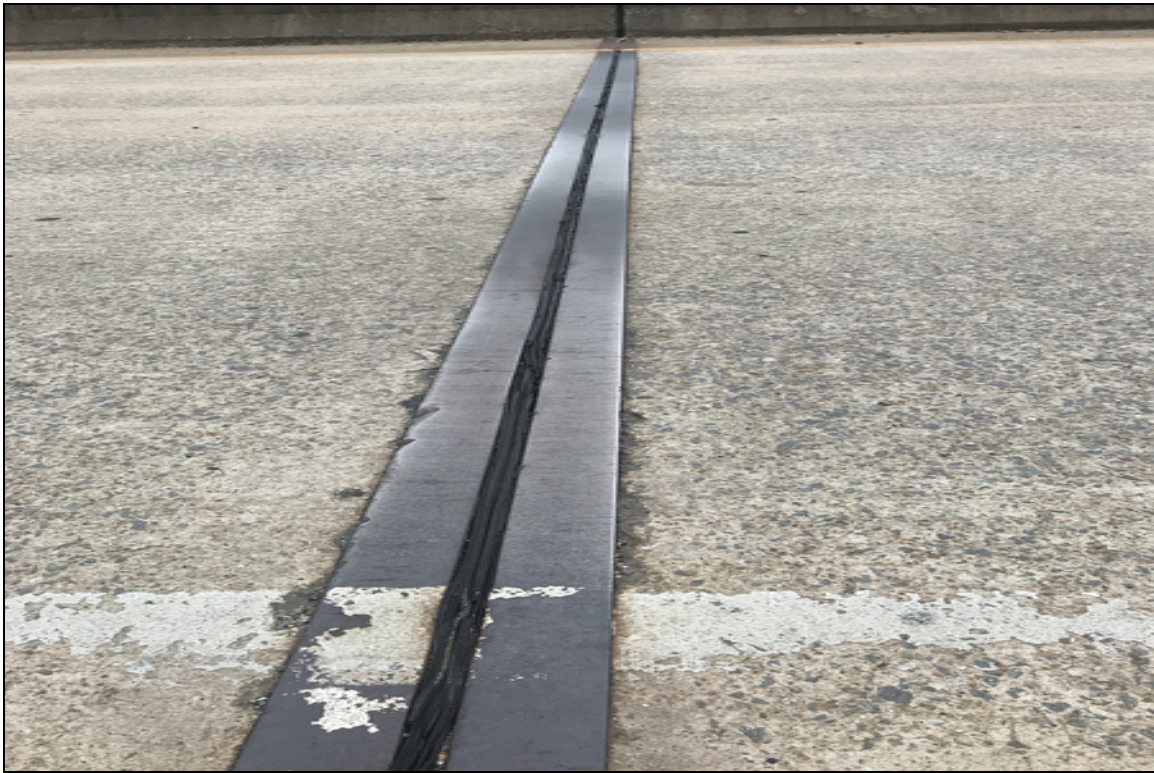
Bent 5 joint material is torn and leaking.

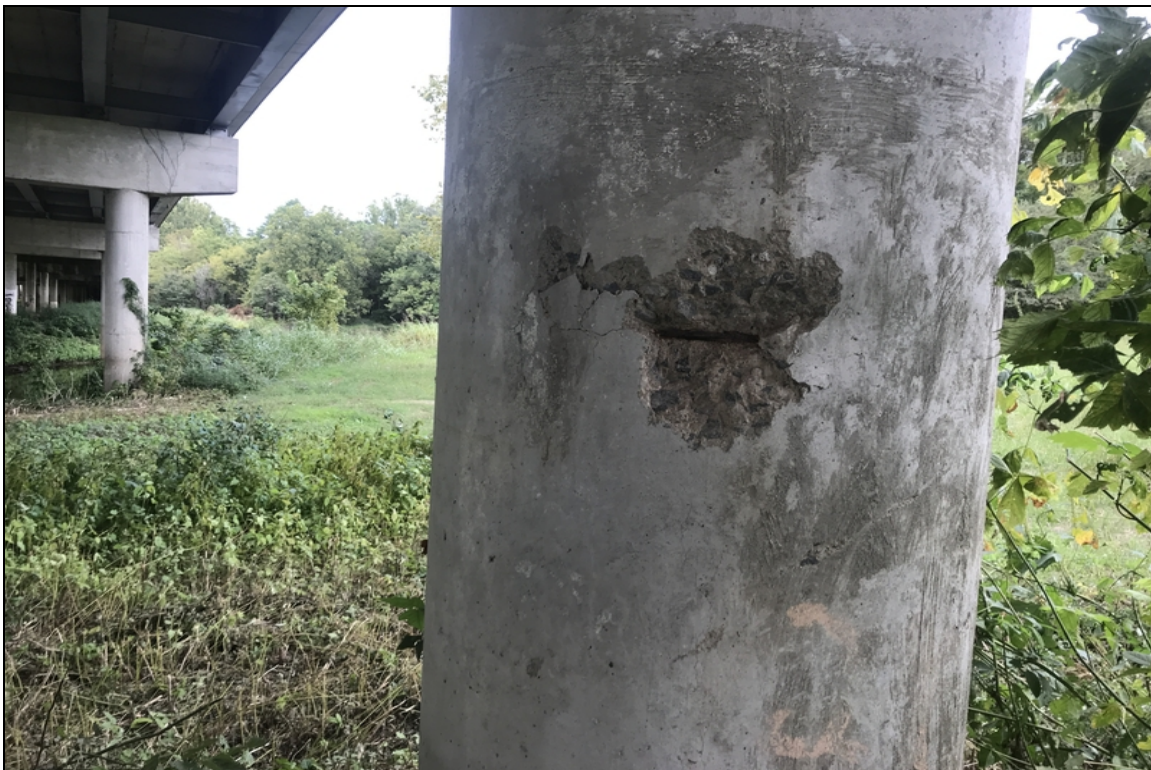
Bent 21 column 1 ahead has spall with exposed rebar.

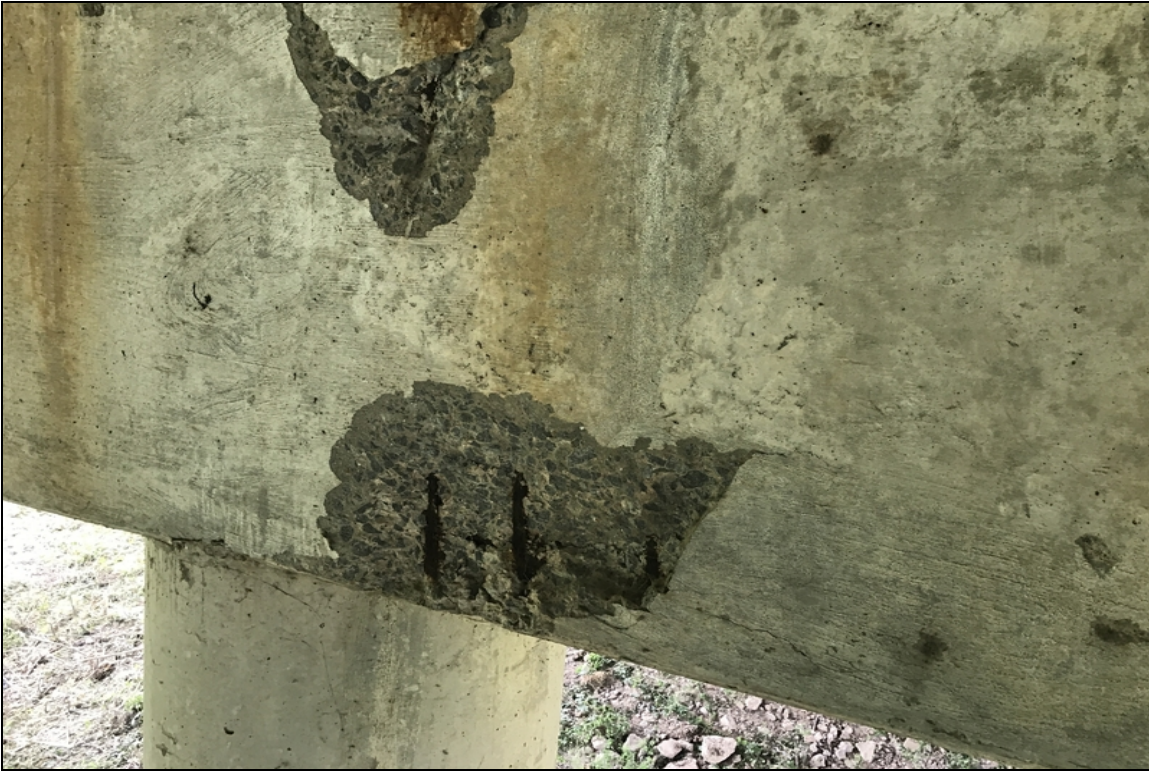
Bent 21 cap back spalls with exposed rebar.

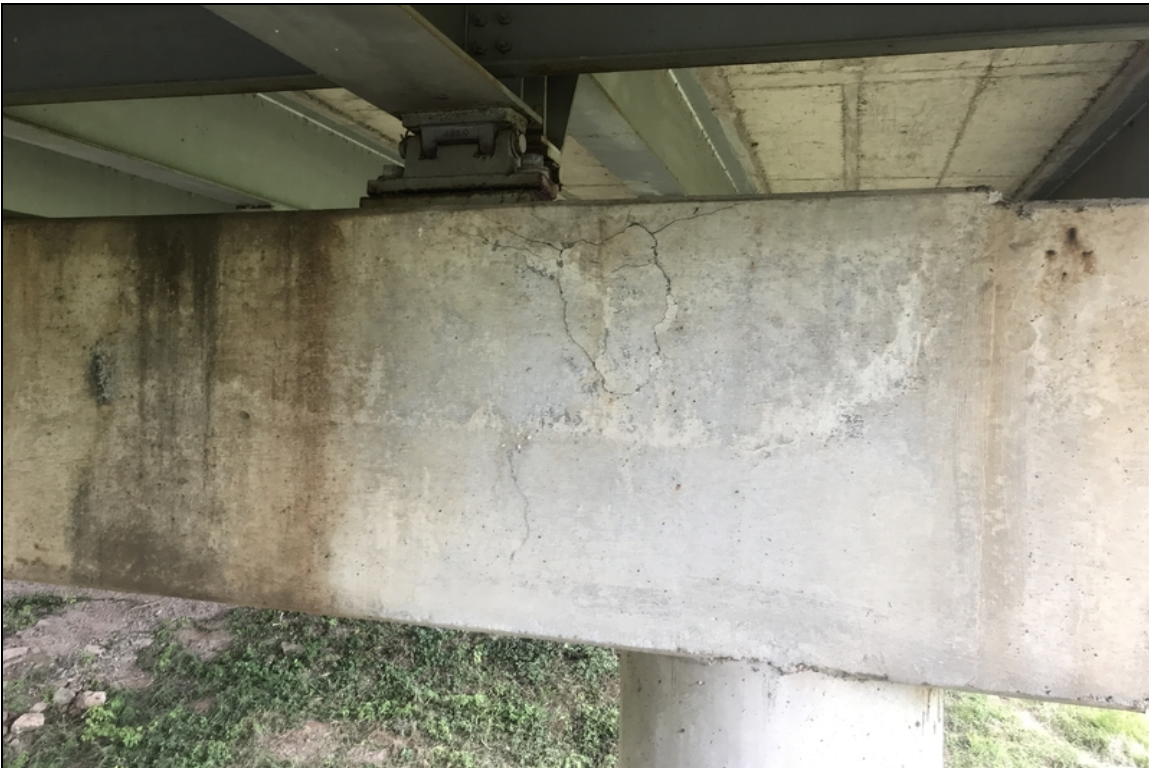
Bent 21 cap has cracking near girder 9.

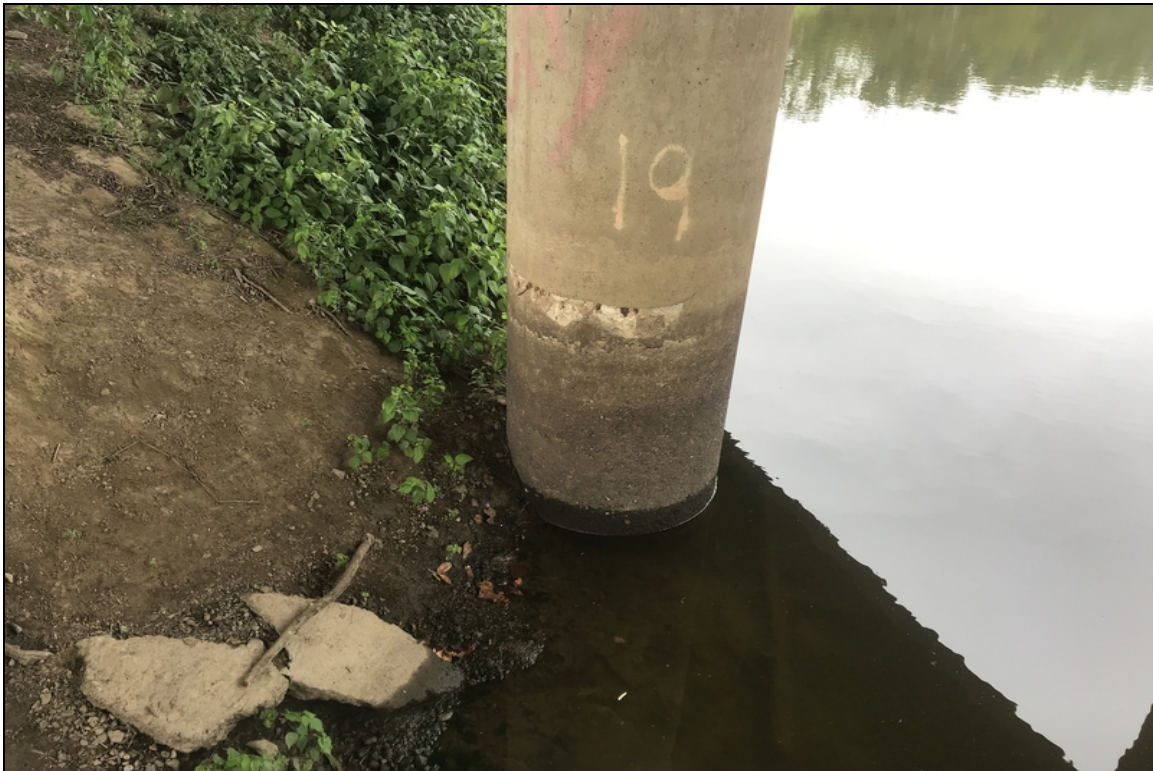
Bent 19 column 2 has spalling with exposed rebar.

Bent 19 Column 2 right ahead side: A narrow, horizontal band (4" tall x 18" around) of spalling ~2' up from ground/waterline. (A very small amount of steel exposed – no section loss.)

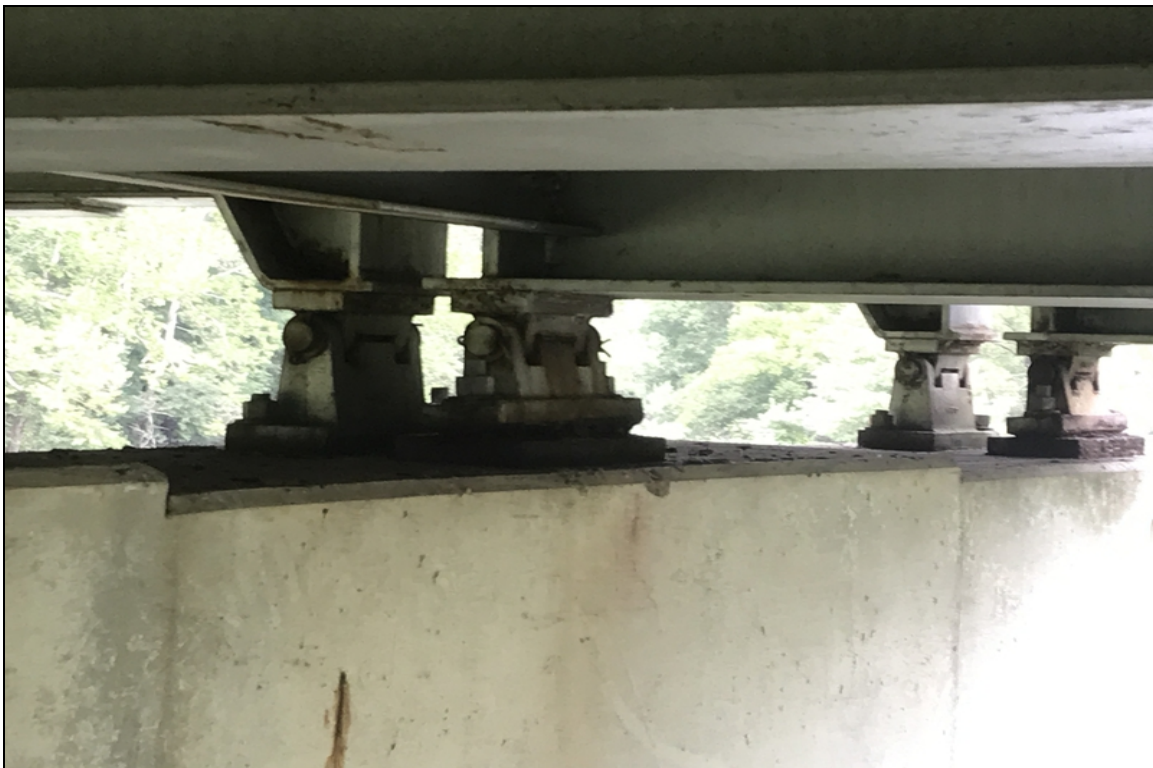
Bent 18 bearing 2 ahead is leaned back possibly due to pack rust.

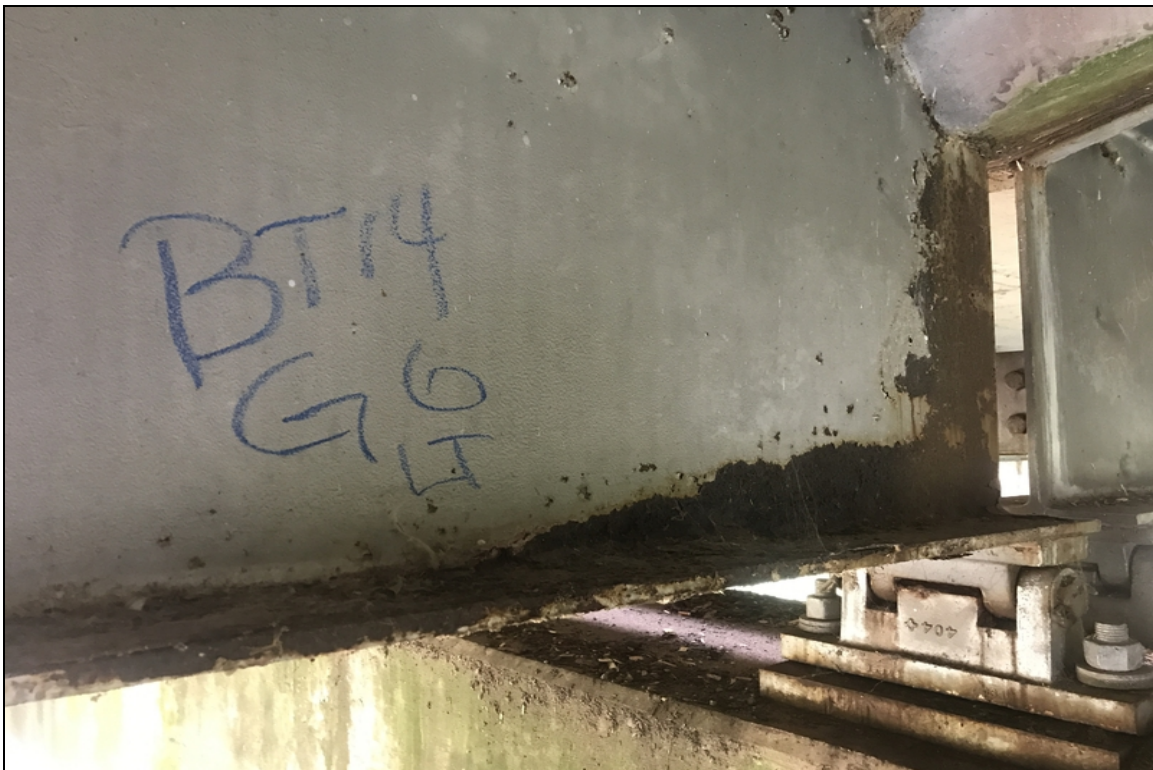
Bent 14 girder 6 left has corrosion with some flaking to web and lower flange.

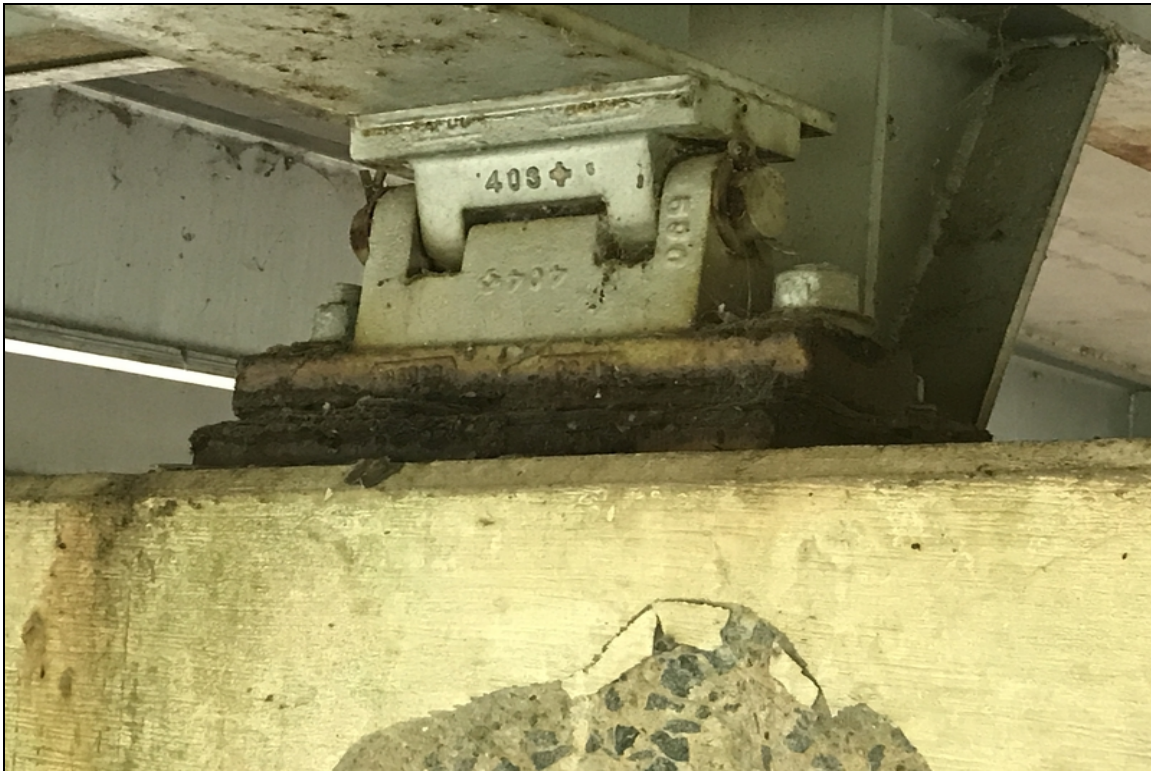
Bent 10 bearing4 ahead has heavy flaking rust. Common most bearing this bridge.

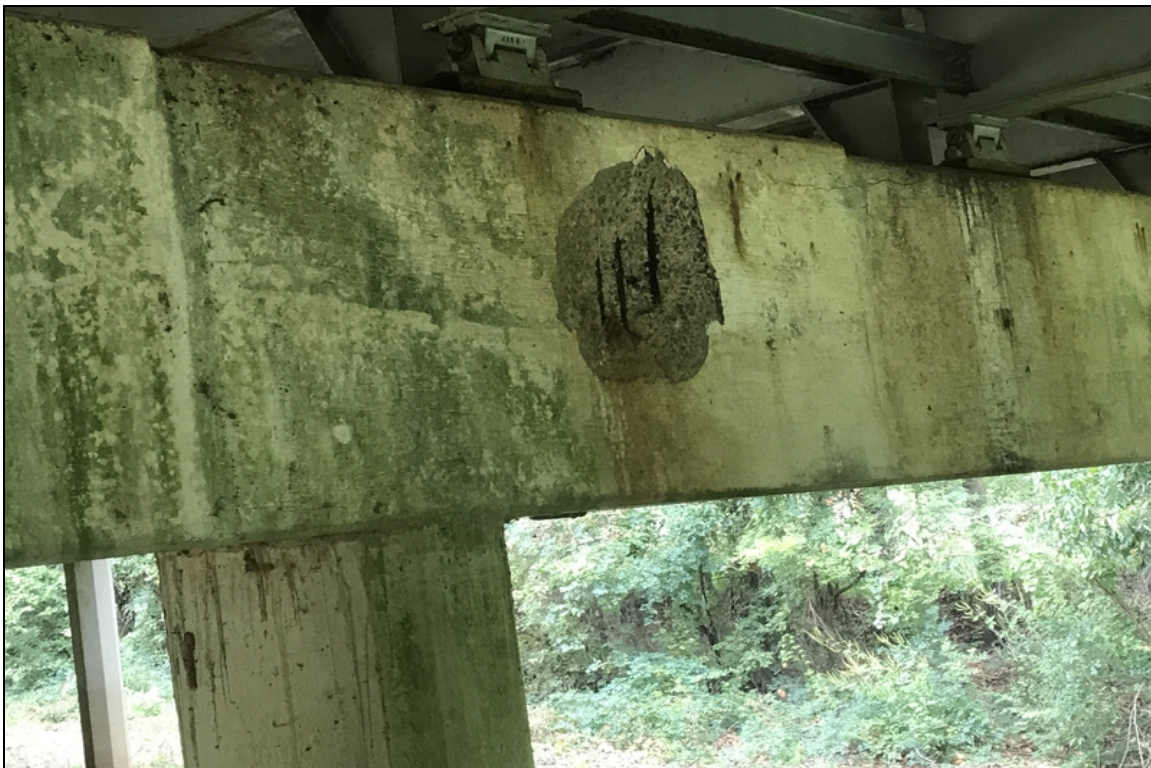
Bent 10 cap ahead has spalling with exposed rebar.

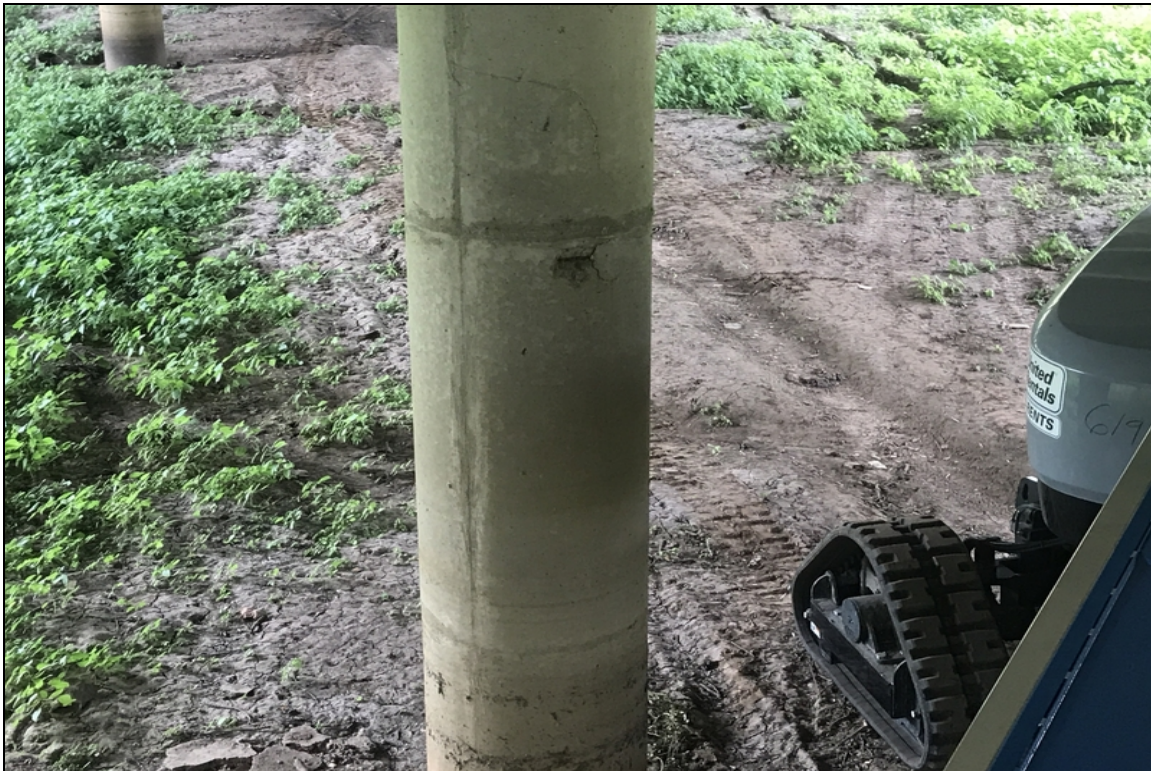
Bent 10 column 2 has spall with exposed rebar.

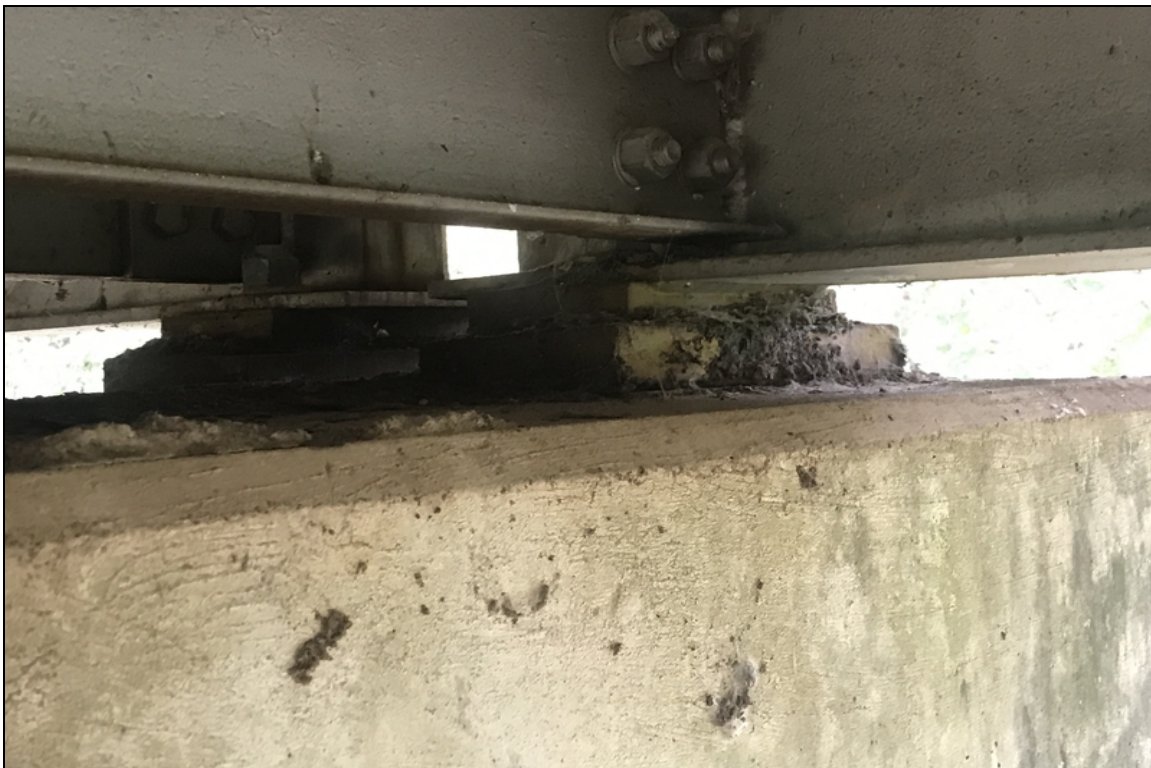
Bent 9 bearing 1 has flaking rust between bearing and plate.

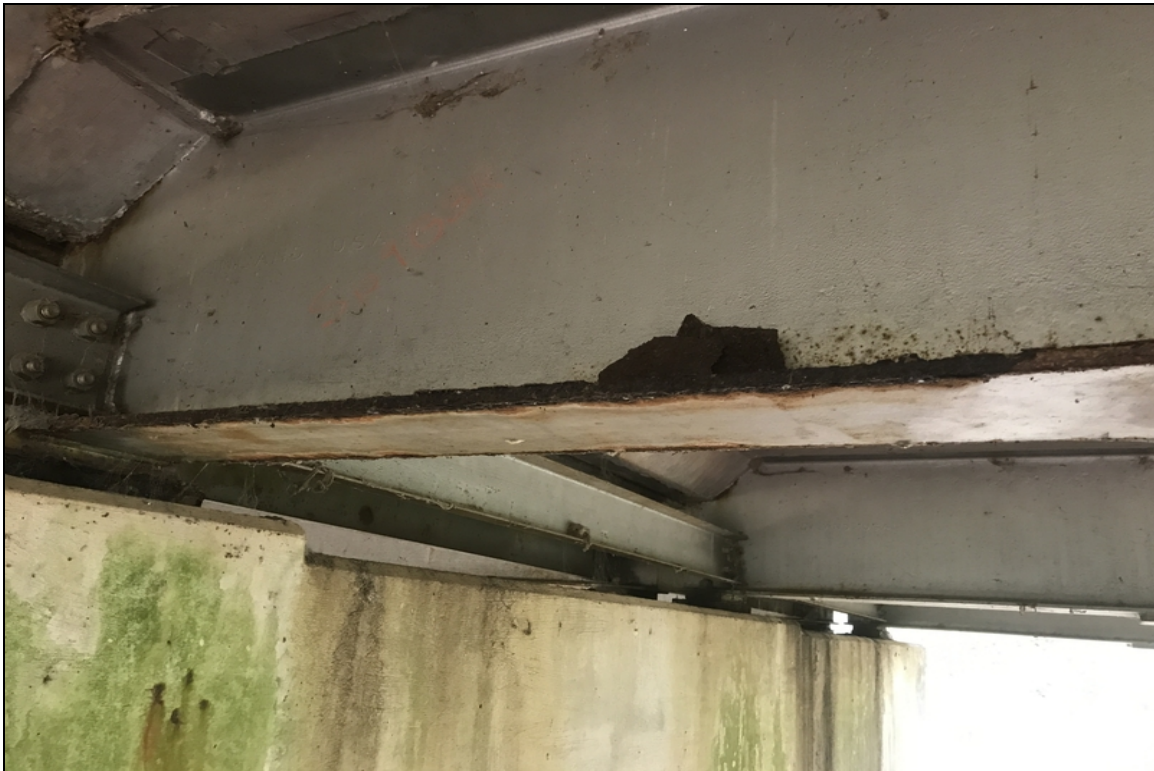
Span 9 girder 3 right has flaking rust.
