Bridge #05429(Routine)

US 65-14B LM 5.94 over Imbeau Bayou Outlet

Team Lead: Sharon Hooks Inspection Date: September 21, 2020

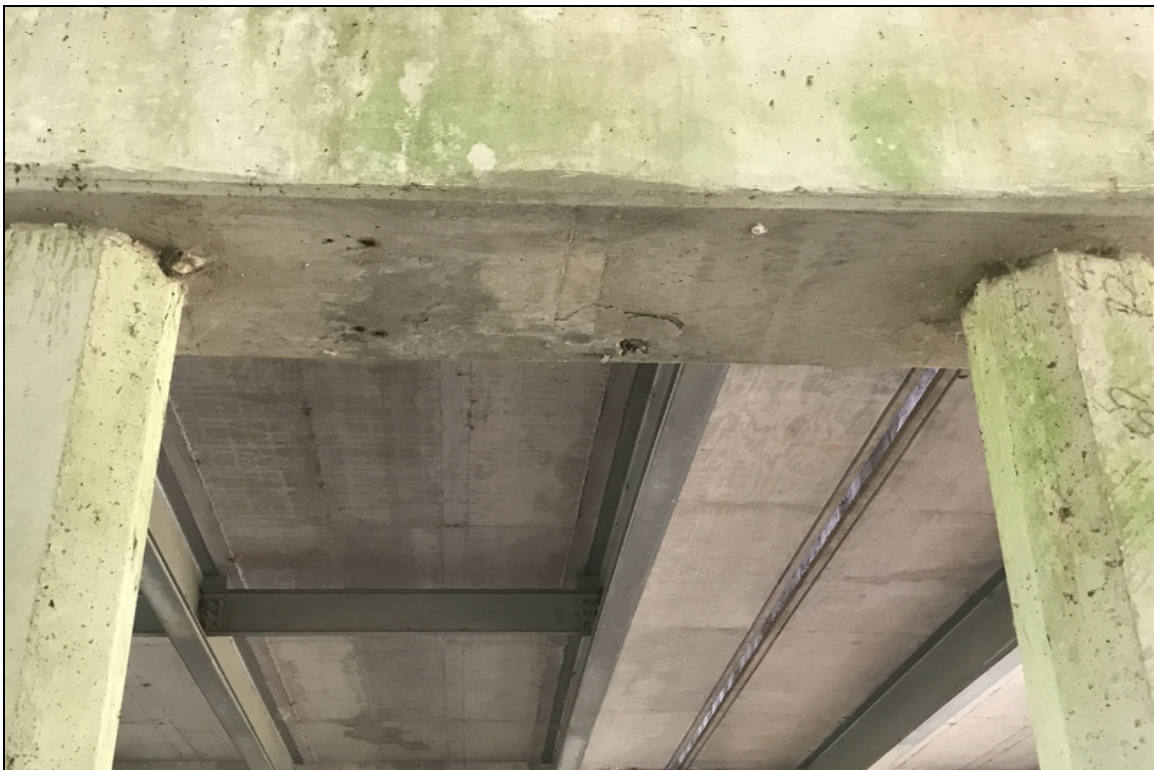
Bent 6 between piles 5 & 6 cap has small delam.

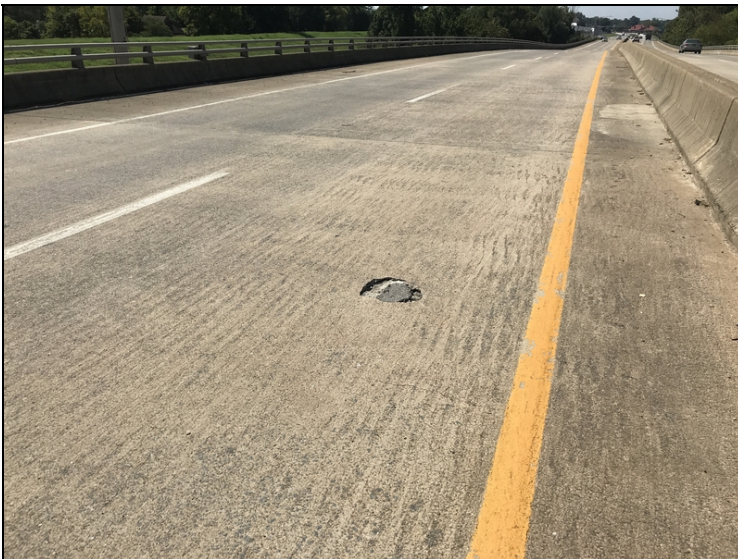
Spans 4, 13, 17, 19, 22, & 25 left lane and Span 20 right lane: Scattered small spalls - unable to determine depth.
NOTE: Several spalls have been filled with asphalt mix. Several small spalls with exposed rebar in various locations.
Updated 9/21/2020 SDH.

Deck - Span 20 right: Spall

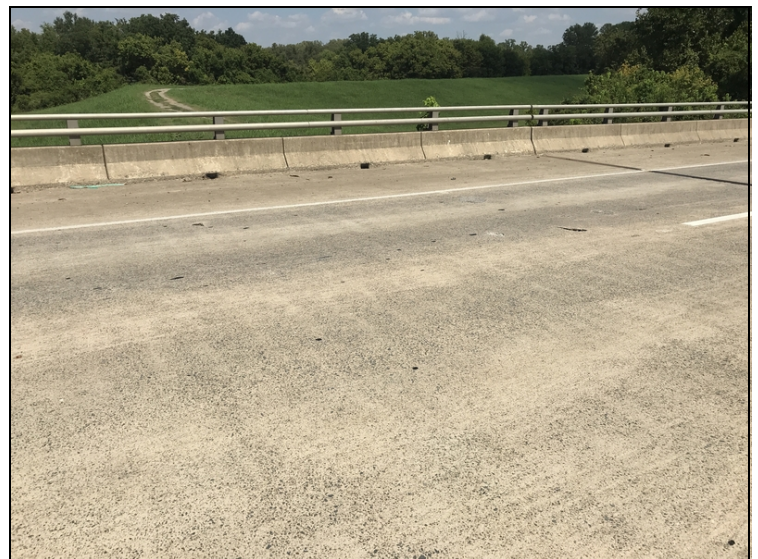
Deck - Span 22 left: Spalls

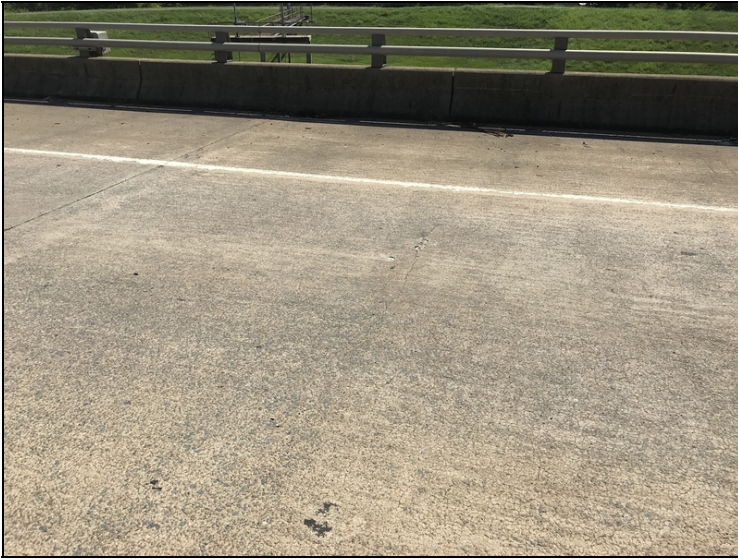
Deck - Span 19 right: Cracking/spalling

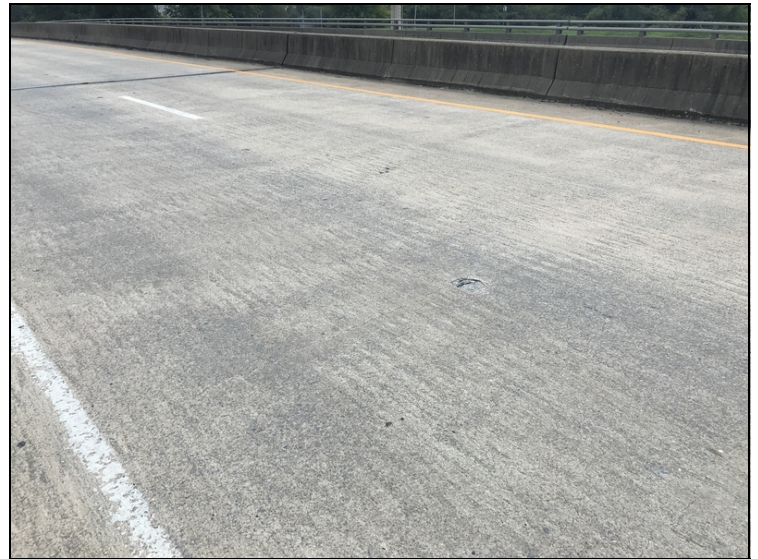
Deck - Span 17 left: Crack/spall

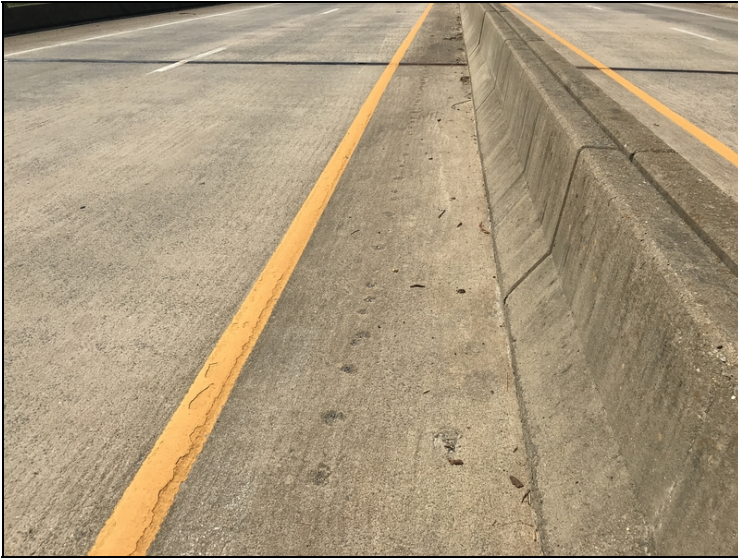
All spans over Girders 1, 5, 6, & 10: Very small spalls over tops of shear connectors – near gutterlines.

Deck - Span 21 right: Spalling over shear connectors

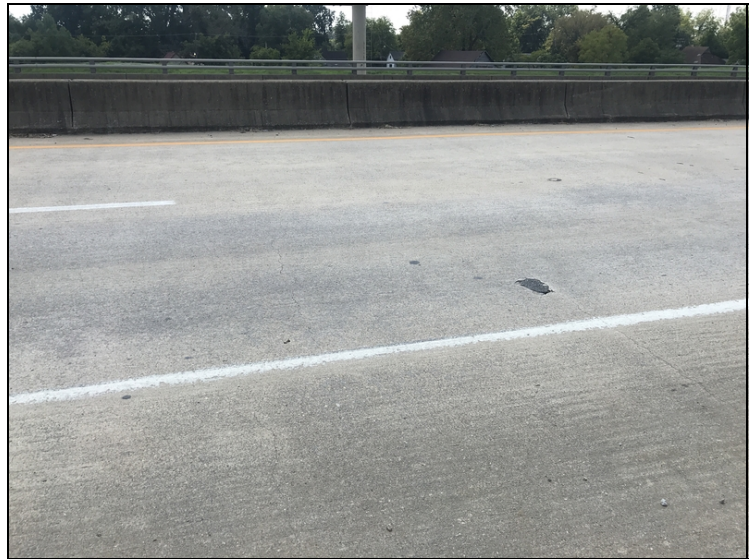
Deck - Span 19 left: Cracking/spall

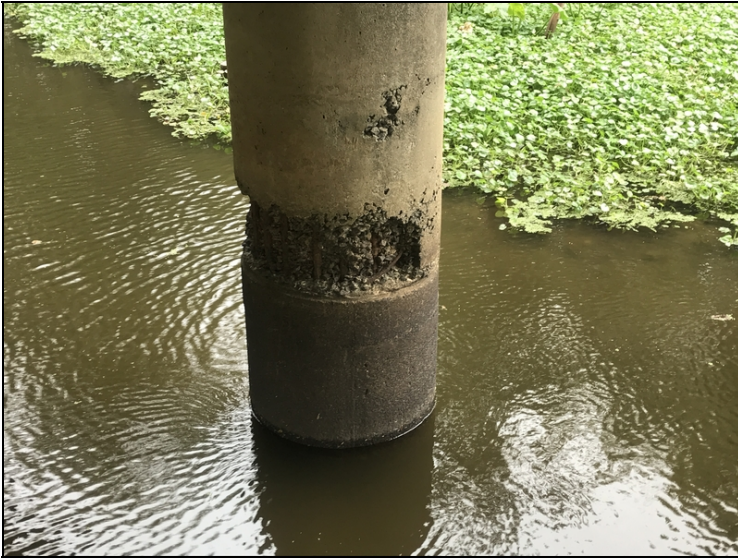
Bent 14 column 1 has spalling/ abrasion to lower 2'
of column with exposed rebar

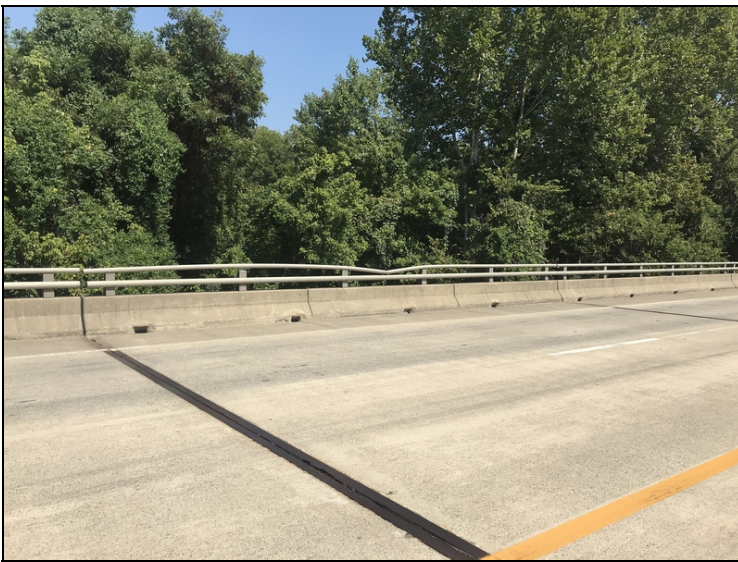
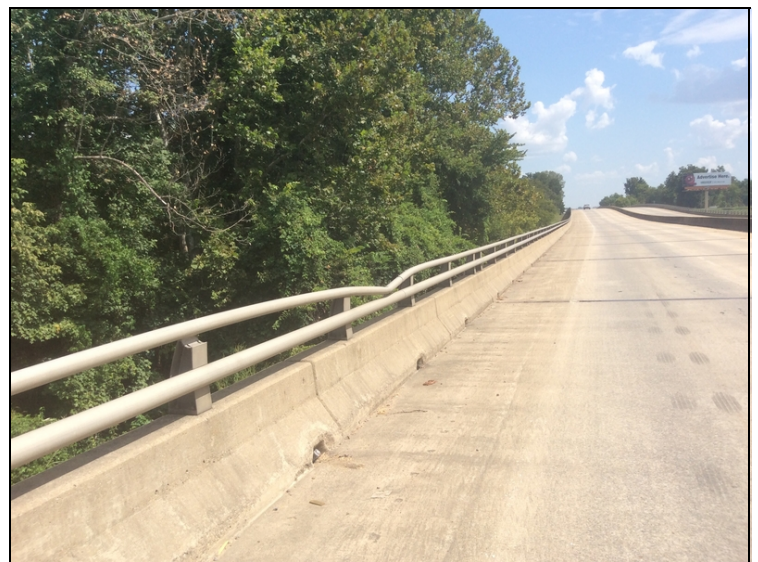
Railing – Spans 5 left, 9 left, 13 left, 15 left, & 27 right: Minor damage to rail or post.

Railing - Bent 5 left: Damage

repair as time permits

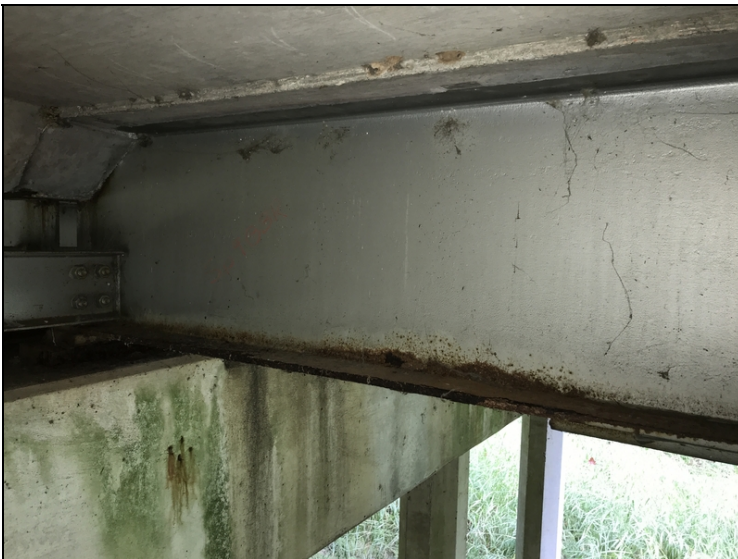
Girders & bearings – various locations: Some corrosion with minor section loss on webs & flanges of girders and on bearings, mainly at bents with open joints.

Span 9 Girder 3 right @ Bent 9: Corrosion

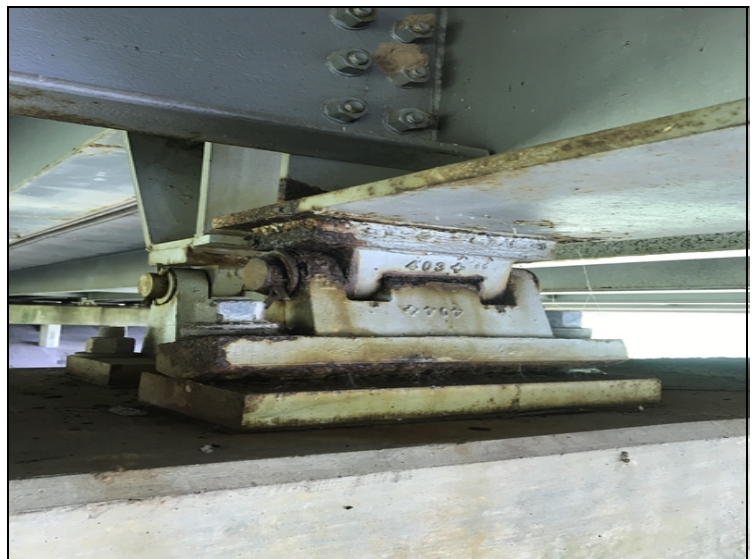
Bent 21 Back- Bearing 5 : Corrosion

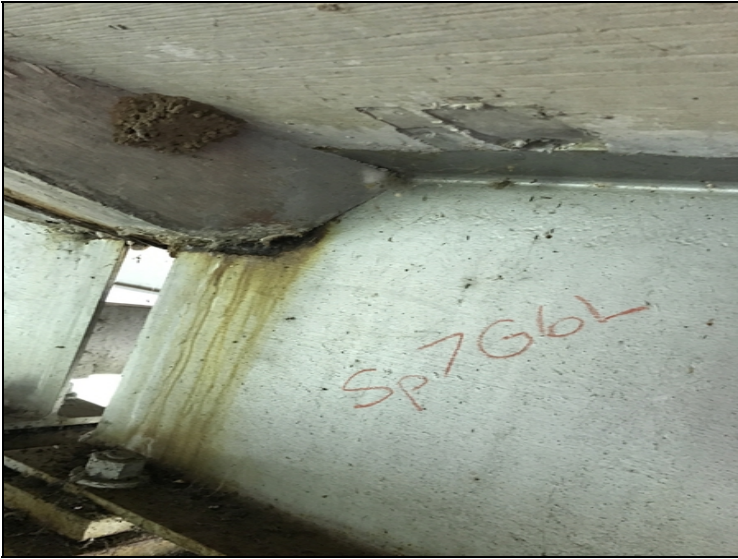
Span 7 - Girders 6 Left : Corrosion on haunch.

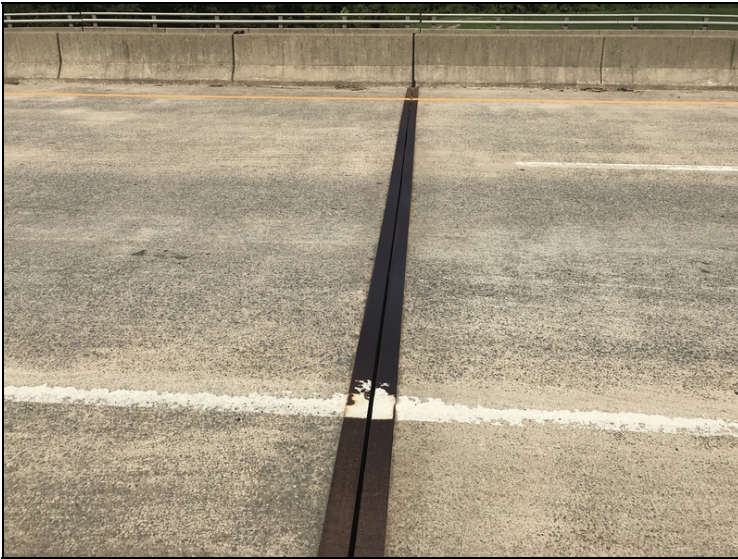
Joints – Bents 11, 14, 17, 22, & 23 left lanes & Bents 11, 14, 17, 22, & 23 right lanes: Joint material has fallen out – resting on cap in many locations.
Dirt & debris build-up on caps, around bearings, and on end of girders in most locations.

Joint - Bent 23 right: Material missing

repair joint material as time permits

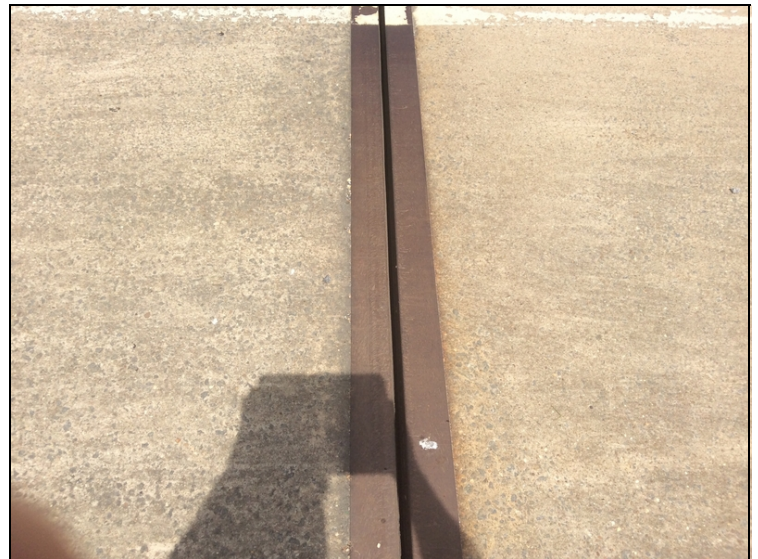
Span 23 expansion joint material missing in right hand lane and remaining joint torn and damaged.

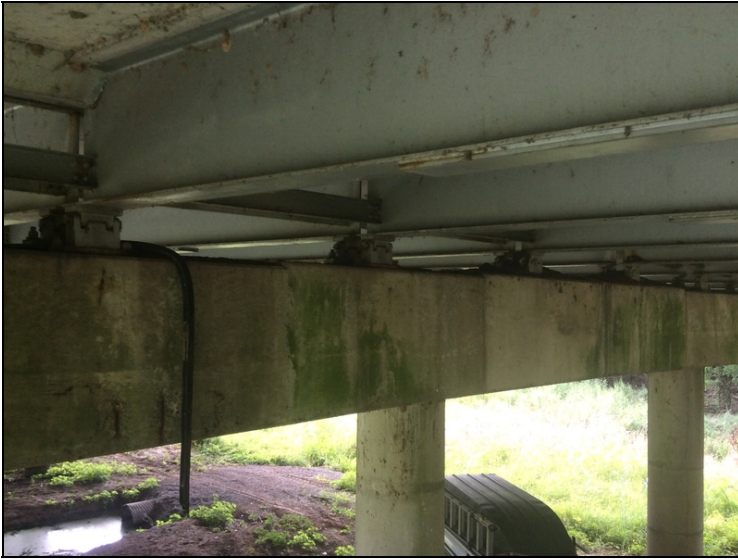
Bent 11 Joint material laying on cap with moisture and debris on cap

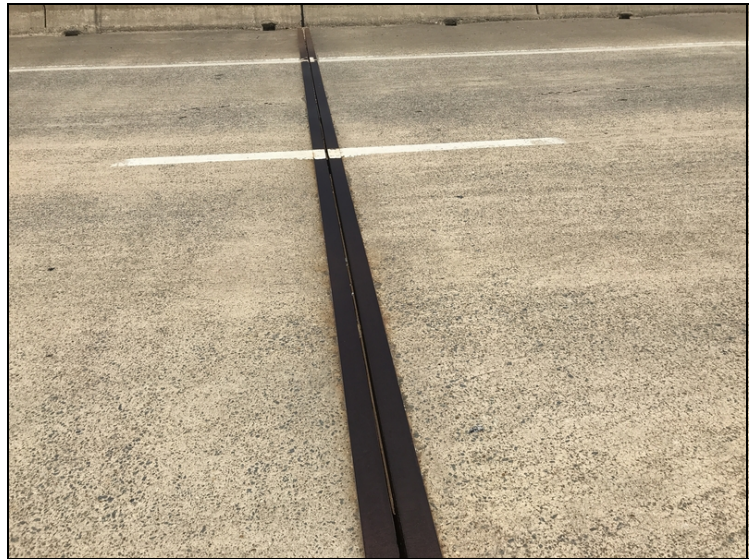
Joint - Bent 11 left: Material missing

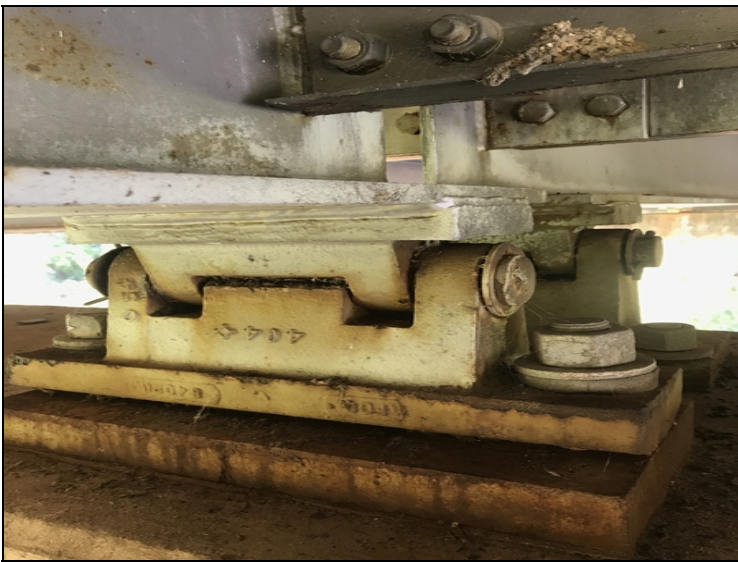
Bent 16 Bearing 7 ahead and Bent 22 Bearings 1, 2, 4, & 7 back: Cotter pin & washer missing off one end of pin.

Bent 16 - Bearing 7: no cotter pin

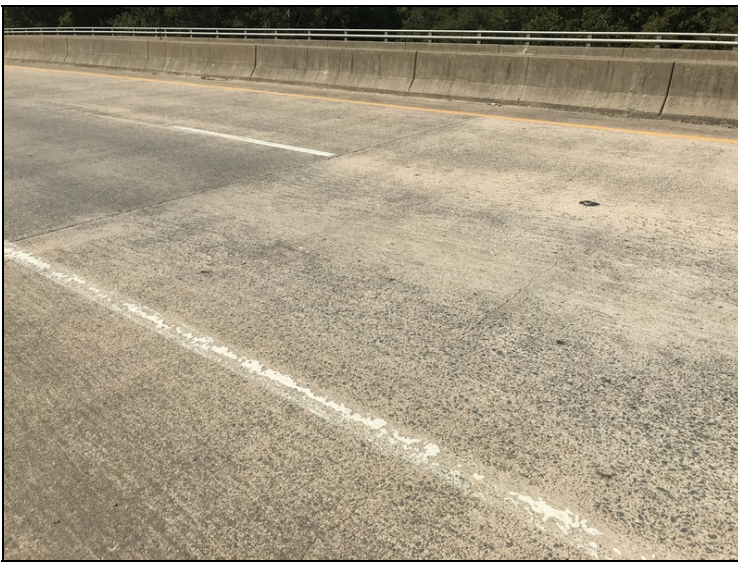
Deck – all spans: Unsealed, minor- to moderate-sized map cracking & a few unsealed, hairline- to moderate-sized transverse cracks, especially Spans 6, 17, 18, 19, 21, 24, & 28 left side and Spans 4, 19, & 26 right side.

Deck - Span 19 right: Transverse cracking

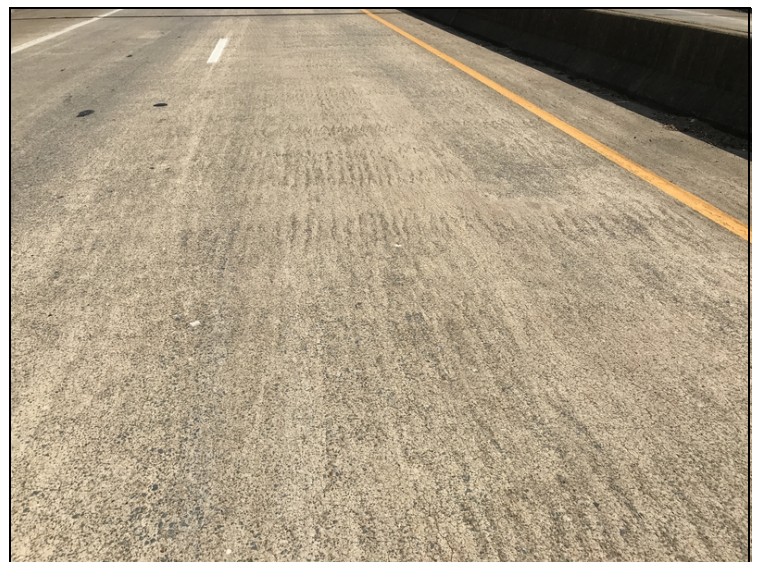
Deck - Span 11 left: Map cracking

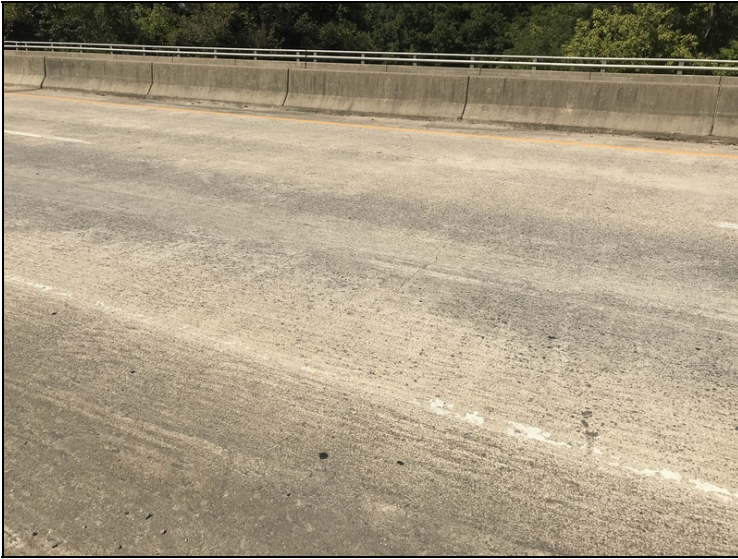
Deck - Span 11 right: Transverse cracking

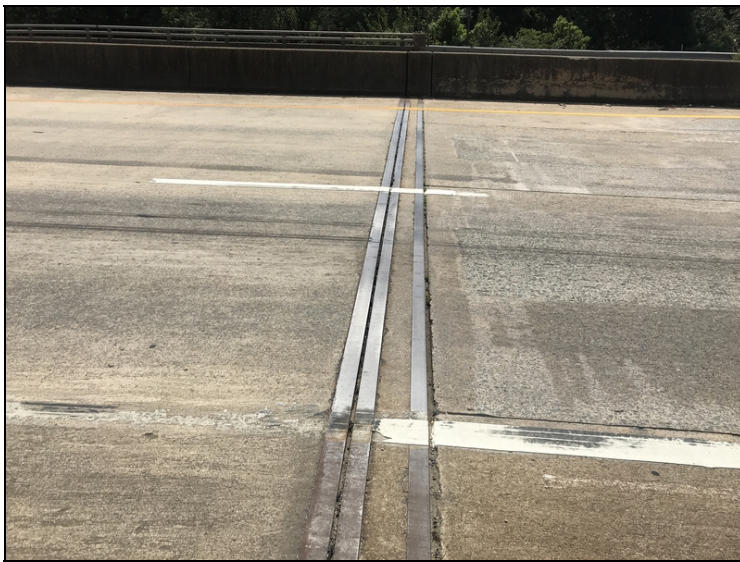
Joints – Bents 1-10, 12-13, 15-16, 18, 21, 23 right lane, & 24-30: Some minor to heavy tattering of joint material - some minor leakage.

Joint - Bent 1 left: Damage

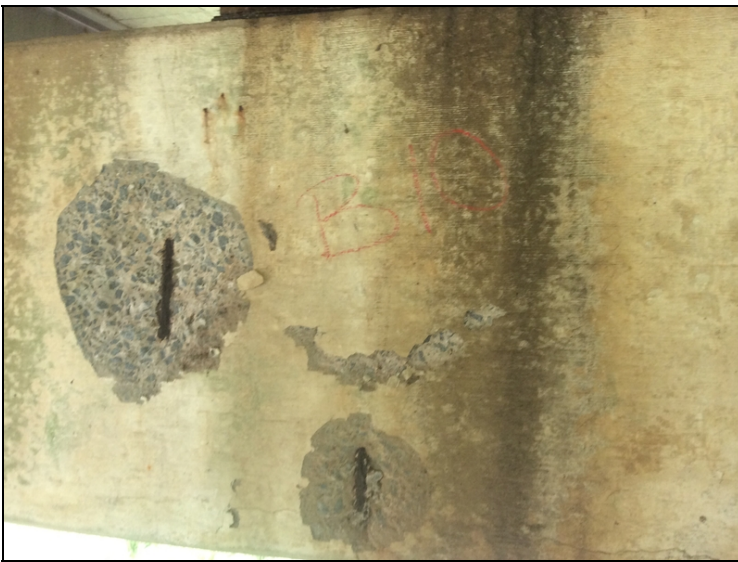
Cap – Bent 10 ahead side: Several areas of spalling/delamination (approximate 2' square) on face of cap.

Bent 10 delam with exposed rebar over pile 2 and
between piles 3-4

repair as time permits

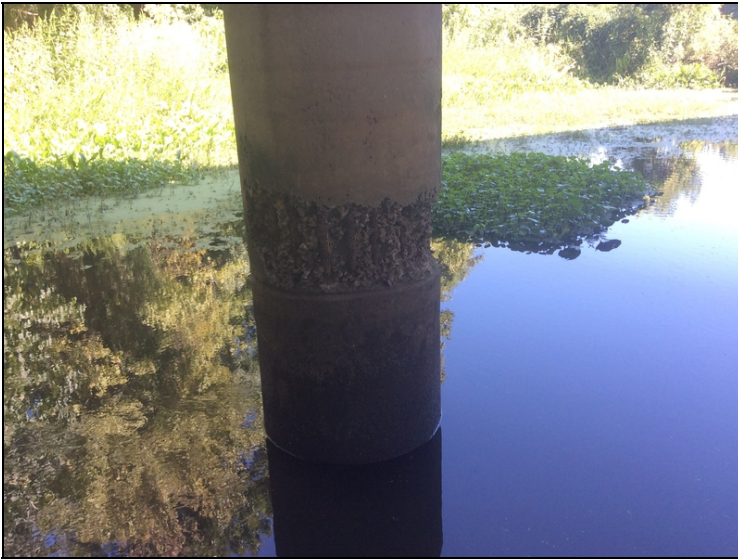
Bent 14 Column 1: Spalling with exposed rebar (with some section loss) on right side - approximately 2' above normal water-line (half the circumference of the column and up to 3" deep).

Bent 14 column 1 approx 2' above water line spall with exposed rebar to half the circumference of the column 1' high. Very light flaking rust starting on exposed rebar.

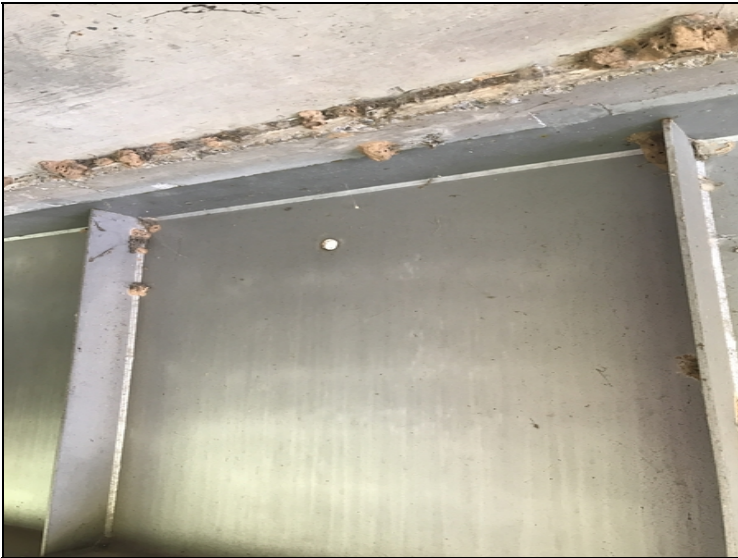
Span 19 - Girders 1, 2, 9, & 10: Approximately 1" diameter holes have been drilled/torch-cut in webs of girder - holes need to be filled with properly-sized bolts/nuts and torqued to proper specifications to prevent cracking of the webs in these locations (a couple of the holes already have a bolt/nut loosely inserted).

Span 19 - Girder 2 at Bent 20: Hole in web

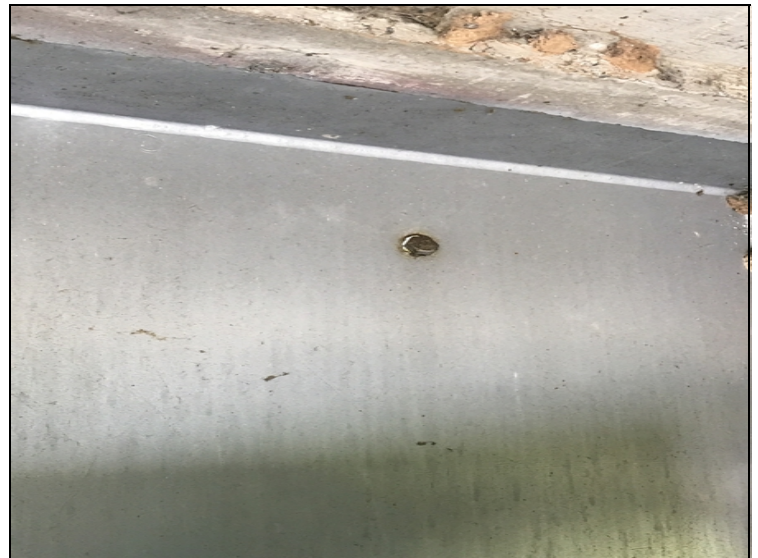
Span 19 - Girder 1 near Bent 20: Hole in web with loose bolt
