Bridge #02893(Routine, Underwater type 2)

SH 114-02 LM 0.83 over Deep Bayou

Team Lead: Greg Loomis **Inspection Date:** December 29, 2020

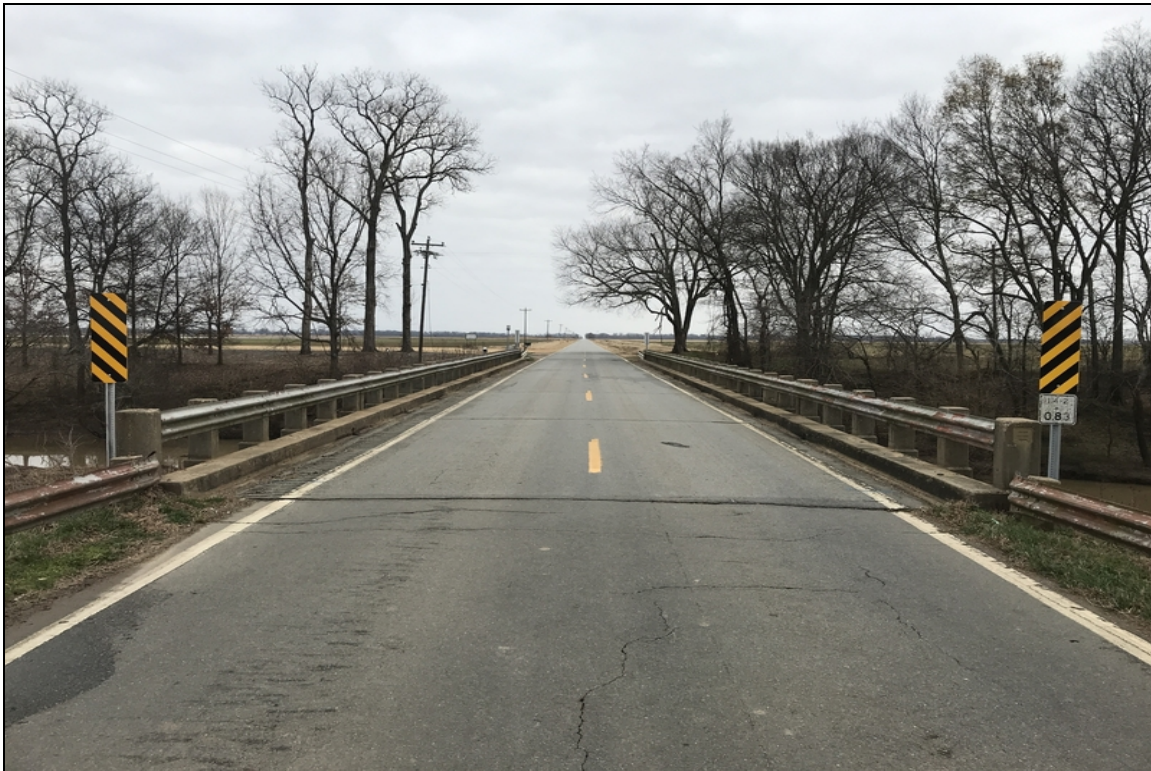
Roadway view

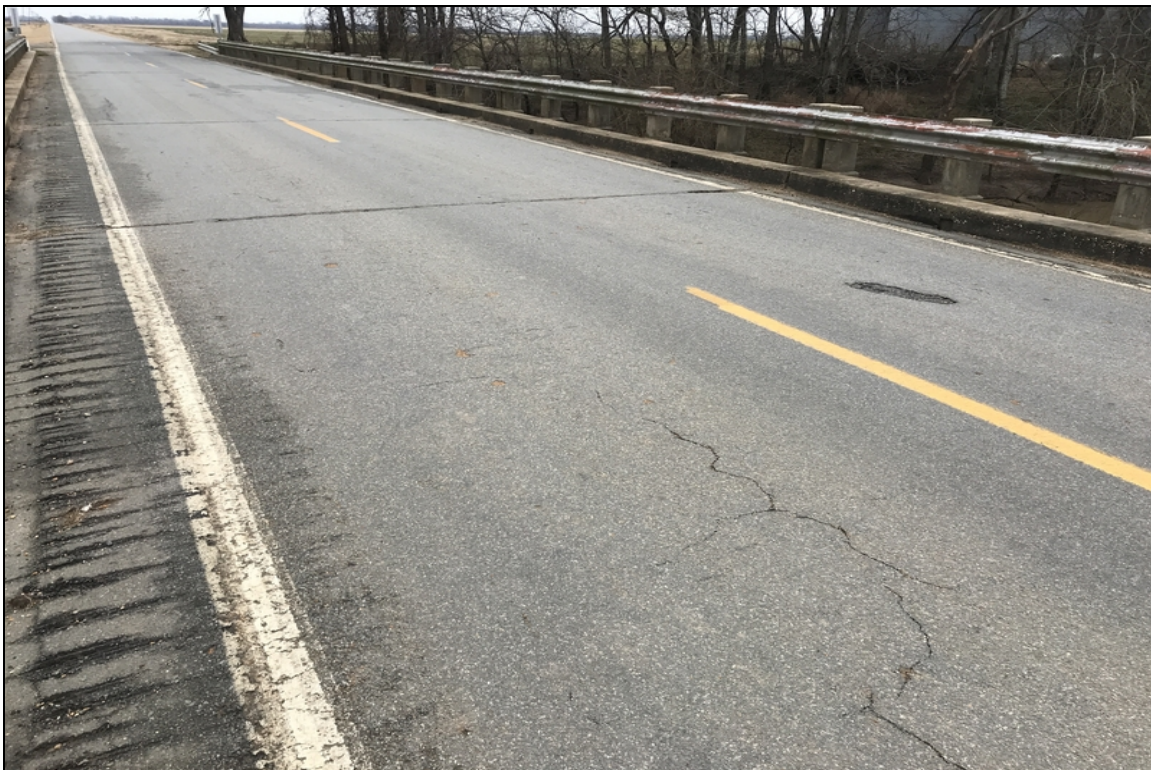
Deck - Spans 16: Typical

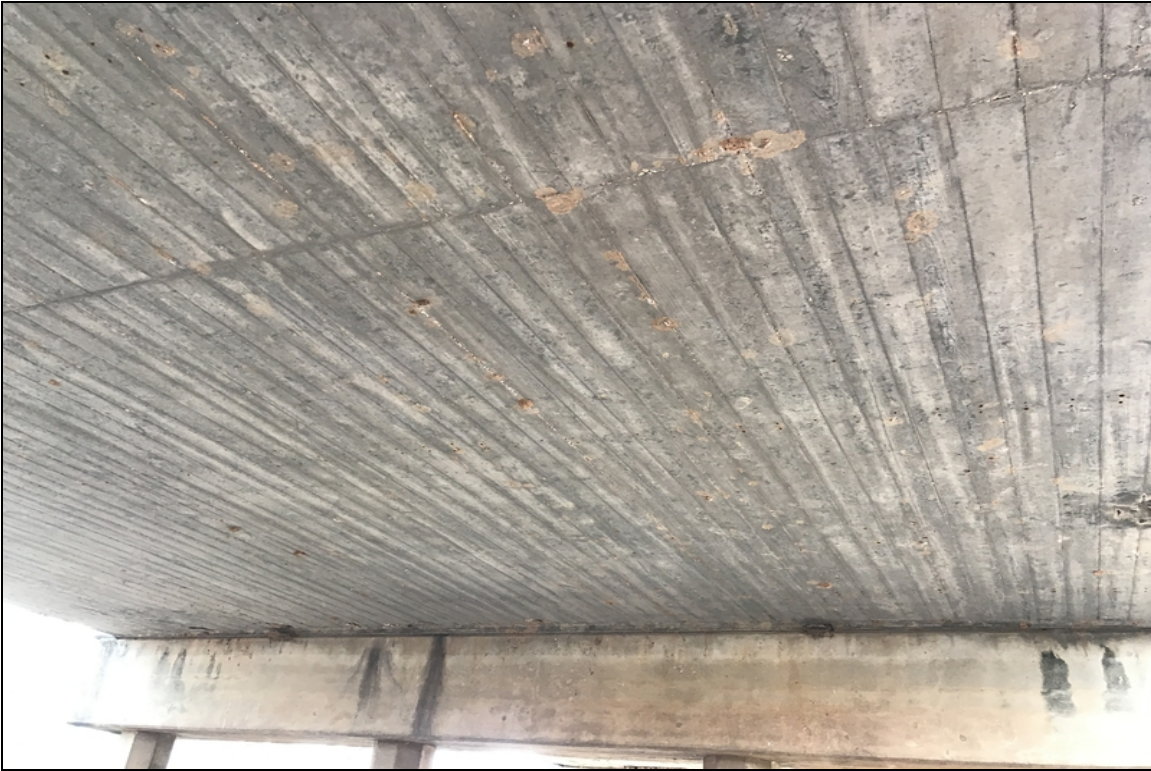
Soffit - Span 2: Typical

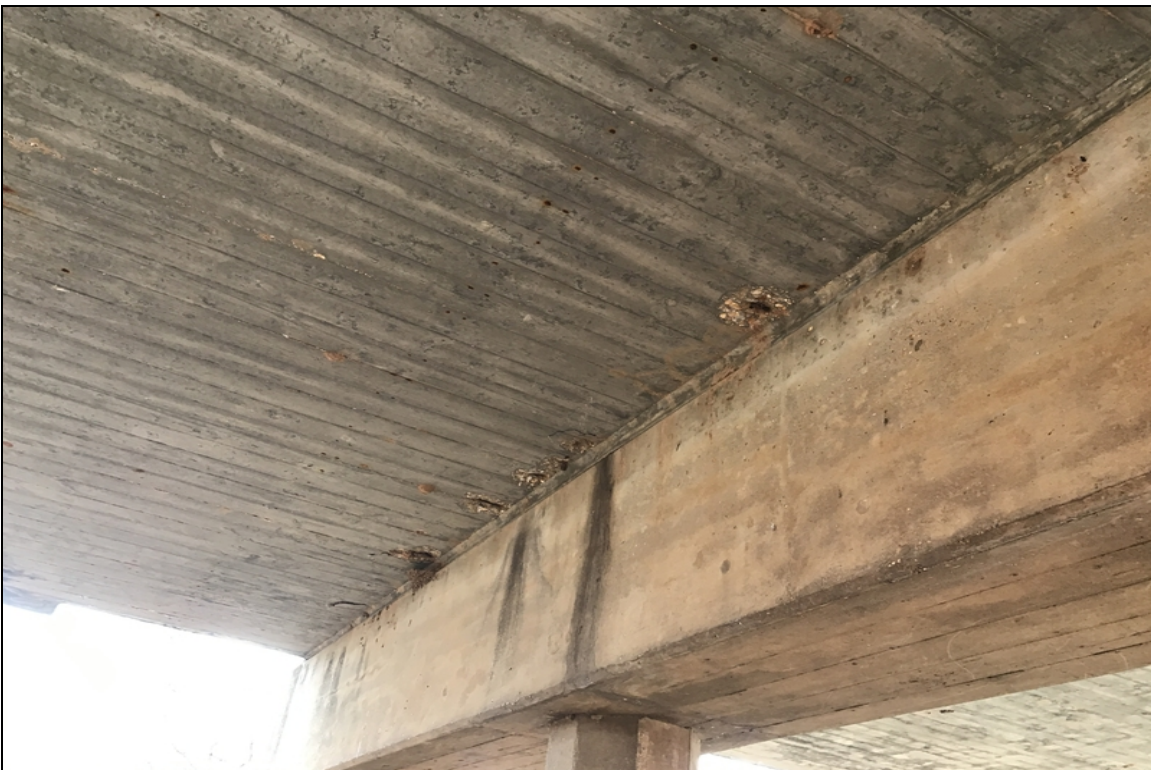
Soffit - Span 2 @ Bent 3 left: Rebar exposed

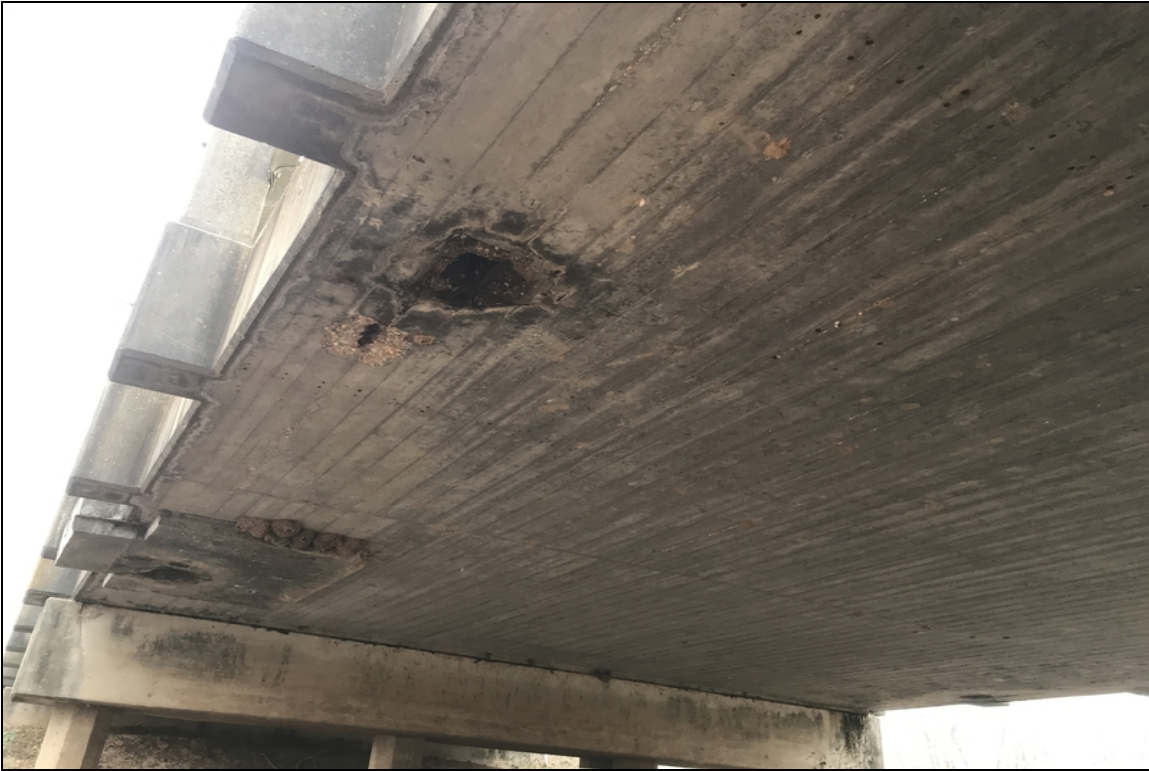
Soffit - Span 2 right: Patched/spalling

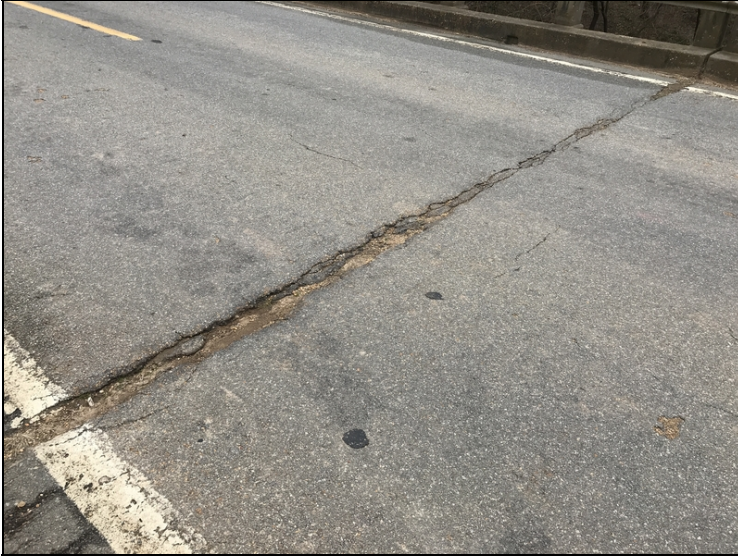
Deck – all spans: Moderate to large transverse cracking - especially at joints - with some material spalling up and leaving small potholes.

A couple minor-sized longitudinal cracks.

Wearing surface - Bent 5: Deterioration (potholes)

Date Reported: 12/08/2014
Priority: C - Important
Type of Work: Repair
Status: Open
Component: 510 - 38 - RC Slab
