Bridge #02894(Routine, Underwater type 2)

SH 114-02 LM 4.15 over Kersh Canal

Team Lead: Greg Loomis Inspection Date: December 29, 2020

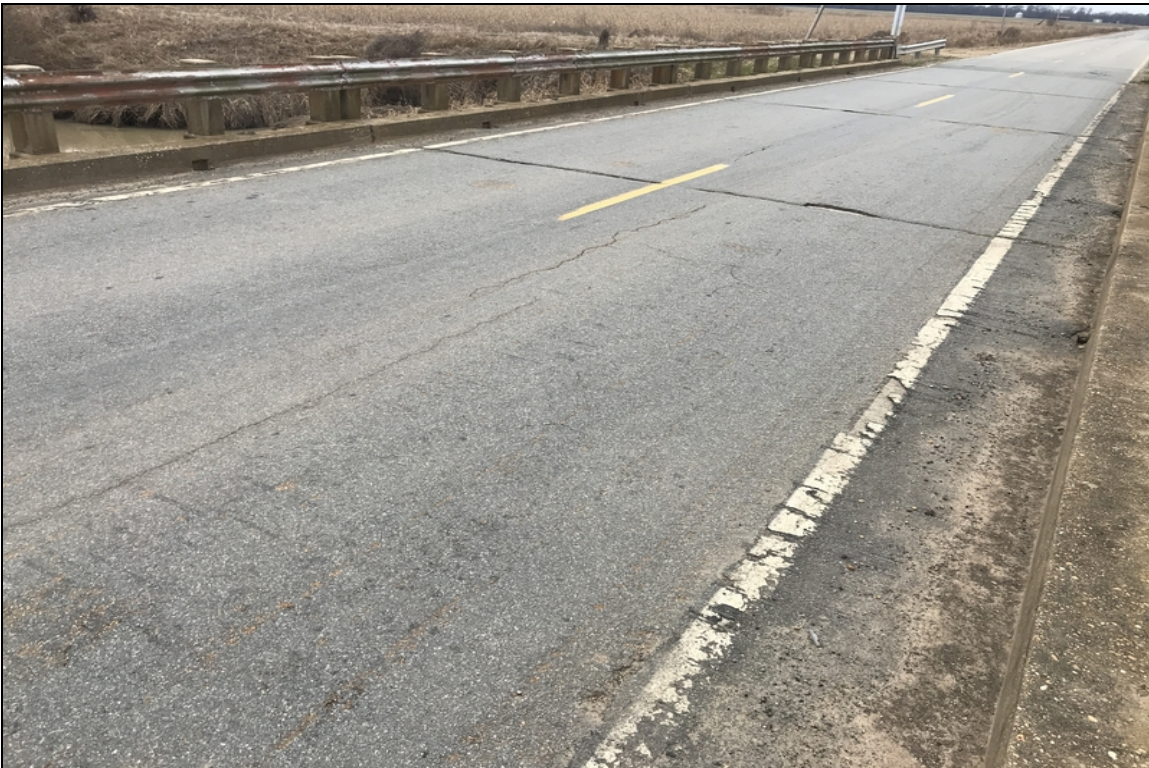
Deck - Spans 1-4: Typical

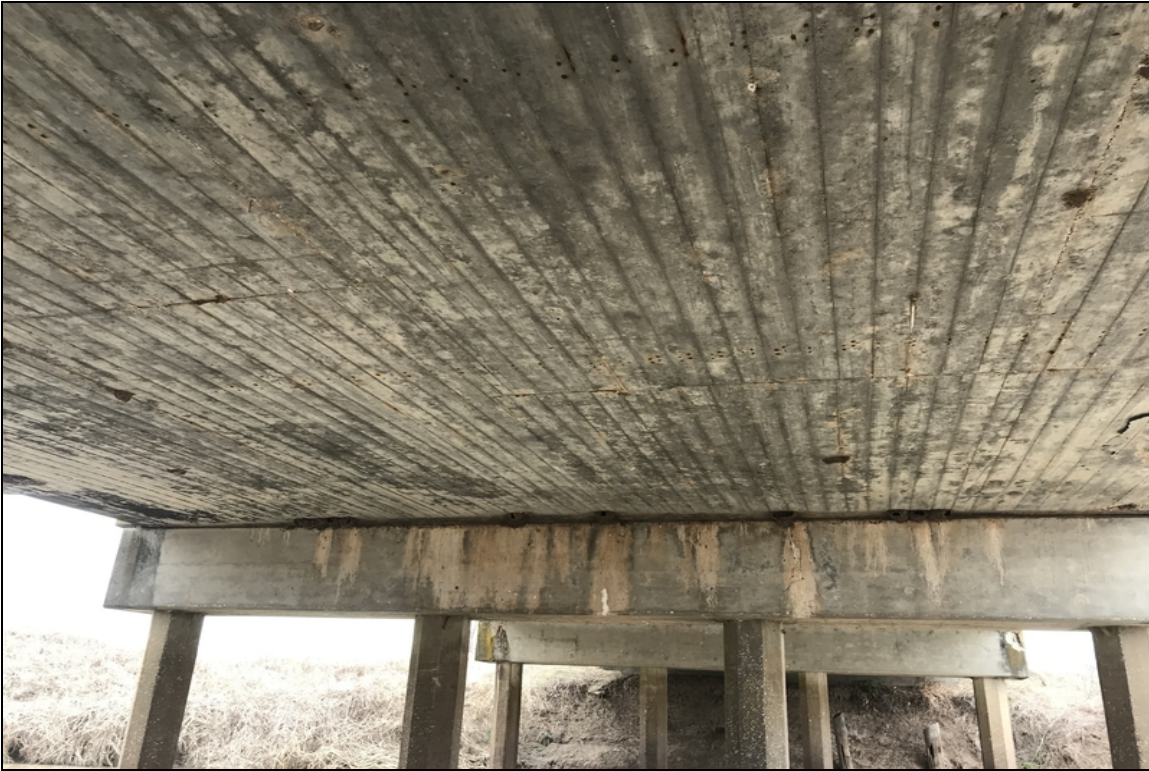
Soffit - Span 2: Typical

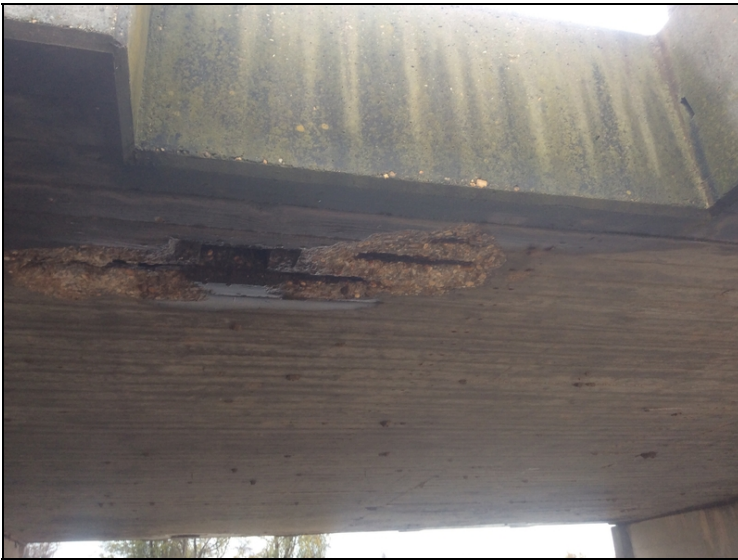
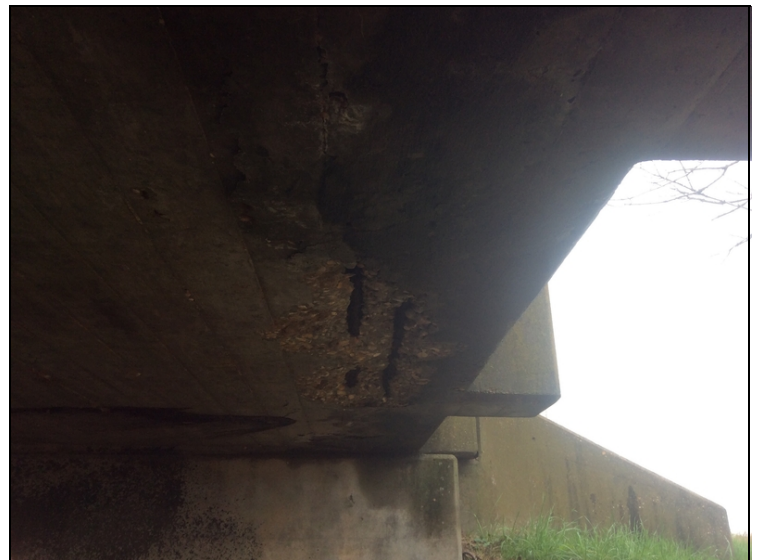
Soffit - all spans: Moderate to heavy deterioration/delaminations/spalling, around drains and along gutter-lines.

Span 2 first drain opening on outside of soffit but common on most drain openings

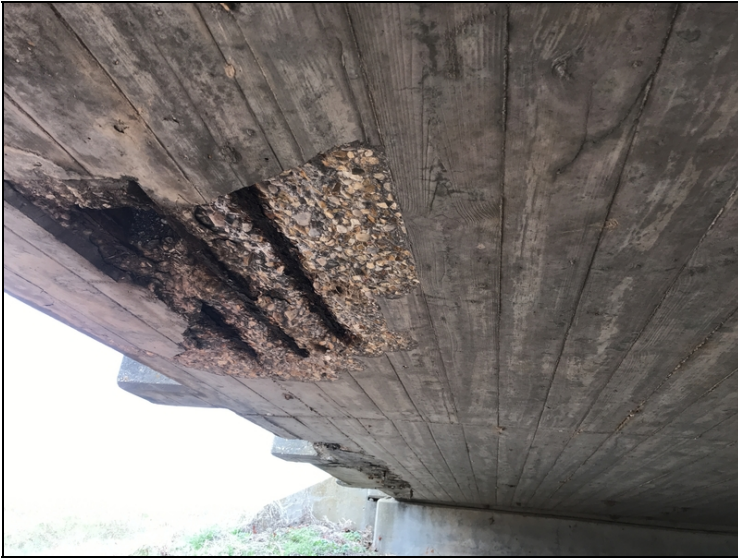
Soffit - Span 1 right: Rebar exposed

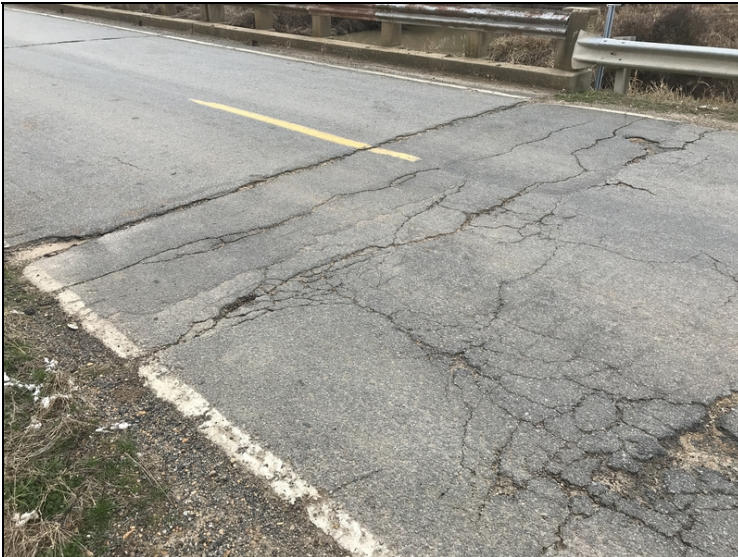
Moderate to large transverse cracking - especially at joints - with some material spalling up and leaving small potholes.

Approach roadway - Bent 1: Deterioration of wearing surface

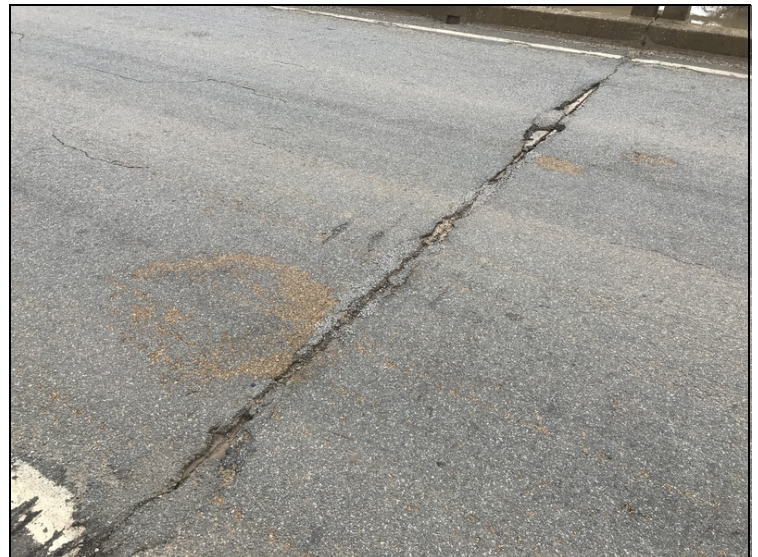
Joint - Bent 3: Deterioration of wearing surface (potholes)

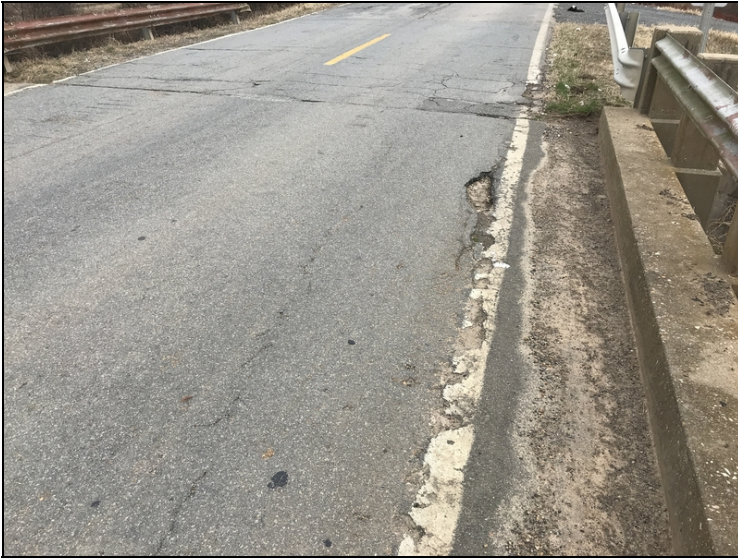
Span 4 right: Spalling of wearing surface (and deck) along edge-line.

Wearing surface/deck - Span 4 right: Spalling

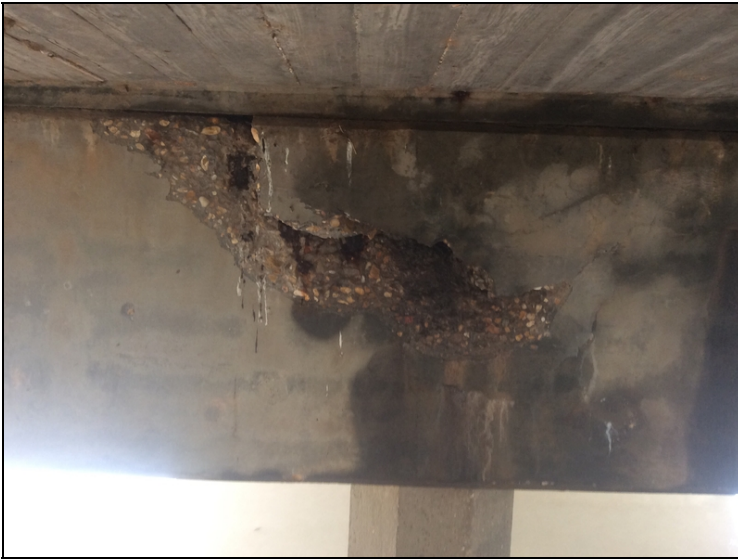
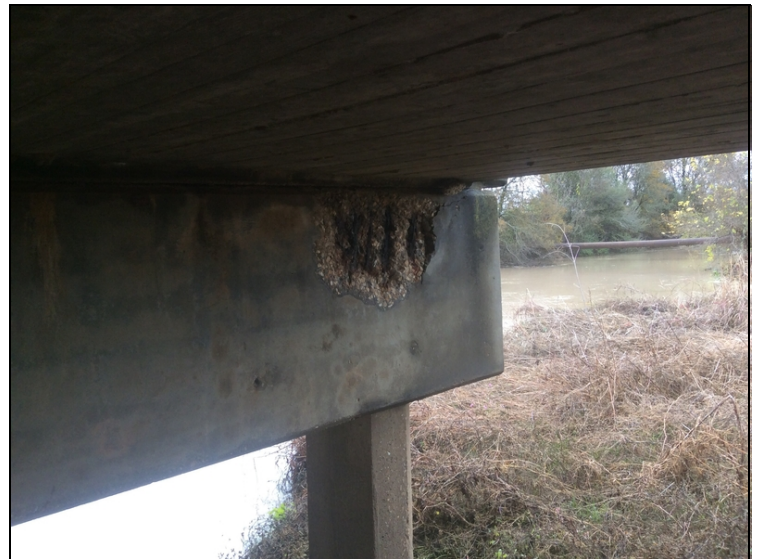
Caps – all bents: Some minor deterioration/cracking/delaminations/spalling (with rebar exposed) on faces of caps, with some light efflorescence - heaviest on Bent 2 back side.

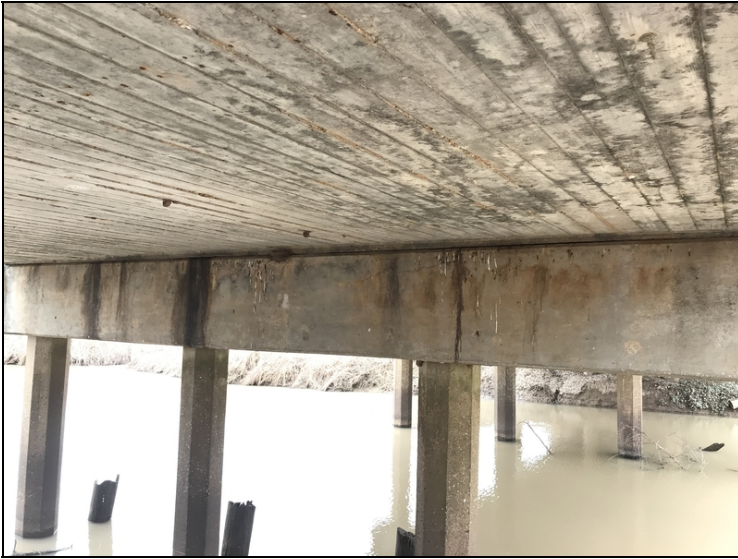
Cap - Bent 4 ahead: Cracking

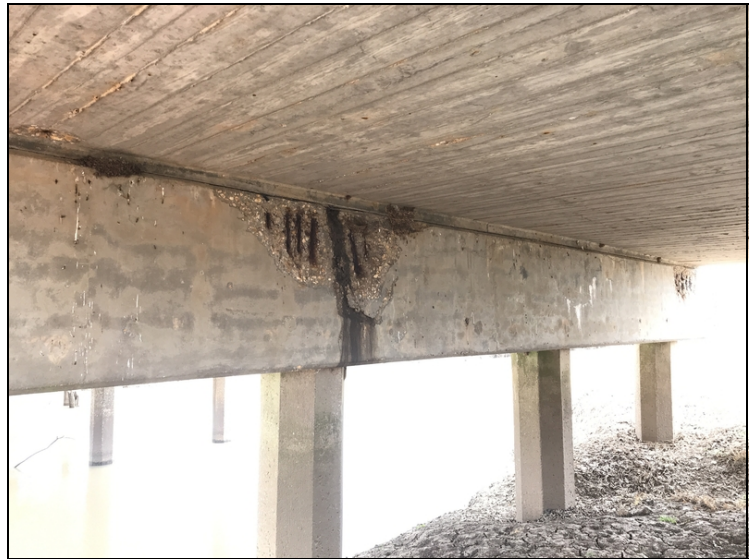
Cap - Bent 2 back: Rebar exposed

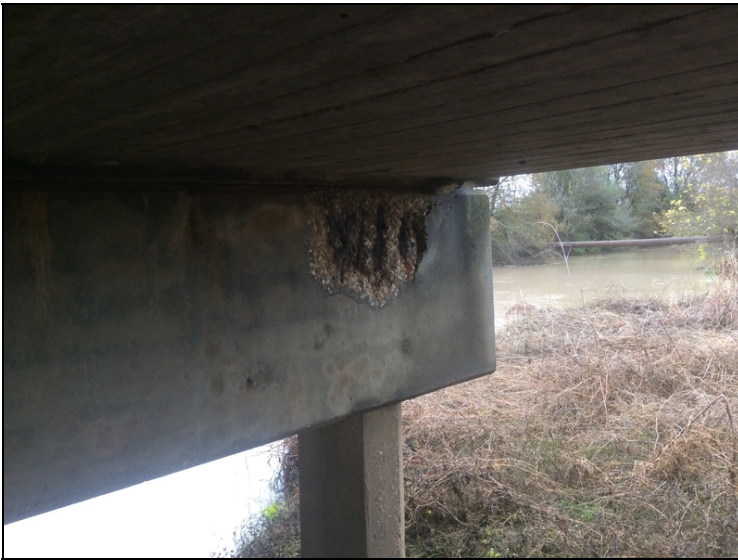
Spall with exposed rebar on bent 1 over pile 4

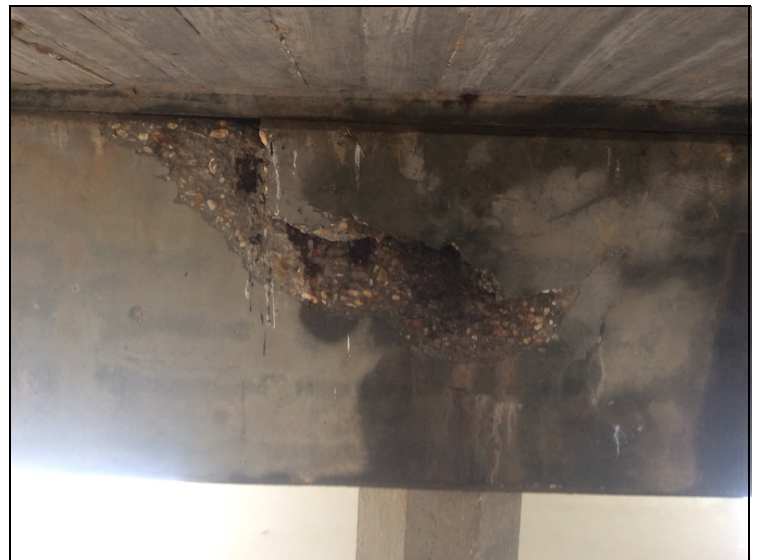
Crack Delams and spall with exposed rebar on bent 1 over pile 2&4
