Bridge #02895(Routine, Underwater type 2)

SH 114-02 LM 6.64 over Chotaw Bayou

Location: 0.5 M W SH 83-Gould

Team Lead: Greg Loomis Inspection Date: December 29, 2020

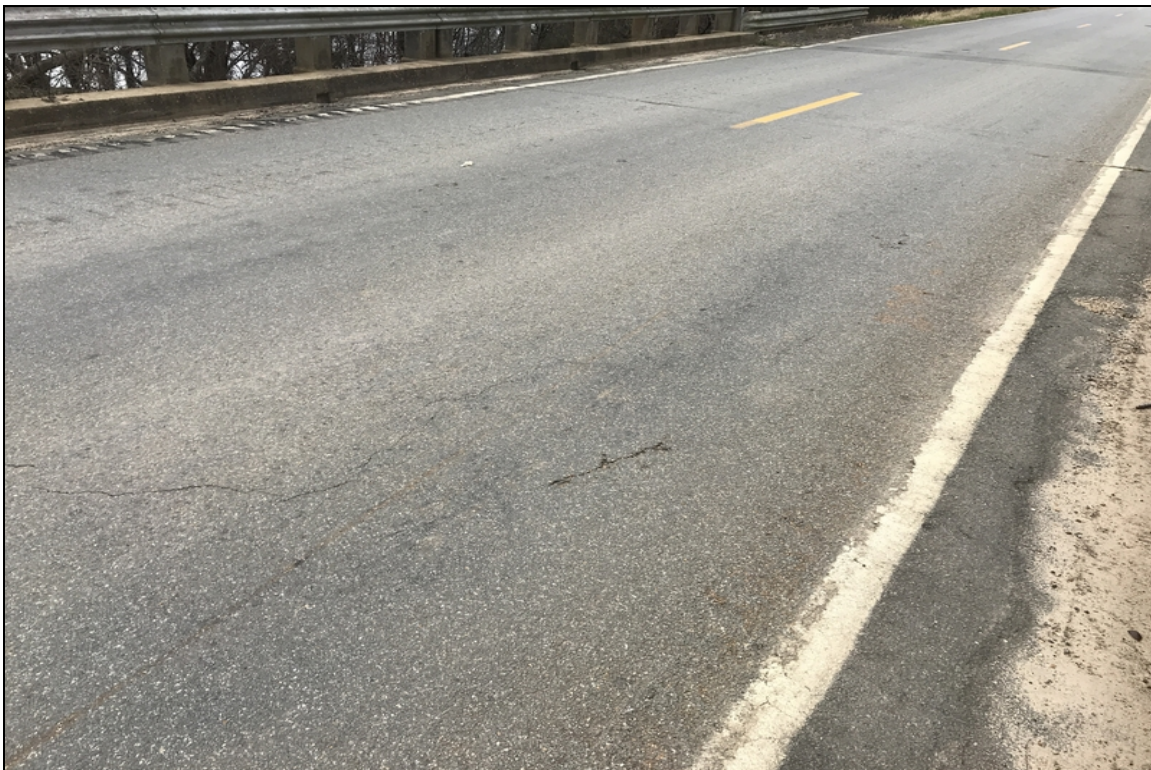
(38)							
Deck: 26'-6" wide x 56' long = 1484 sqft. Wearing surface: 22' wide x 56' long = 1232 sqft. Wearing surface - all spans: Some scattered minor- to moderate-sized cracking, mainly in wheel ruts. with some minor-sized transverse cracking at joints.							
Soffit - all spans: Some minor deterioration around drain holes.							
215	Reinforced Concrete Abutment	LF	69	52	17	0	0
1080	Delamination/Spall/Patched Area	LF	1	0	1	0	0
1090	Exposed Rebar	LF	1	0	1	0	0
6000	Scour	LF	15	0	15	0	0

Deck - Spans 1-2: Typical

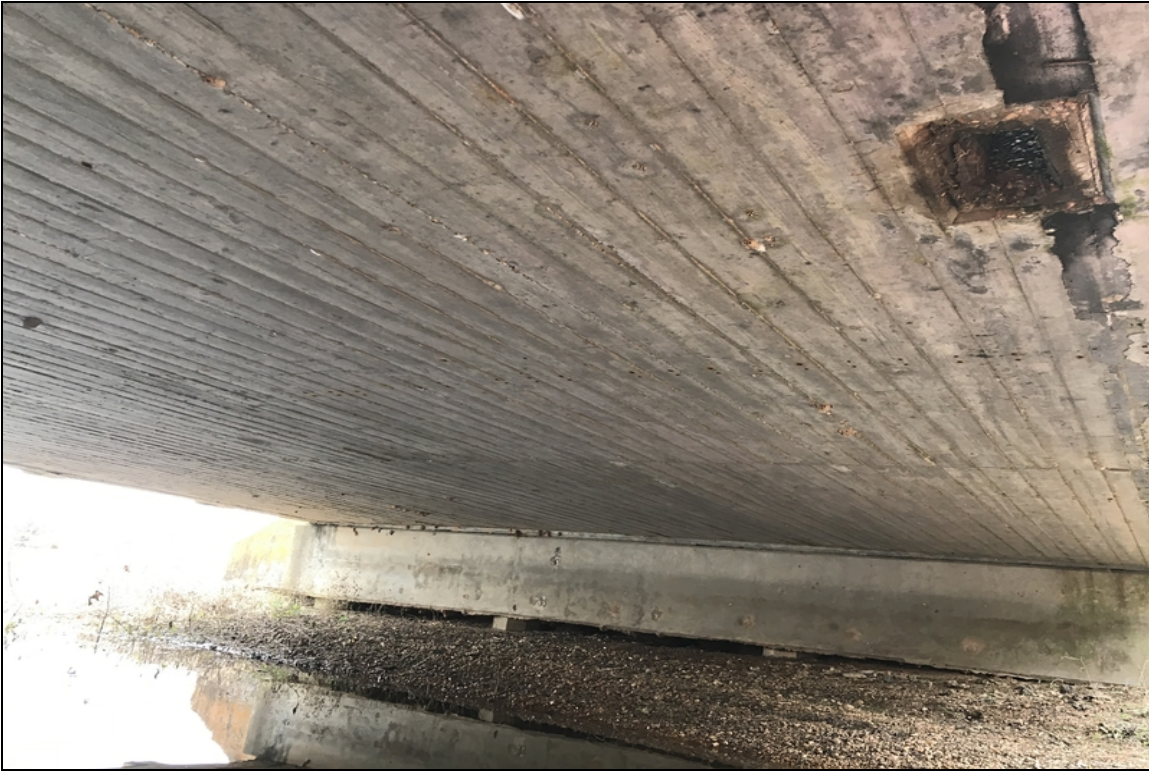
Soffit - Span 2: Typical

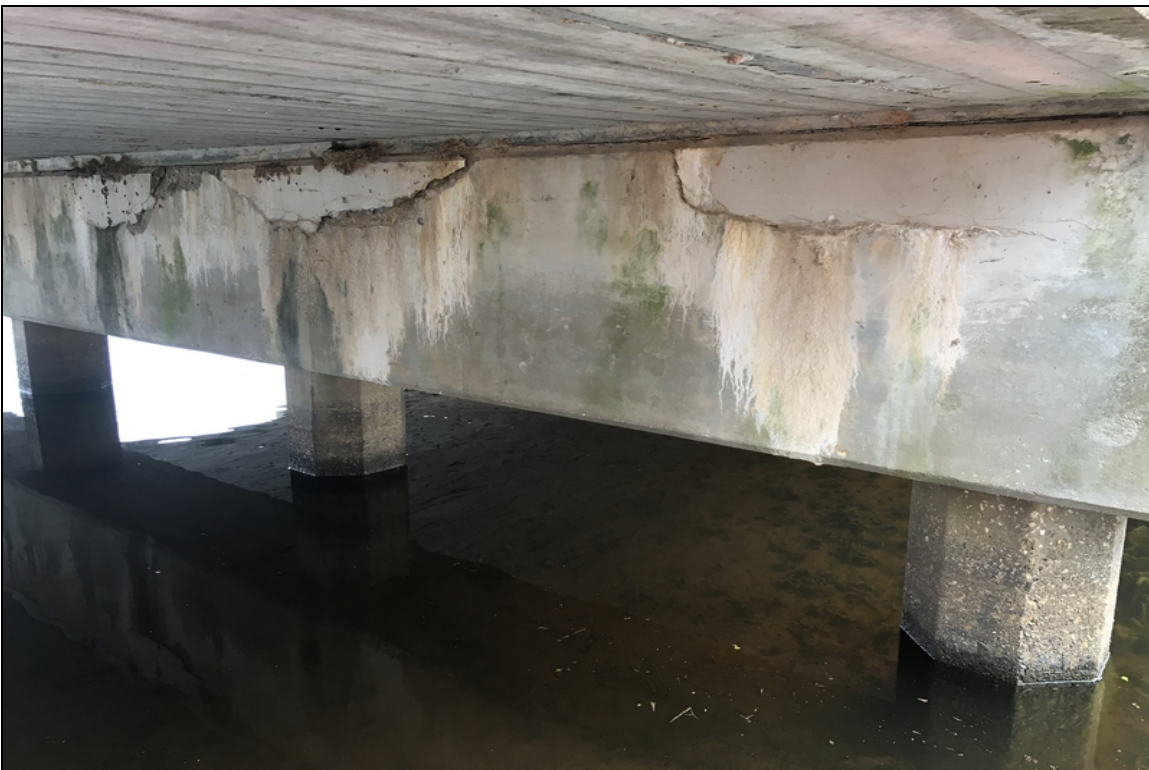
(234)							
Cap: 27'-6" = 28' each / Bent 2. Bent 2: Some minor cracking/delaminations/spalling on back face of cap, with some efflorescence on ahead face.							
301	Pourable Joint Seal	LF	24	0	0	24	0
2350	Debris Impaction	LF	24	0	0	24	0

Cap - Bent 2 back right: Cracking/delamination

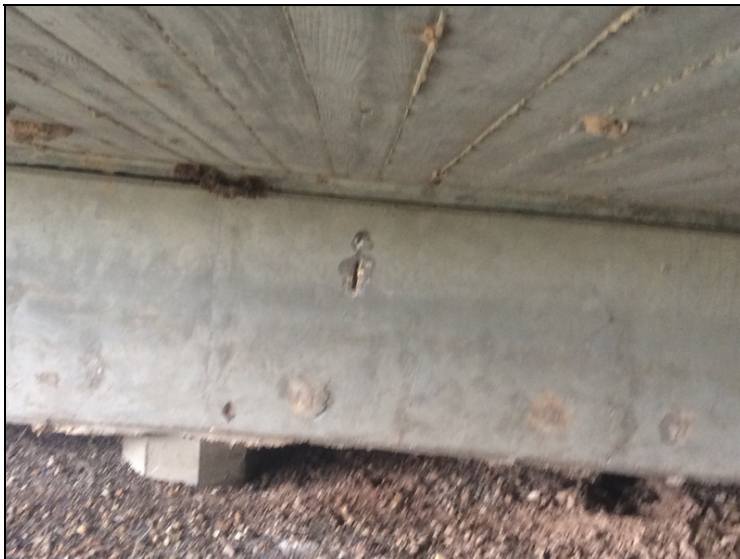
Bent 3: Very small spall with rebar exposed.

Abutment bent 3 spall with exposed rebar

Date Reported: 01/26/2011
Priority: D- Routine
Type of Work: Repair
Status: Monitor
Component: 234 - Reinforced Concrete Pier Cap

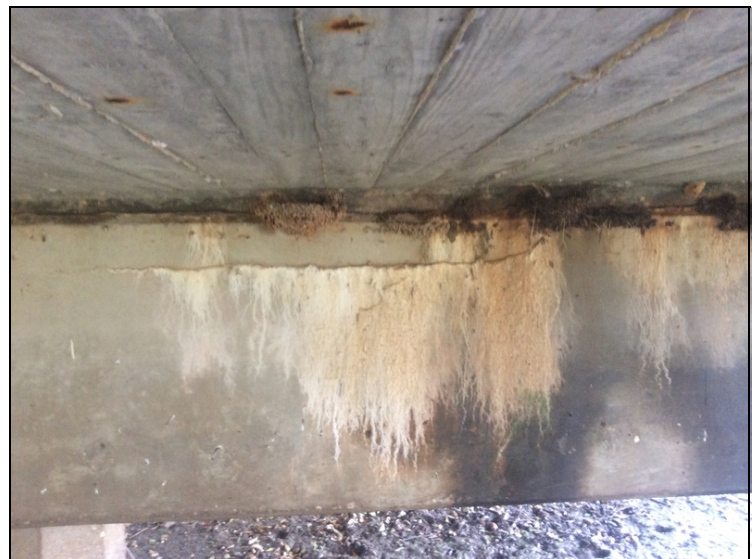
Bent 2: Some minor cracking/delaminations/spalling on back face of cap, with some efflorescence on ahead face.

Cracks with with efflorescence on cap 2 behind

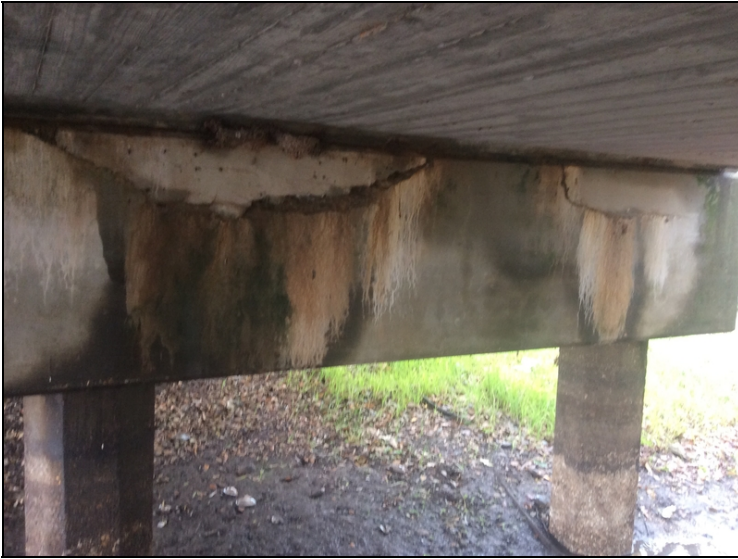
Bent 2 cap has spalls and Delams.

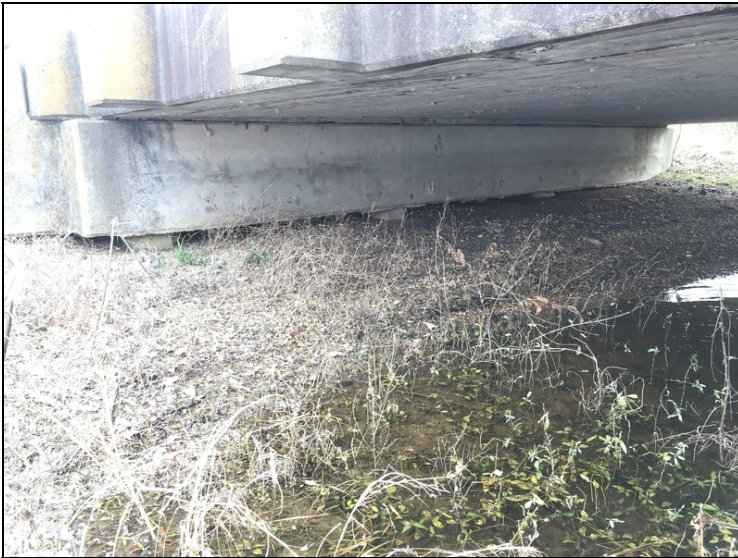
End-slope - Bent 3: Some minor (4-6") of settlement under abutment cap, mainly from center to left side.

Abutment - Bent 3: Settlement of end-slope

Date Reported: 12/29/2020
Priority: D- Routine
Type of Work: Repair
Status: Open
Component: Approach

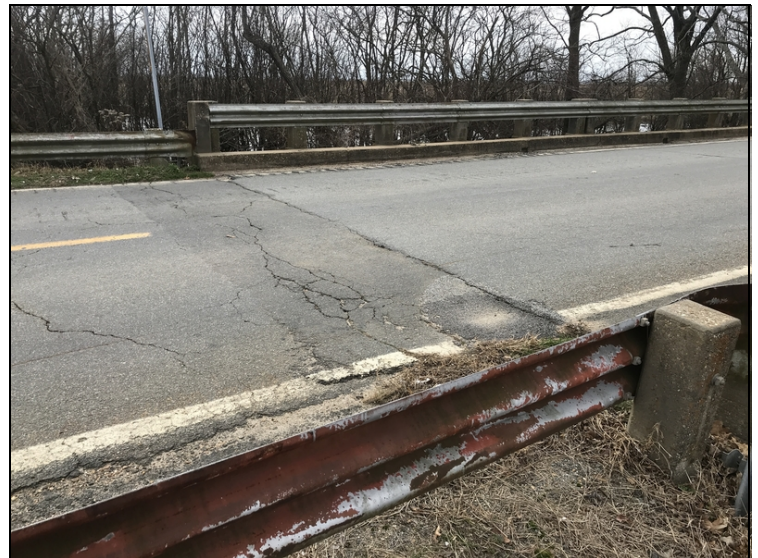
Approach roadway - Bent 3: Some deterioration/cracking of asphalt wearing surface with some settlement in wheel ruts of left lane right at bridge end.

Approach roadway - Bent 3:
Deterioration/settlement
