Bridge #02896(Routine, Underwater type 2)

SH 114-02 LM 8.46 over Gould Ditch

Location: 0.5 Mi W US 65-Gould

Team Lead: Greg Loomis Inspection Date: September 01, 2020

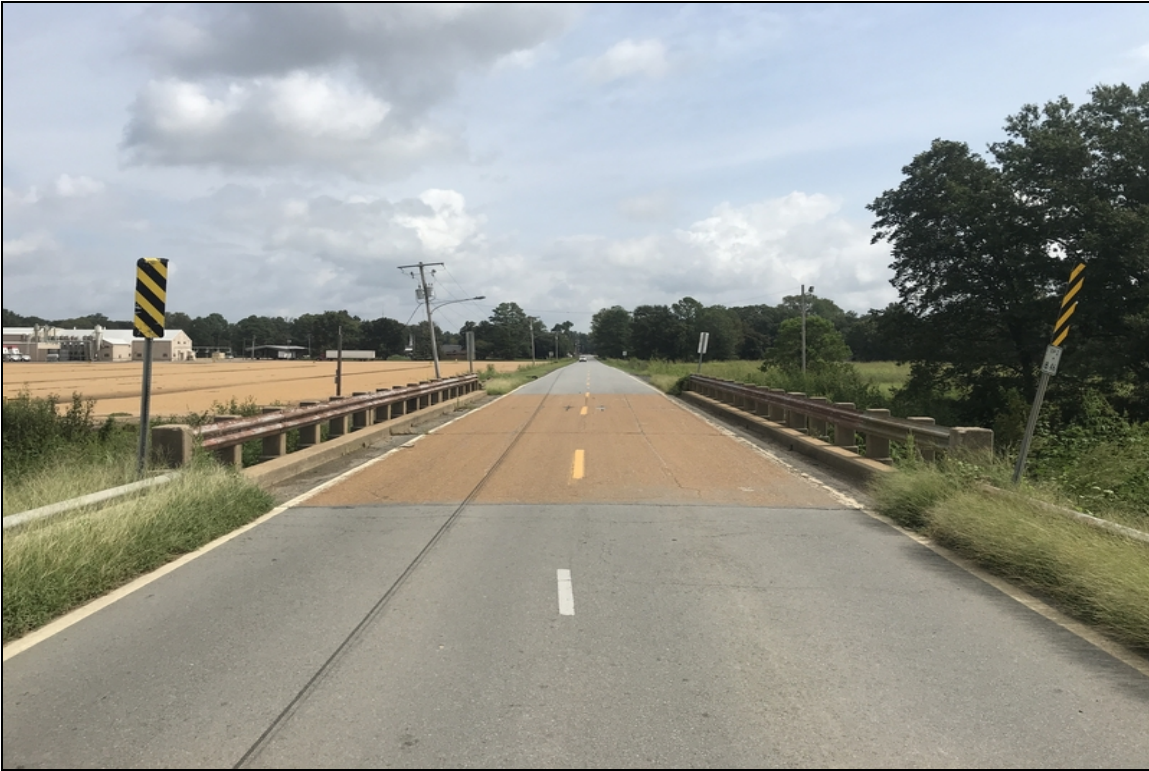
Roadway view

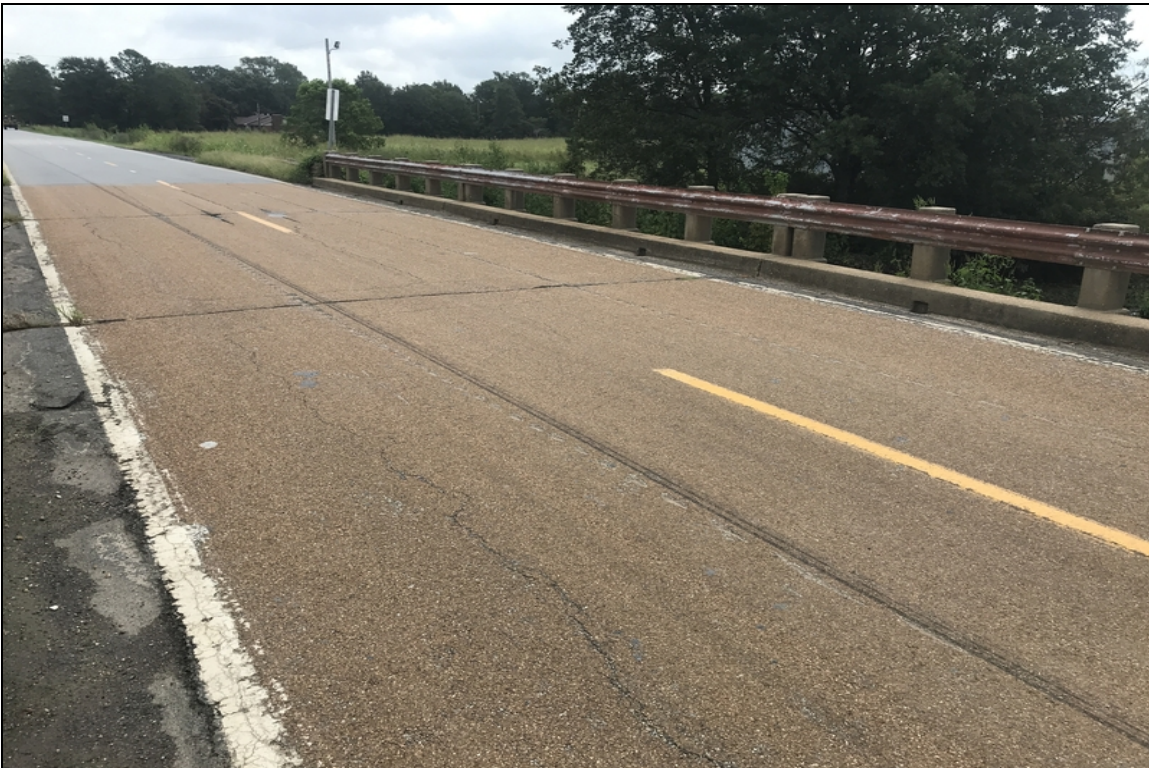
Deck - Spans 1-3: Typical

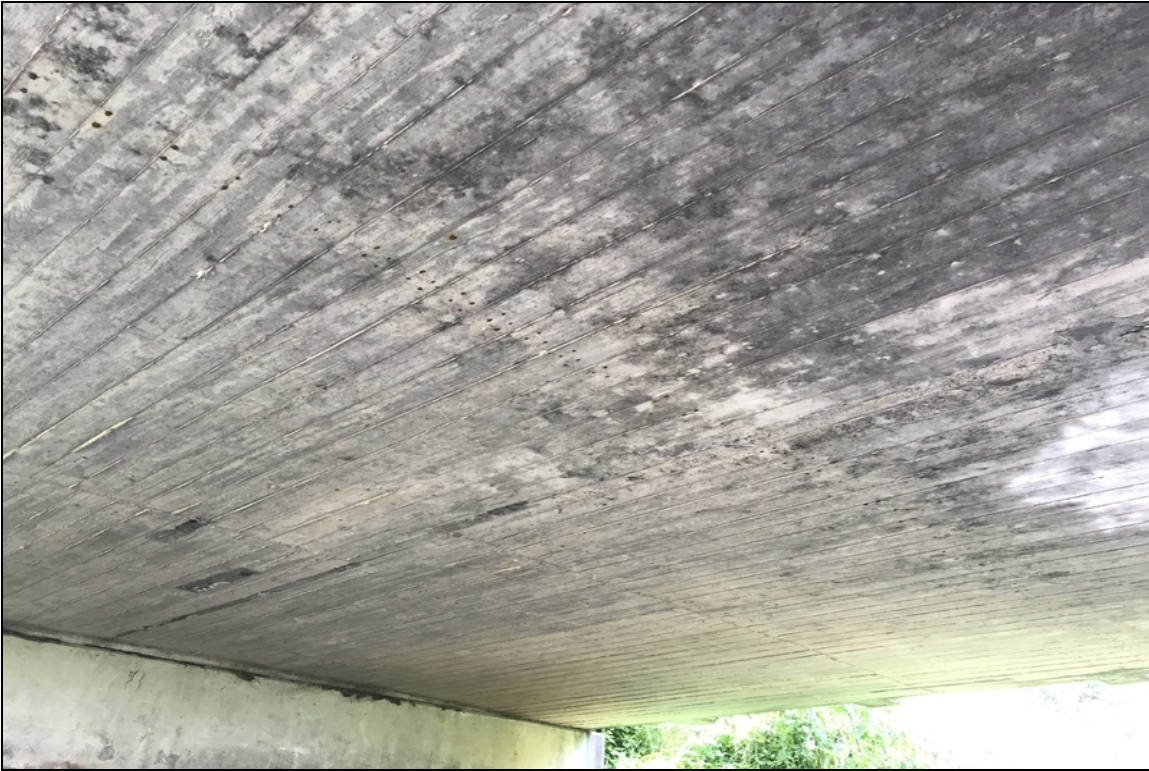
Soffit - Span 3: Typical

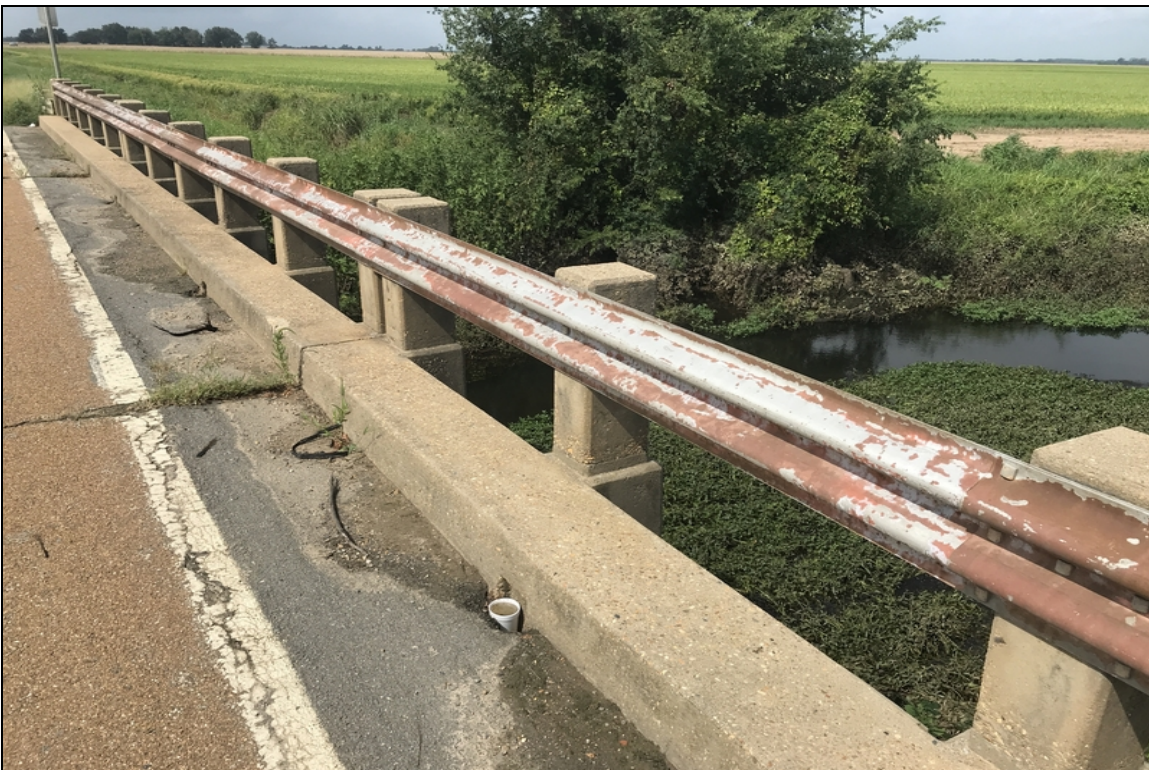
ELEM	DESCRIPTION	UNITS	TOTAL	CS1	CS2	CS3	CS4
	Railing: 84' each side. Coating: 2.5 square feet per linear feet of railing. Metal railing on concrete posts. Paint deteriorating with some primer showing through and freckled rust starting to form on metal railing.

Railing - Spans 2-3 left: Paint peeling

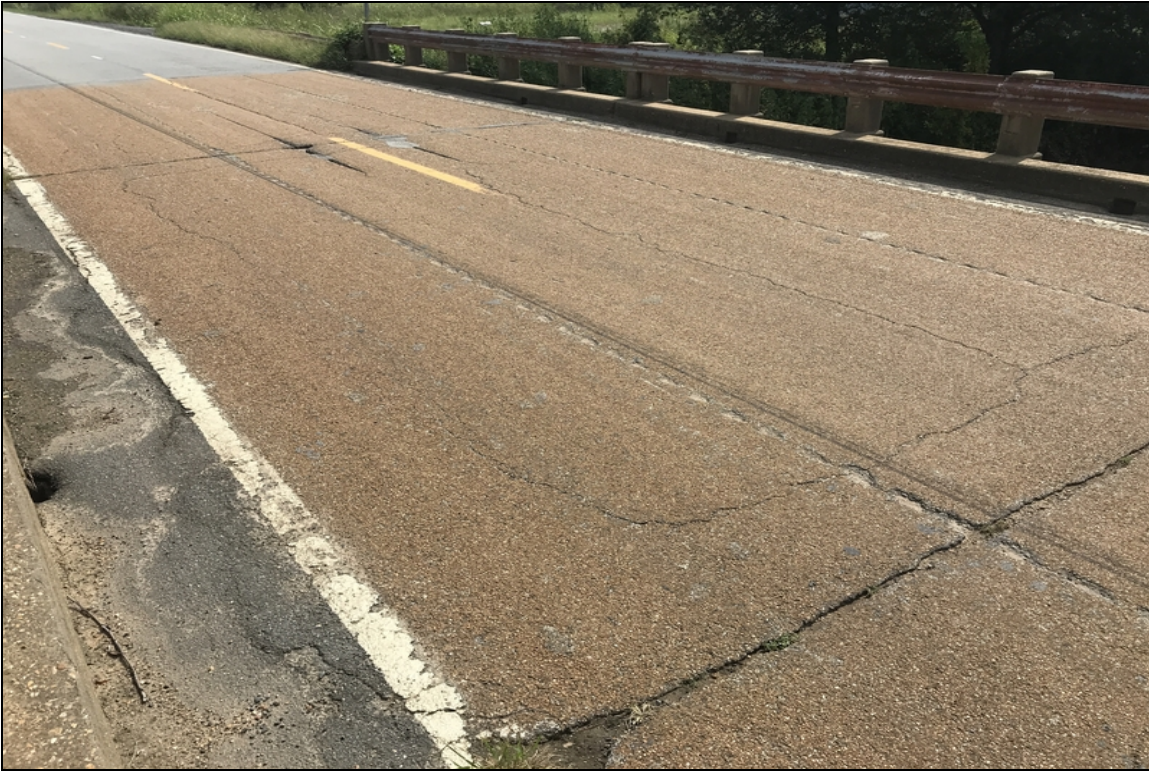
Wearing surface - Span 2: Cracking

Asphalt wearing surface - all spans: Some longitudinal cracking with a few transverse crack close to bents - heaviest cracking on Spans 2 & 3.
A couple areas with gouges from farming equipment - and some spalling up/patching at Bent 3.

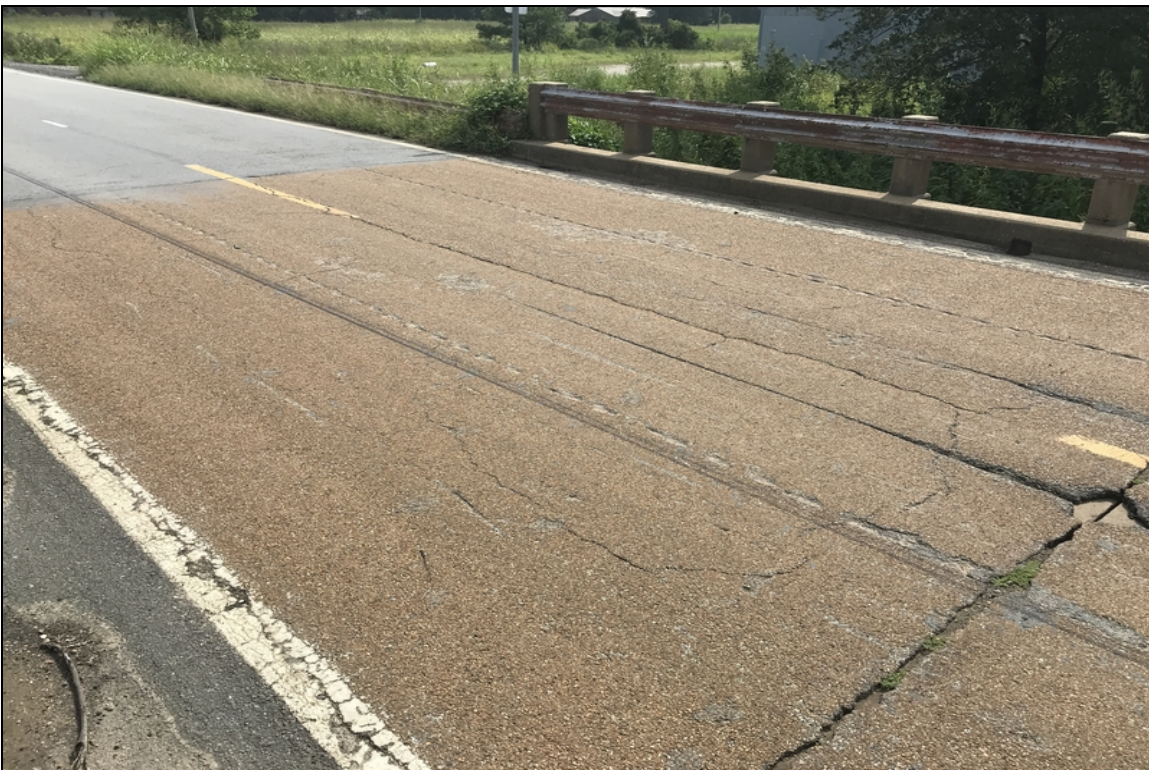
Wearing surface - Span 3: Cracking

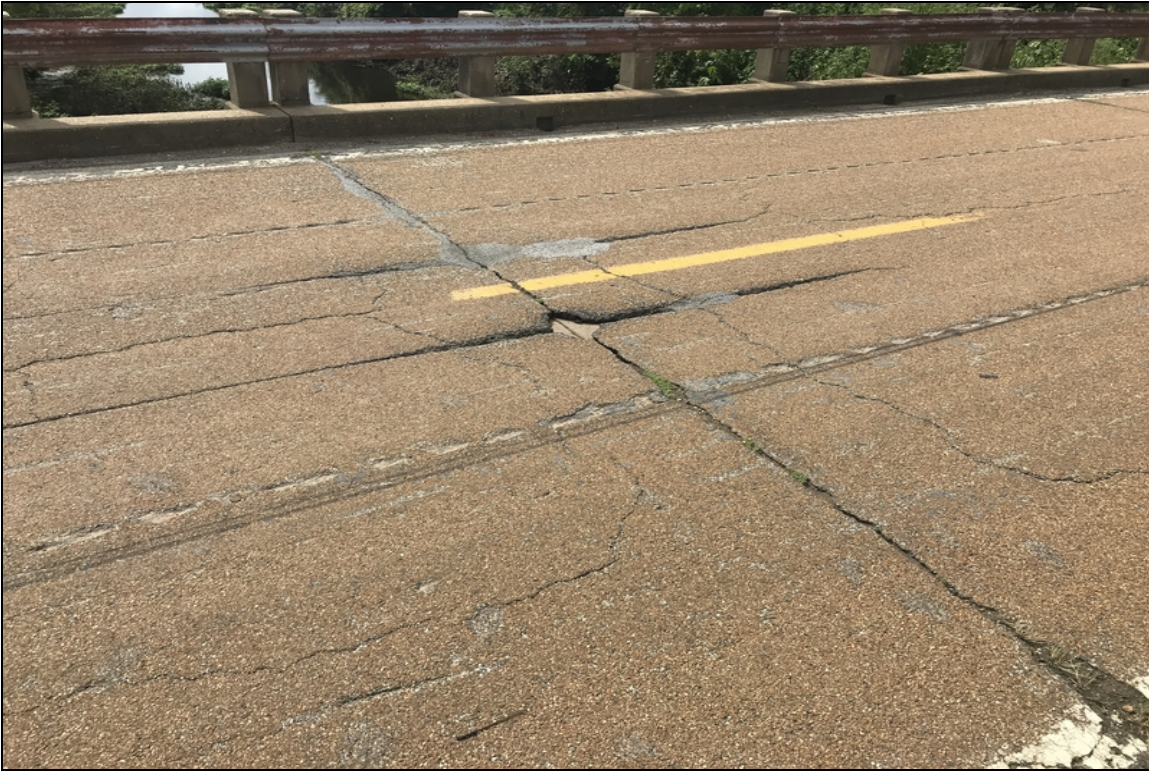
Wearing surface @ Bent 3: Cracking/spalling

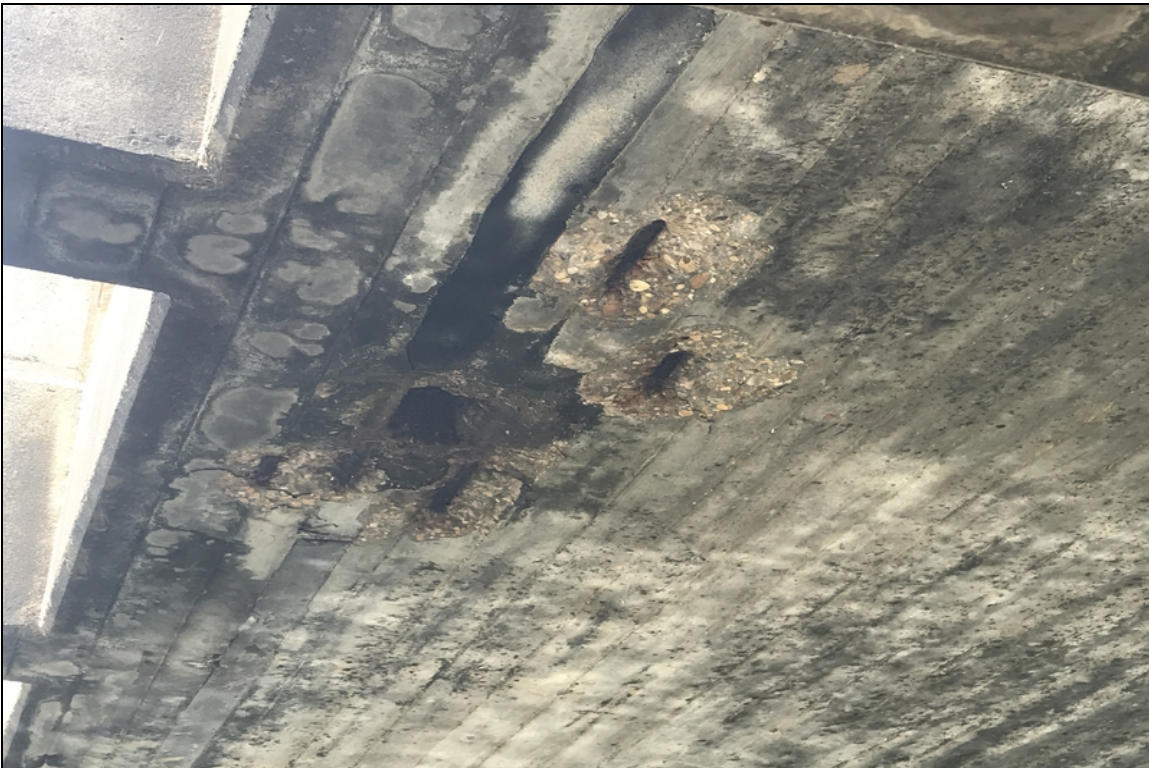
Soffit - Span 2 right: Exposed Rebar @ drain

Soffit: Some deterioration, delamination, and minor spalling (some steel exposed with minor section loss) around drains and along gutterlines.

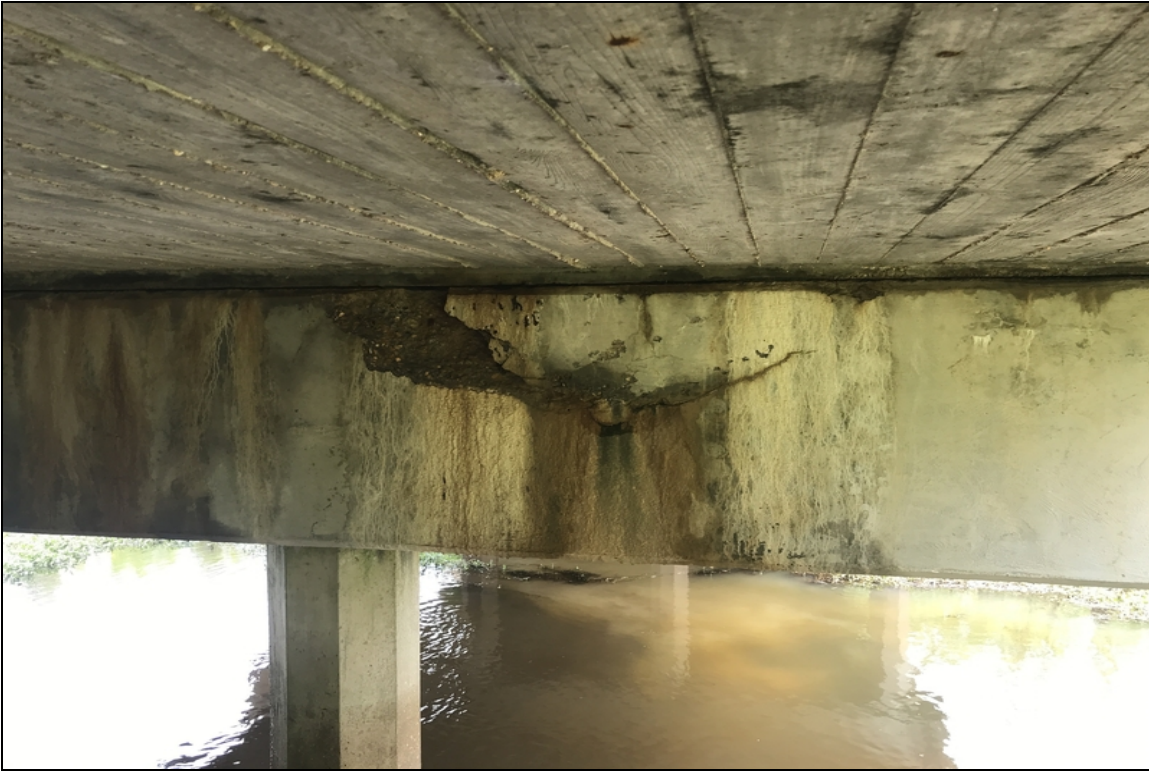
Cap - Bent 2 back right: Spalling/delamination

Bent 2 back: Area of delamination with minor spalling around edges over Pile 4 (3')
Some hairline-sized horizontal cracks with minor efflorescence on remaining caps.

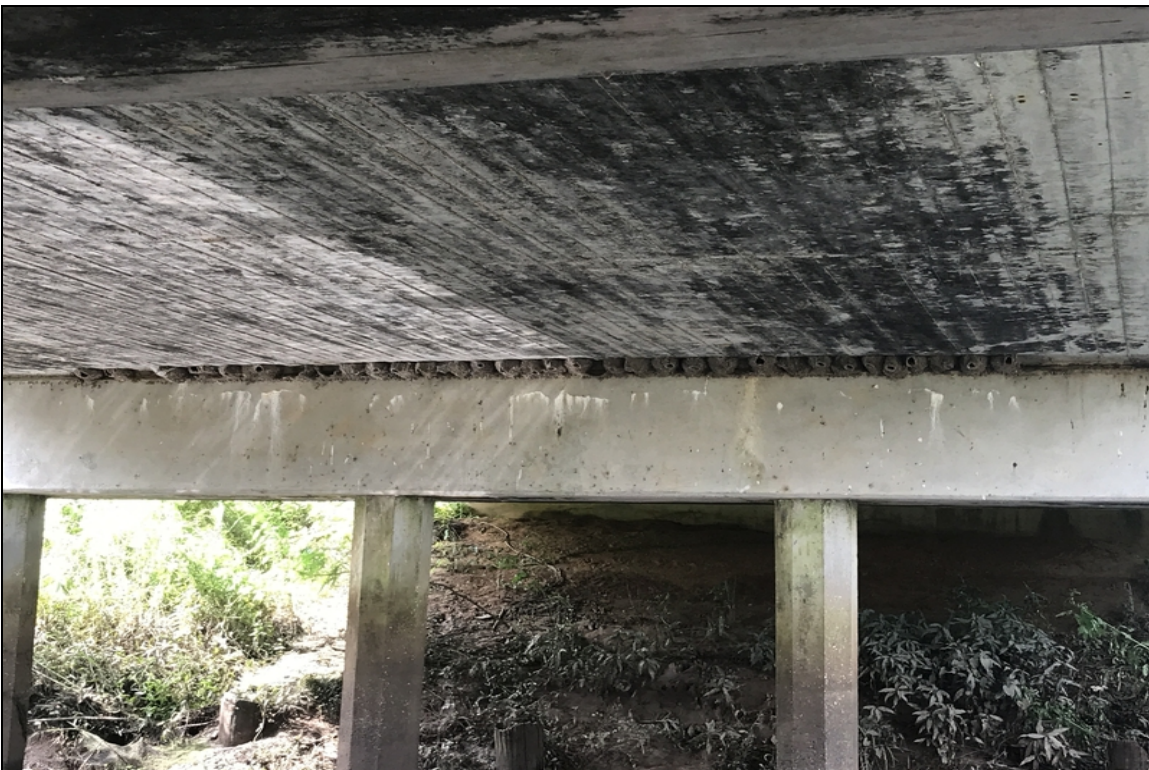
Cap - Bent 2 ahead: Efflorescence

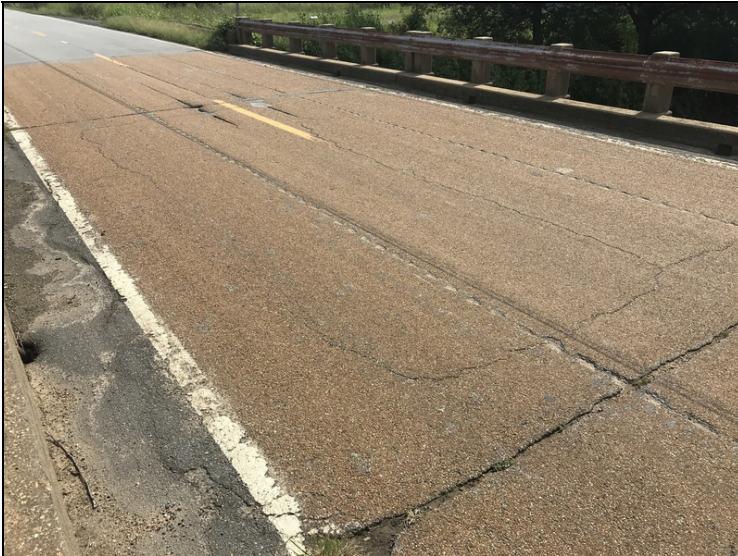
Wearing surface - Span 2: Cracking

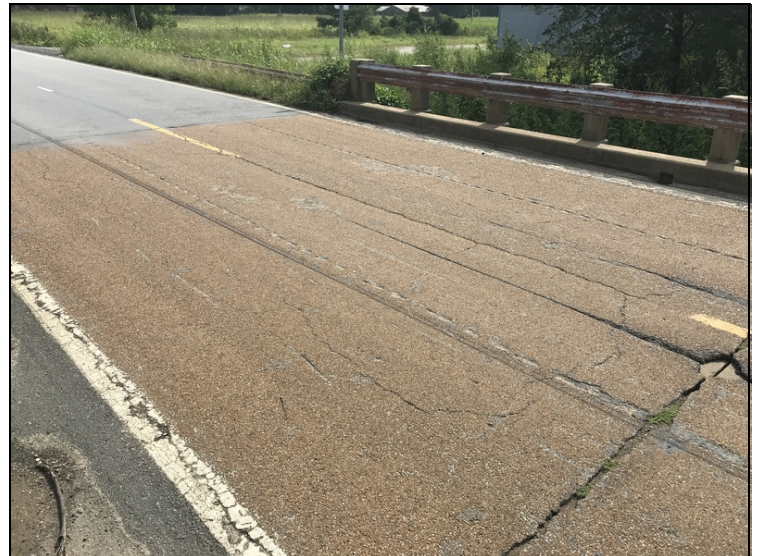
Wearing surface - Span 3: Cracking

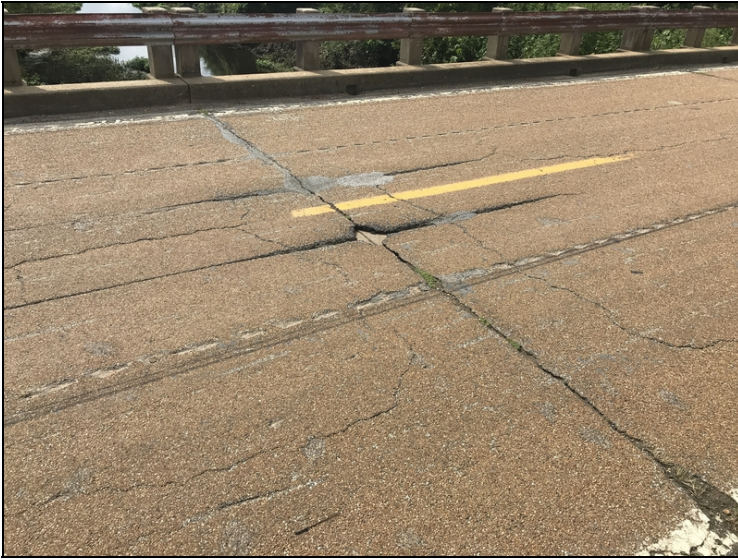
Wearing surface @ Bent 3: Cracking/spalling

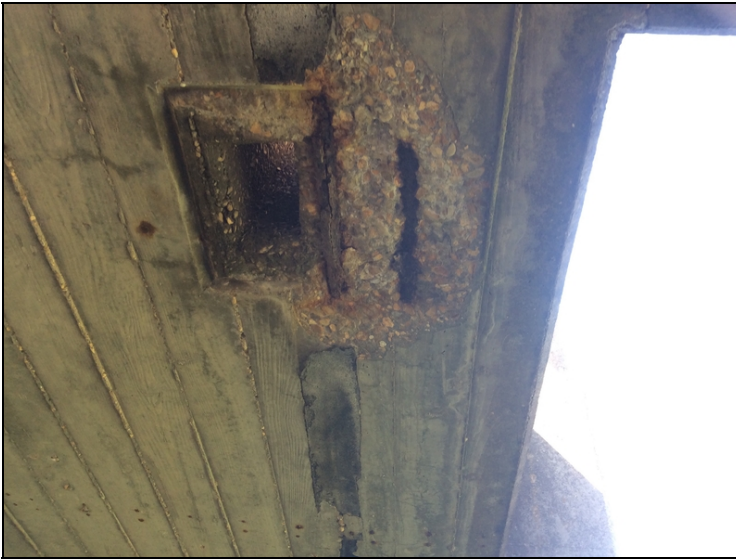
Delams with exposed steel around drains

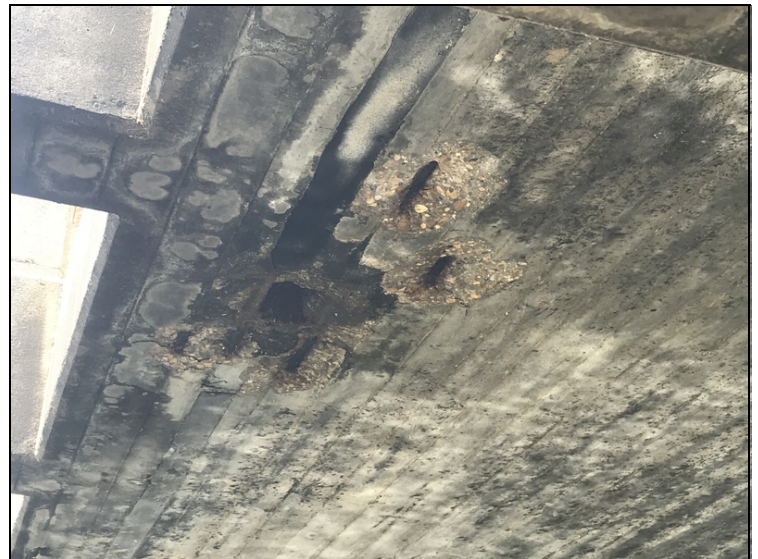
Soffit - Span 2 right: Exposed Rebar @ drain

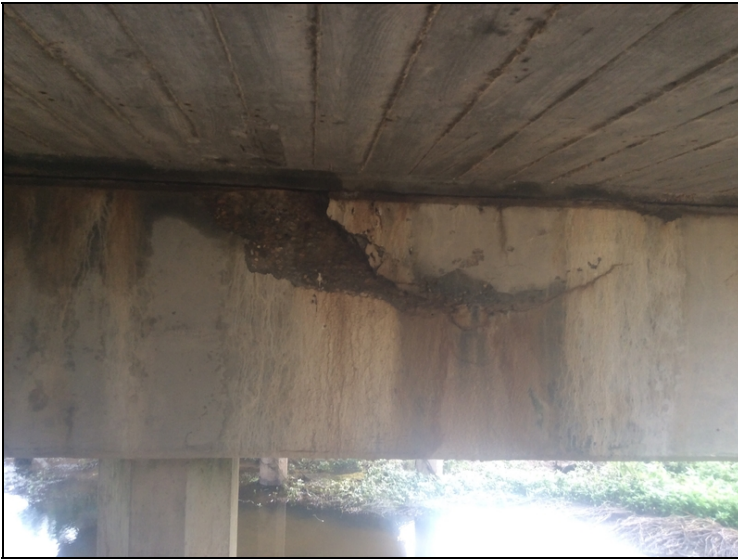
Bent 2 back near mid span has delam.

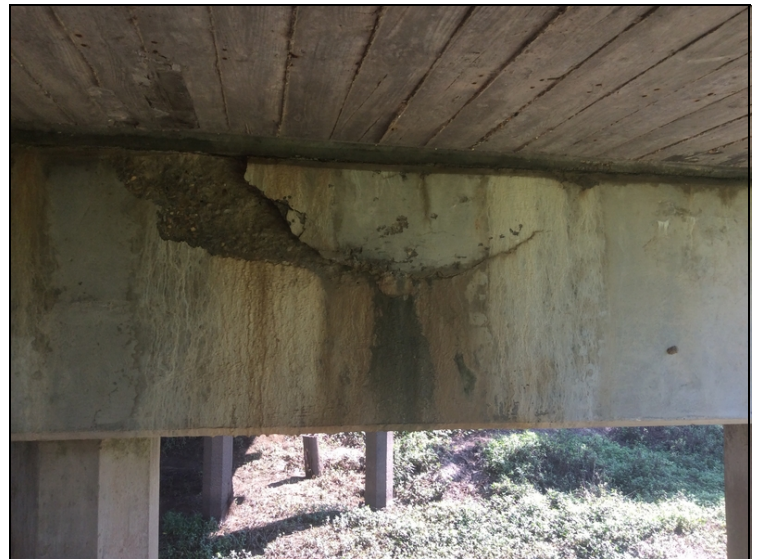
Large Delam on bent 2 cap .

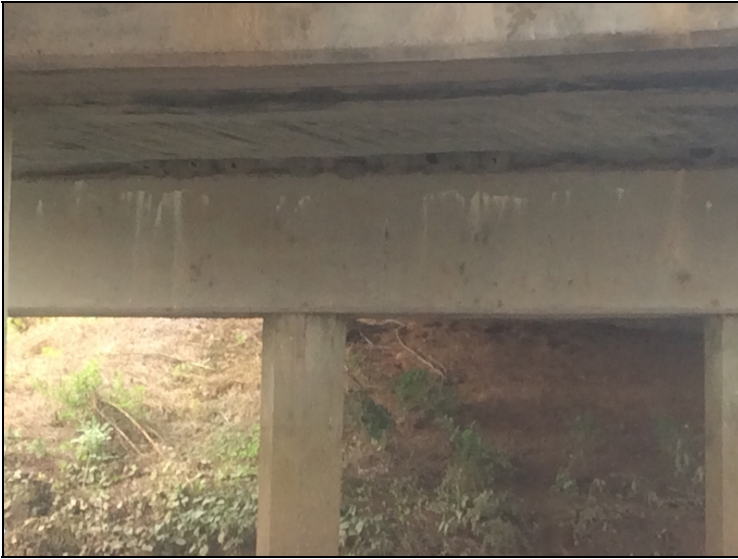
Large cracks with efflorescence on bent 2 cap ahead.

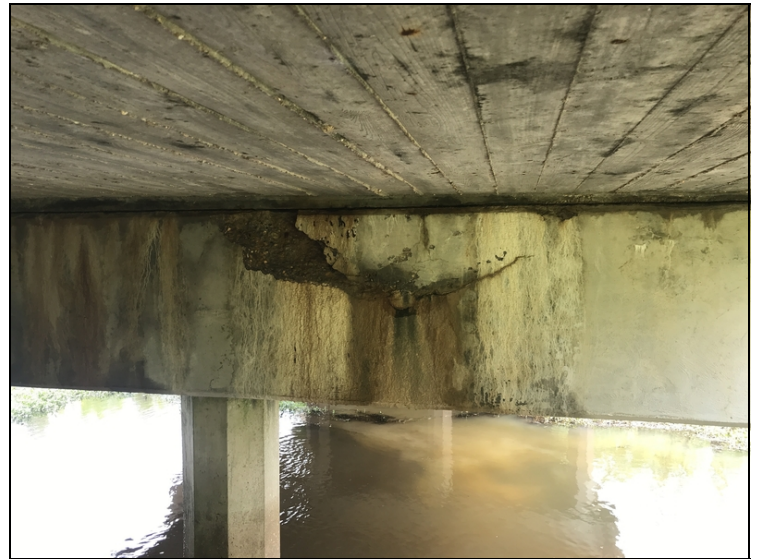
Cap - Bent 2 back right: Spalling/delamination

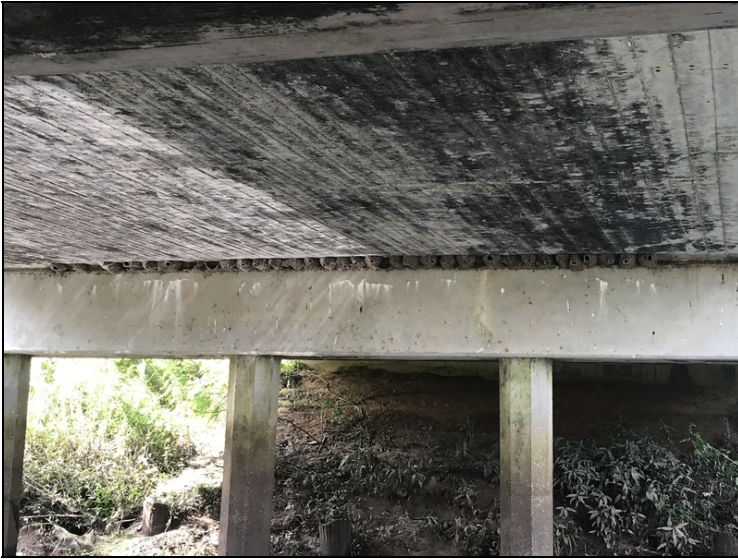
Cap - Bent 2 ahead: Efflorescence
