Asset #A5500(Routine)

I-530 SB LM 33.77 over US 270

Location: @ US 270-White Hall

Team Lead: Sharon Hooks, Inspection Date: 10/10/2022

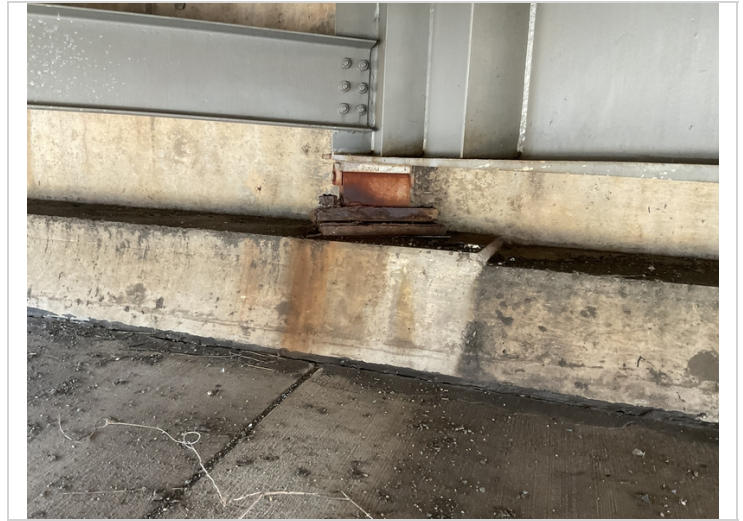
Bent 4 Bearing 3 has heavy flaking rust to masonry plate.

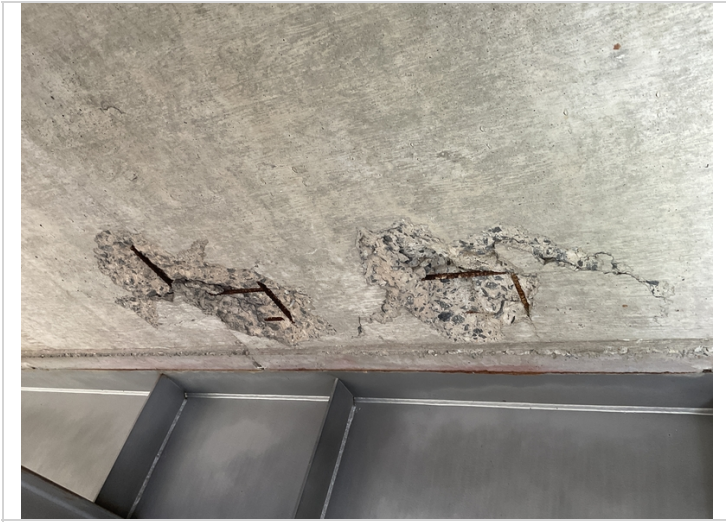
Span 1 at Bent 2 has spall with exposed rebar on under side of deck between girders 2&3.

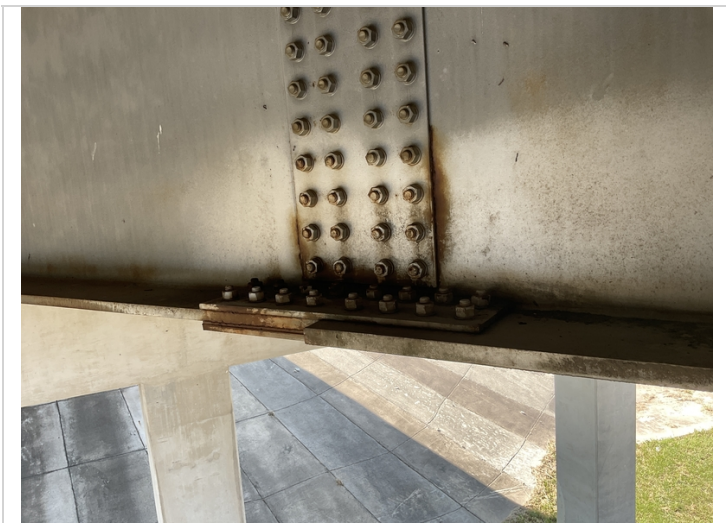
Span 2 girder 2 left at second splice plate ahead of Bent 2 has heavy rust and corrosion to lower web and flange.

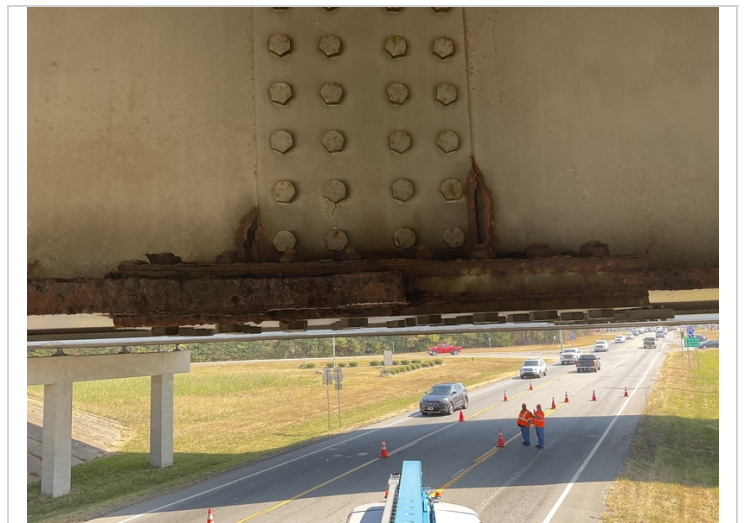
Span 2 girder 2 right at second splice plate ahead of Bent 2 has heavy rust and corrosion to lower web and flange. Pack rust forming between girders and built up members.

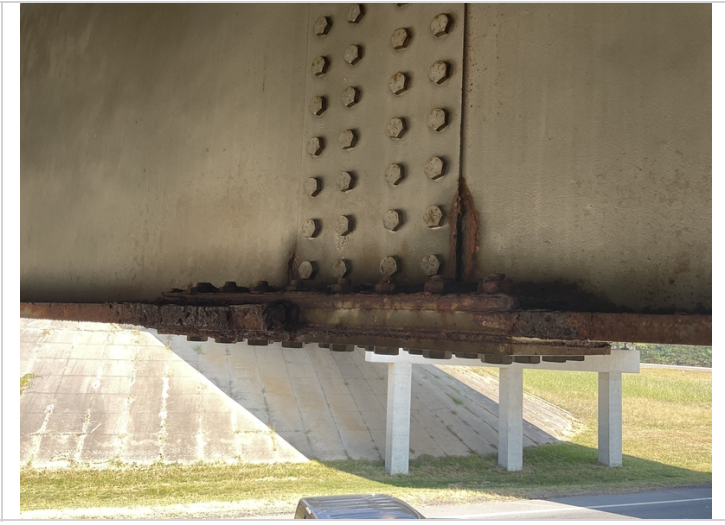
Span 2 girder 2 right at second splice plate ahead of Bent 2 has heavy rust and corrosion to lower web and flange.

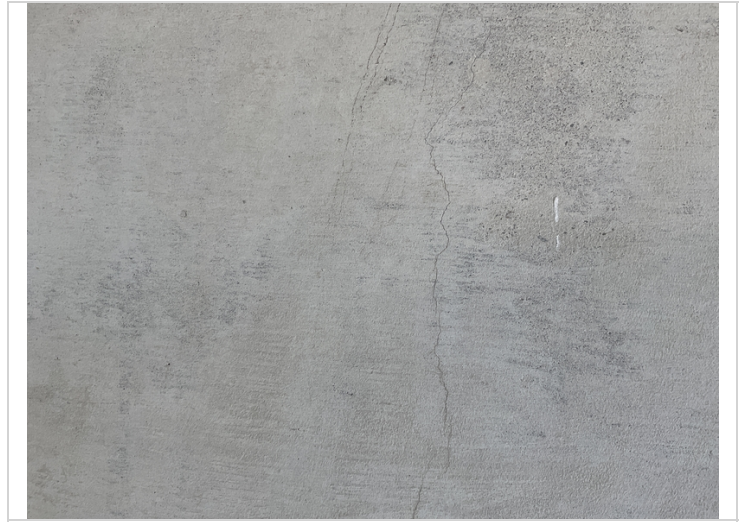
Bent 3 cap back has hairline vertical cracks.

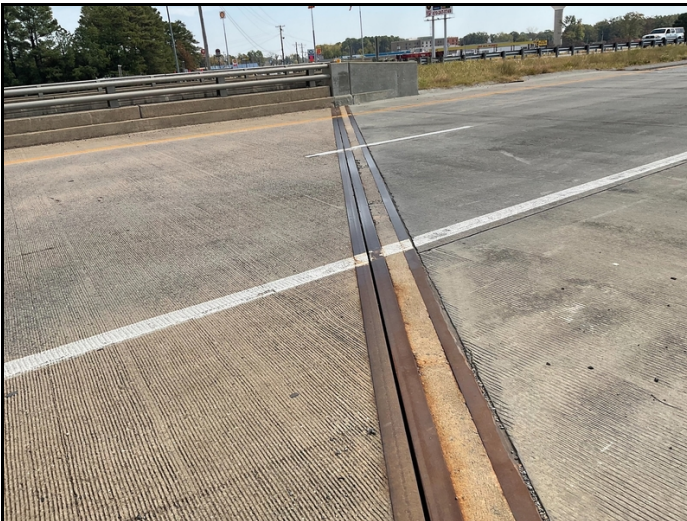
Bent 4: Joint material missing from middle of right (outside) lane onto right shoulder, allowing stormwater to leak through onto ends of girders, bearings and top of cap.

Bent 4 joints seal is missing.

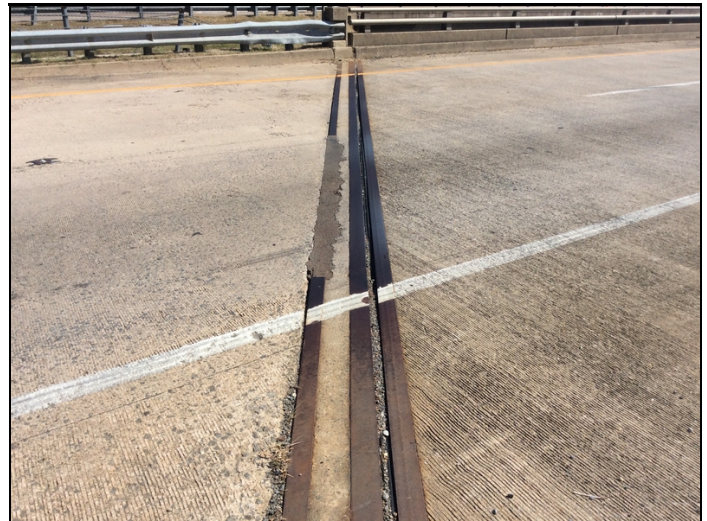
Bent 1: Joint material is beginning to lose adhesion and sag in various locations and is allowing stormwater to leak through at times.

Joint - Bent 1 (leaking)

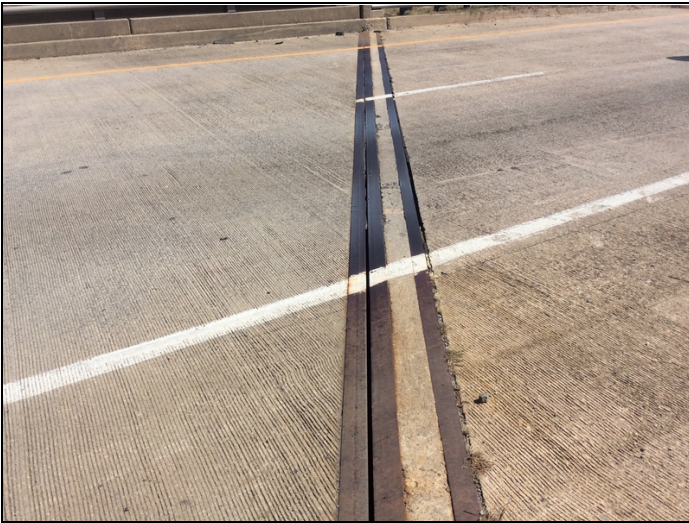
Joint - Bent 4 (loss of adhesion)

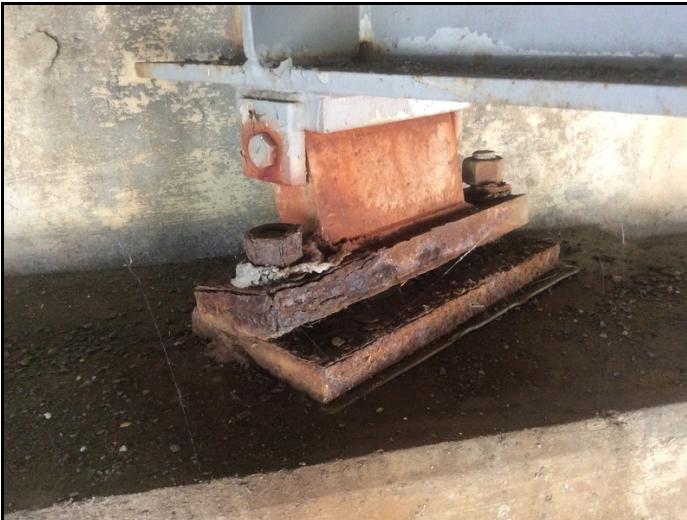
Bearings – Bents 1 & 4: Paint peeling with some rust beginning – heaviest at Bent 4 – with some pack rust under rockers, somewhat restricting movement.

Bent 4 Bearing 3 (corrosion)

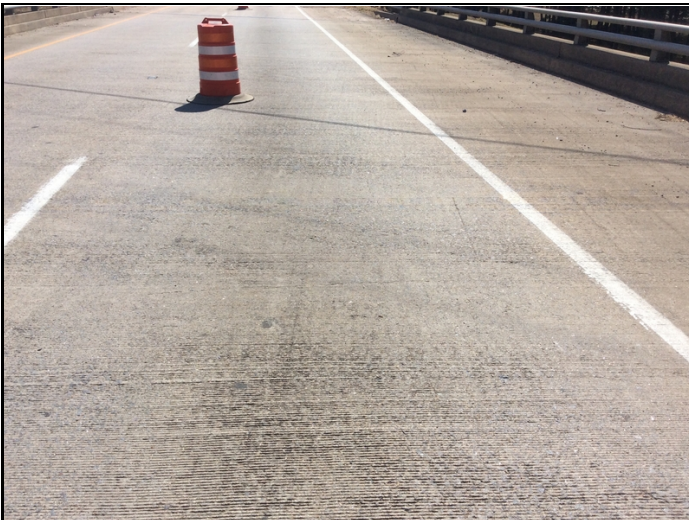
Few unsealed minor- to moderate-sized transverse cracks in various locations - a couple with reflective efflorescence on soffit.

Unsealed minor- to moderate-sized longitudinal cracks, mainly over Girder 4 in right (outside) lane.

Deck - Span 2 right (cracking)

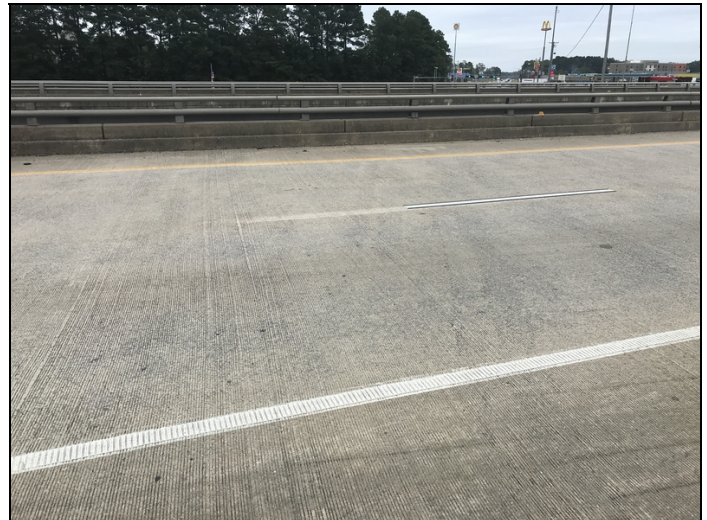
Deck - Span 2 @ midspan: Cracking

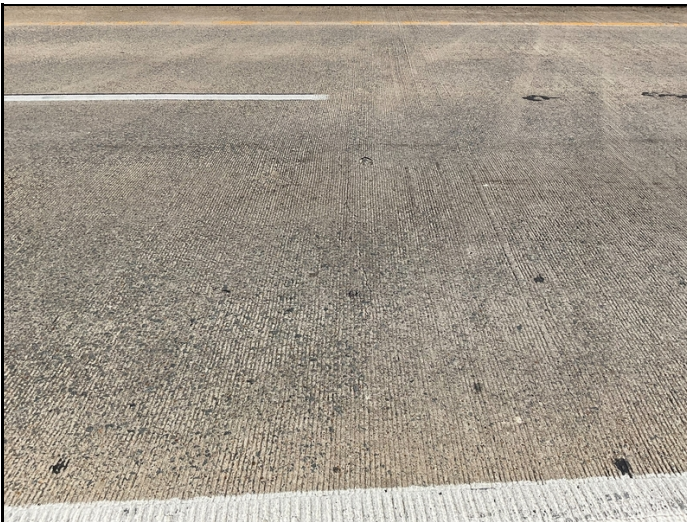
Span 2 has large unsealed cracks .

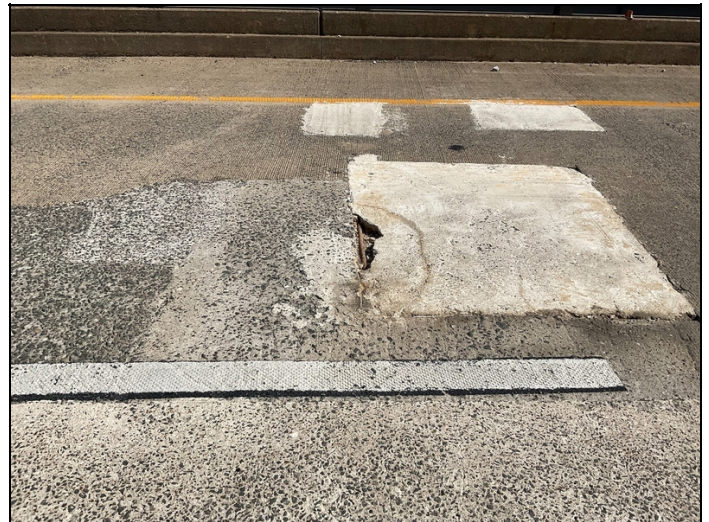
Active spall (currently patched with asphalt) in left (inner) lane close to center-line.

Span 2 left lane has spalls with exposed rebar and patched area.

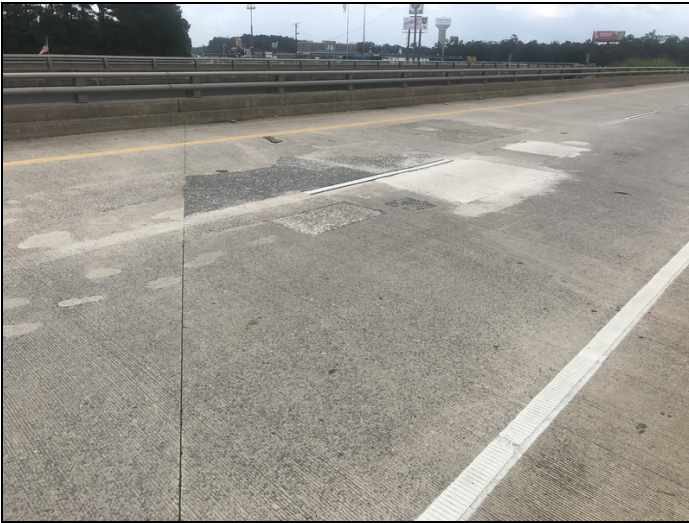
Some cracking, spalling, and patches with little or no efflorescence.

Spans 1&2 have spalls and repaired areas.

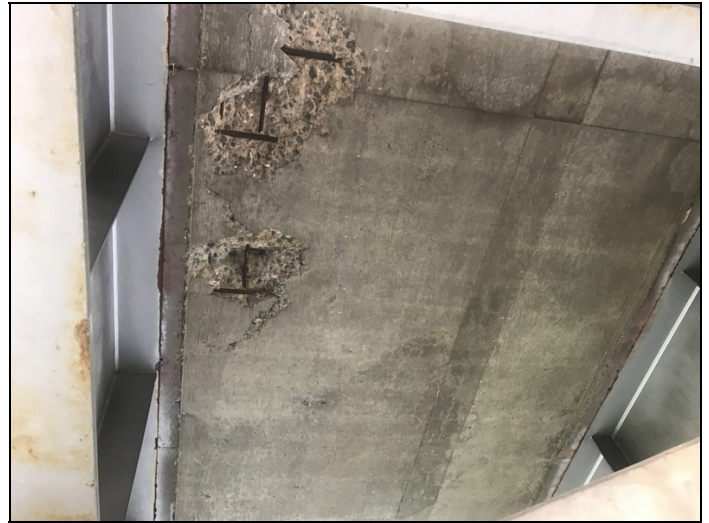
Span 2 soffit at bent 2 between girders 2-3 has spalling with exposed rebar.

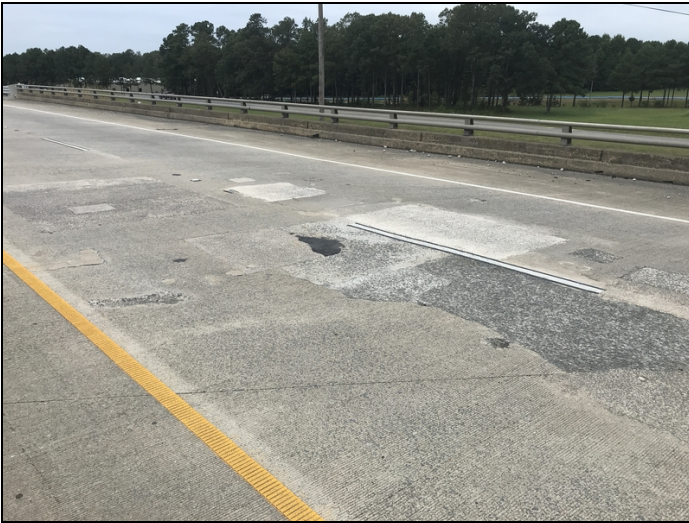
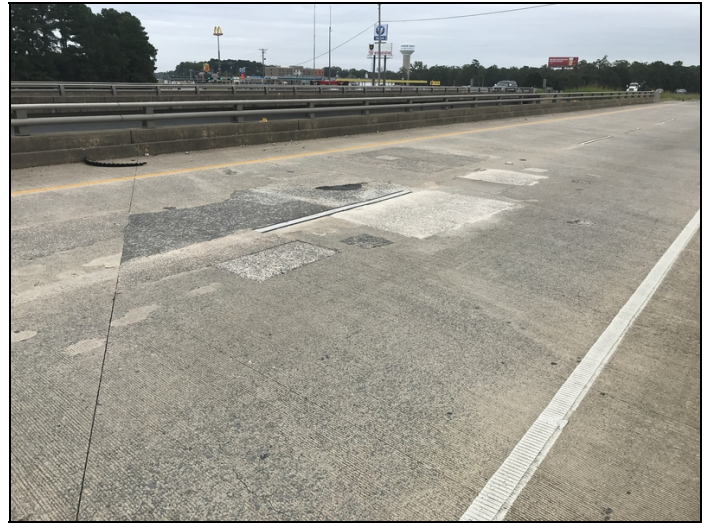
Deck - Span 2 @ Bent 2: Spalling/patches

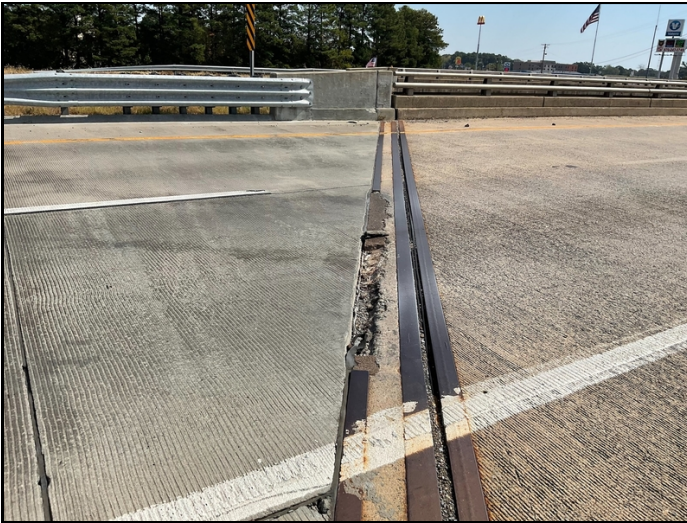
Bent 1 joint armor is missing. (with pot holes at the header).

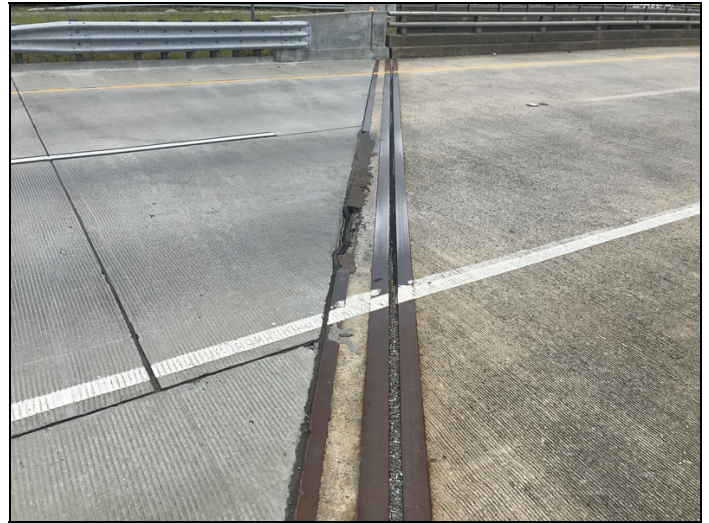
Abutment - Bent 1: Some deterioration, spalling, and patching (some of approach-side road-iron has been removed) on top of backwall of right (outer) lane.

Large spall and missing patches are making area between approach slab and bridge end very rough to the traveling public - these defects are in the outer (high-traffic) lane.

Abutment Bent 1 right: Spalling on top of backwall

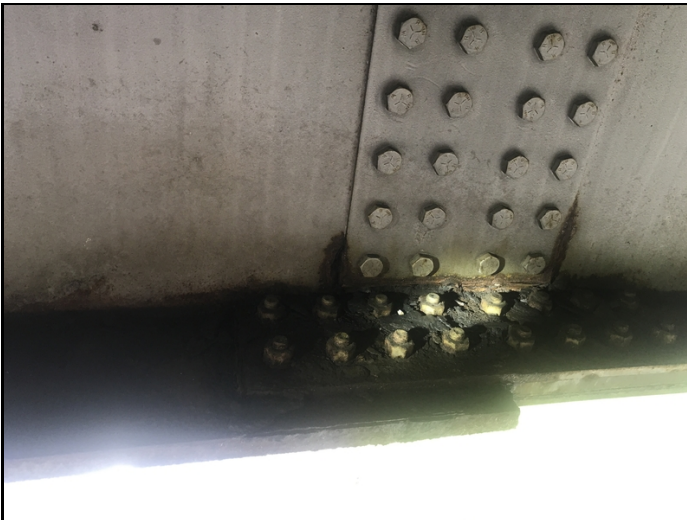
Span 2 Girder 2 - second splice plate ahead of Bent 2: Heavy flaking rust to splice plate at lower web and lower flange with pack rust forming.

Span 2 girder 2 second splice plate ahead of bent 2 left has heavy rust with some flaking from moisture seepage.

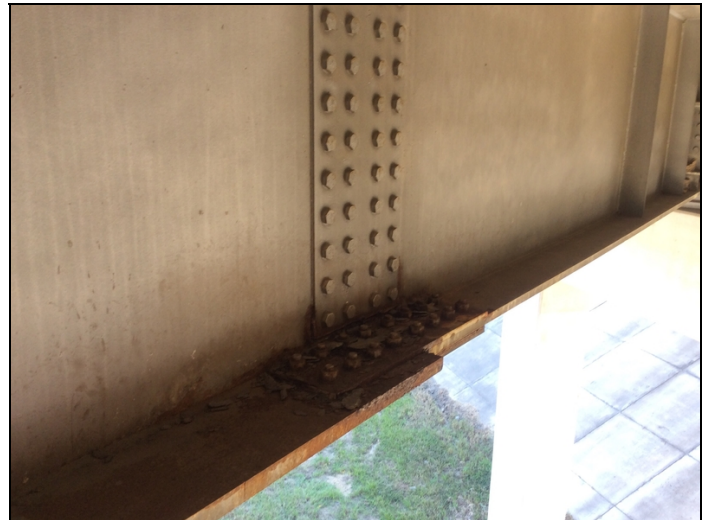
Span 2 Girder 2 @ Splice 2 (corrosion)

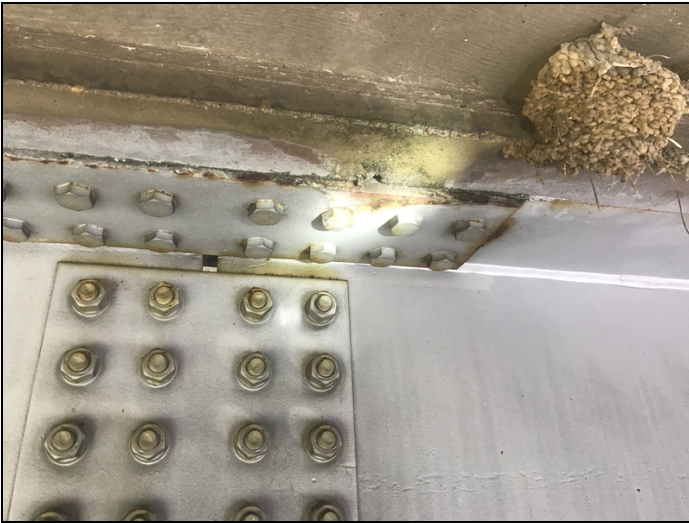
Span 2 second splice plate ahead of bent 2 girder 2 has moisture from deck.

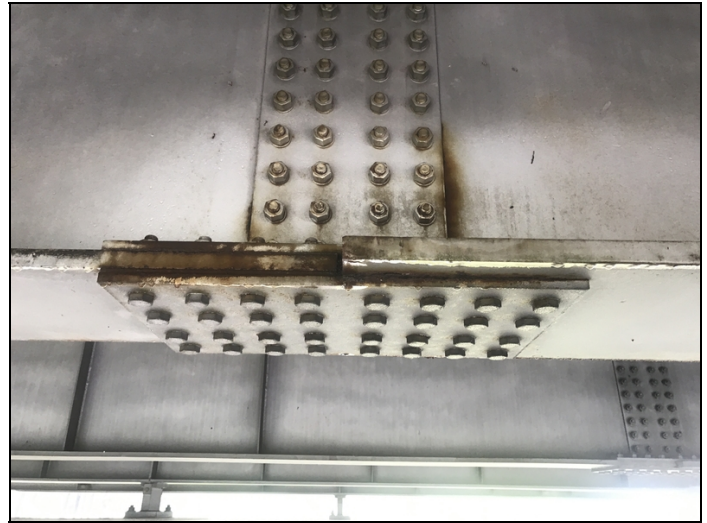
Span 2 second splice plate ahead of bent 2 girder 2 has moisture and rusting at splice plate with water running back down top of bottom flange.

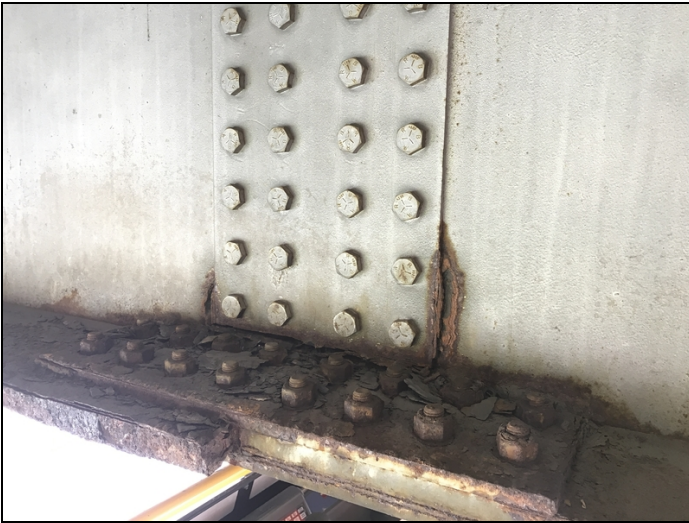
Span 2 Girder 2 @ Splice 2: Corrosion

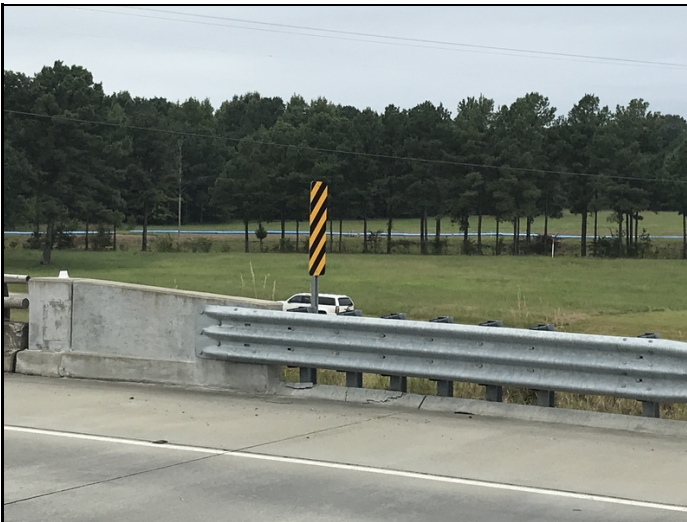
Sign - Bent 1 right: No log mile sign in place - object marker and post are in place.
Sign should read: 530-5

+
33.77

Sign - Bent 1 right: No log mile sign

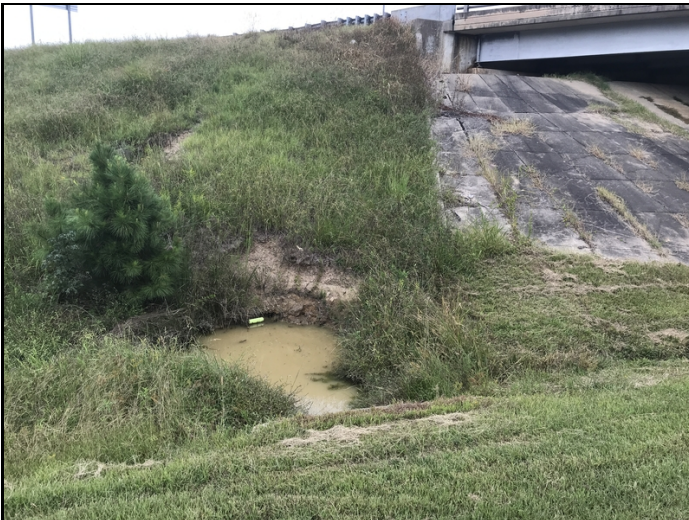
End-slope - Bent 1 right: An area of erosion at bottom of end-slope just outside of concrete slope paving - at end of cross-drain under US 270 on right (west) side of bridge.

End-slope - Bent 1 right: Erosion
