Asset #B5500(Routine)

I-530 NB LM 33.77 over US 270

Location: @ US 270-White Hall

Team Lead: Sharon Hooks, Inspection Date: 10/10/2022

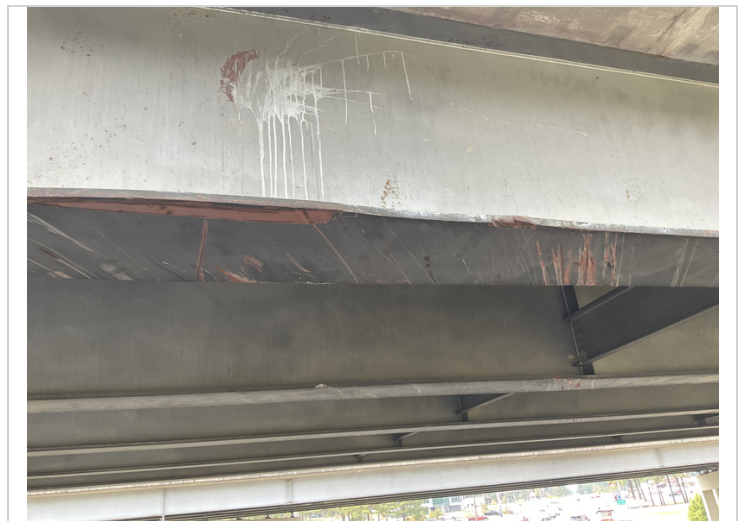
Oversize (height) load made contact with Span 2 Girder 1 just past mid-span (over eastbound/center turn lane - traveling opposite normal traffic).

Some superficial scratches were made to bottom and edge of bottom flange - approximately 6-8 sqft of transverse scratches. Most scratches go through finish coat but not primer coat.

No bending or distortion was noted to flange or web in this area.

Span 2 girder 1 near mid span has previous traffic impact.

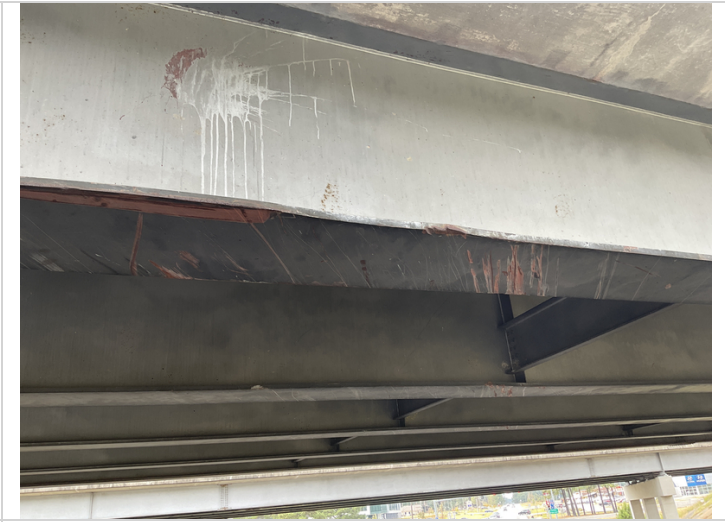
Span 2 girder 1 traffic impact.

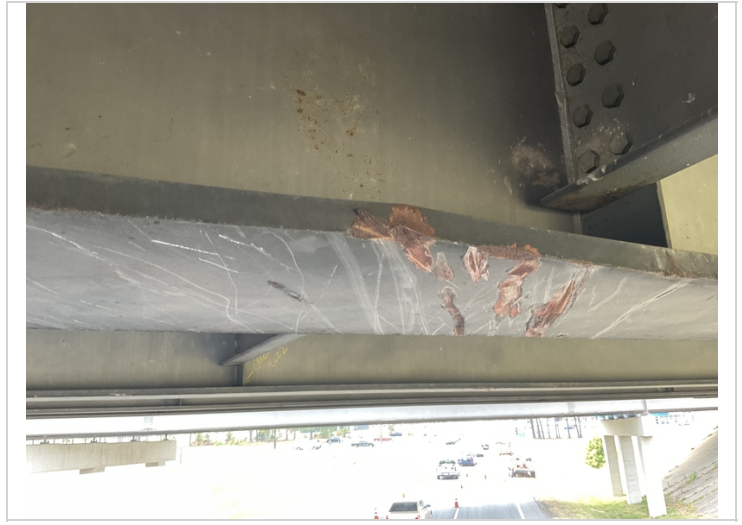
Span 2 girder impact damage.

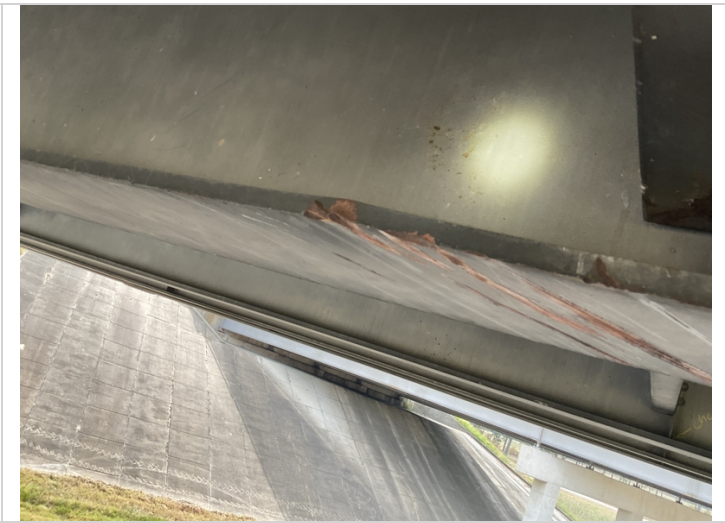
Span 2 girder 2 impact damage.

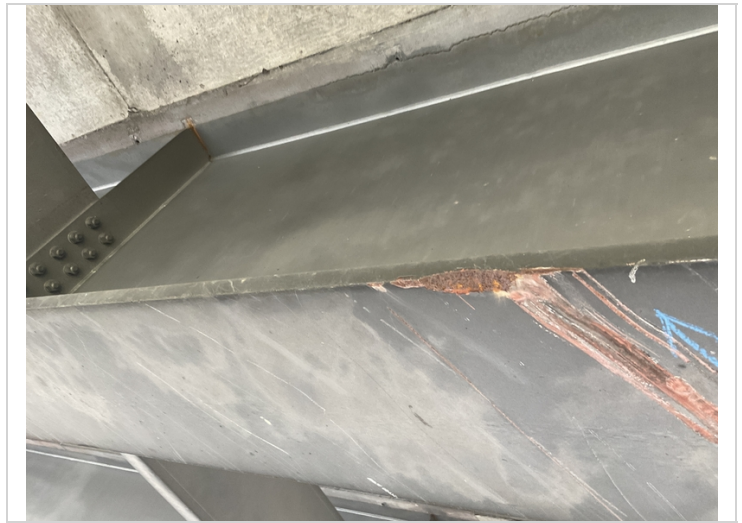
Span 2 girder 3 has traffic impact.

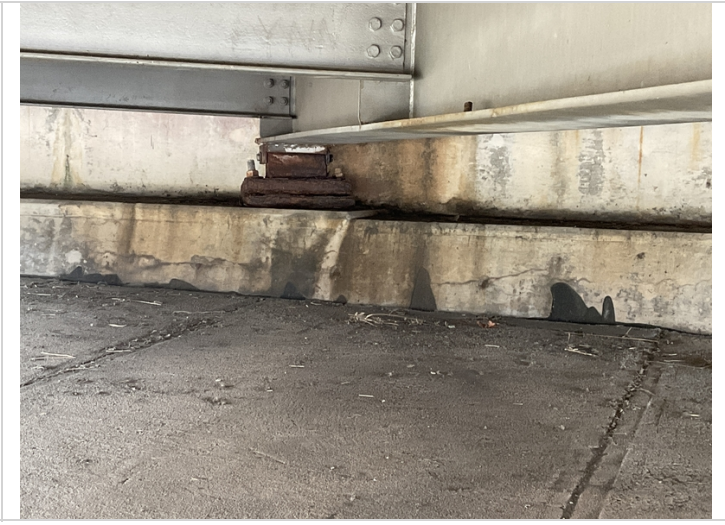
Bent 1 abutment has cracking.

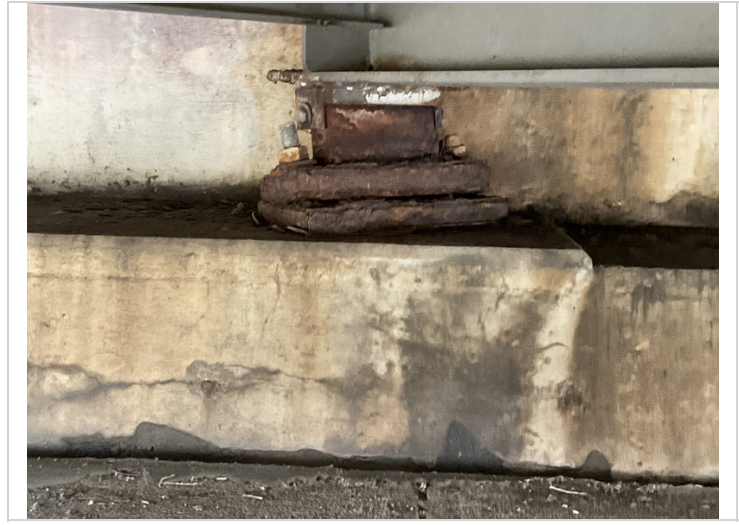
Bent 1 bearing 3 has heavy flaking corrosion..

Bent 1 Bearing 3: has heavy flaking and pack rust to bearing and sole plate..

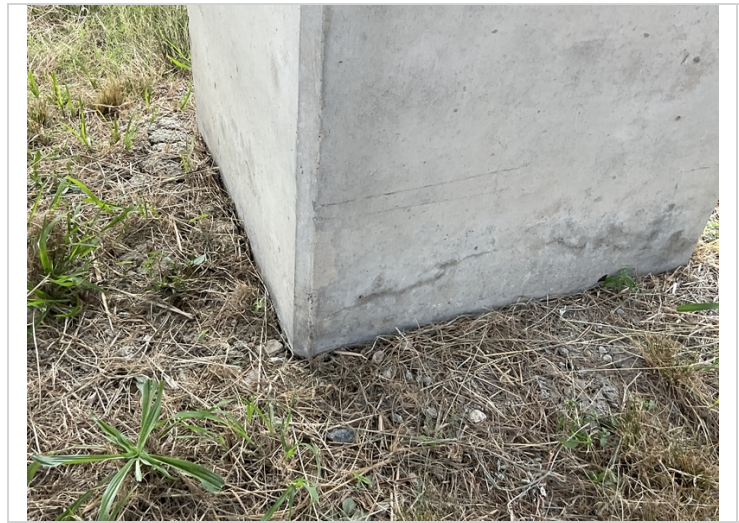
Bent 2 column 2 at ground level has cracking.

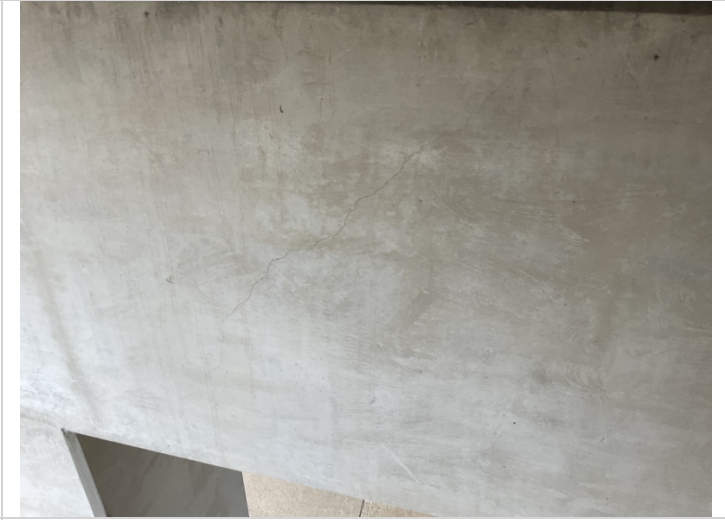
(234) Caps: 44'-6" = 45' each (skewed) / Bents 2 & 3. Bent 3 back: Some hairline diagonal and vertical cracks.							
302	Compression Joint Seal	LF	96	40	52	4	0
2320	Seal Adhesion	LF	4	0	0	4	0
2330	Seal Damage	LF	32	0	32	0	0
2360	Adjacent Deck or Header	LF	20	0	20	0	0

Bent 3 cap back has small diagonal cracks.

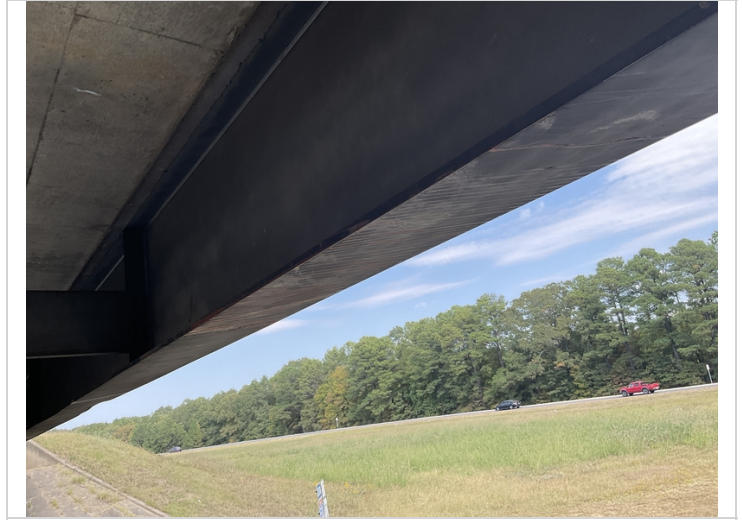
Span 2 girder 1 has scratches and scrapes.

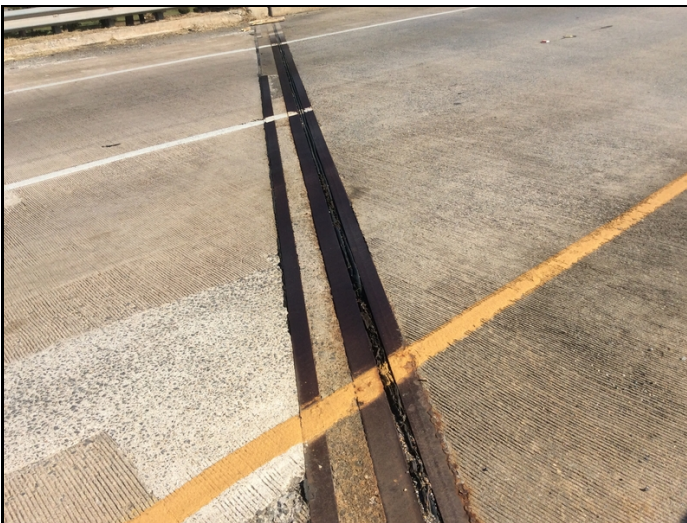
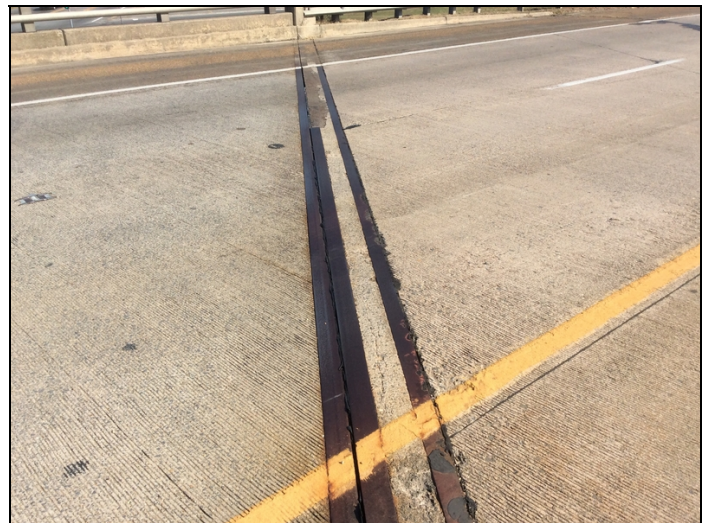
Bent 1: Joint material has deteriorated and is tattered in right (inside) lane and right shoulder (12').

Bent 4: Small area of minor sagging of joint material in left (outside) lane, just inside of white line. (4')

Remaining joint material is wearing and tattering - joint appears to be closed tighter than planned and material seems "pinched".

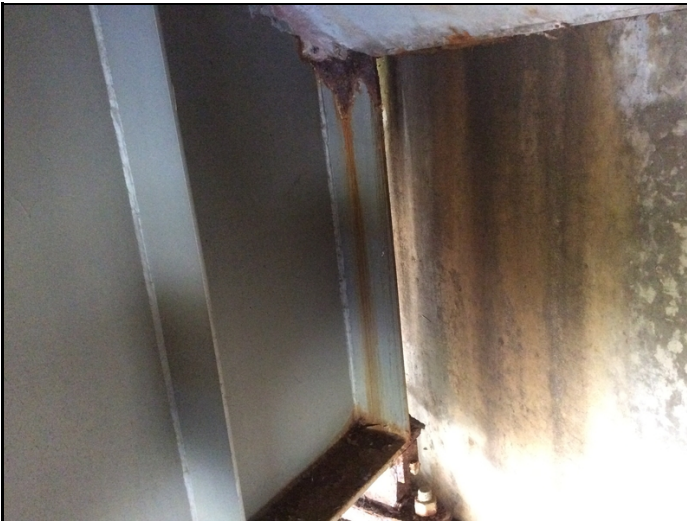
Span 1 Girder 3 @ Bent 1 (corrosion)

Span 1 Girder 3 @ Bent 1: Some corrosion and minor section loss to web, flanges and stiffener at end of girder on both sides.

A couple spots of rust, mainly around splices or at haunches near abutments.

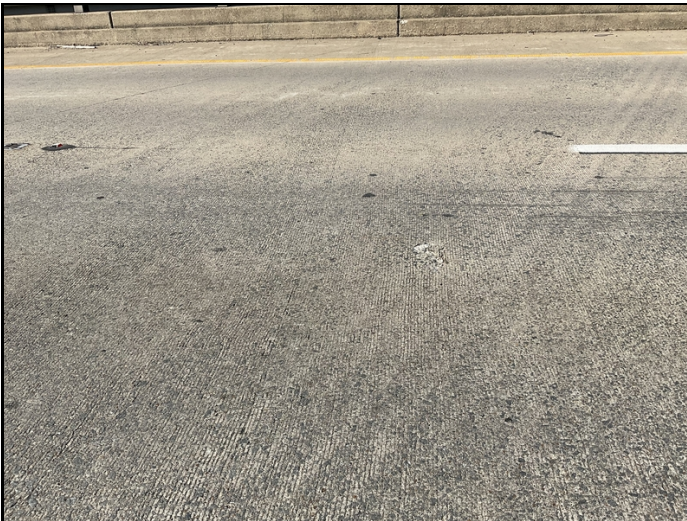
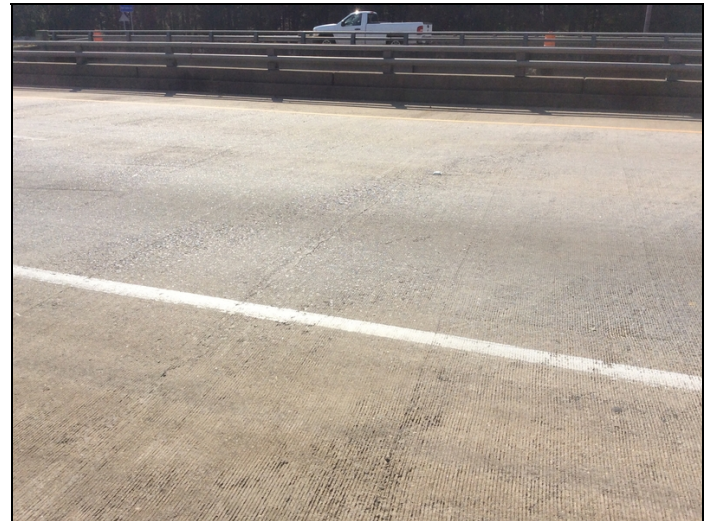
Few unsealed minor- to moderate-sized transverse cracks in various locations - a couple with reflective efflorescence on soffit.

Unsealed minor- to moderate-sized longitudinal cracks, mainly over girder in left (outside) lane.

A couple scattered, very small/shallow spalls, mainly in left (outer) lanes.

Deck span 2 has cracks and small spalls.

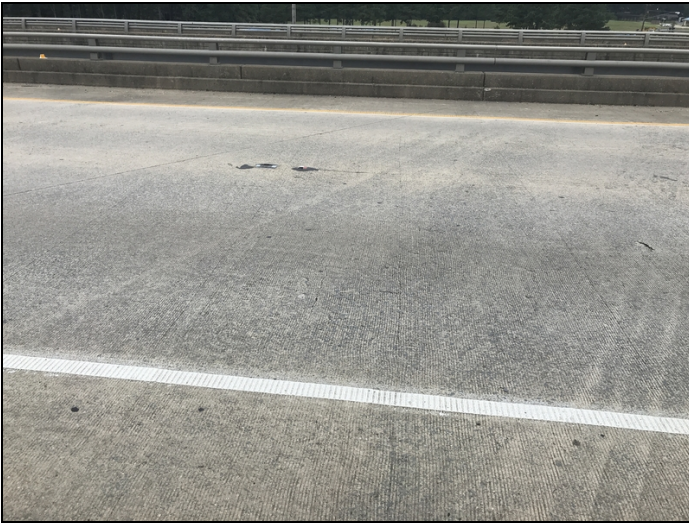
Deck - Span 1 left @ Bent 2: Cracking/minor spalling

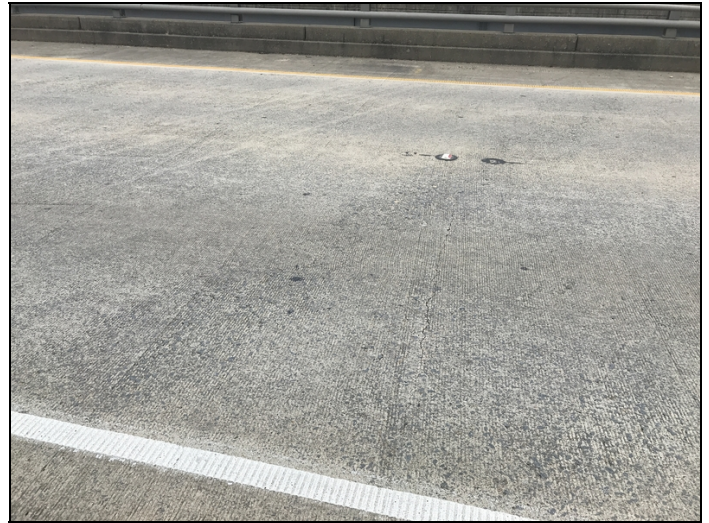
Deck - Span 2 @ midspan: Cracking/abrasive wear

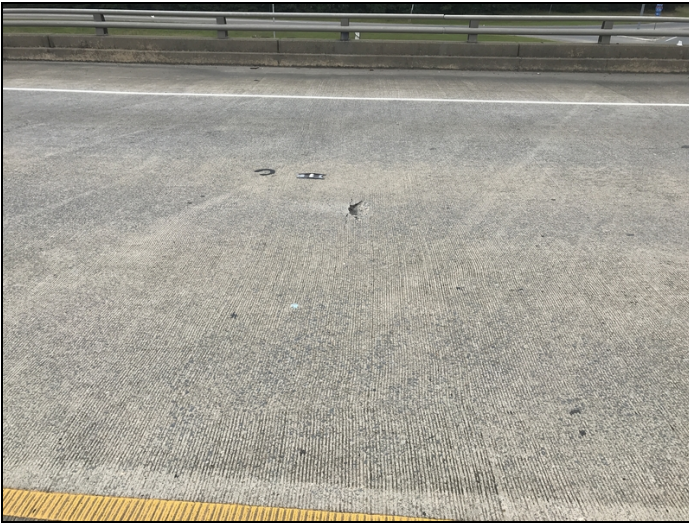
Deck - Span 2 right @ 3/4 span: Cracking/spalling

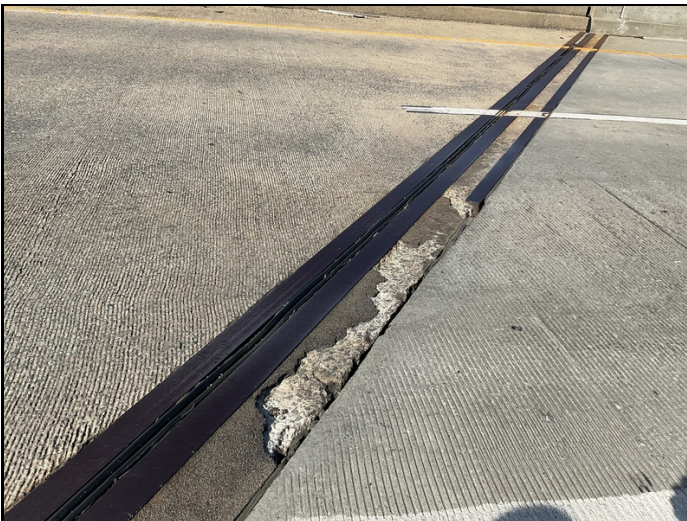
Bent 1 road iron has section missing. Common bent 4.

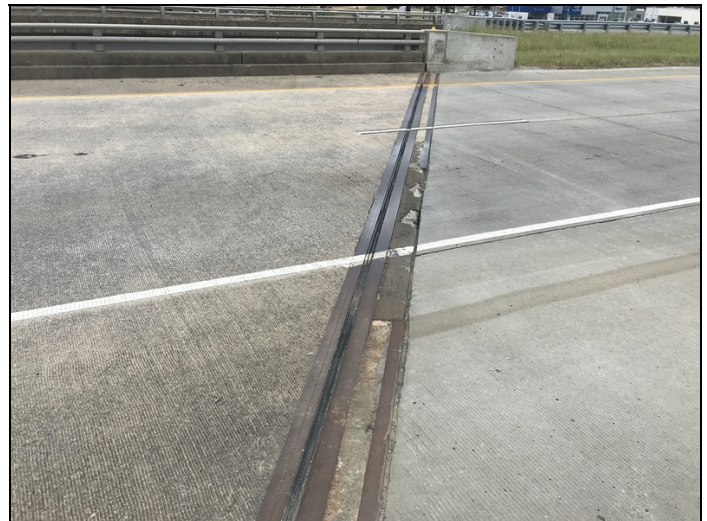
Bent 1 left : Some deterioration, spalling, and patching (some of approach-side road-iron has been removed) on top of backwall of left (outer) lane.

Spalling and missing patches are making area between approach slab and bridge end very rough to the traveling public - these defects are in the outer (high-traffic) lane.

Abutment - Bent 1 left: Spalling on top of backwall

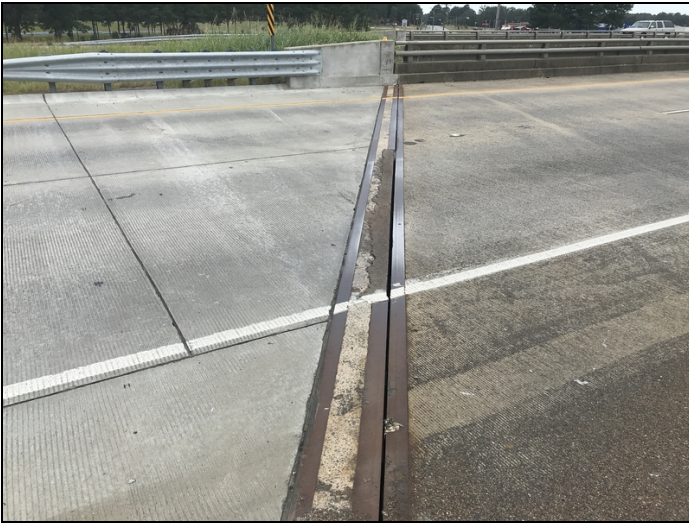
Bent 4 left : Some deterioration, spalling, and patching (some of approach-side road-iron has been removed) on top of backwall of left (outer) lane.

Abutment - Bent 4 left: Spalling on top of backwall

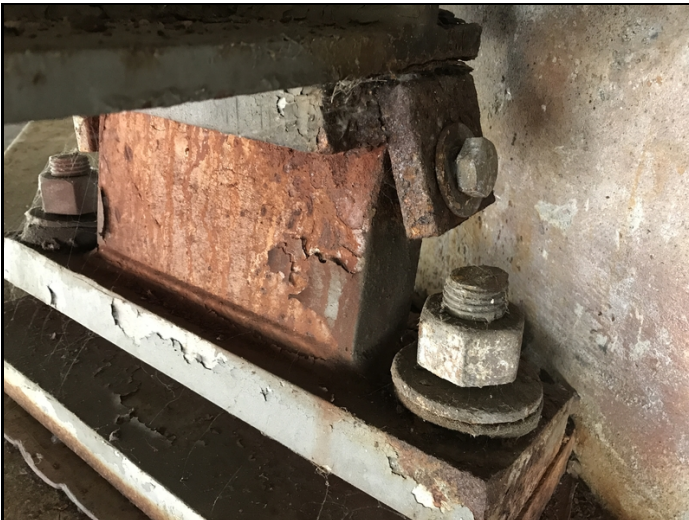
Bent 1 Bearing 2: Left side hinge plate (ear) weld is cracking and plate is bending out.

Bent 1 Bearing 2: Cracking of weld/bending out of hinge plate (ear)

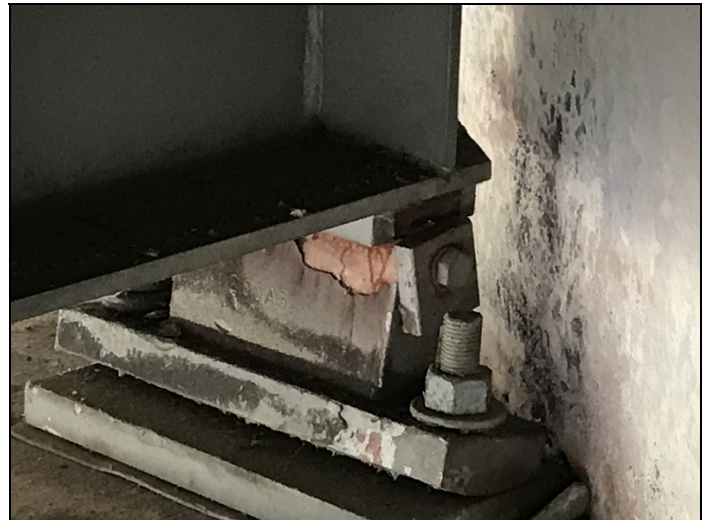
Bent 1 Bearing 4: Left side hinge plate (ear) has broken off - plate no longer attached to girder.

Bent 1 Bearing 4: Hinge plate (ear) broken loose

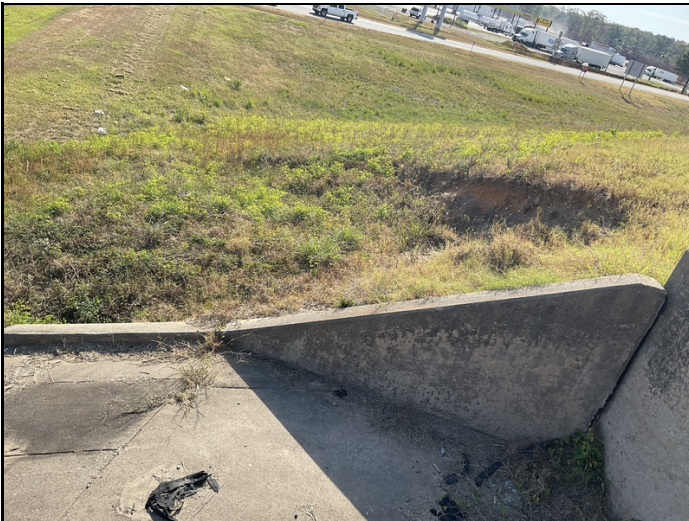
Erosion to South East side slope.

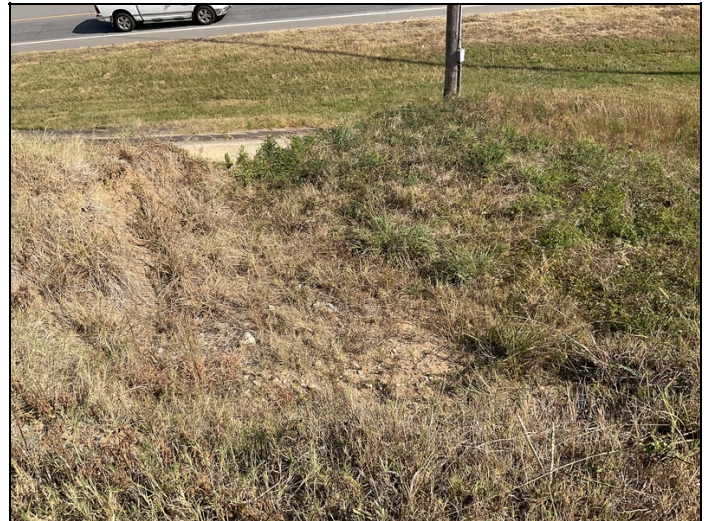
Erosion to South East side slope.

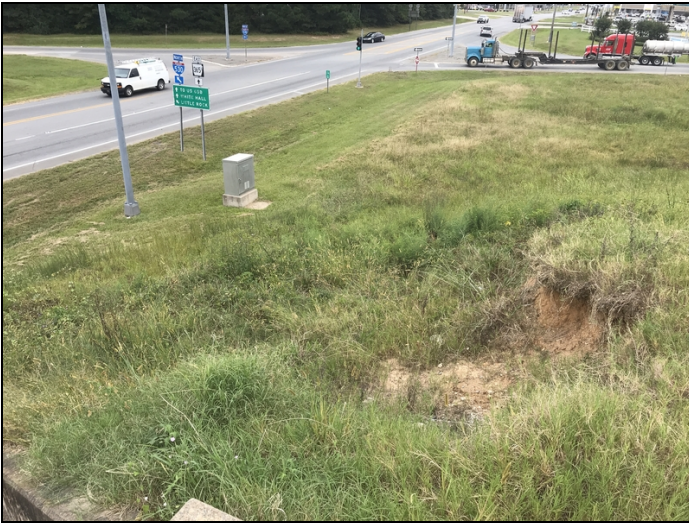
Roadway (side) slope on left outside of concrete slope paving has slumped down.

Roadway slope - Bent 4 left: Erosion/slope slumping

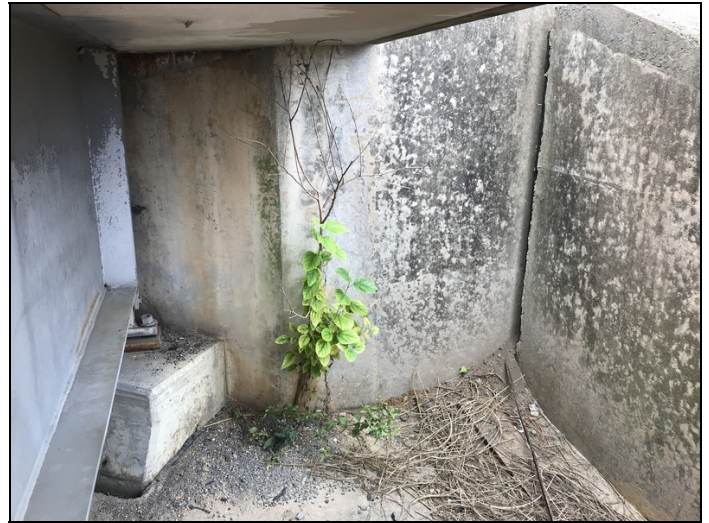
Concrete slope paving across end-slope has moved/slumped down - leaving a 2-3" gap between paving and abutment.

Slope paving - Bent 4 right: Moving/slumping

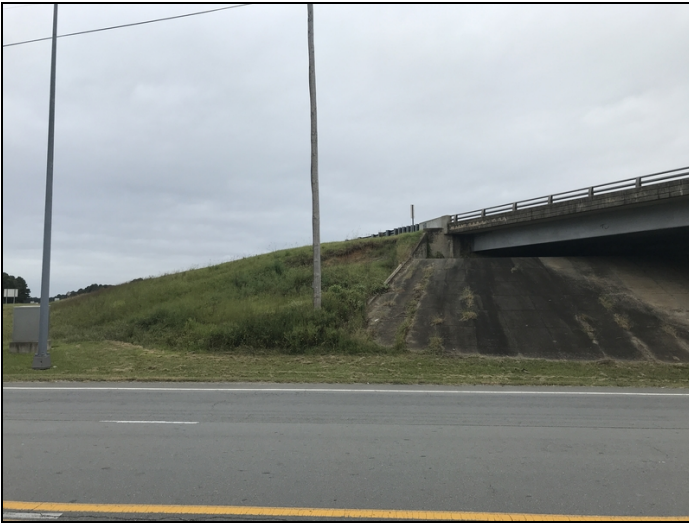
Roadway slope - Bent 4 left: Erosion/slope slumping
