Asset #A5501 (Routine)

I-530 SB LM 31.85 over SH 256

Location: 1.4 Mi W SH 365-WhiteHall

Team Lead: Sharon Hooks, Inspection Date: 09/14/2022

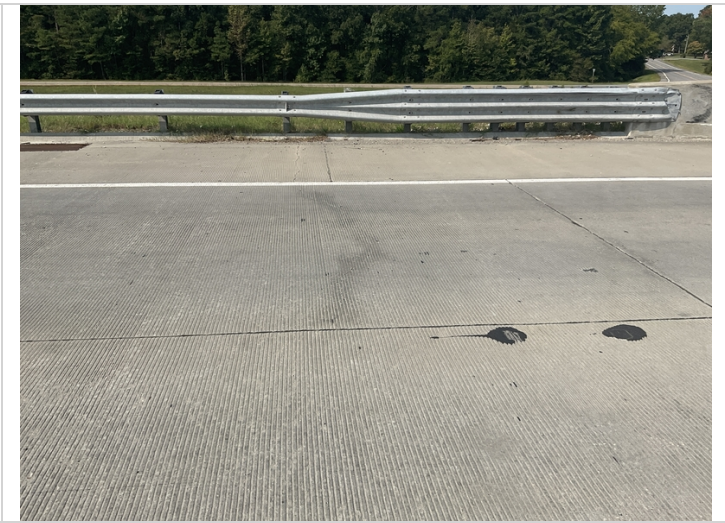
| ELEMENTS | DESCRIPTION | UNITS | TOTAL | CS1 | CS2 | CS3 | CS4 |
|---|---|---|---|---|---|---|---|
| (321) Approach slabs: (24' wide x 35' long) 840 square feet each / Bents 1 & 4. Bent 1: Approach slab has minor cracks Bent 4: Approach slab has moderate to heavy cracking. | | | | | | | |

South approach slab has moderate to heavy cracking.

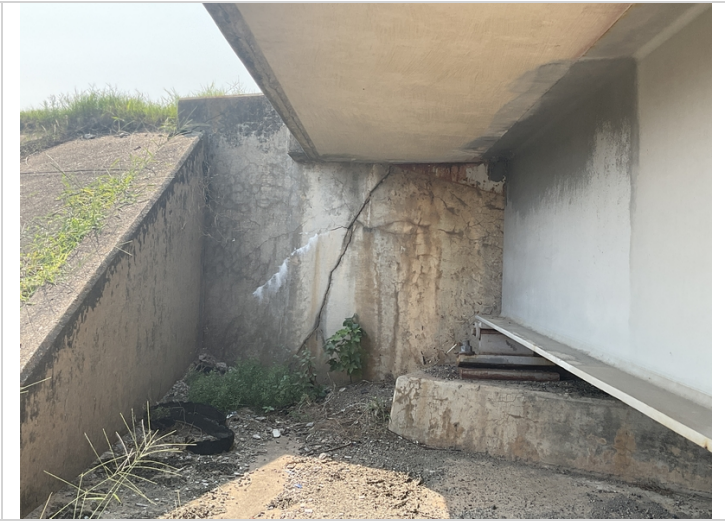
| ELEMENTS | DESCRIPTION | UNITS | TOTAL | CS1 | CS2 | CS3 | CS4 |
|--|---|---|---|---|---|---|---|
| (215) Abutments: 41'-6" = 42' each (skewed - with 10'-6" wings each bent) / Bents 1 & 4. Bent 4: Some minor- to moderate-sized horizontal/map-cracking across face of cap. Bent 4 left: Moderate- to large-sized cracking on wing-wall. | | | | | | | |

Bent 4 left at back wall has large cracks with efflorescence.

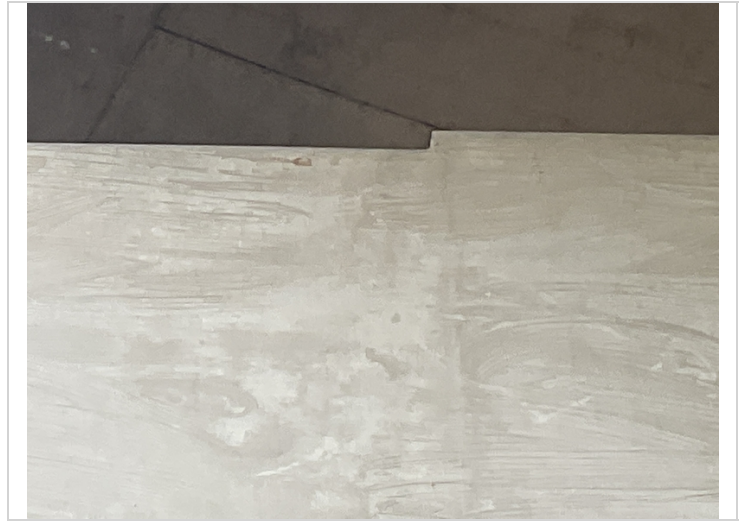
| ELEMENTS | DESCRIPTION | UNITS | TOTAL | CS1 | CS2 | CS3 | CS4 |
|--|---|---|---|---|---|---|---|
| (234) Caps: 42' each (skewed) / Bents 2 & 3. Bent 2 cap ahead has very small vertical cracks. | | | | | | | |

Bent 2 cap ahead right near column 3 has minor cracking.

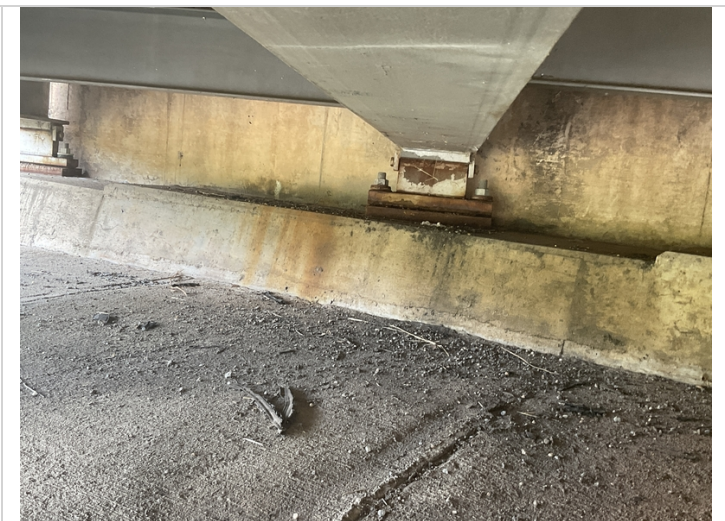
| ELEMENTS | DESCRIPTION | UNITS | TOTAL | CS1 | CS2 | CS3 | CS4 |
|---|---|---|---|---|---|---|---|
| (311) Movable bearings: 6 per bent / Bents 1, 3, & 4. Coating: 2.0 square feet each. Bents 1 & 4: Some paint flaking off of bearings with a couple places of very minor, light surface rust. Some pack rust under rocker at Bent 4 Bearing 6, somewhat restricting movement. | | | | | | | |

Bent 1 bearing 5 has heavy corrosion.

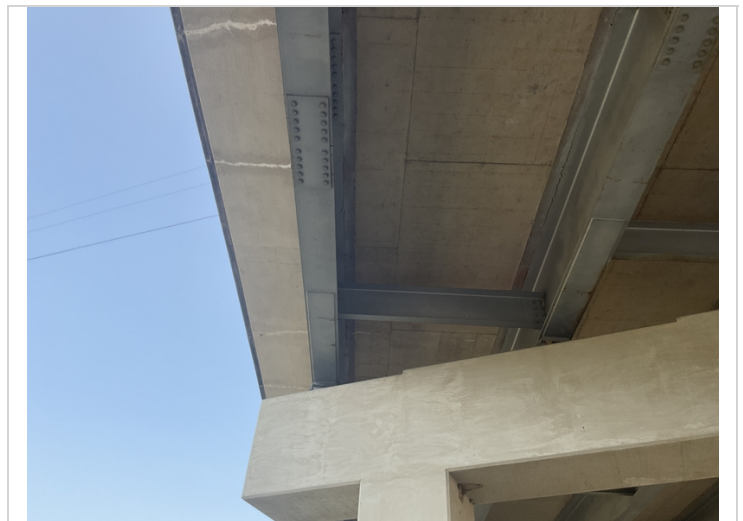
| ELEMENTS | DESCRIPTION | UNITS | TOTAL | CS1 | CS2 | CS3 | CS4 |
|--|---|---|---|---|---|---|---|
| (12) Deck: 42' wide x 168' long = 7056 sqft. One or two minor, unsealed, transverse cracks with some light, reflective efflorescence on soffit. Very light unsealed map-cracking (curing cracks?) scattered throughout deck. Soffit – all spans: Some scattered cracking with efflorescence on overhangs (90 sqft CS2). | | | | | | | |

Span 1 underside of deck right side near bent 2 has cracking with efflorescence.

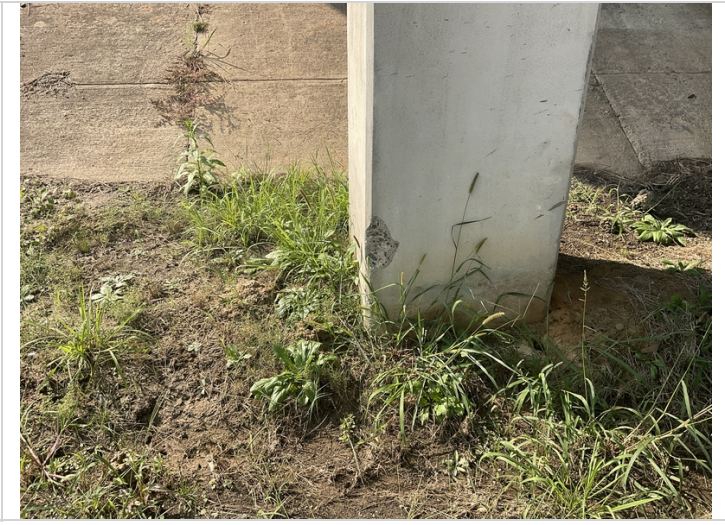
| ELEMENTS | DESCRIPTION | UNITS | TOTAL | CS1 | CS2 | CS3 | CS4 |
|--|---|---|---|---|---|---|---|
| (205) Columns: 3 per bent / Bents 2 & 3. Bent 3 Column 1: Small (6-8" tall) chip on left back corner 12" above groundline. | | | | | | | |

Bent 3 column 1 has minor spall.

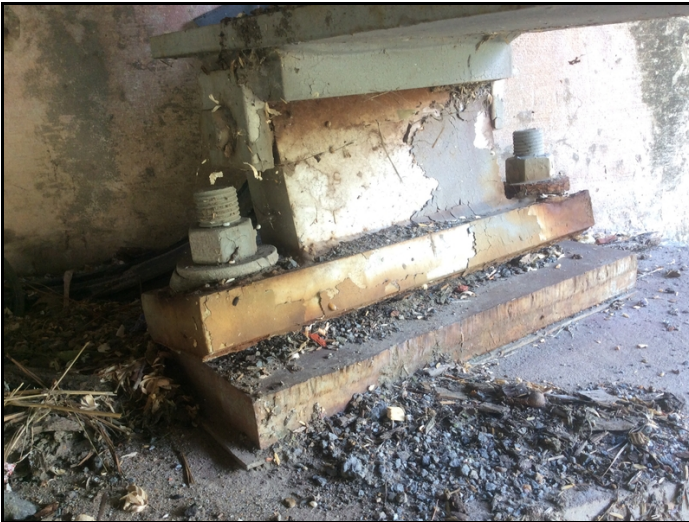
Bearings – Bents 1 & 4: Some paint flaking off of bearings with a couple places of very minor, light surface rust. Some pack rust under rocker at Bent 4 Bearing 6, somewhat restricting movement.

Bent 4 Bearing 6 (corrosion)

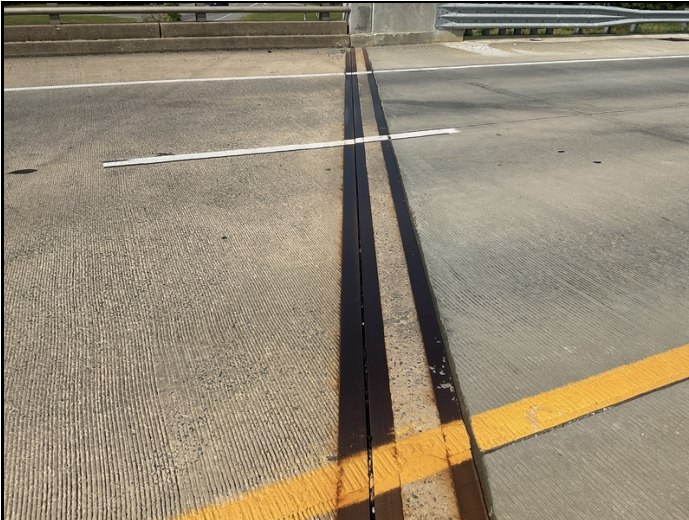
Bent 1: Joint is almost completely closed up. Preformed joint material is mostly missing.

Bent 1 joint material missing.

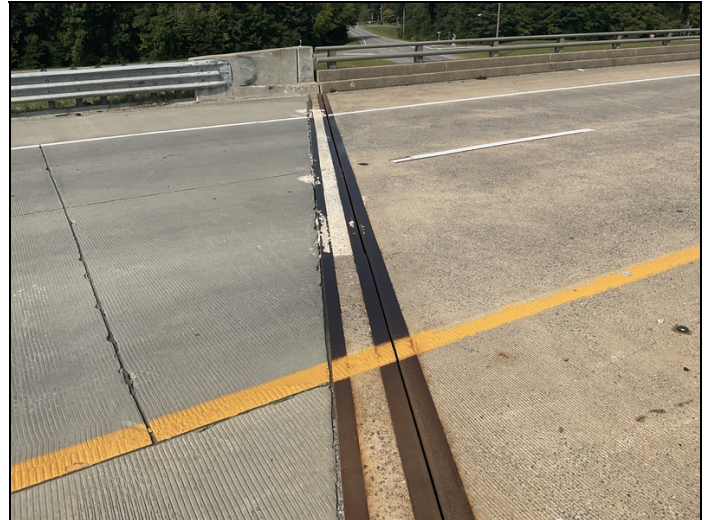
Bent 4: Preformed joint material has come loose and has fallen out across most of joint. Some minor cracking, very small spalls, and light deterioration on top of remaining backwall, heaviest near centerline.

Bent 4 joint material missing.

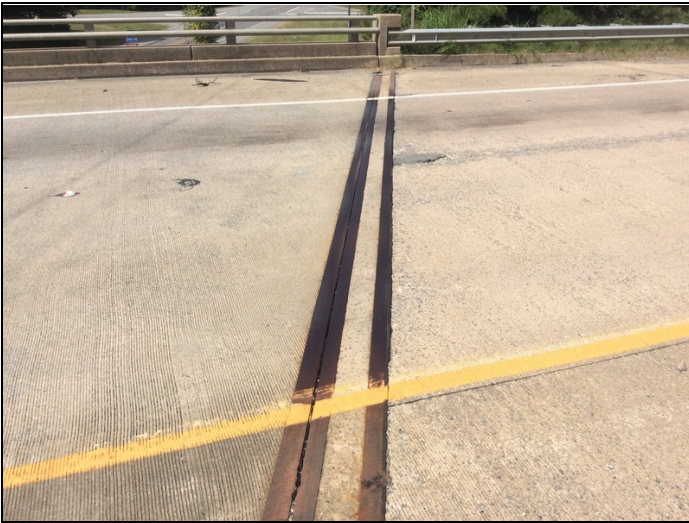
Joint - Bent 1 (material pinched)

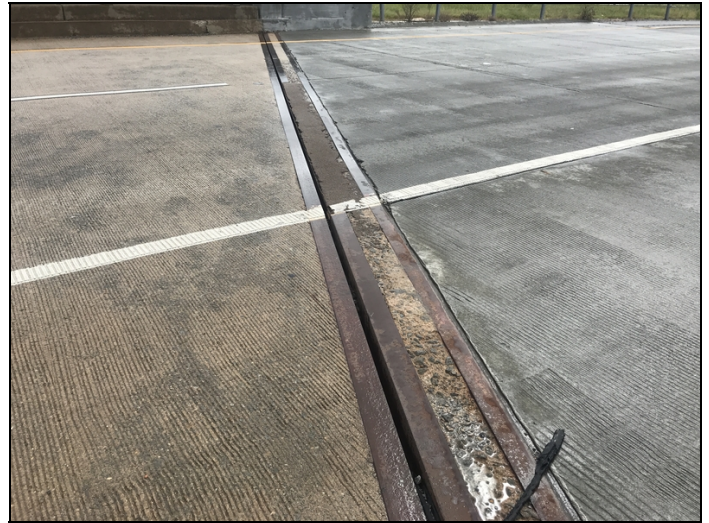
Bent 4 compression joint seal missing and road iron missing also.

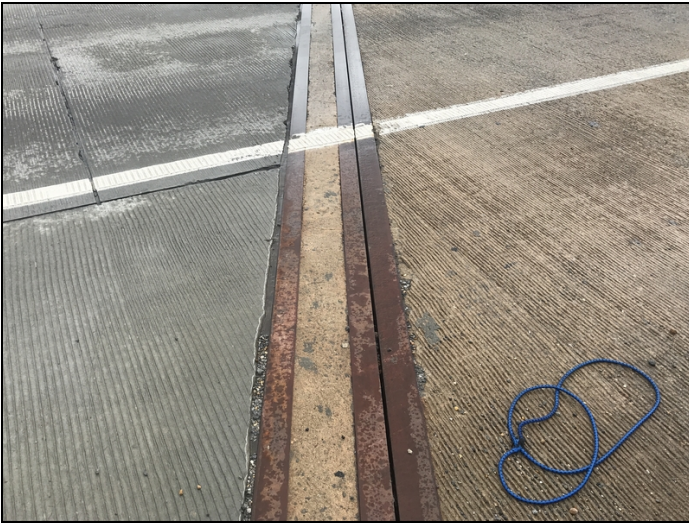
Bent 1 compression joint seal missing .

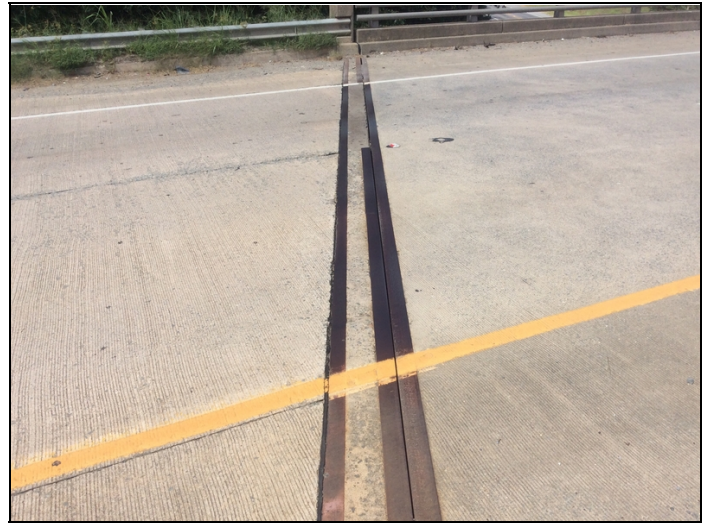
Joint - Bent 4 (material missing)

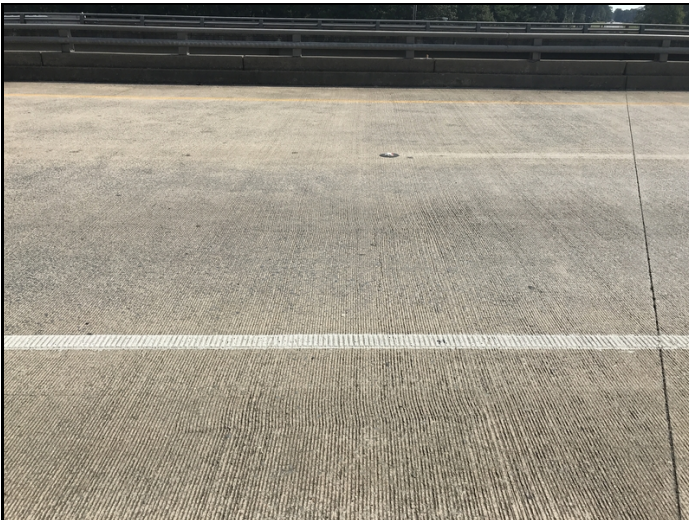
Deck - all spans: One or two minor, unsealed, transverse cracks with some light, reflective efflorescence on soffit.

Deck - Span 2 right: Transverse cracking
