Asset #B5501 (Routine)

I-530 NB LM 31.85 over SH 256

Location: 1.4 Mi W SH 365-WhiteHall

Team Lead: Sharon Hooks, Inspection Date: 09/14/2022

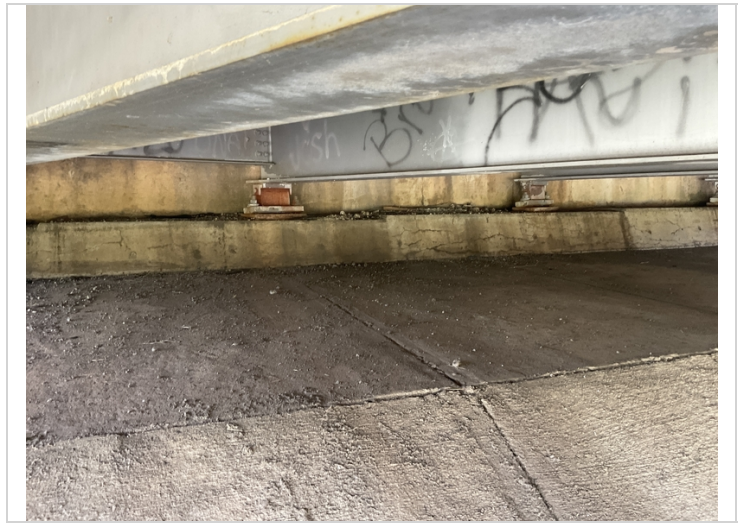
(215) Abutments: 41'-6" = 42' each (skewed - with 10'-6" wings each bent) / Bents 1 & 4. Bent 4: Some minor- to moderate-sized horizontal/map-cracking across face of cap.							
234	Reinforced Concrete Pier Cap	LF	84	84	0	0	0

Bent 4 abutment has cracking.

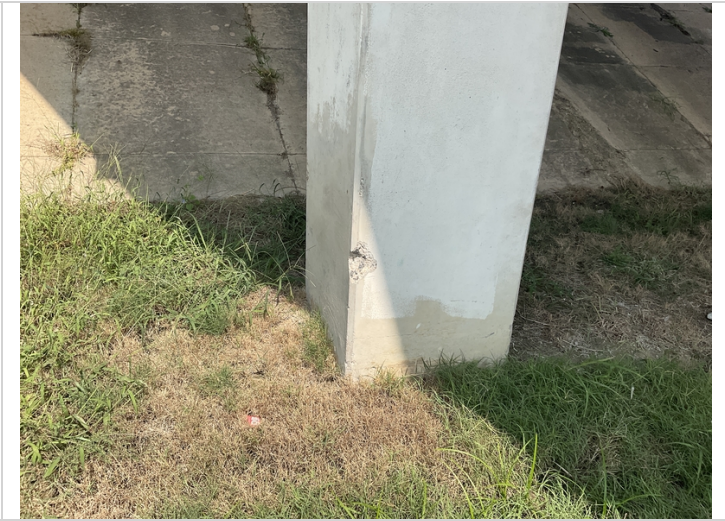
(205) Columns: 3 per bent / Bents 2 & 3. Bent 2 Column 3: Small (6-8" tall) chip on right ahead corner 2' above groundline.							
215	Reinforced Concrete Abutment	LF	105	63	42	0	0
1130	Cracking (RC and Other)	LF	42	0	42	0	0

Bent 2 column 3 right has small spall.

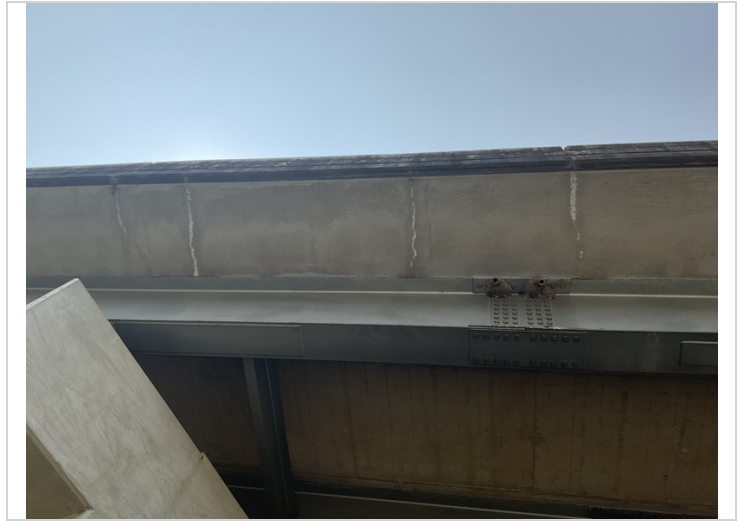
Cracks with efflorescence on soffit all spans mainly on outside areas.

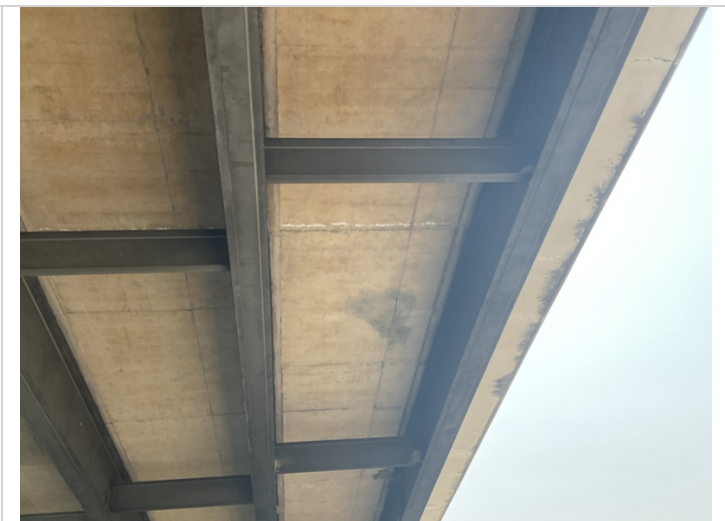
Span 2 bay 4 & 5 have cracking with efflorescence.

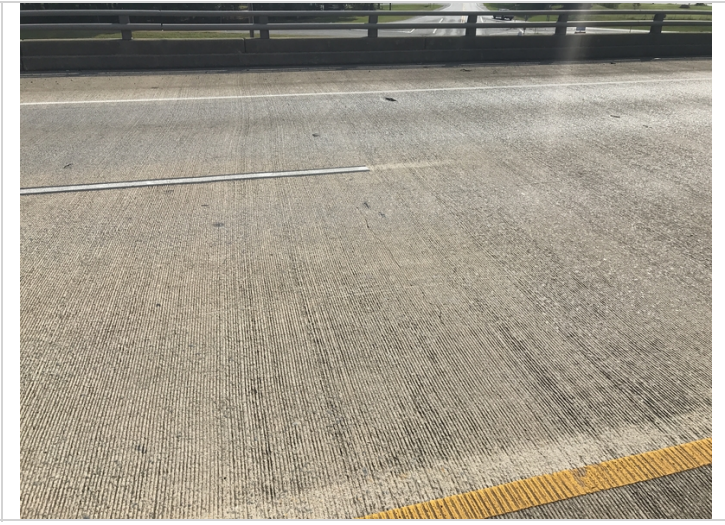
Deck - Span 2 @ midspan: Cracking

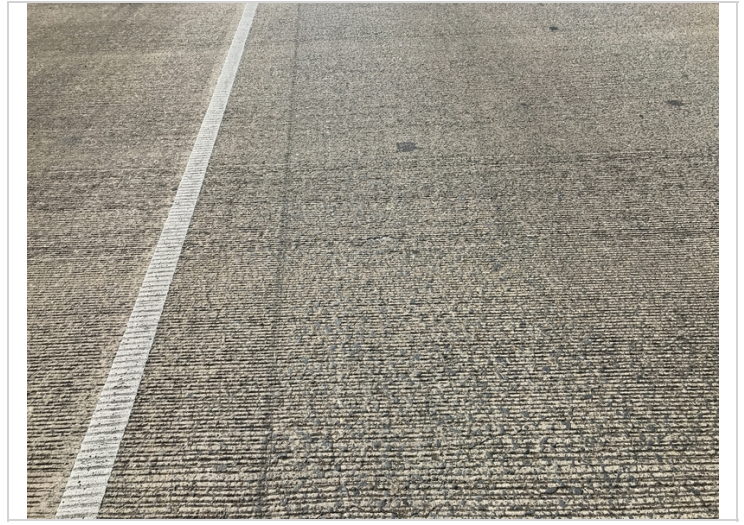
Deck - Span 1 left: Cracking

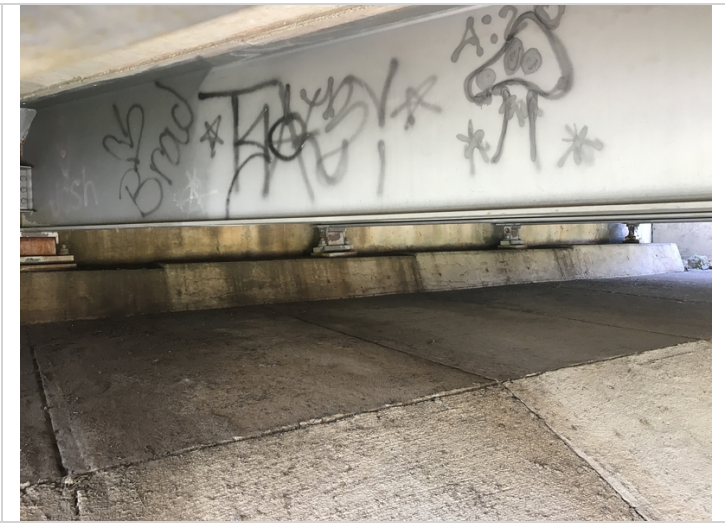
Abutment - Bent 4 right: Cracking

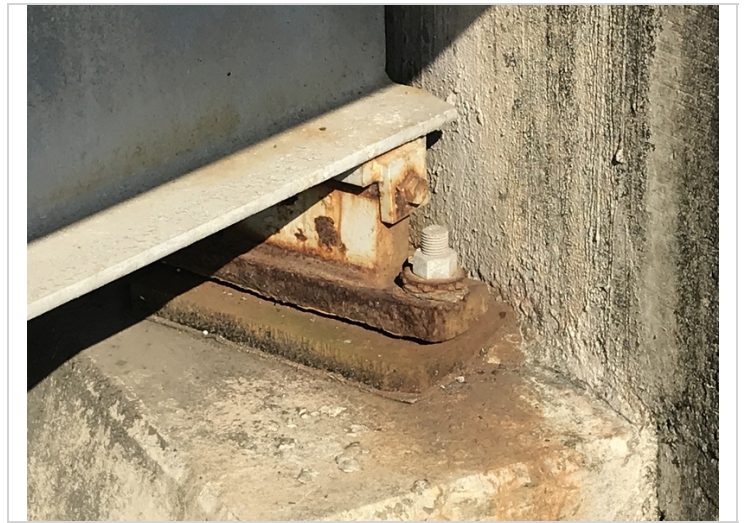
(311) Movable bearings: 6 per bent / Bents 1, 3, & 4. Coating: 2.0 square feet each. Bents 1 & 4: Some paint flaking off of bearings with a couple places of very minor, light surface rust. Bent 1 Bearing 1: Some pack rust under rocker, somewhat restricting movement. Bent 3 Bearing 4: Loose nuts on anchor bolts.							
313	Fixed Bearing	EA	6	6	0	0	0
515	Steel Protective Coating	SF	12	12	0	0	0

Bent 1 Bearing 1: Corrosion

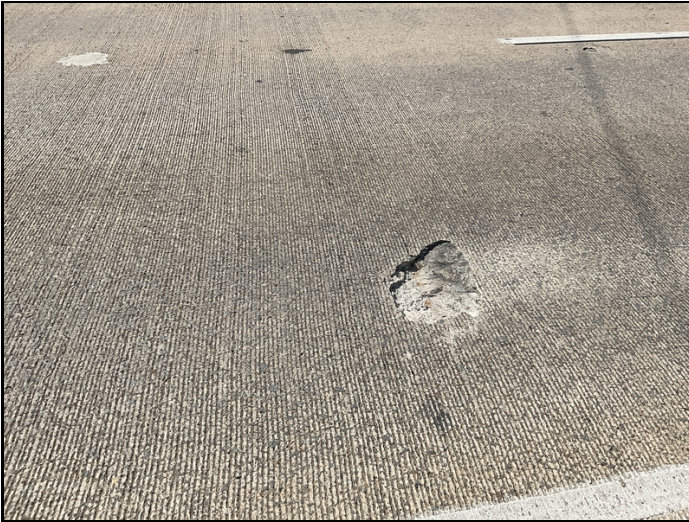
Deck - Span 1-2 left: A couple small shallow spalls in left (outer) lane in outer wheel rut.

Span 1 left side as approach has small spalls.

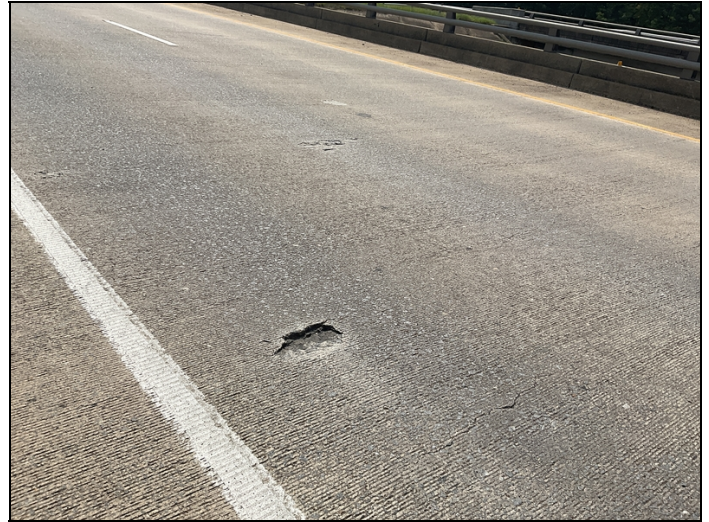
Spans 2 left has small spalls and heavy map cracking.

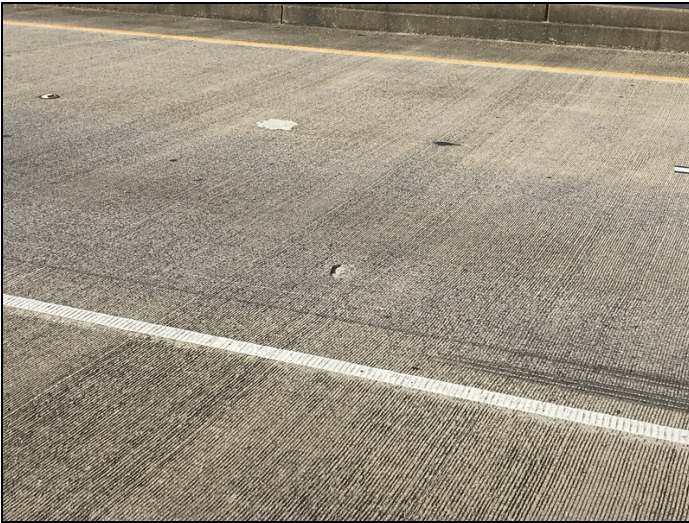
Deck - Span 1 left: Spall

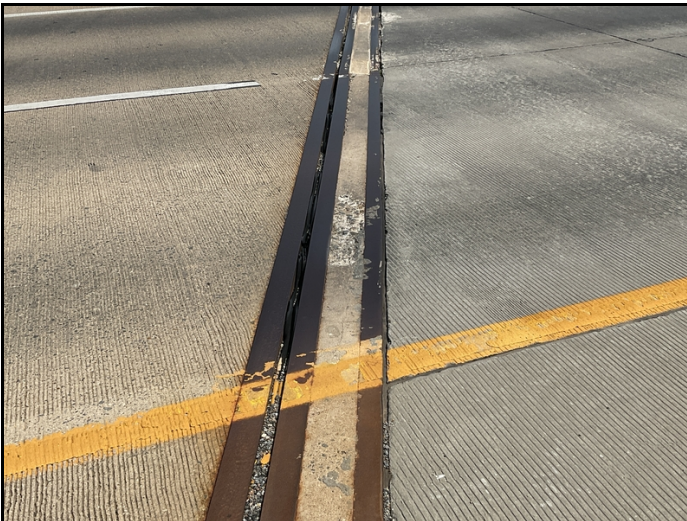
Some cracking\deterioration\spalling of backwall with road-iron becoming loose in a couple areas, especially in left (outside) lane just inside wheel ruts – road-iron pops and makes noise when traffic runs directly over it at this location.

Bent 4 top of back wall has small spalls

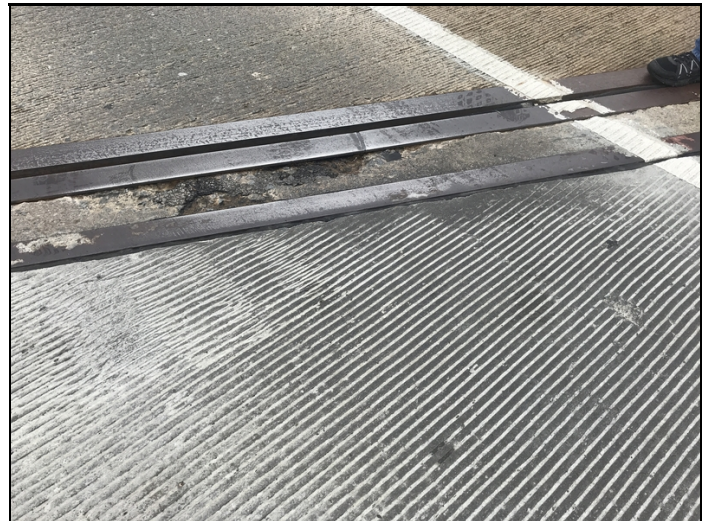
Bent 4 road iron is loose under traffic (making noise)but still intact.

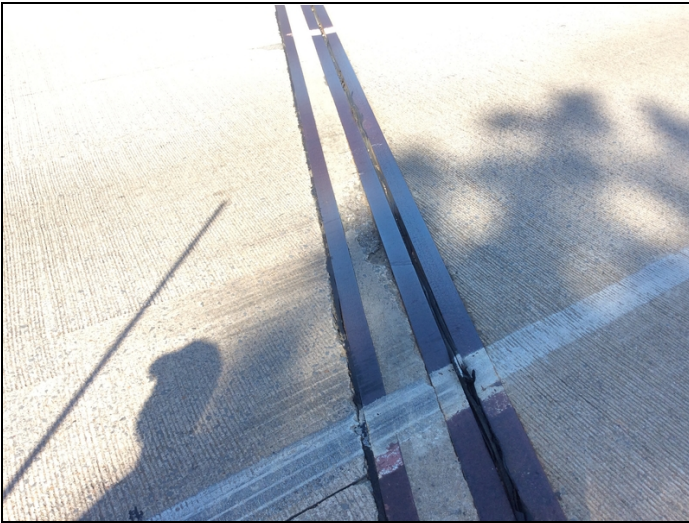
Joint - Bent 4 left (spalling of backwall)

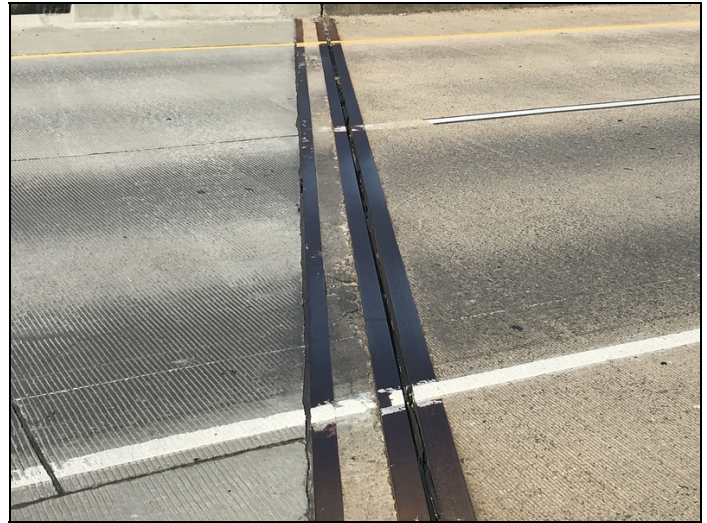
Joint - Bent 4 left: Spalling of adjacent deck/loose road iron

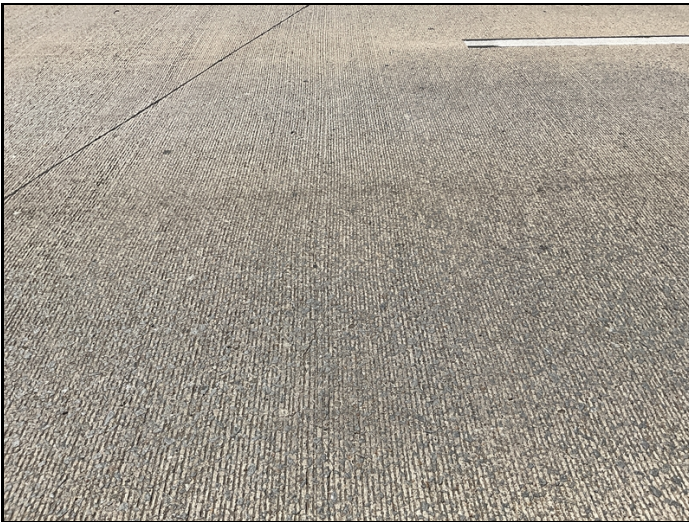
Span 2 left lane has heavy map cracking.

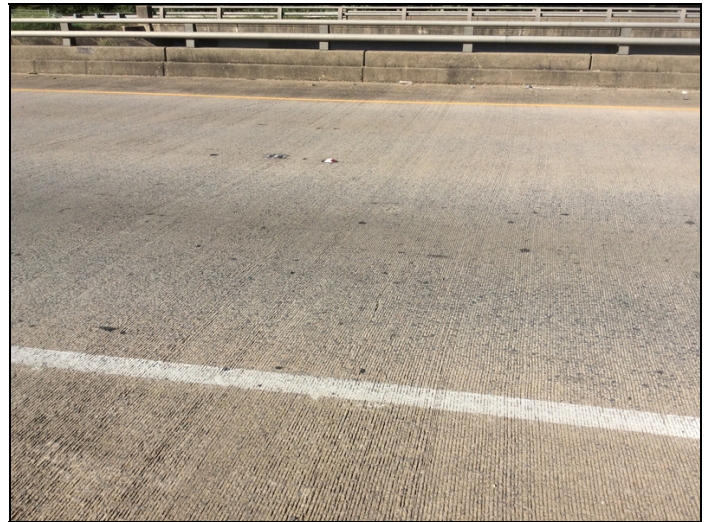
Deck - all spans: One or two minor, unsealed, transverse cracks with some light, reflective efflorescence on soffit.

Deck - Span 2 (transverse cracking)

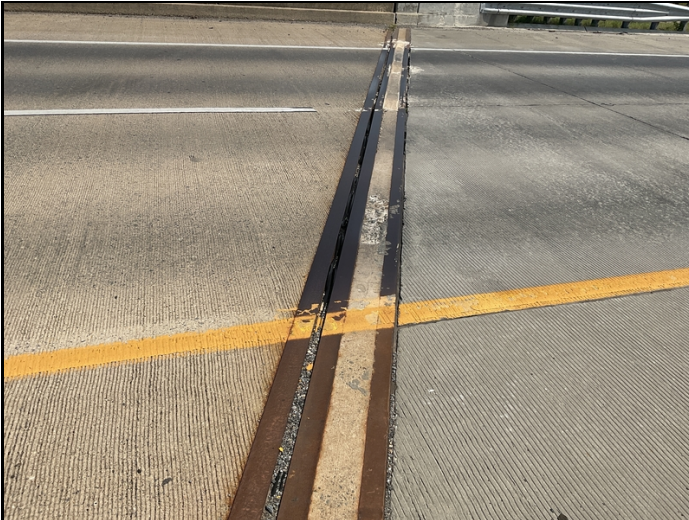
Bent 4: Preformed joint material is sagging or bulging up in several places.

Bent 4 joint seal has loss of adhesion and is leaking.

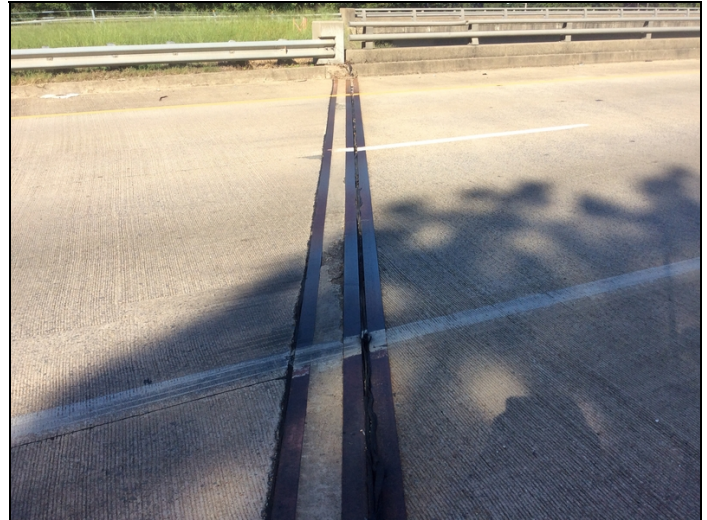
Joint - Bent 4 (tattering and loosing adhesion)

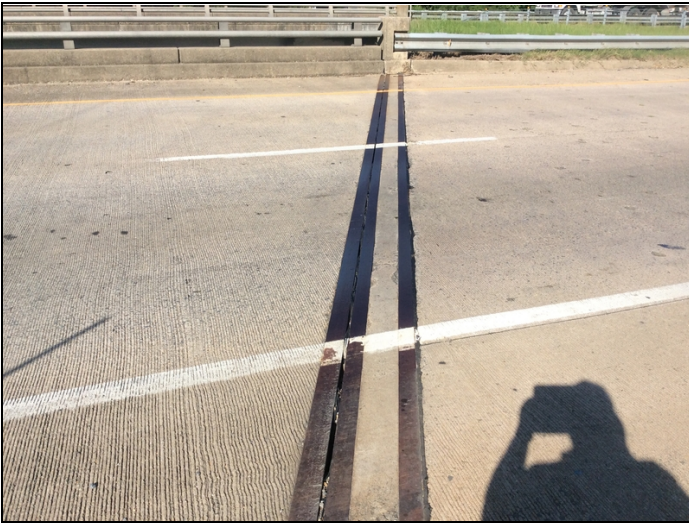
Bent 1: Joint is almost completely closed up. Preformed joint material is squeezed tight and tattered. A couple very small shallow spalls with some light deterioration on top of backwall.

Joint - Bent 1 (loosing adhesion)

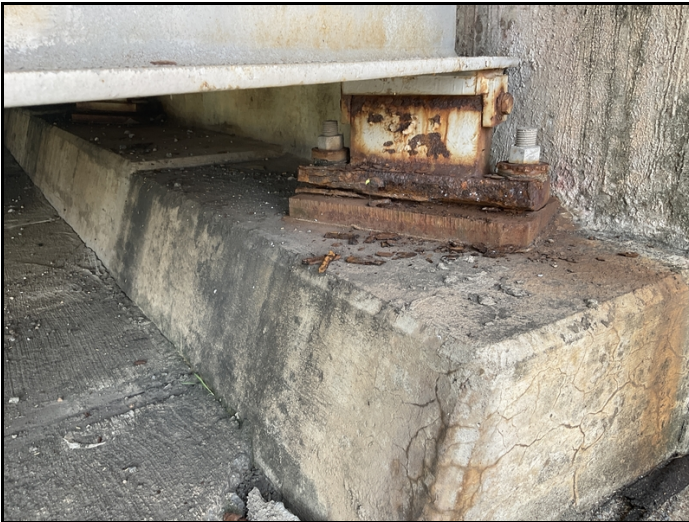
Bearings – Bents 1 & 4: Some paint flaking off of bearings with a couple places of very minor, light surface rust. Some pack rust under rocker at Bent 1 Bearing 1, somewhat restricting movement.

Bent 1 bearing 1 has heavy flaking rust.

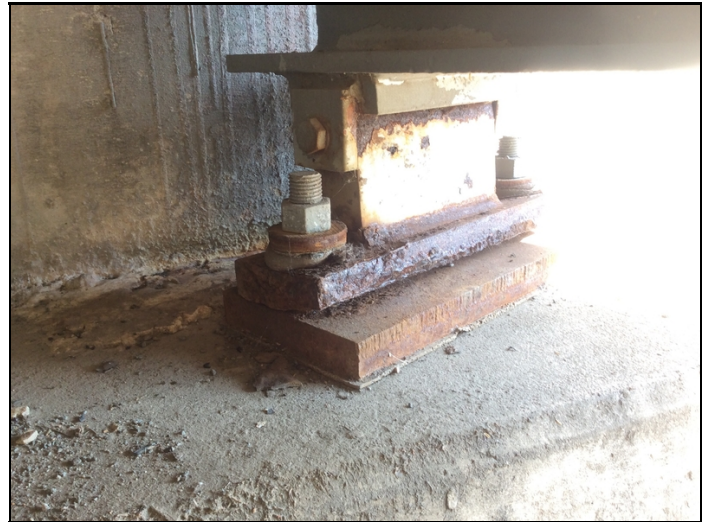
Bent 1 Bearing 1 (corrosion)

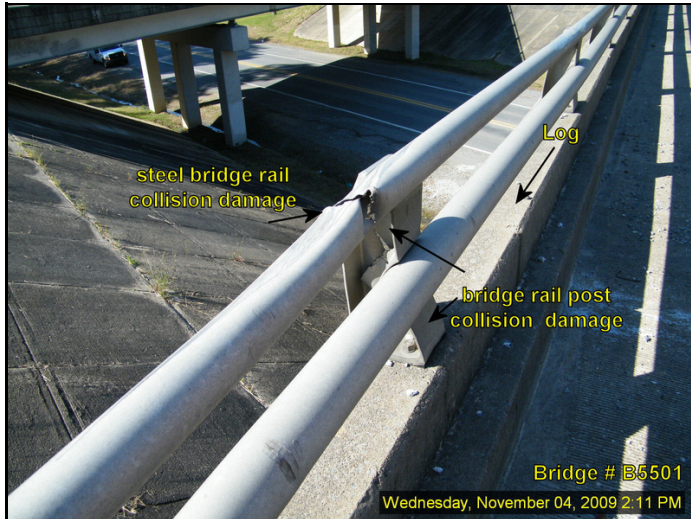
Span 3 right: Minor damage to rail and post near Bent 4.

Railing - right side near Bent 4: Collision damage
