Asset #A5611 (Routine)

I-530 SB LM 29.86 over SH 104

Location: @ SH 104-White Hall

Team Lead: Sharon Hooks, Inspection Date: 09/14/2022

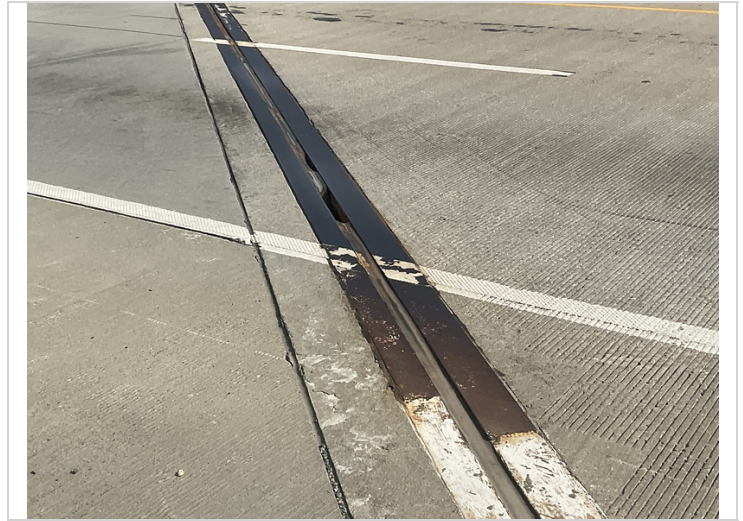
(301) Joint : 57' each (skewed) / Bents 1 & 4. Bents 1: Pourable joint material is beginning to lose adhesion in various locations. Several areas of material appear thin and some small holes are beginning to show through.							
311	Movable Bearing	EA	15	5	0	10	0
1000	Corrosion	EA	9	0	0	9	0
1020	Connection	EA	1	0	0	1	0
515	Steel Protective Coating	SF	30	10	0	20	0
3440	Effectiveness (Steel Protective Coatings)	EA	20	0	0	20	0

Bent 1 joint seal has loss of adhesion and is leaking.

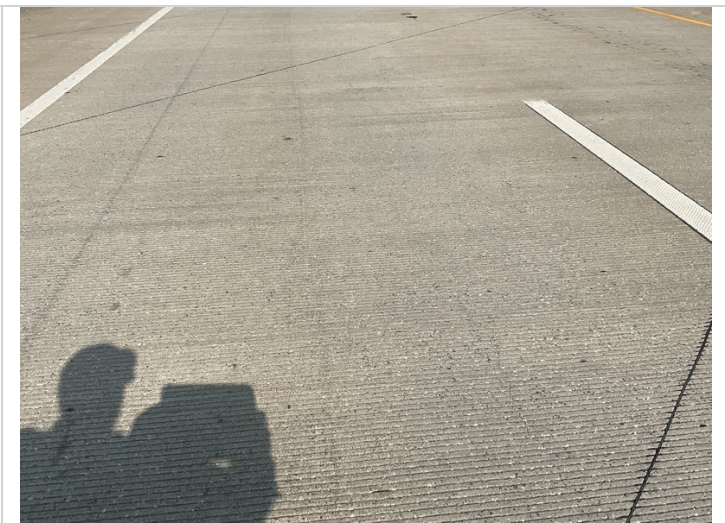
(12) Deck: 42' wide x 242' long = 10,164 sqft.							
Span 1: Some hairline- to minor-sized longitudinal cracking over Girder 3 (20 sqft CS2).							
Soffit – all spans: Some transverse cracking with efflorescence (60 sqft CS2) with scattered cracking on overhang (132 sqft CS2).							
Deck was hydro-demo'ed and overlaid under contract prior to 2016 inspection.							
Deck has longitudinal and transverse cracking up to .015"							
Old notes.							
PREVIOUS NOTES FOLLOW:							
Scattered unsealed moderate- to large-sized transverse cracks with some light efflorescence on soffit, mainly over Bents 2 & 3 and on Span 2. (upto 0.060 inch)							
Span 3: Minor- to moderate-sized longitudinal crack near centerline.							
NOTE: Span 1 mid-span: Full depth patch between Girders 3 & 4.							
Some small patches in right (outside) lane over Bent 2.

Span 2 near center line has longitudinal cracking in deck.

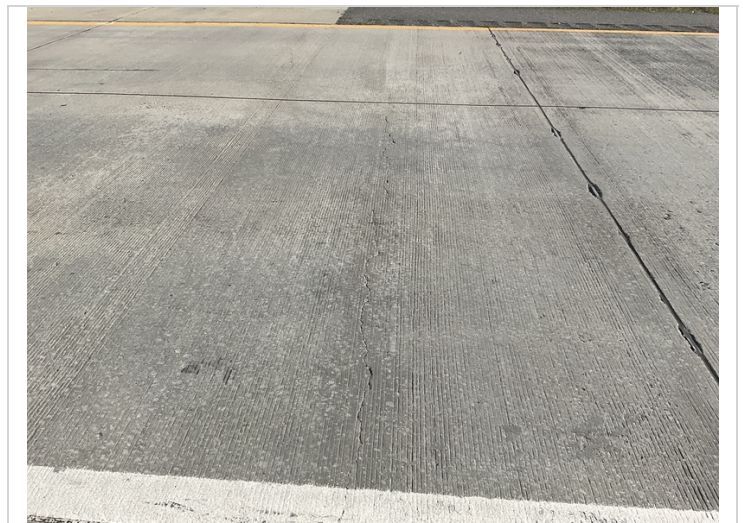
(321) Approach slabs: (24' wide x 35' long) 840 square feet each / Bents 1 & 4. Bent 4: One transverse crack / a couple unsealed minor-sized transverse/diagonal cracks close to bridge, mainly on left (inner) lane (28 sqft CS2). Bent 4 right: Spalling/potholes at approach slab/back-wall joint - at right (outer) edge line).							
330	Metal Bridge Railing	LF	490	490	0	0	0
515	Steel Protective Coating	SF	1176	1176	0	0	0

South end of approach slab has moderate cracking.

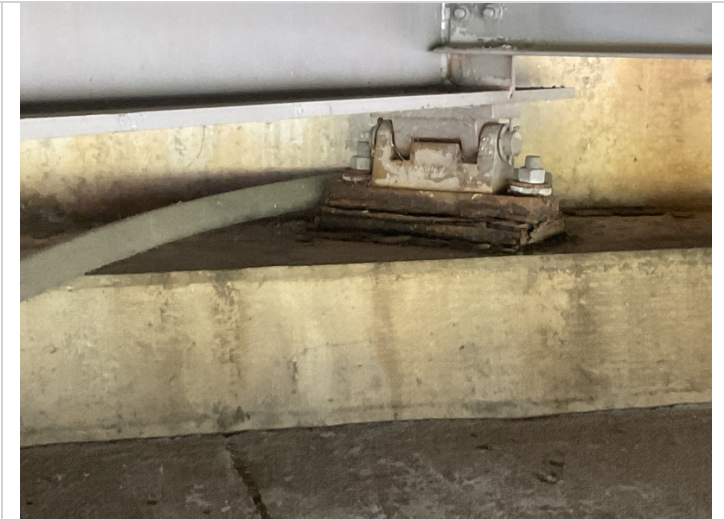
(311) Moveable bearings: 5 per bent / Bents 1, 2, & 4. Coating: 2.0 square feet each. Bearings - Bents 1 & 4: Surface rust with some flaking and peeling of paint, especially at the masonry plate. Bent 1 Bearing 2: Nut missing off anchor bolt on left side. Bent 1 Bearing 5: Anchor bolt rusted through on left side. Bent 4 Bearing 5 left: Bolt corroded and worked out.							
313	Fixed Bearing	EA	5	5	0	0	0
515	Steel Protective Coating	SF	10	10	0	0	0

Bent 4 bearing 3 has heavy flaking corrosion.

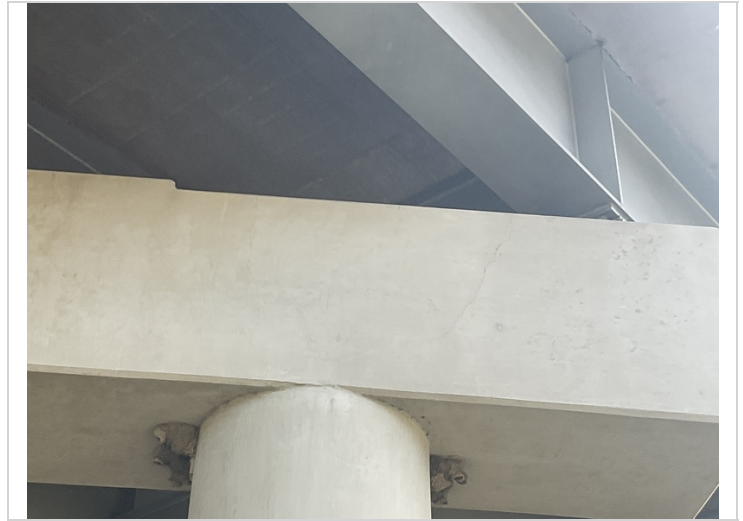
(234) Caps: 57' each / Bents 2 & 3. Bent 2 and 3 cap have some vertical hairline cracks forming near steps.							
301	Pourable Joint Seal	LF	114	85	25	0	4
2310	Leakage	LF	10	0	10	0	0
2320	Seal Adhesion	LF	15	0	15	0	0
7000	Damage	LF	4	0	0	0	4

Bent 3 cap right behind has moderate sizes cracking

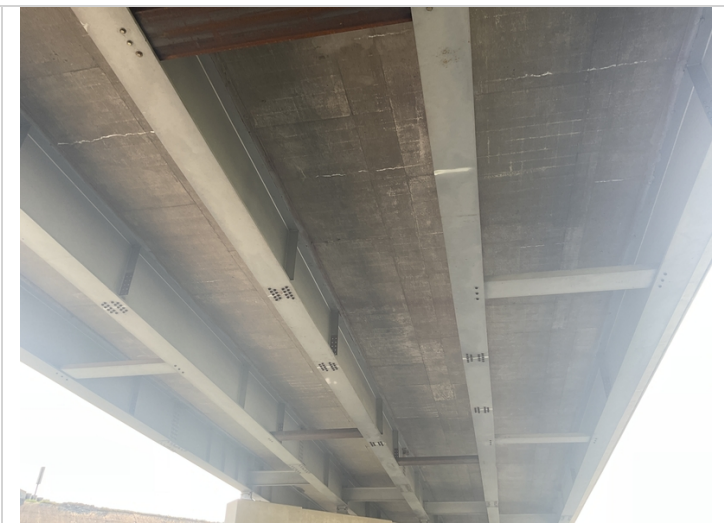
Under view of old repairs and cracking with efflorescence on soffit areas of deck.

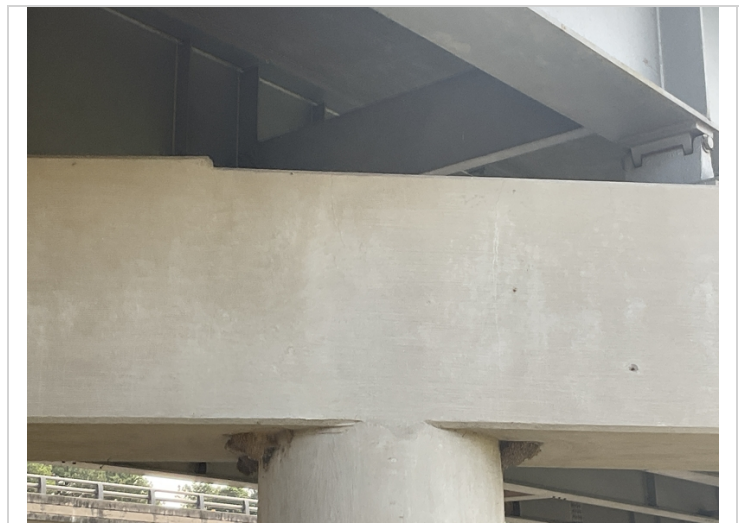
Bent 2 cap right back over column 3 has moderate cracking.

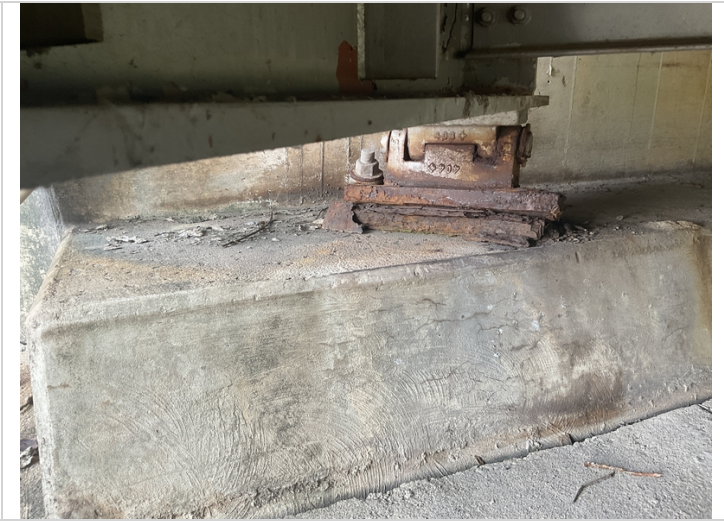
Bent 1 bearing 5 has heavy flaking rust.

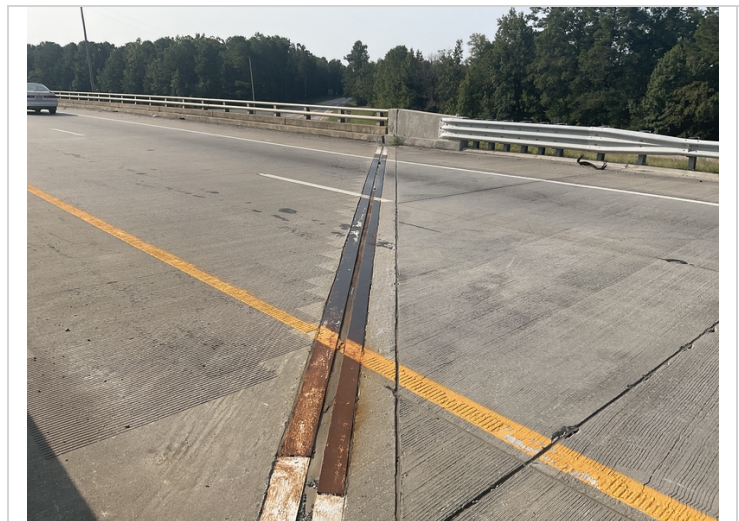
Bent 1 joint seal has small holes and seals and are leaking.

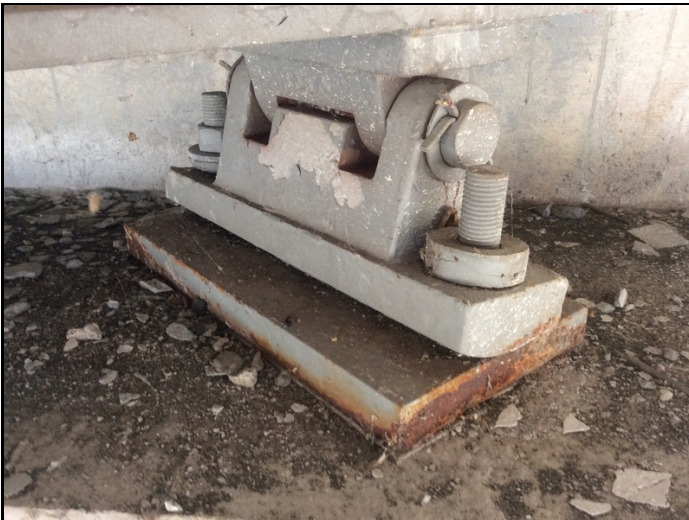
Bent 1 Bearing 2: Nut missing off anchor bolt on left side.

Bent 1 Bearing 2 (anchor nut missing)

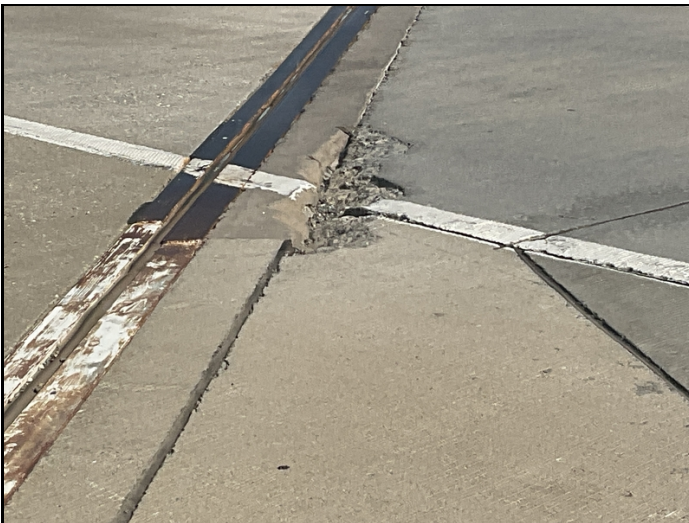
Approach slab/abutment - Bent 4 right: Spalling/potholes at approach slab/back-wall joint - at right (outer) edge line).

Bent 4 at end of header and approach slabs has spalls in concrete.

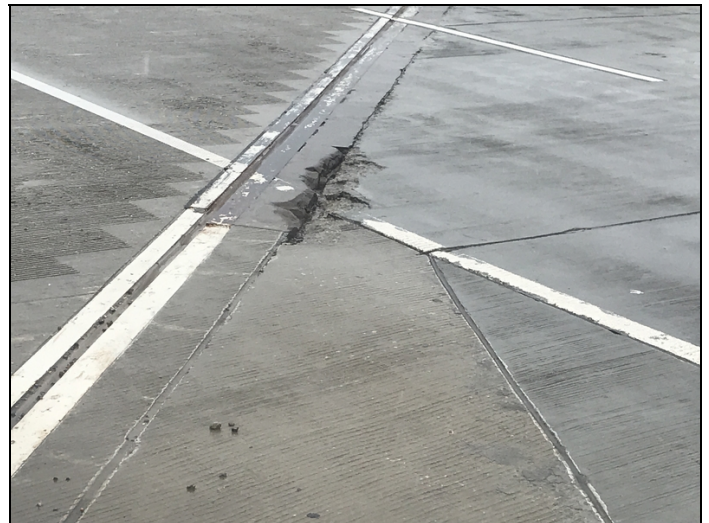
Bent 4 approach slab has potholes near joint armor .

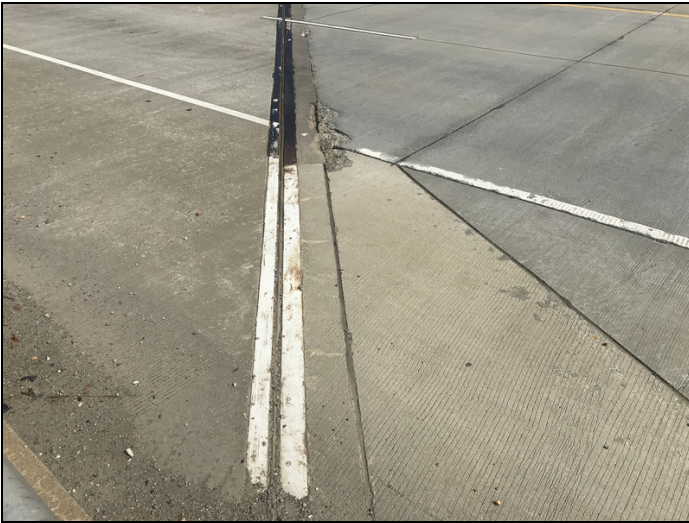
Approach slab - Bent 4 right: Spalling/potholes

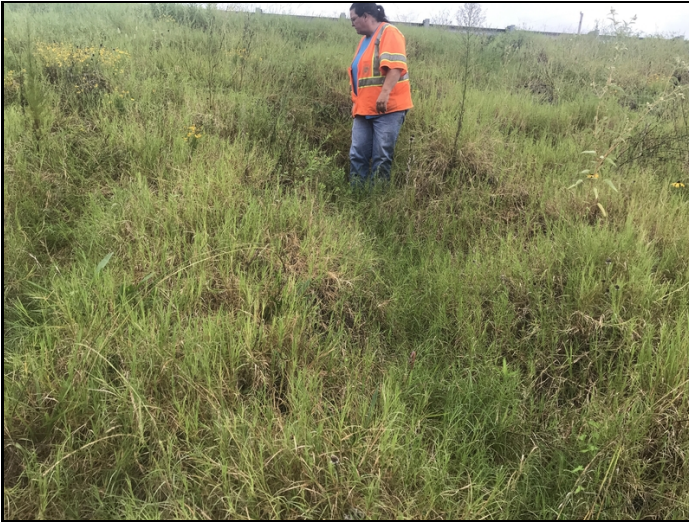
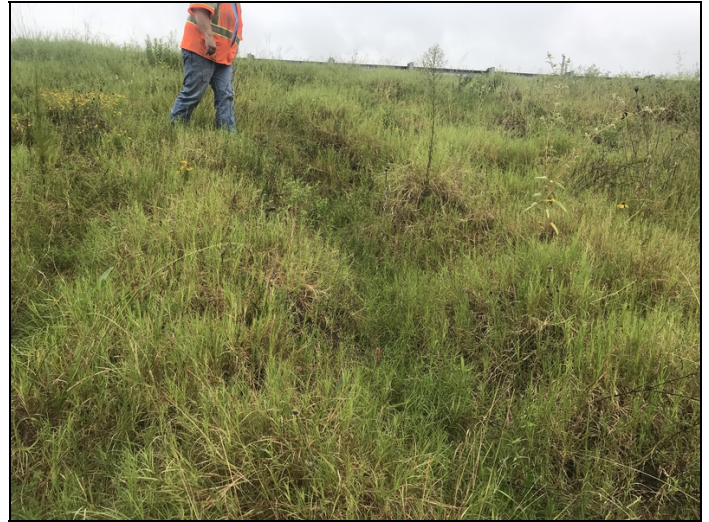
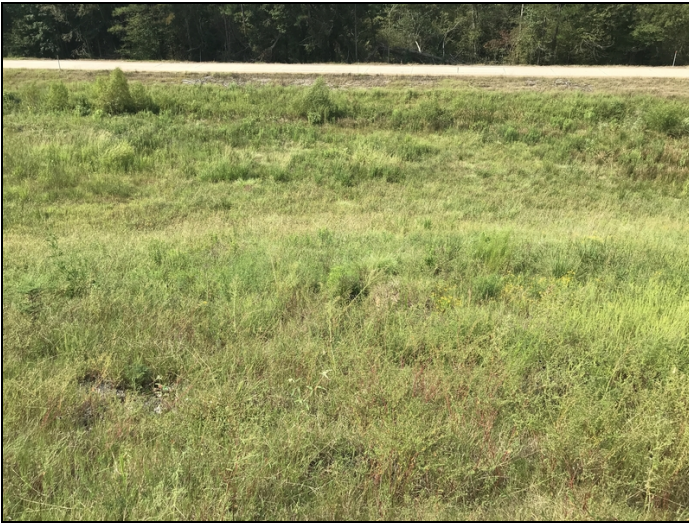
Approach roadway slope - Bent 1 right: Some slope erosion at end of gutter - approximately halfway down side slope.

Approach roadway - Bent 1 right: Slope erosion

Approach roadway slope - Bent 1 right: Erosion

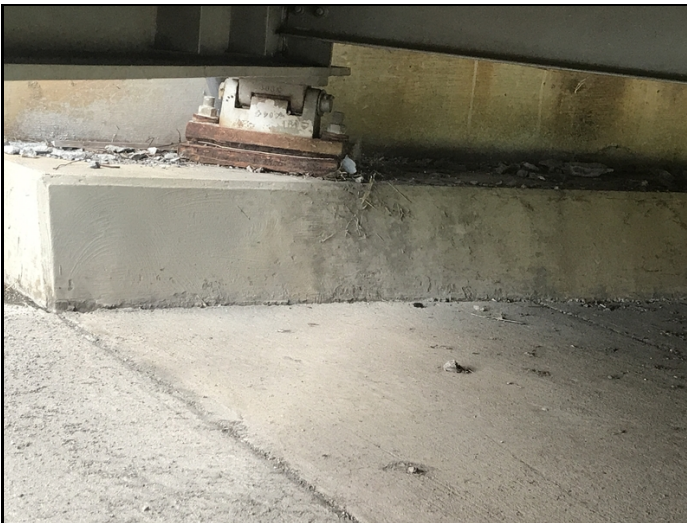
Bearings – Bents 1 & 4: Surface rust with some flaking and peeling of paint, especially at the masonry plate.

Bent 4 bearing 4 flaking rust common on bent 1 & 4 .

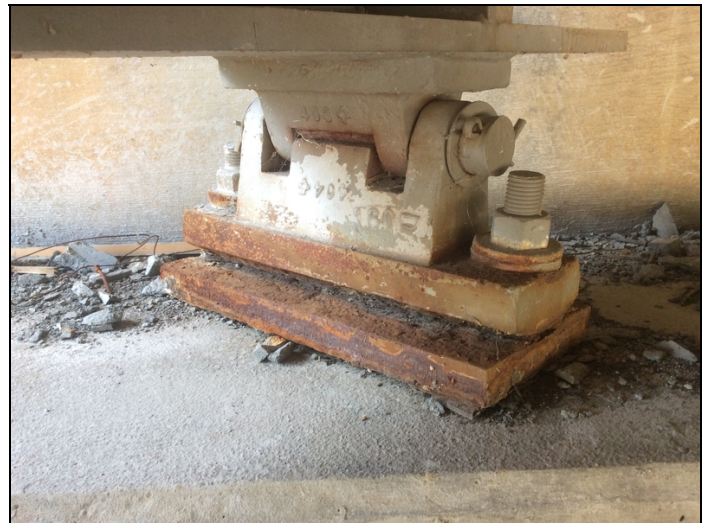
Bent 4 Bearing 1 (corrosion)

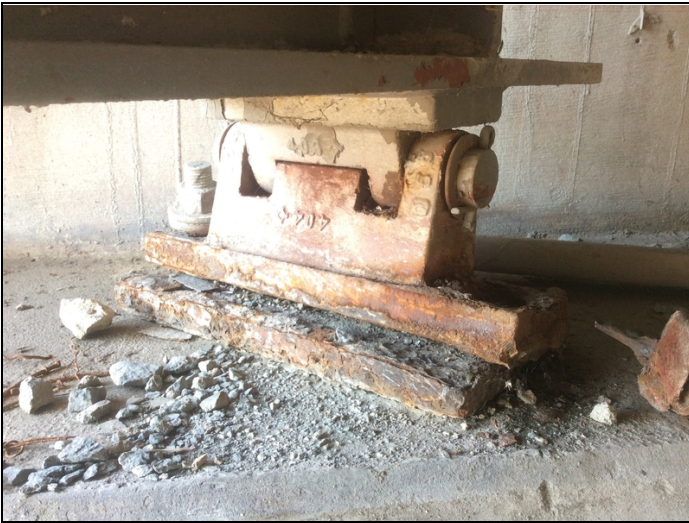
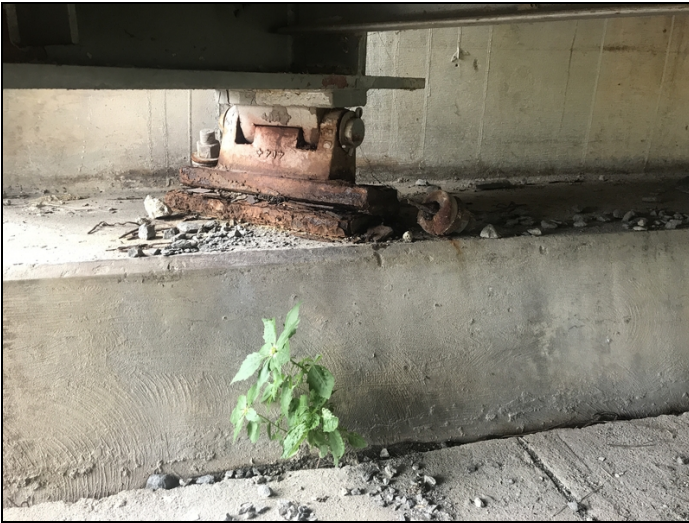
Bent 1 Bearing 5 (anchor bolt rusted away)

Bent 1 bearing 5 has heavy flaking rust and anchor bolt rusting away,

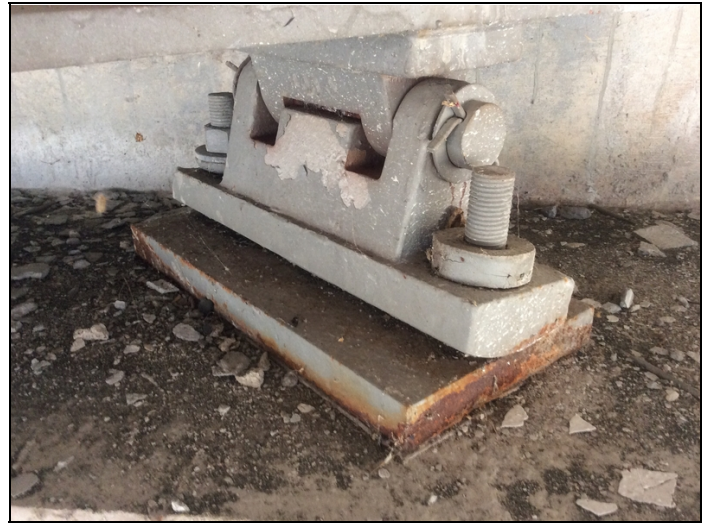
Bent 1 Bearing 2 (anchor nut missing)

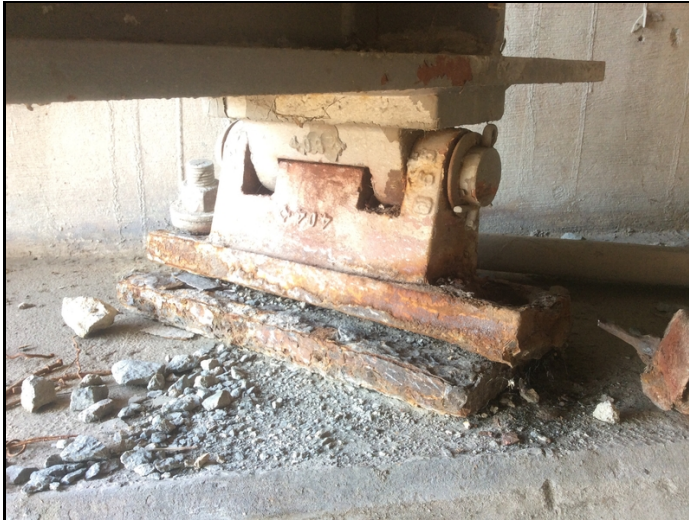
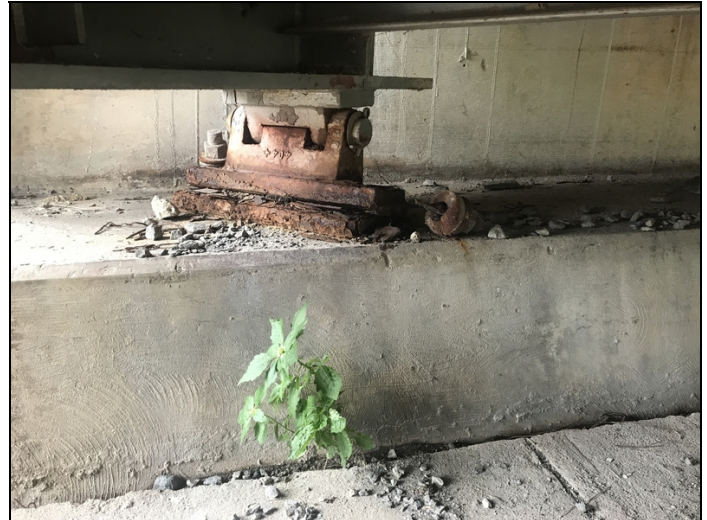
Bent 1 Bearing 5: Anchor bolt rusted through on left side.

NOTE: Anchor bolts need to be in place to restrict lateral movement.

Bent 1 Bearing 5 (anchor bolt rusted away)

Bent 1 bearing 5 has heavy flaking rust and anchor bolt rusting away,

work this in a quick as you can

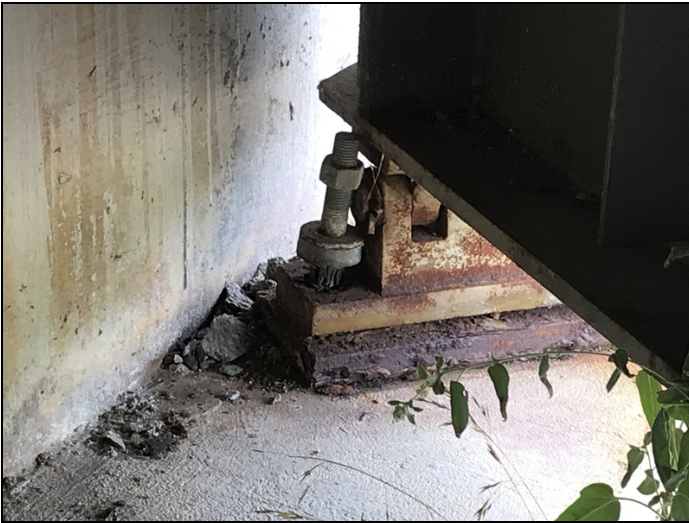
Bent 4 Bearing 5: Bolt corroded and worked out on left side.

Bent 4 Bearing 5 left: Bolt corroded and worked out
