Asset #B5611 (Routine)

I-530 NB LM 29.87 over SH 104

Location: @ SH 104-White Hall

Team Lead: Sharon Hooks, Inspection Date: 09/14/2022

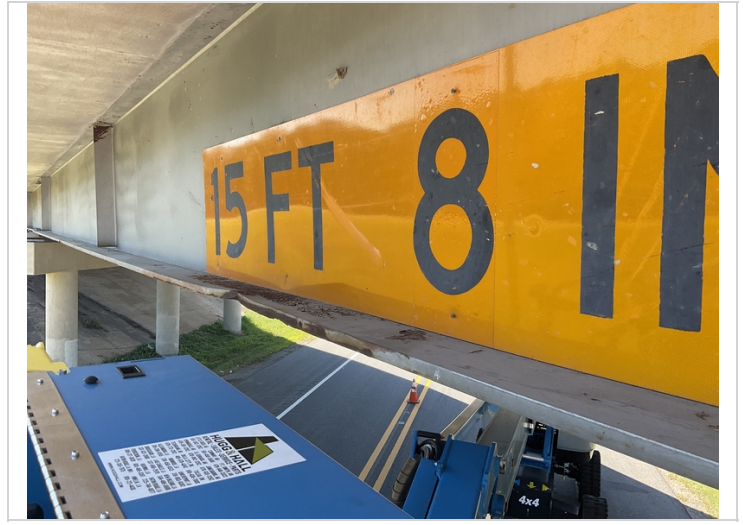
Span 2 Previous damage on girder 1.

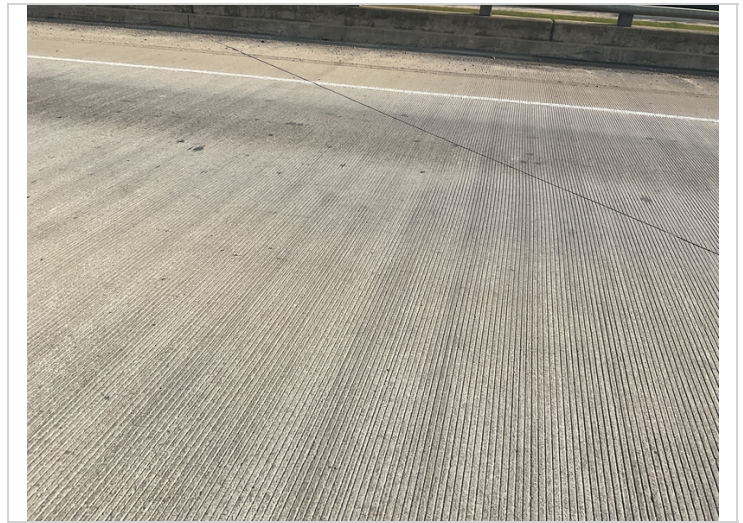
Span 3 near centerline has deck cracking.

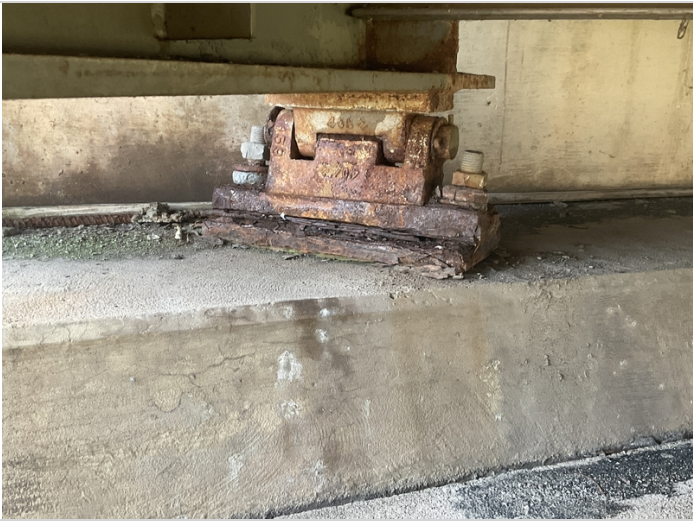
Bent 4 bearing 1 has heavy corrosion.

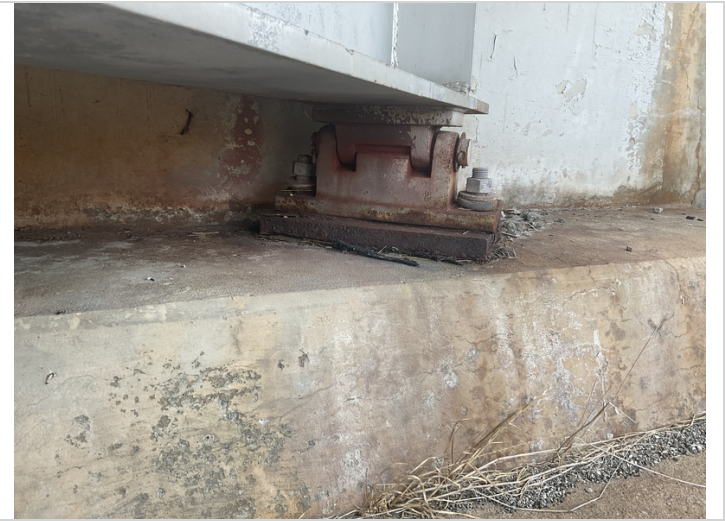
Bent 4 bearing 5 has moderate corrosion.

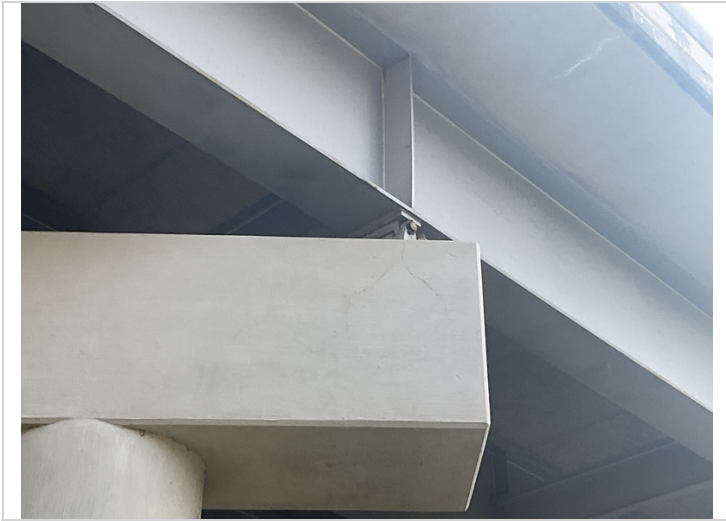
(234) Caps: 51' each (skewed) / Bents 2 & 3. Some loss of grout on top of caps around anchor bolts. Bents 2 & 3: Some hairline vertical cracks forming at steps. Bent 3 cap right near girder 5 has cracking near end.

Bent 3 cap right near girder 5 has cracking.

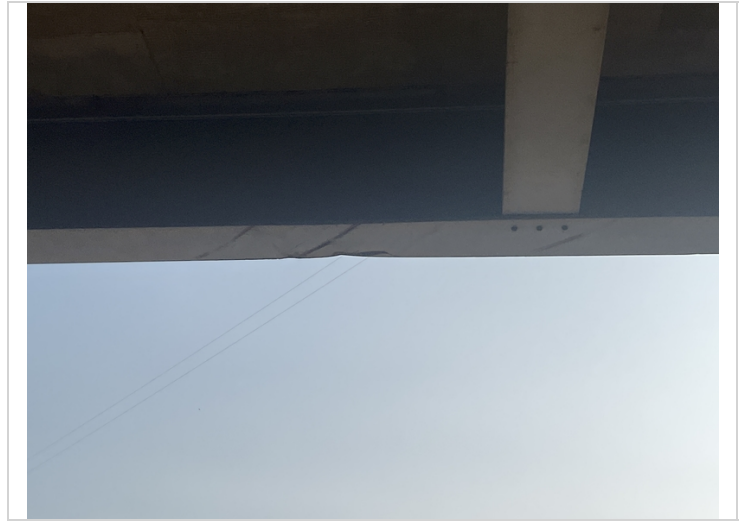
Span 2 girder 1 has traffic impact to lower flange. Damage is old.

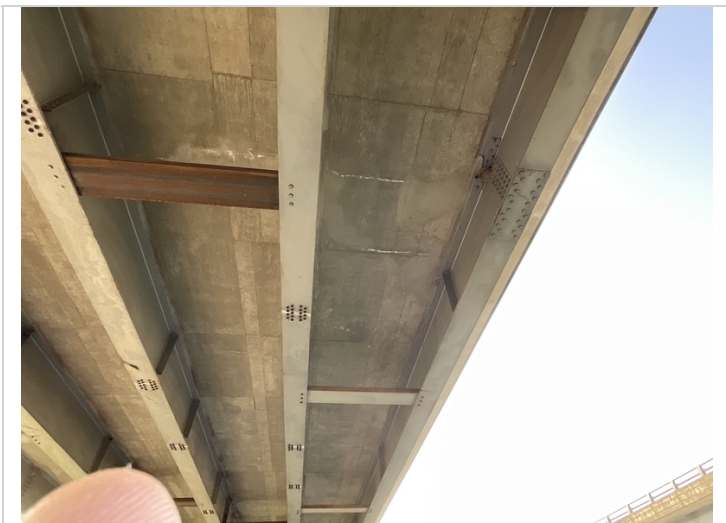
Span 2 bay 4 has cracking with efflorescence on soffit areas.

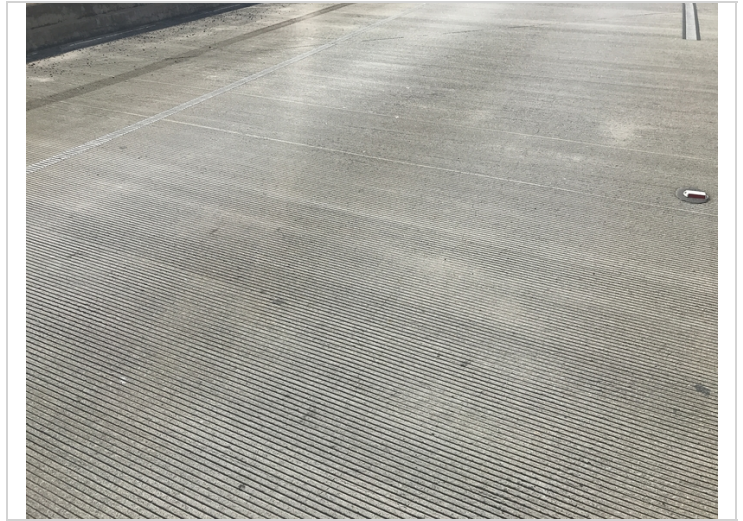
Deck - Span 2 over Girder 3: Longitudinal cracking

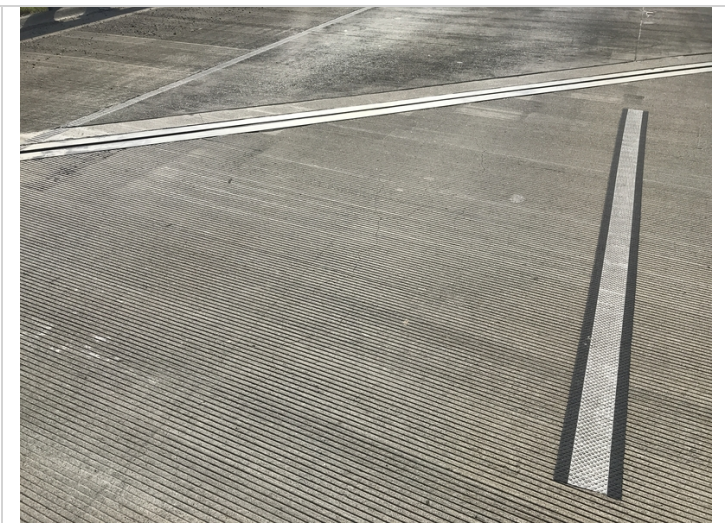
Deck - Span 1 @ Bent 1: Longitudinal cracking

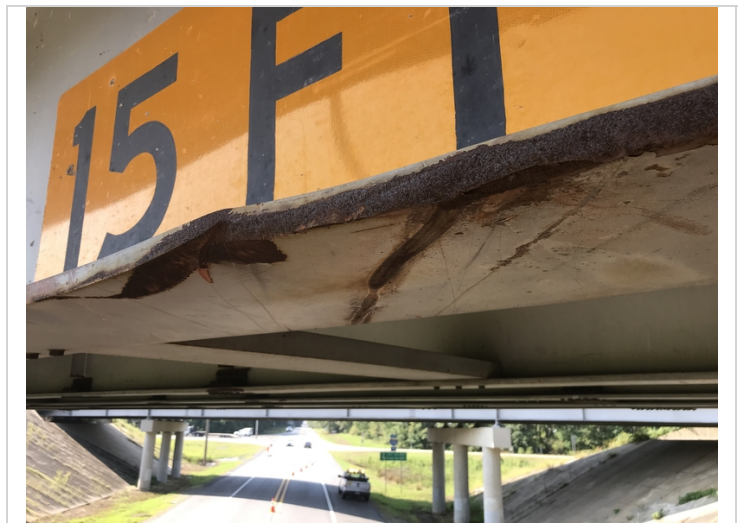
Span 2 Girder 1: Damage to bottom flange

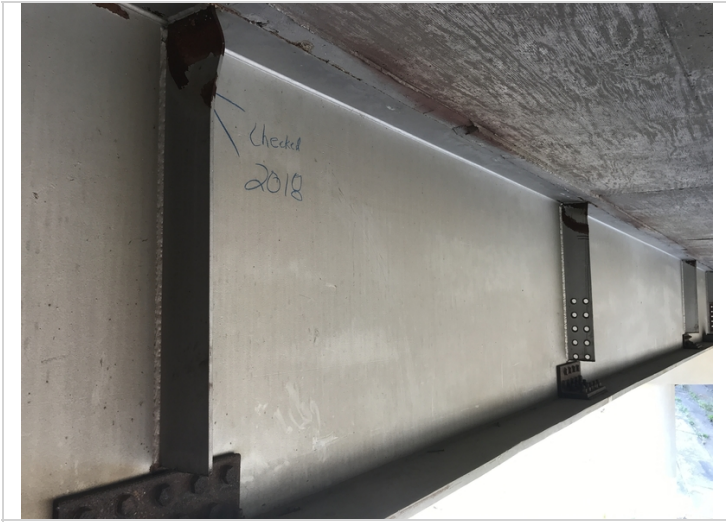
Span 2 Bay 2 left: Damage to stiffeners

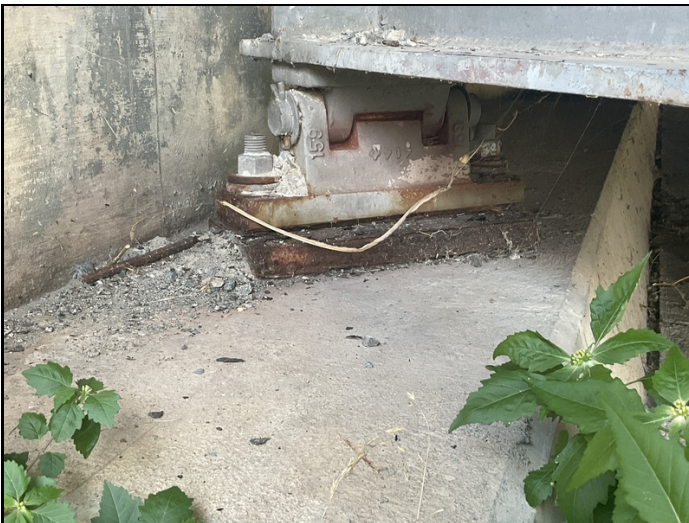
Bearings – Bents 1 & 4: Rusty with some flaking and peeling of paint, especially at the masonry plate.

Bent 1 bearing 5 has pack rust under bearing. Common on all movable bearings.

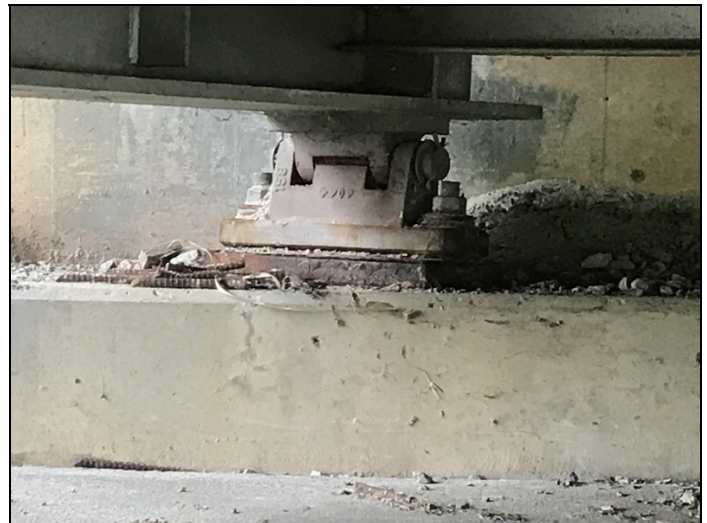
Bent 1 bearing 5 has flaking rust .

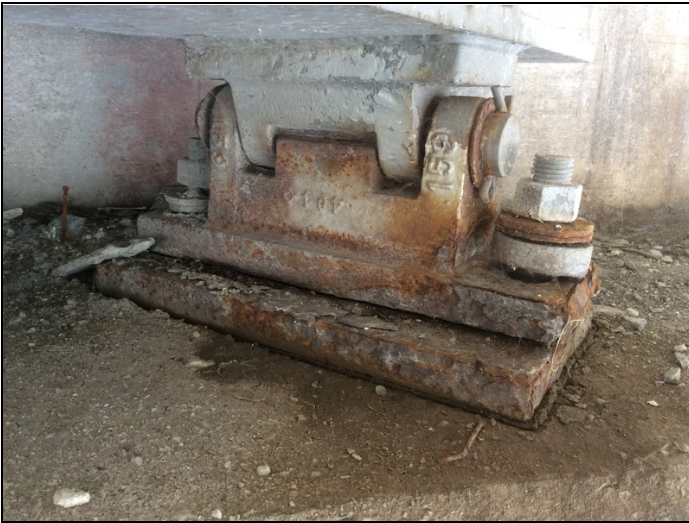
Bent 4 Bearing 4 (corrosion)

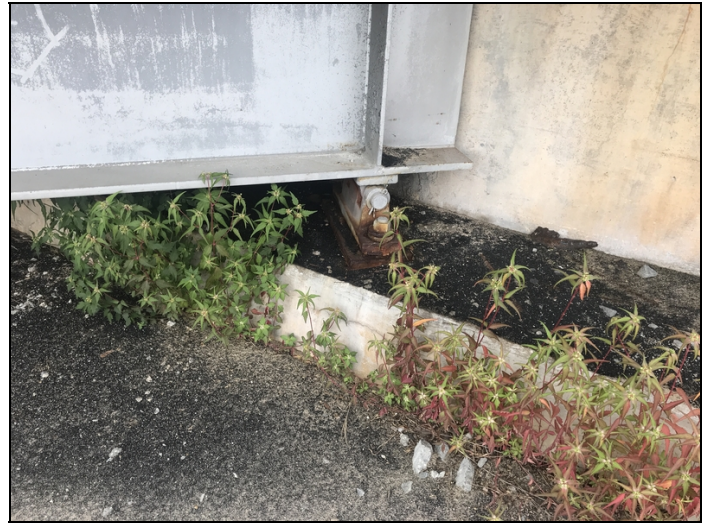
Bent 1 bearing 1 flaking rust.

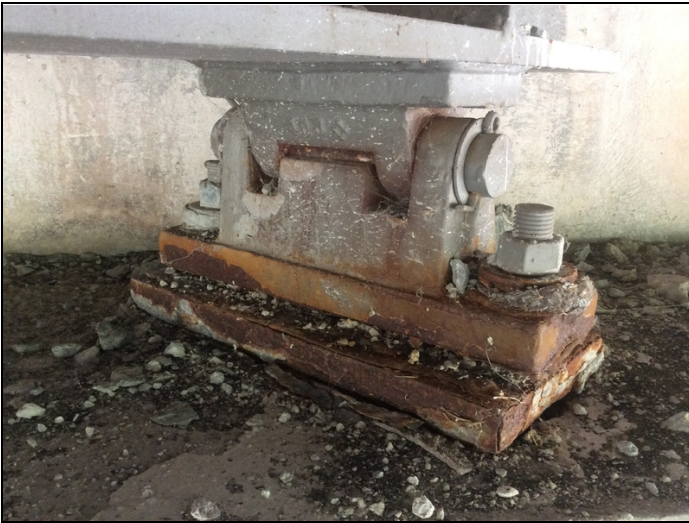
Bent 1 Bearing 2 (corrosion)

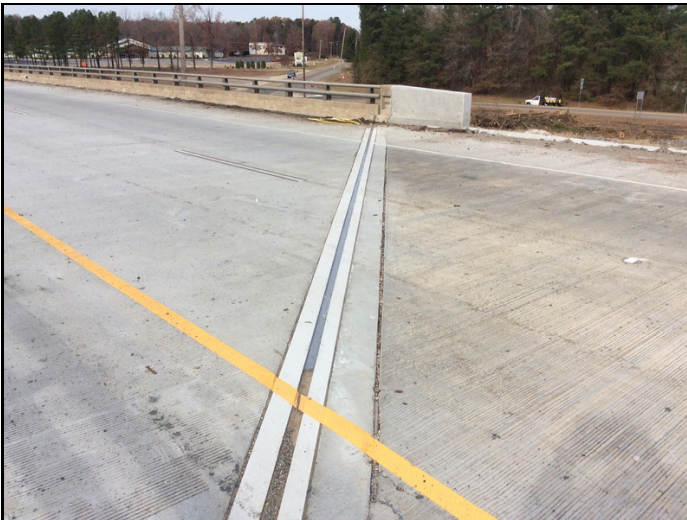
Approach slab - Bent 4: No joint filler between abutment backwall and edge of approach slab and no joint filler in intermediate joint.

Approach slab/joint - Bent 4 (joint repaired)

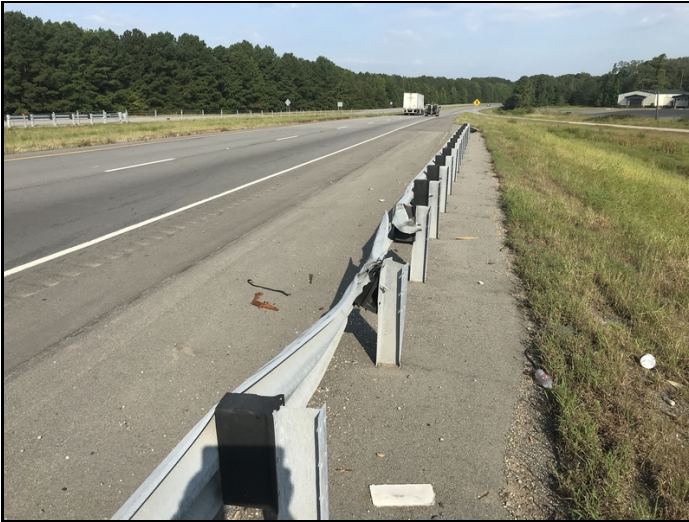
Approach railing - Bent 1 left: Impact damage to rail and spacer blocks

Approach railing - Bent 1 left: Impact damage

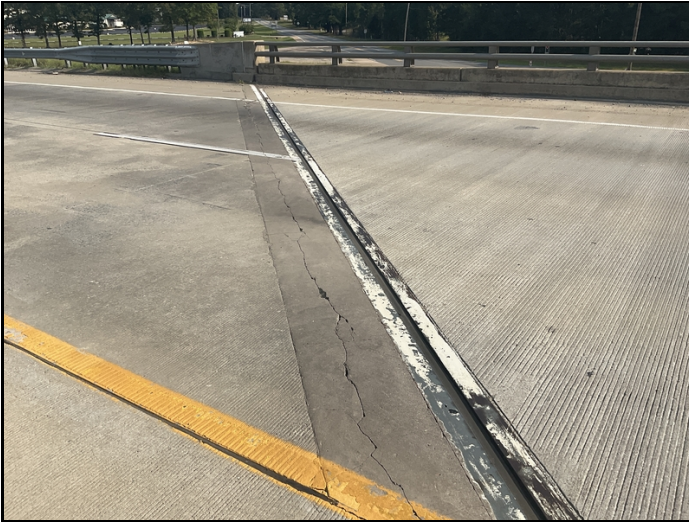
Abutment - Bent 1: Some deterioration, cracking, and minor spalling on top of backwall at left side of left (outer) lane.

Bent 1 abutment at top of back wall has heavy cracking.

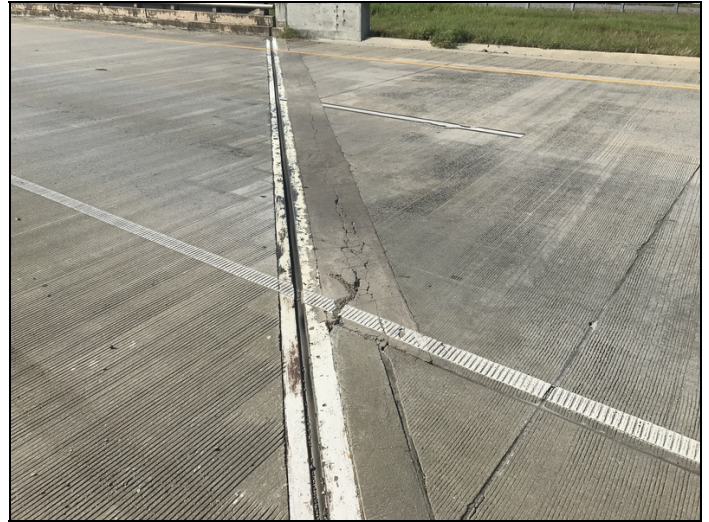
Approach slab/abutment - Bent 1 left: Cracking/spalling

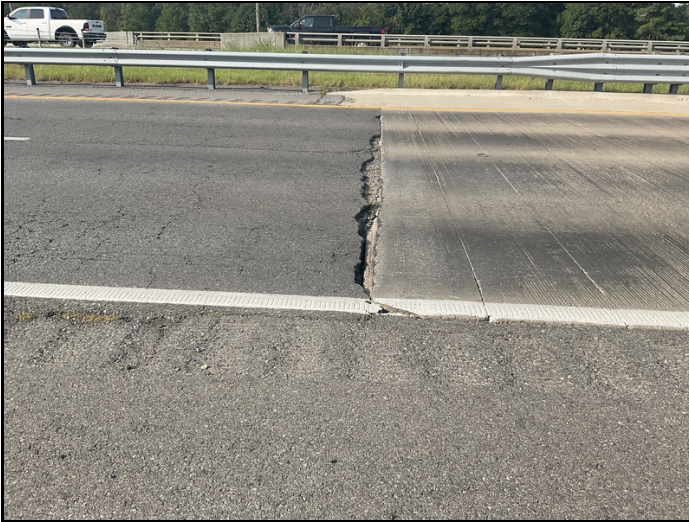
Potholes on South end of bridge approach at concrete approach slabs.

Asphalt roadway at approach slabs has spalled and causing potholes in both lanes on South end of bridge.
