Asset #A5612(Routine)

I-530 SB LM 23.76 over CR 117 (Jefferson)

Location: 1.0 Mi W SH 365-Jefferson

Team Lead: Sharon Hooks, Inspection Date: 02/14/2022

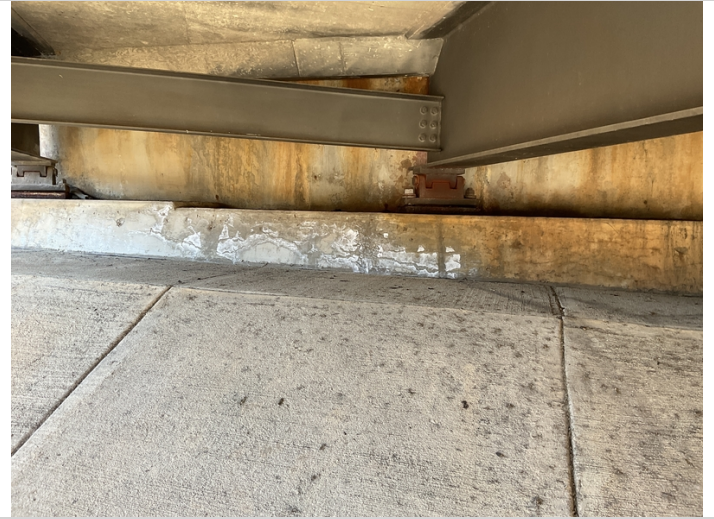
(215) Abutments: 45'-0 3/8" = 46' each (skewed - plus approximately 15' wings/total each bent) / Bents 1 & 4. Bent 1 - Abutment: A few scattered cracks and efflorescence. Bent 4 - Abutment: Cracking on entire element.							
234	Reinforced Concrete Pier Cap	LF	86	84	2	0	0
1010	Cracking	LF	2	0	2	0	0

Bent 4 abutment has map cracking on step down.

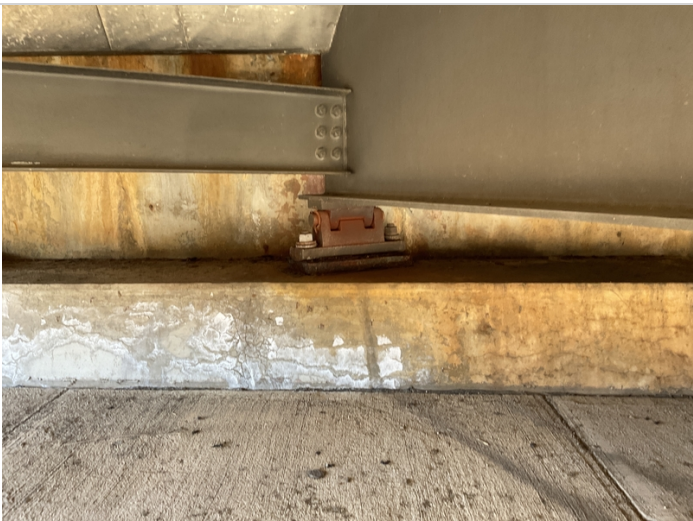
(311) Moveable bearing: 5 per bent / Bents 1, 3, & 4. Coating: 3 square feet each. Bent 1 Bearing 3: Anchor nut missing on right side. Bent 4 Bearing 2: Bearing has some "play" around pin - minor (1/4-3/8") vertical movement under traffic. Bent 4 Bearing 4: Anchor bolt corrosion has allowed bolt to break off. Bent 1 & 4 bearings are have light corrosion with some pack rust between rockers and masonry plates.							
313	Fixed Bearing	EA	5	0	5	0	0
1000	Corrosion	EA	5	0	5	0	0
515	Steel Protective Coating	SF	15	15	0	0	0

Bent 4 abutment at bearing 2 has corrosion.

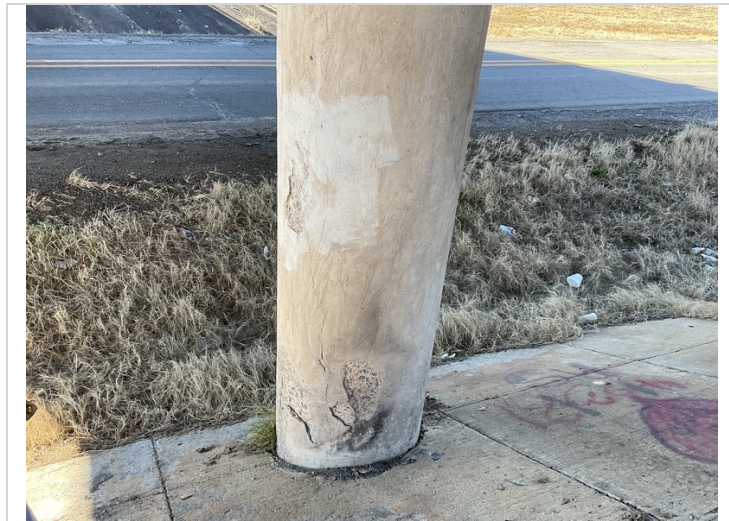
(205) Columns: 3 per bent / Bents 2 & 3. Bent 2 Column 2: Shallow spalling (collision/fire damage) on left side from groundline up 6'.							
215	Reinforced Concrete Abutment	LF	122	22	10	90	0
1120	Efflorescence/Rust Staining	LF	15	0	0	15	0
1130	Cracking (RC and Other)	LF	85	0	10	75	0

Bent 2 column 2 has cracking and spalls.

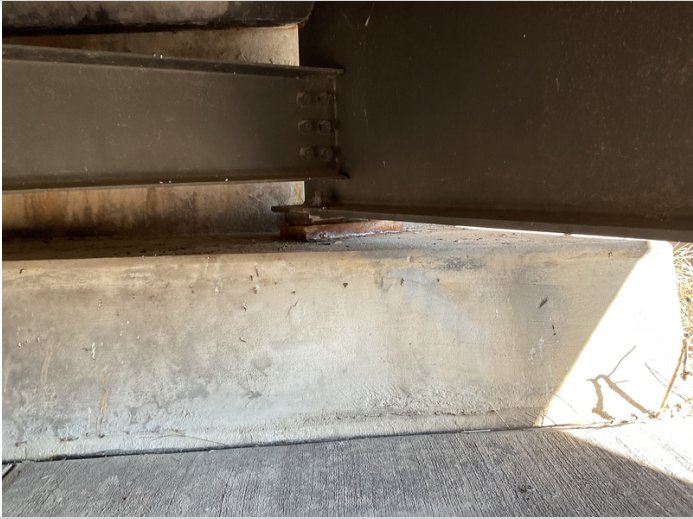
Bent 1 left bearing 1 has corrosion.

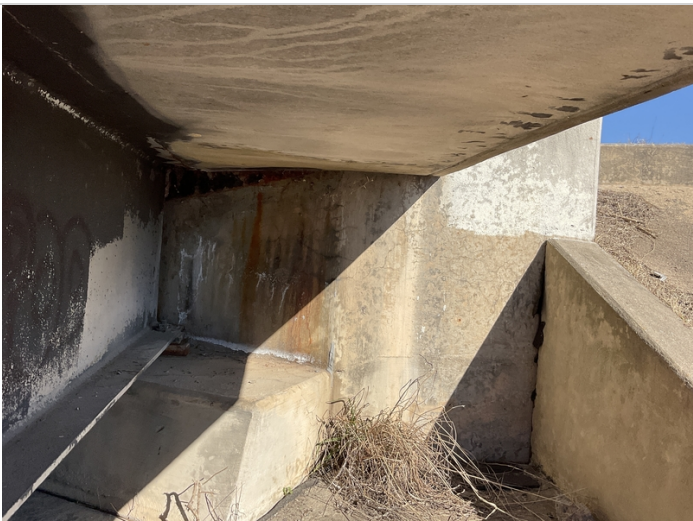
Bent 1 left at abutment has cracking with efflorescence.

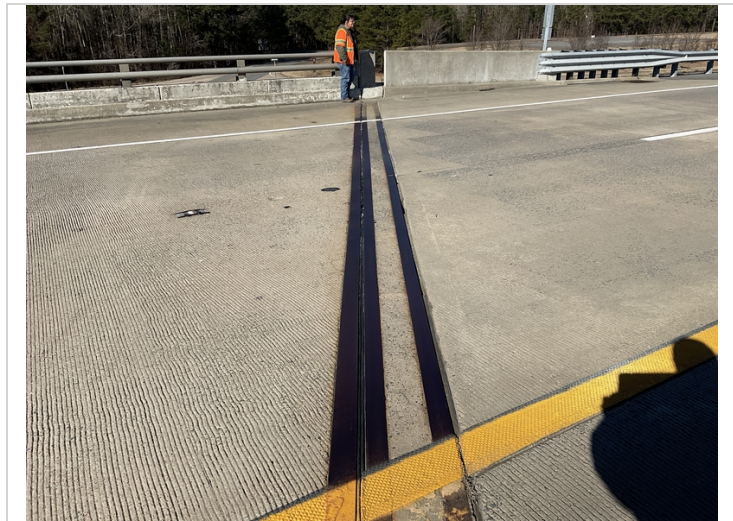
Bent 1 joint seals torn and leaking.

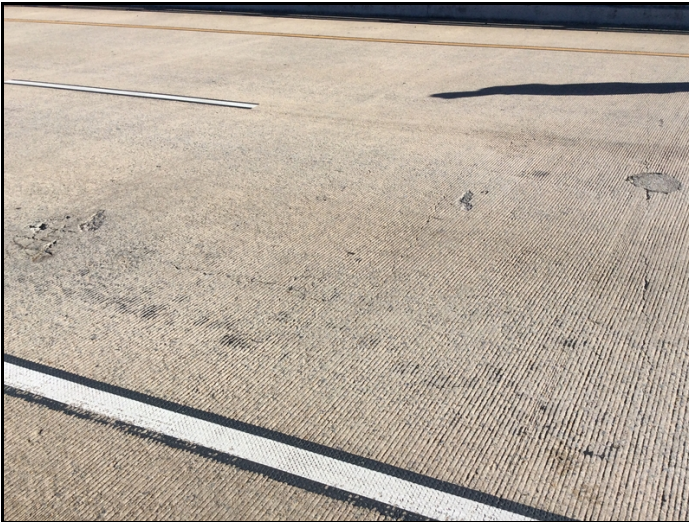
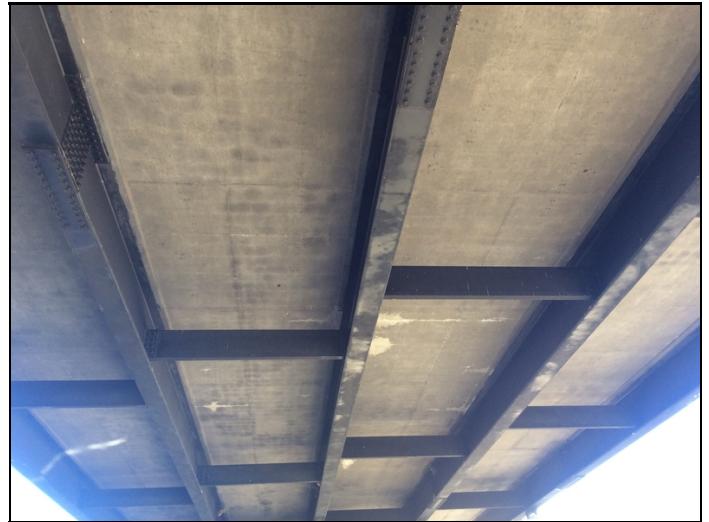
Deck – all spans: Unsealed, moderate-sized transverse & longitudinal cracks with some reflective efflorescence showing on soffit, mainly in right (outside) lane.

Type of Work: Repair (General)

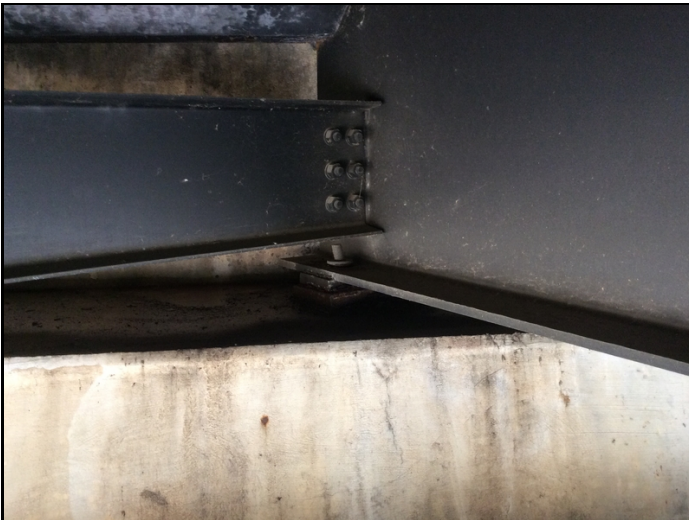
Bearing 3 @ Bent 1: Anchor nut missing on right side.

Bent 1 - Bearing 3: Missing nut

Type of Work: Repair (General)

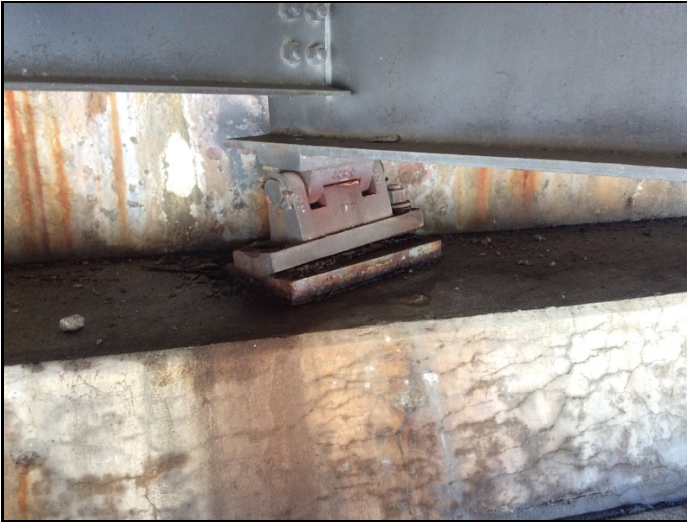
Bearing 4 @ Bent 4: Anchor bolt corrosion has allowed bolt to break off.

Bent 4 - Bearing 4: Missing bolt

Type of Work: Repair (General)

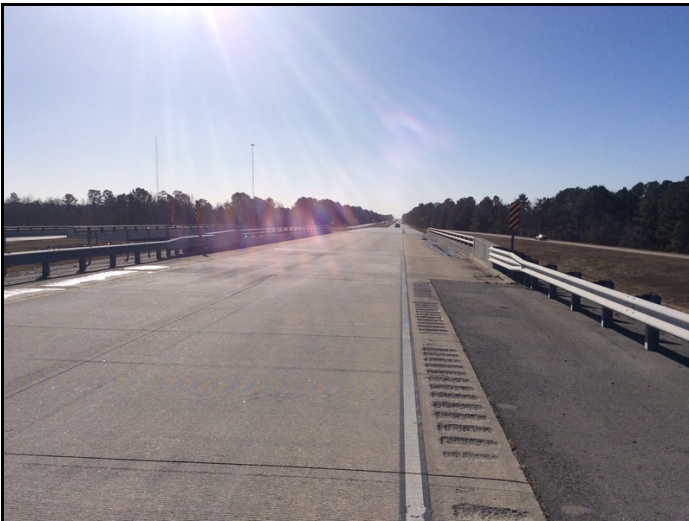
Roadway view

Signs - Bent 1 right: No log mile sign - object marker and post in place.

Sign should read "530 - 5
+
23.76"
