Asset #B5612(Routine)

I-530 NB LM 23.76 over CR 117 (Jefferson)

Location: 1.0 Mi W SH 365-Jefferson

Team Lead: Sharon Hooks, Inspection Date: 02/14/2022

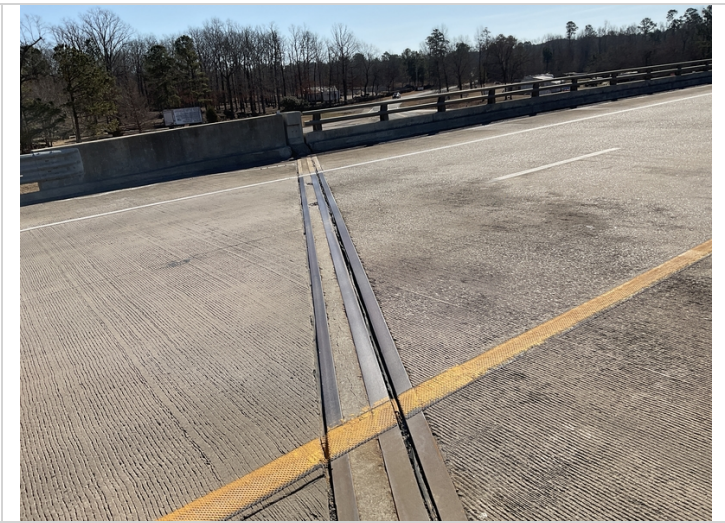
(302) Joints: 48' each (skewed) / Bents 1 & 4. Bent 1- Joint material is allowing stormwater to leak through due to heavy damage. Still partially in place. Bent 4 - Joint material has moderate cracking on entire length with heavier damage on inside lane.							
311	Movable Bearing	EA	15	5	7	3	0
1000	Corrosion	EA	10	0	7	3	0
515	Steel Protective Coating	SF	45	15	0	30	0
3440	Effectiveness (Steel Protective Coatings)	EA	30	0	0	30	0

Bent 1 joint seal is torn and leaking.

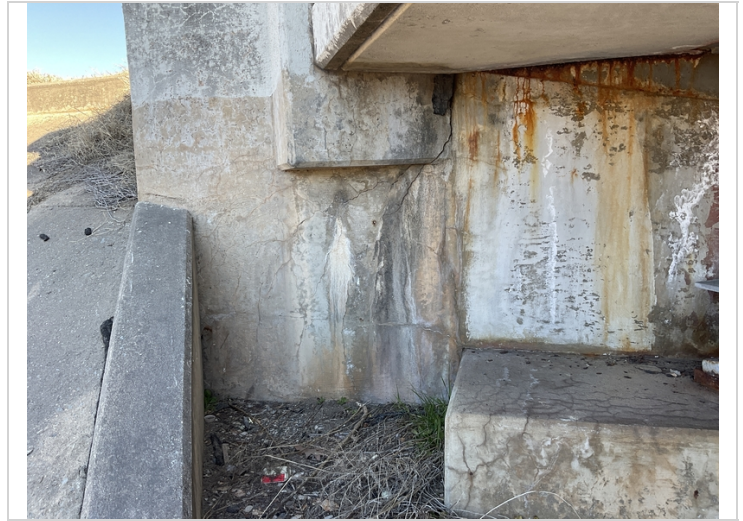
Bent 1 abutment right has cracking with delam.

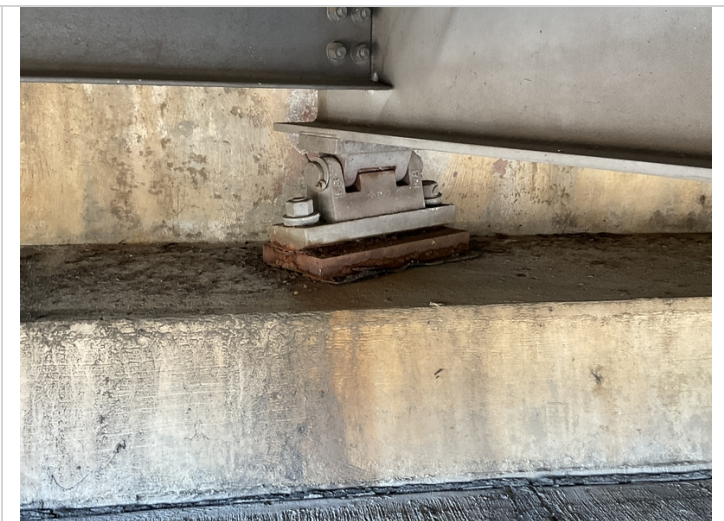
(311) Movable bearings: 5 per bent / Bents 1, 2, & 4. Coating: 3 square feet each. Bearing 2 @ Bent 4: Anchor bolt broke off on right side. Bearing 5 @ Bent 1: Anchor nut missing on right side. Bent 1 & 4 bearings are have light corrosion with some pack rust between rockers and masonry plates.							
313	Fixed Bearing	EA	5	5	0	0	0
515	Steel Protective Coating	SF	15	15	0	0	0

Bent 1 bearing 4 has corrosion common on all bearings.

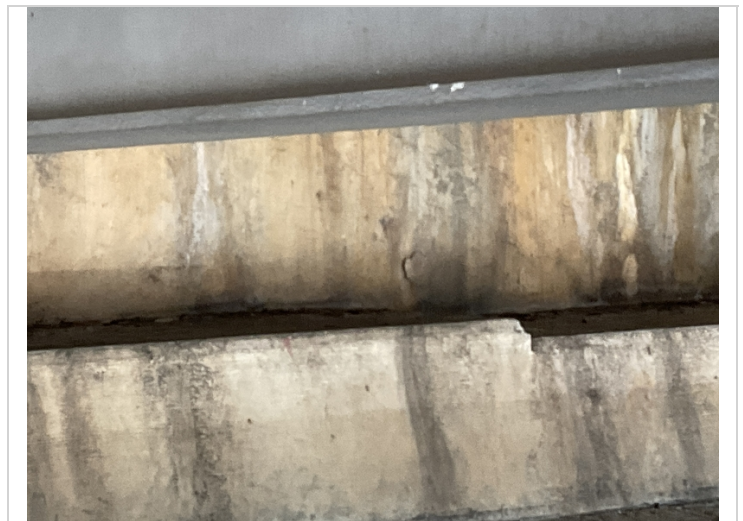
Bent 1 abutment has some cracking and a minor delam.

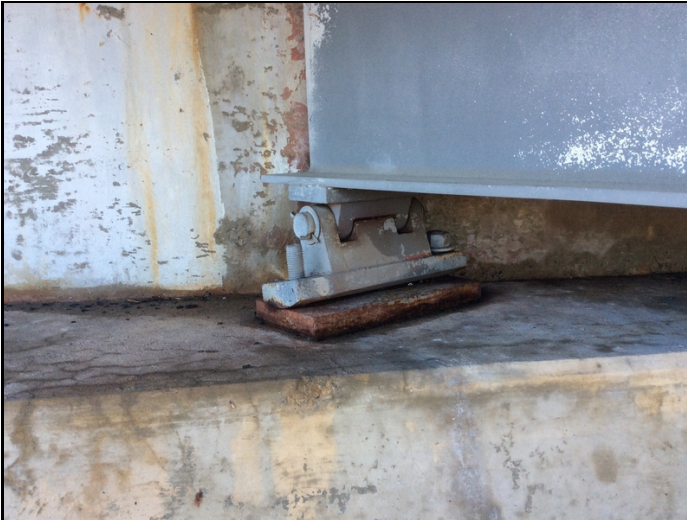
Bearing 2 @ Bent 4: Anchor bolt broke off on right side.

Bearing 5 @ Bent 1: Anchor nut missing on right side.

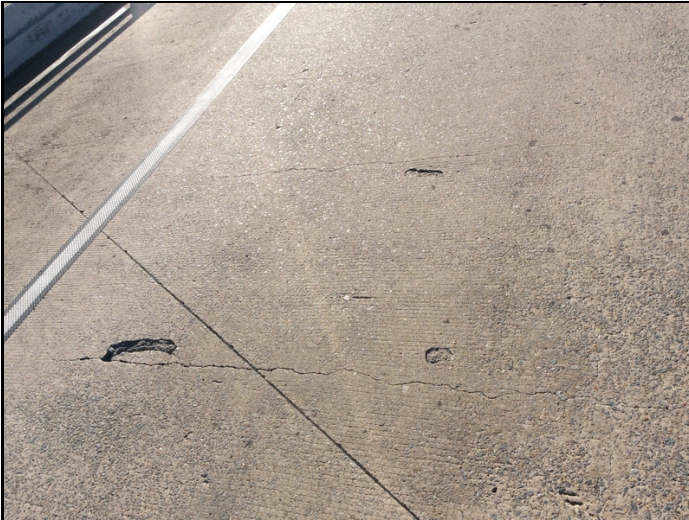
Unsealed, moderate-sized transverse cracks (little or no reflective efflorescence on soffit) - approximately 6-10' intervals, mainly in left (outside) lane with a couple small spalls in Span 1.

Deck - Span 1: Cracking/spalling

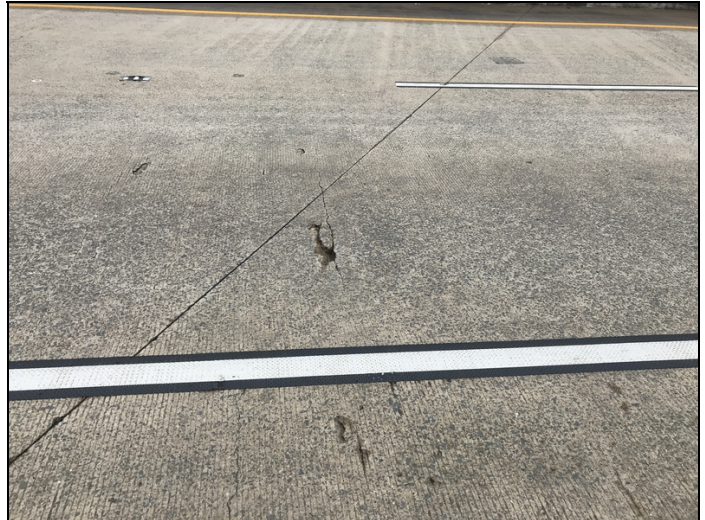
Span 2 right lane: 1' concrete patched area and a very small delamination

Deck - Span 2 : Spalling

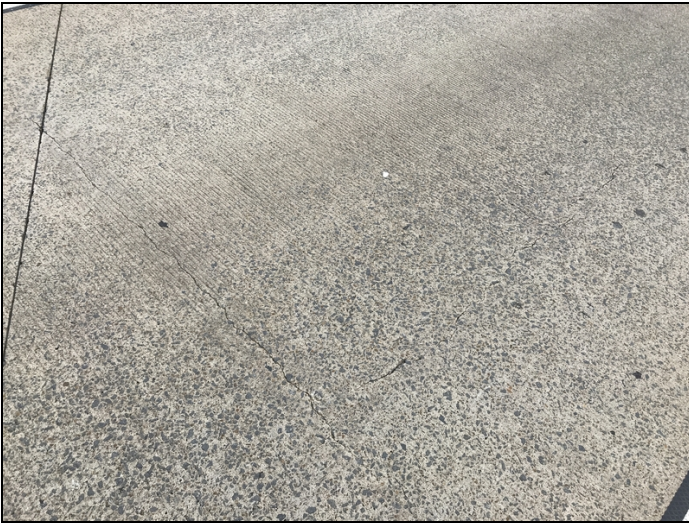
Deck - Span 2 : Cracking

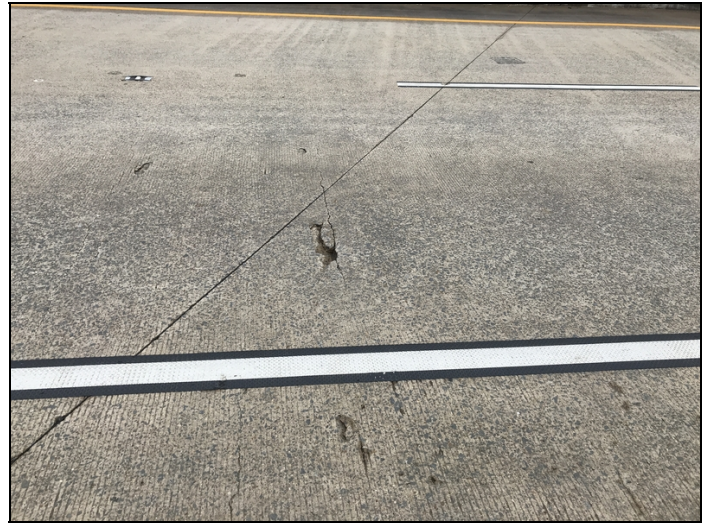
Deck - Span 2 : Spalling

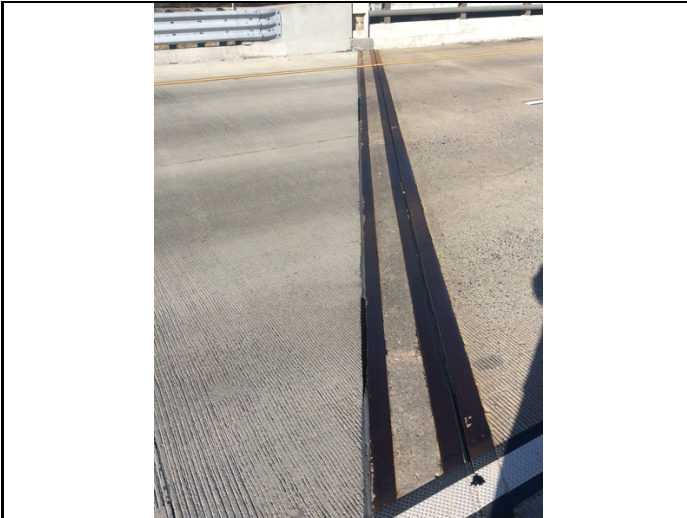
Bent 4 - joint adjacent to approach slab: Pourable joint filler has failed and had left a couple gaps, allowing stormwater to leak through.

Bent 4 - Joint adjacent to approach slab: Loss of
adhesion
