# BRIDGE INSPECTION REPORT NBIS FORM III

Inspected by RLW / TCT  
 Date 04-08-2003

Dist- 02; Co- 01 -- ARKANSAS; Rte- 00299; Sect/Zone- 00/A; Log- 003.650; Str #- 20859

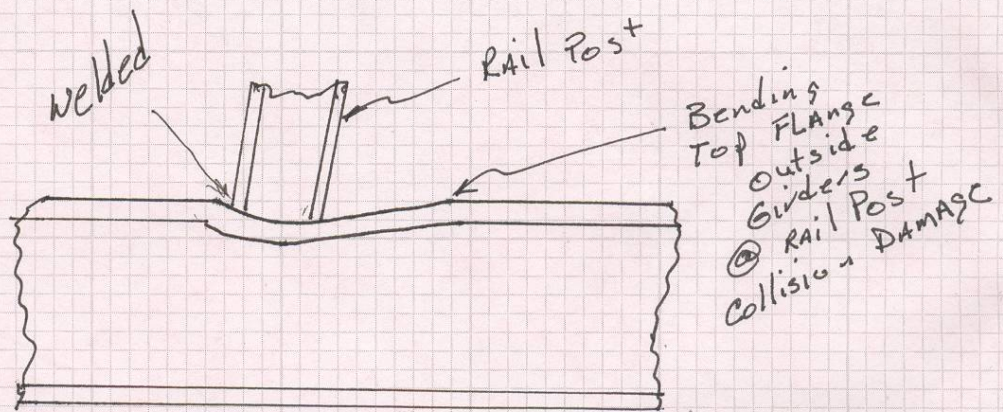
Rt side Post 2 Broken off  
 Post 3 Weld Broken FLange Damaged  
 Post 5 Weld Broken FLange Damaged  
 Post 15 Weld Broken FLange OK

Lt. side Post 3 Post 4 FLange Damaged

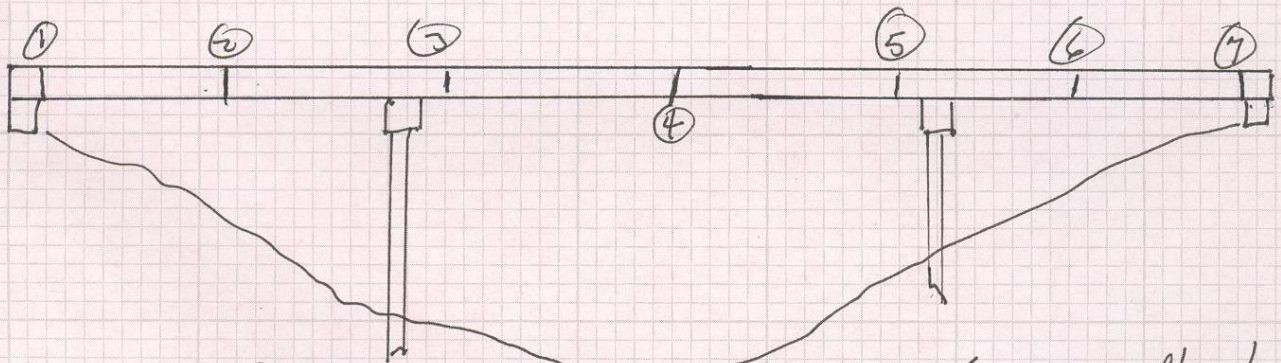
Location of Pin/Connection Plats.

# 4 P/C Plt Deflects most Free Play  
 @ Pins. ( $\frac{1}{8}$ "  $\pm$   $\frac{1}{16}$ " )

# 2 & 6 P/C Plts. Deflect Little. Less Than  $\frac{1}{8}$ " Free play.

Note Cover Plate Between Girders 2 & 3 Weld Broken. These are located @ P/C Plts 3 & 5.
