Bridge 20859 Inspection Report

Route:299 Section:00 Log:3.65

Benzal Lane-GFC over Menard Bayou

Team Lead: Greg Loomis Inspection Date: 08/26/2024

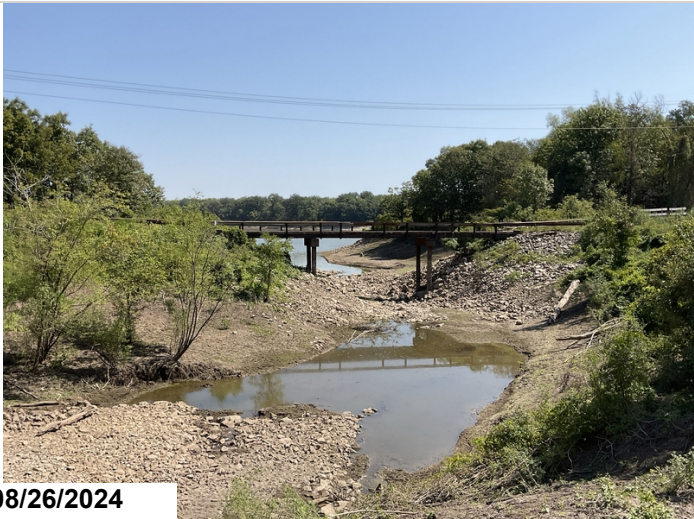
Elevation - Right side view

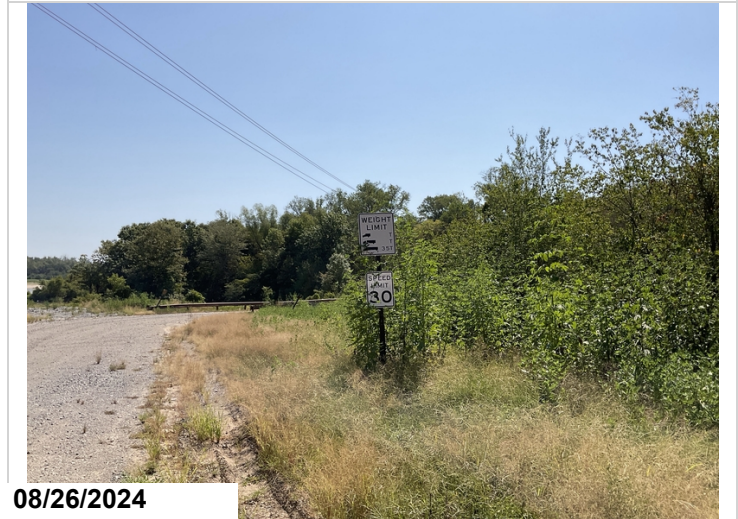
Load posting sign - Beginning

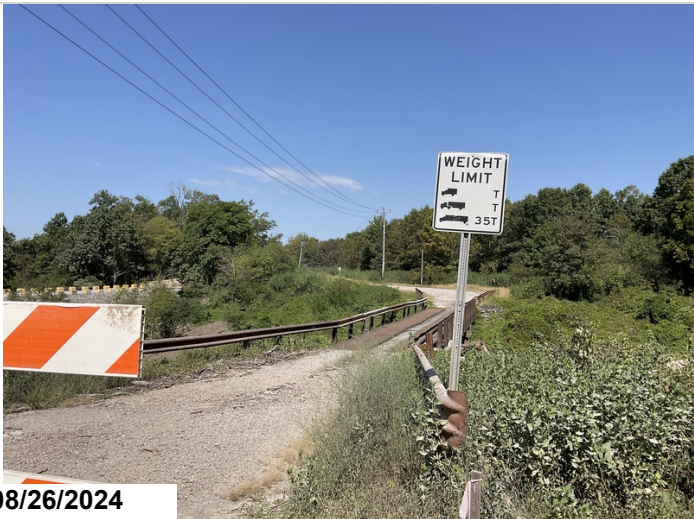
Load posting sign - End

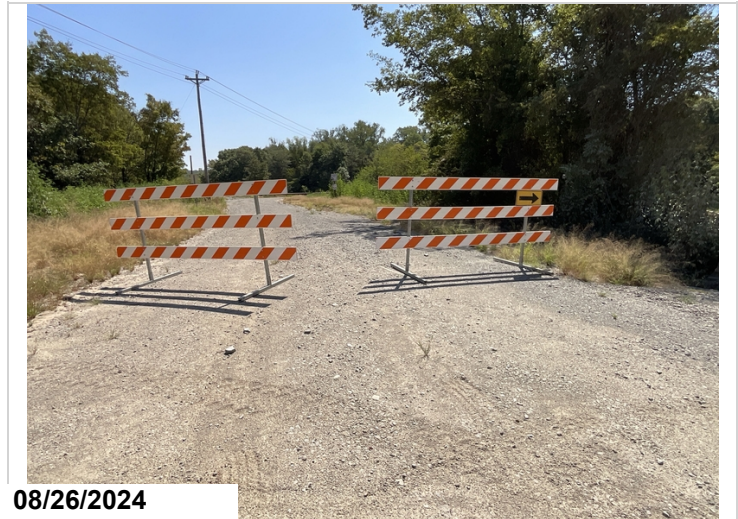
Road closed - West end

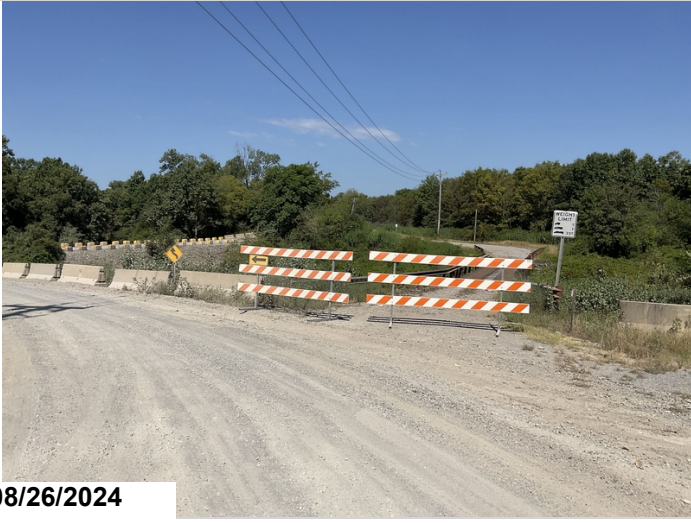
Road closed - East end

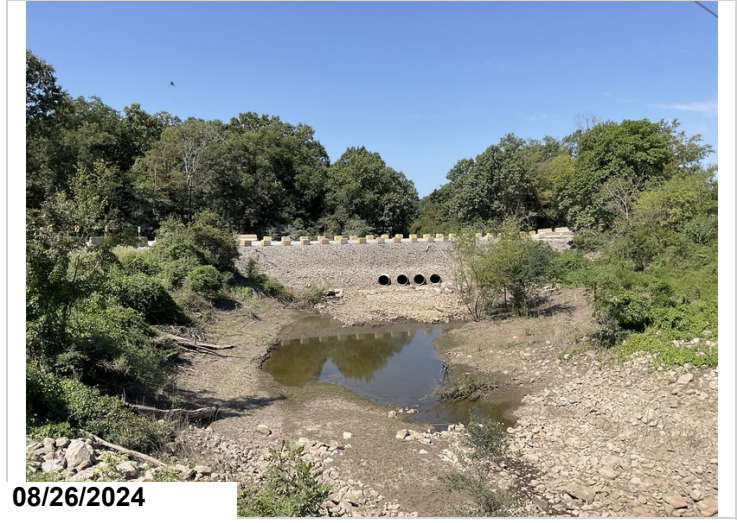
New/detour road
